EVALUATING WINDOW RETENTION OF MOTORCOACH SIDE WINDOWS

SAE Government Industry Meeting:

Aloke K. Prasad, NHTSA
J. Stephen Duffy, TRC, Inc.

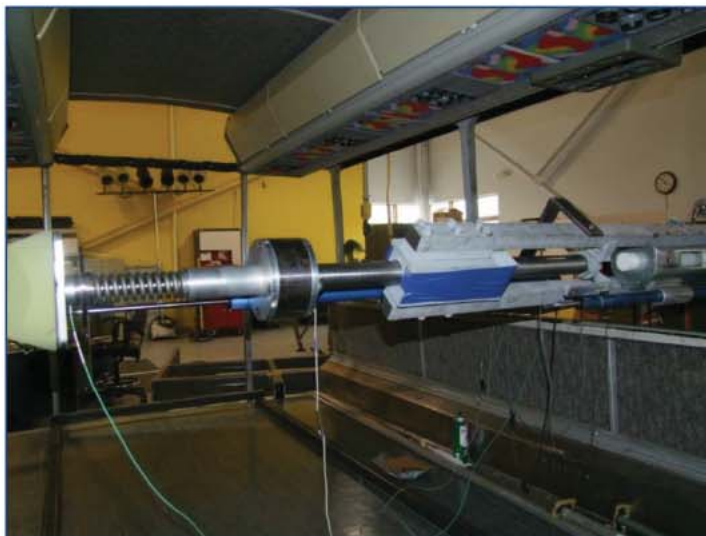
Dynamic Test Procedure (con't)

- Linear – Constrained to Uniaxial Motion at Specified Speed
- Represents Mass and Stiffness of SID Dummy Torso
- Mass of Impactor: 26 Kg (Effective Mass Measurements from Computer Modeling)
- Spring Used to Replicate Compression of Thorax (from Computer Modeling)
- Shoulder Foam Part from SID Affixed to Impactor Face
- Impactor Face Geometry Estimated as Contact Area Between Shoulder and Glazing
- Piezoelectric Force Transducer
- Linear Potentiometer records impactor displacement

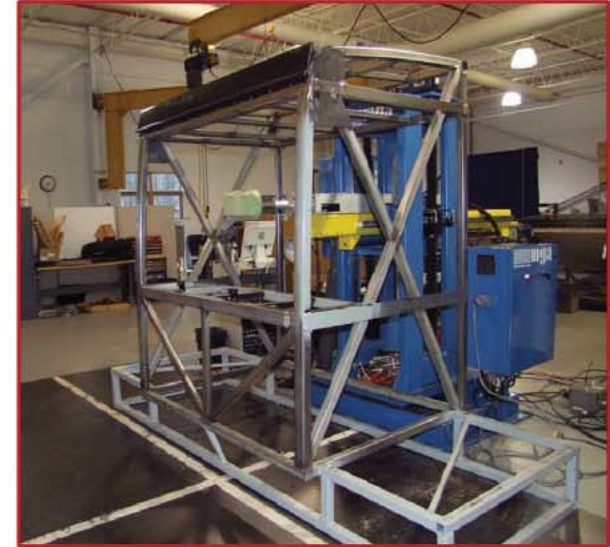
Test Matrix

➤ Motorcoach Frame Testing

➤ MCI-E/J,

Double-glazed
laminated(interior)/tempered
Single-glazed laminated

Van Hool, Prevost

Double-glazed
tempered/tempered

- Center and near latch impacts
- Center impacts with pre-broken glazing

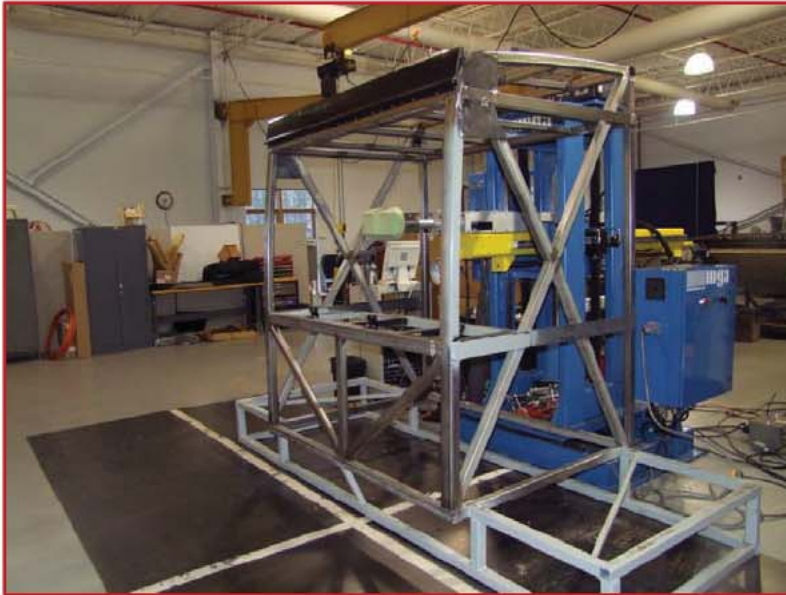
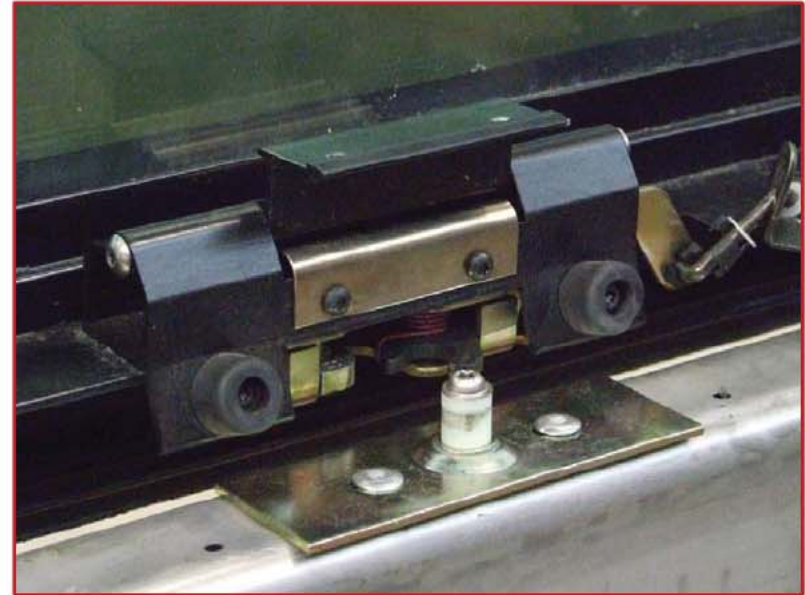
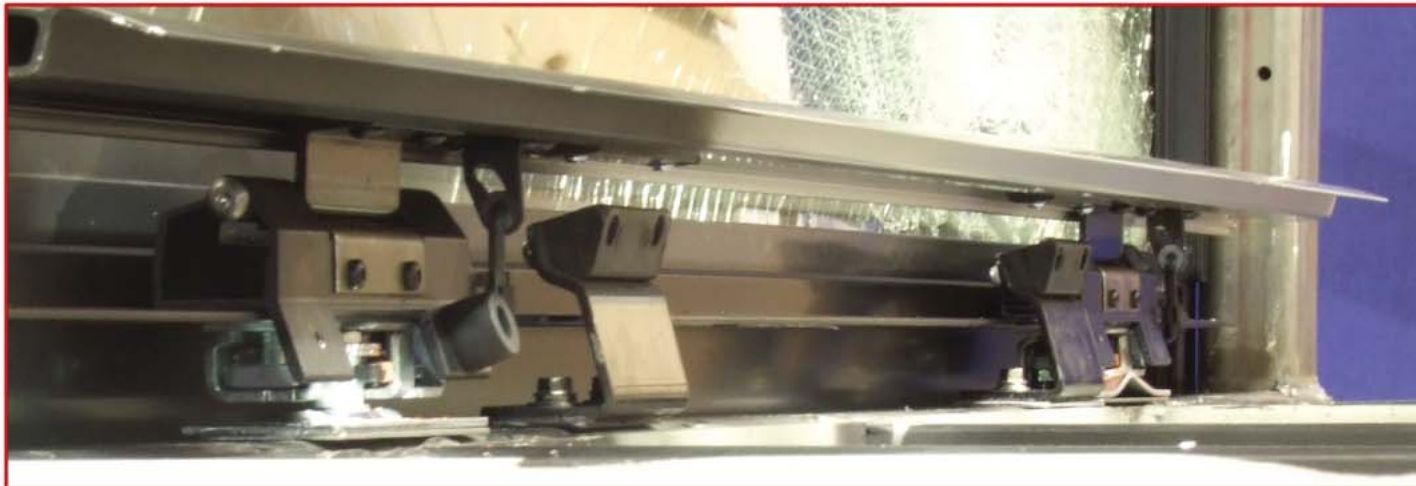
MCI E/J Series

- Single Glazed - Laminated Glass
- Double Glazed-Tempered Outside/Laminated Inside
- Latching Mechanism Similar to Passenger Vehicle

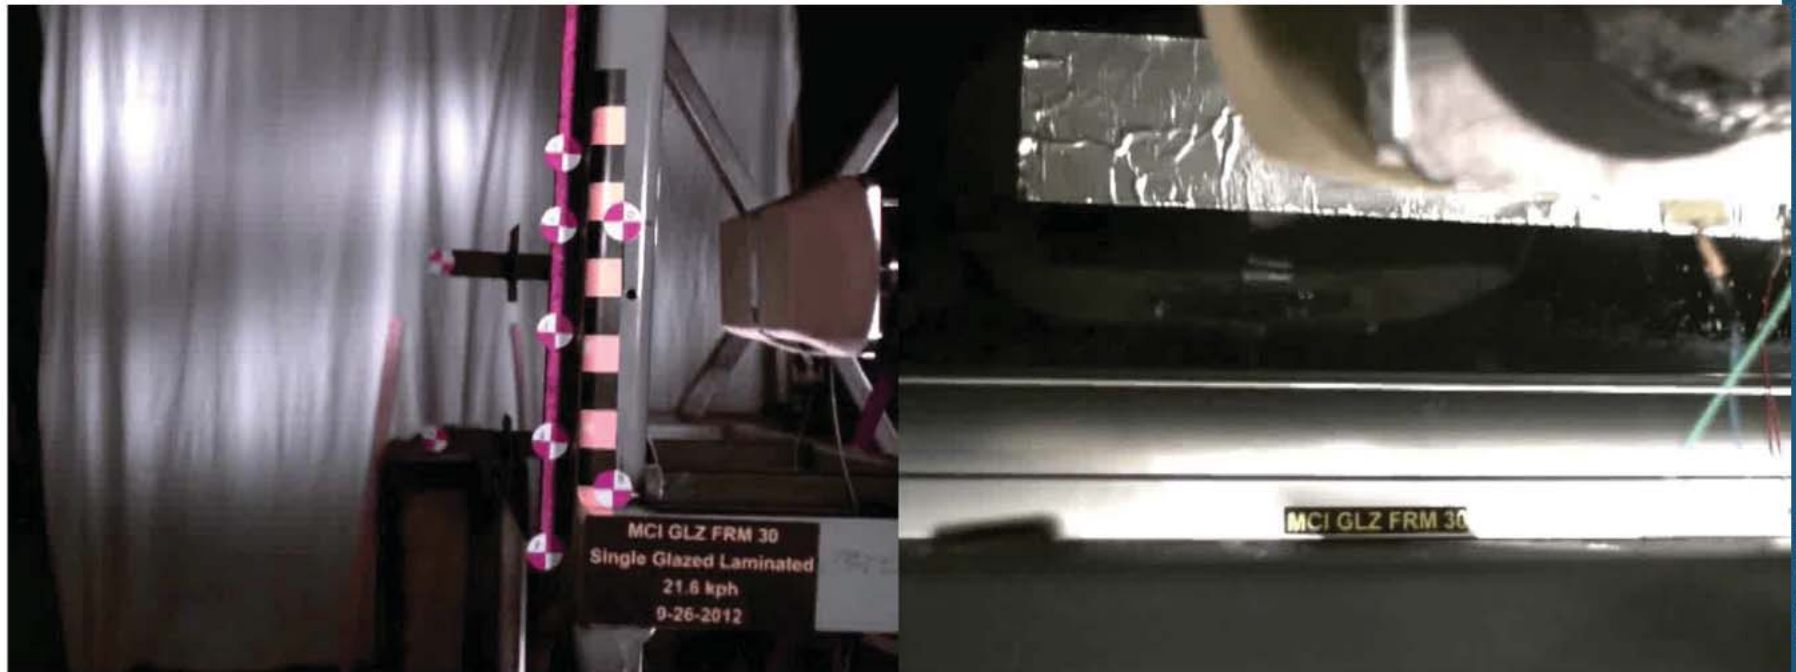
MCI-E/J Near Latch Impact

- Glazing Type: Single Glazed - Laminated
- Impact Speed: 21.6 km/h
- Peak Excursion Beyond Window Plane: 337 mm

- Windows from all three manufacturers exhibited latch openings.
 - Van Hool exhibited latch opening in the 9 – 10 km/h range.
 - Prevost exhibited latch opening in the 11 – 12 km/h range.
 - MCI E/J-series exhibited latch opening in the 18 – 21 km/h range.

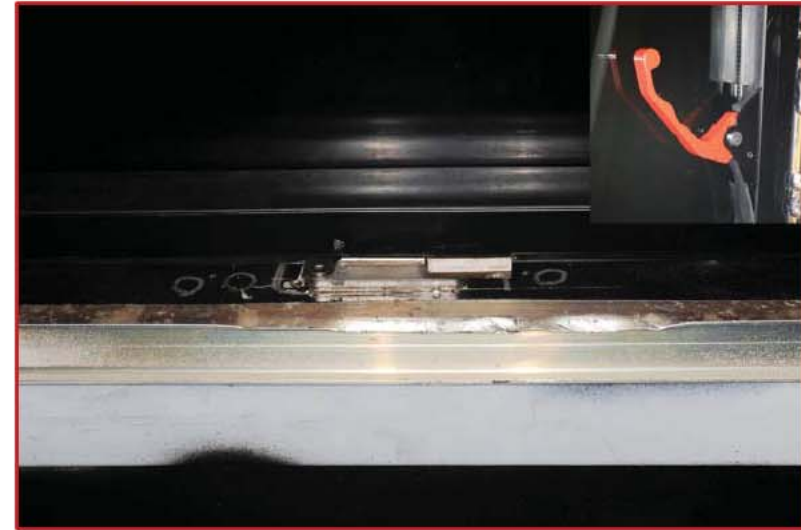
Van Hool C2045

- Double Glazed – Tempered/Tempered Glass
- Sliding Latch Mechanism

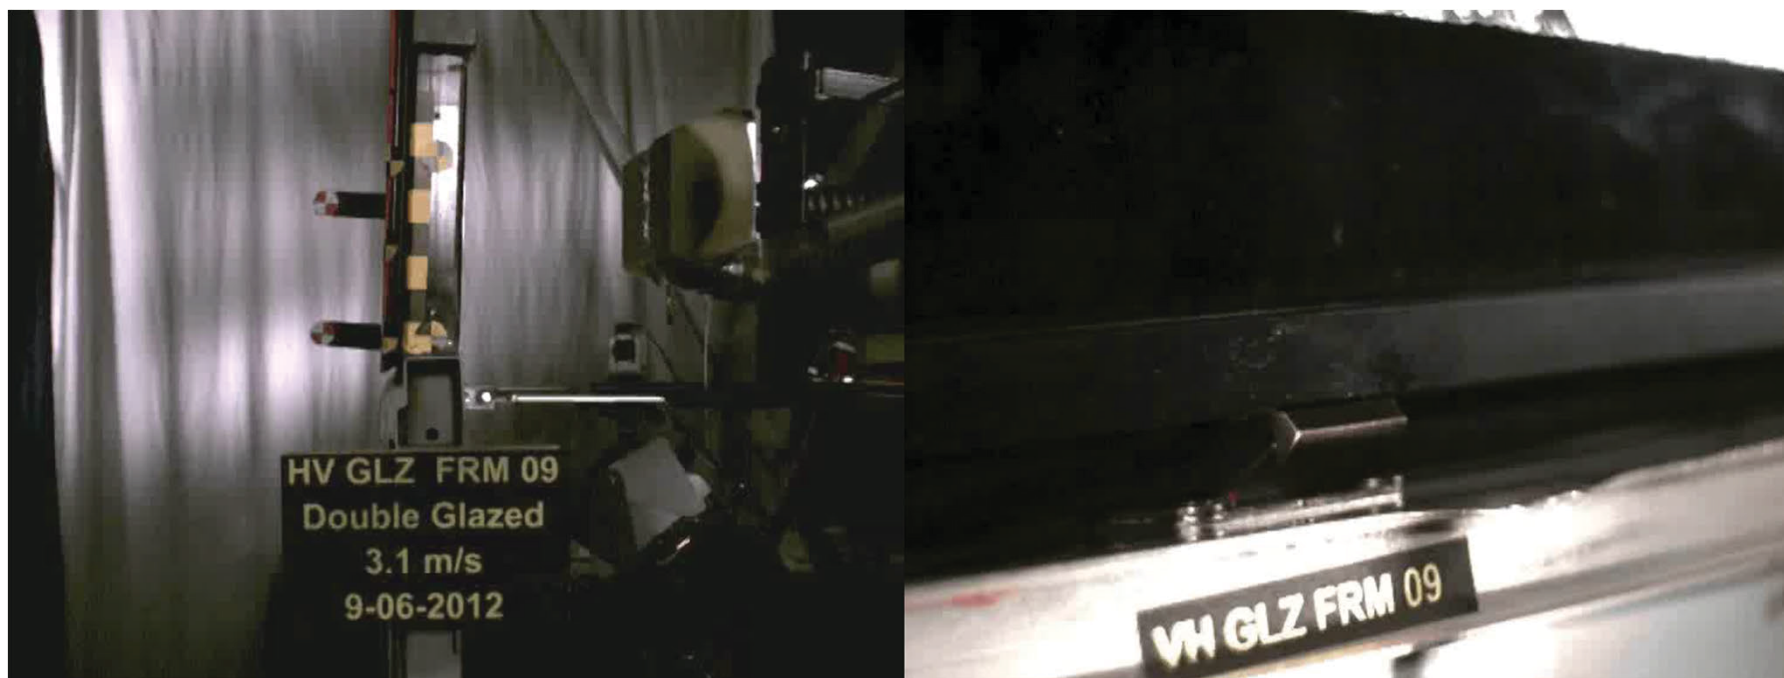
Van Hool Near Latch Impact

- **Glazing Type: Double Glazed - Tempered Outside/Tempered Inside**
- **Impact Speed: 11.0 km/h (TC speed is 21.6 kph)**
- **Peak Excursion Beyond Window Plane: 88 mm**

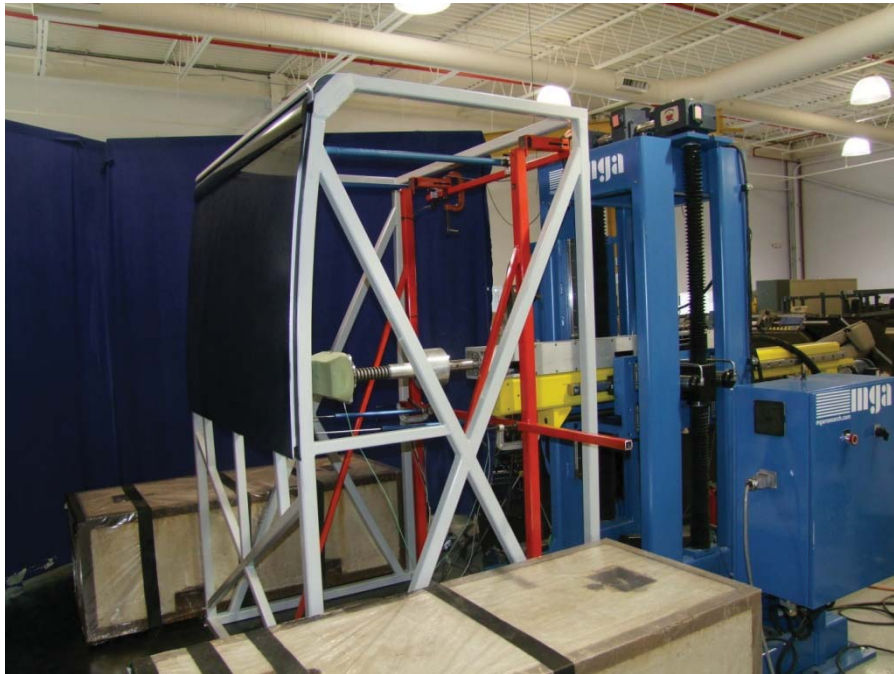
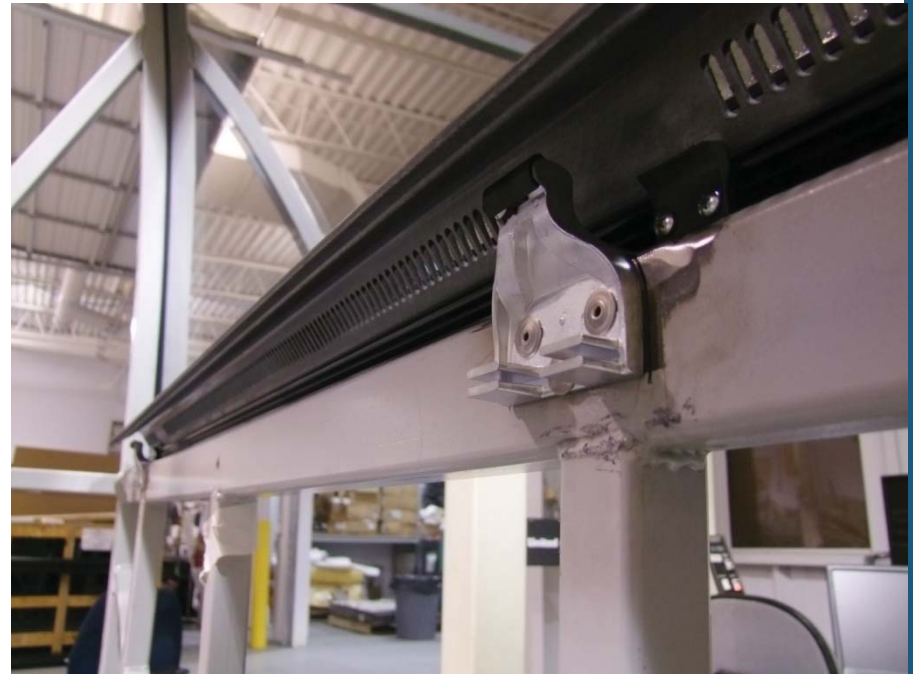
Prevost H3-45

- Double Glazed – Tempered/Tempered
- Latch Bar Latching Mechanism

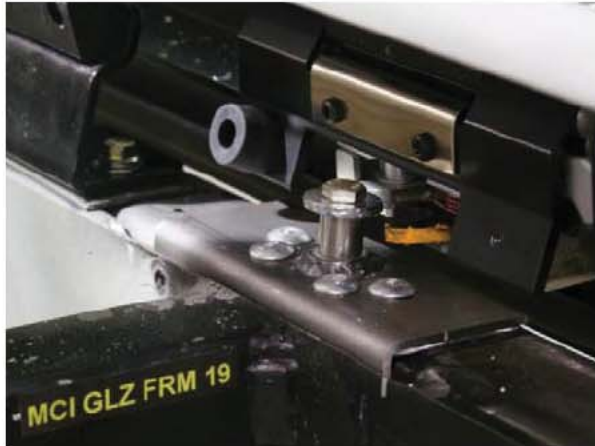
MCI E/J countermeasure

Near latch impact with countermeasure latches:

- MCI: latch & glass intact, simple countermeasure
- Prevost: latch failed, glass intact
- Van Hool: latch failed, glass intact

Center impacts with countermeasure latches:

- MCI: latch intact, laminated pane broke
- Prevost: latch intact, glass panes intact
- Van Hool: latch intact, both panes shatter

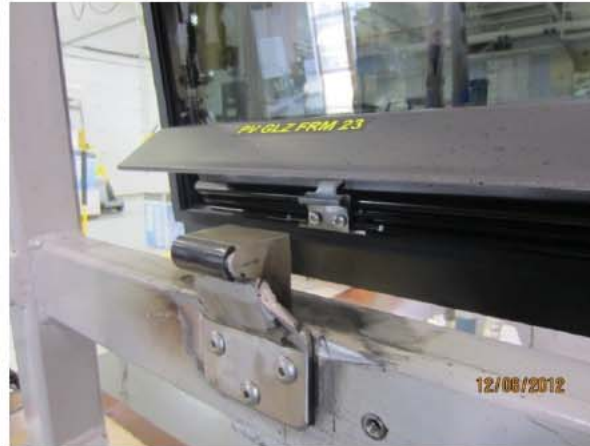
Prevost countermeasure

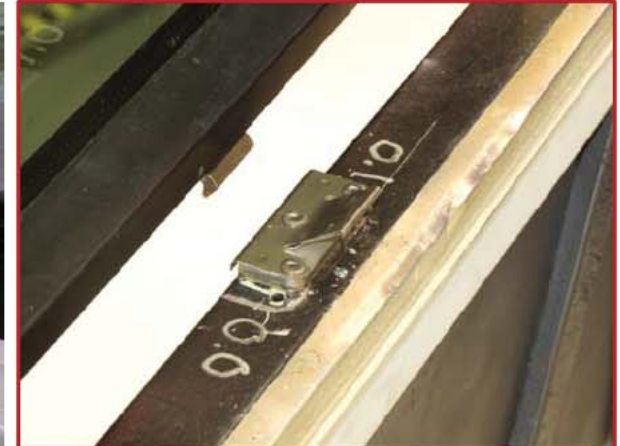
Van Hool production

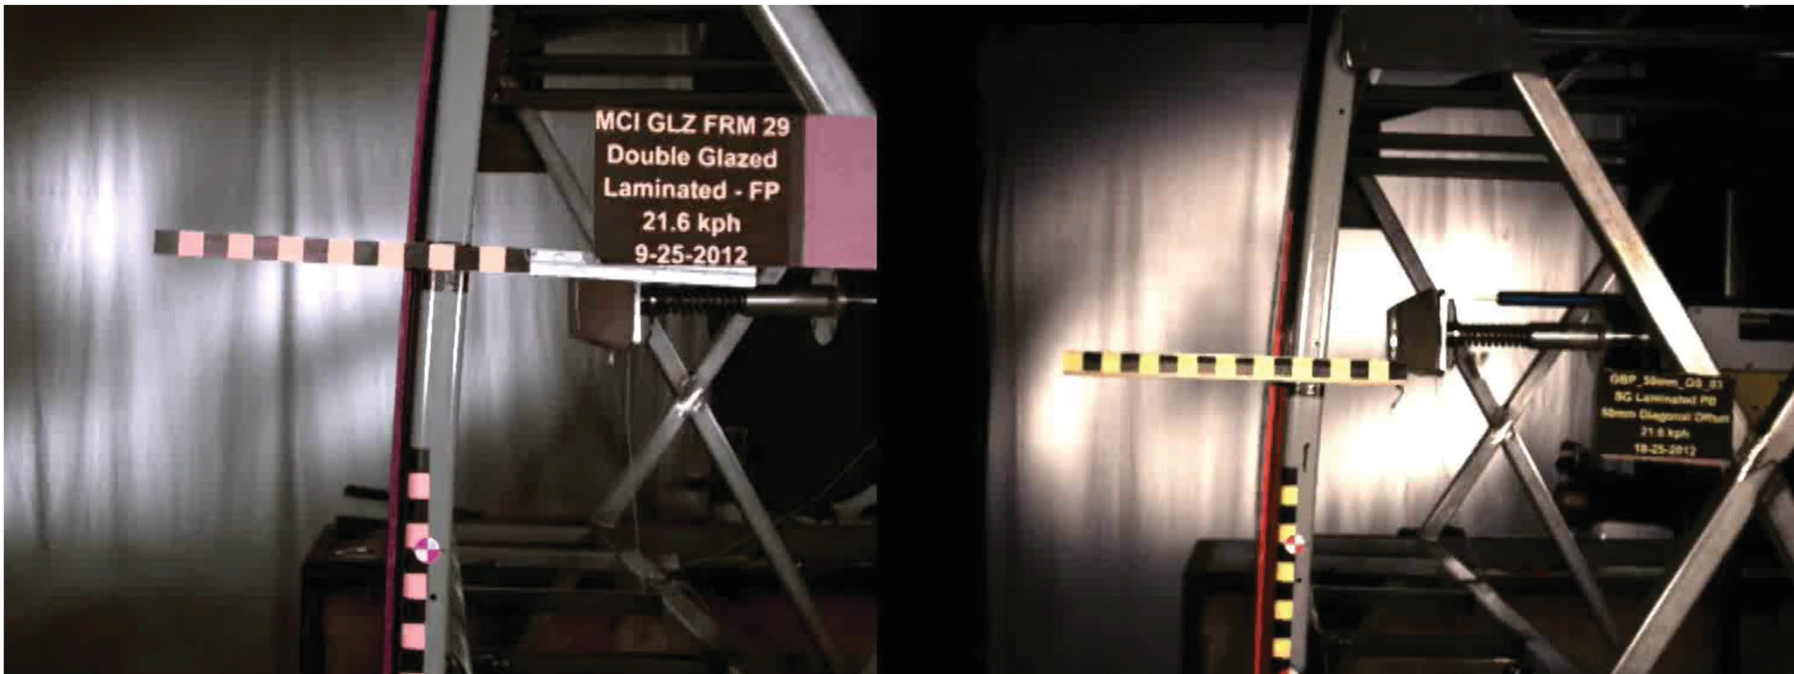
Center Impacts – Pre-Broken

- Glazing Type: MCI - Laminated Glass Pre-Broken
- Impact Speed: 21.6 km/h
- Excursion from linear potentiometer on impactor face plate

Fully Pummeled
224 mm Excursion

50 mm Diagonal Staggered Grid Pattern
199 mm Excursion

- Center of daylight opening impacts (Martec study conditions) into fully pummeled production glazings resulted in an average maximum excursion of 214 mm.
