LTPP Pavement Maintenance Materials: SHRP Crack Treatment Experiment, Final Report

PUBLICATION NO. FHWA RD-99-143

SEPTEMBER 1999

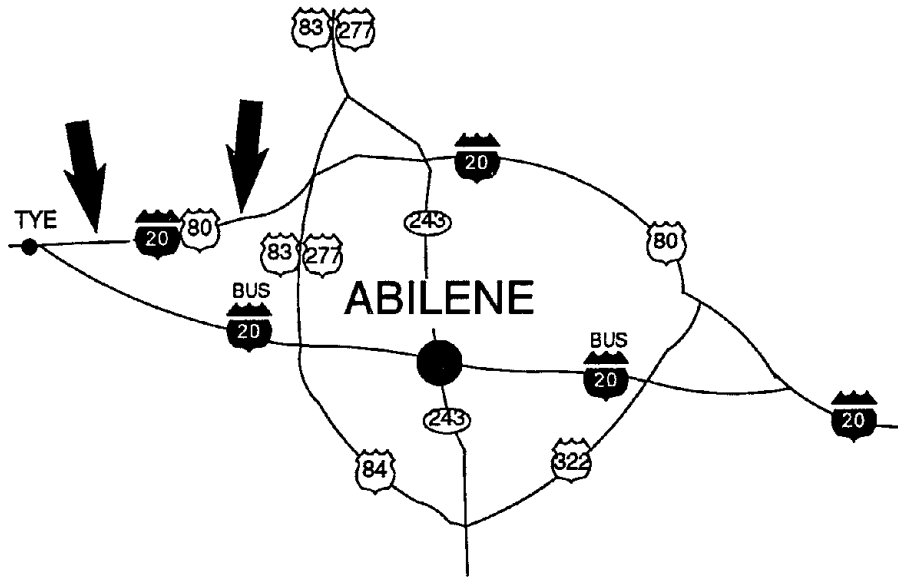
Figure 3. Abilene, Texas transverse crack-seal test site.

This crack-seal test site, representing the dry-nonfreeze climate, was located between mileposts 278 and 282 in the westbound driving lane of Interstate 20 near Abilene, Texas (see figure 3). The pavement section was originally constructed in the mid-1960s using 76 mm of AC, 203 mm of crushed limestone base, and 406 mm of crushed caliche subbase placed on a 152-mm lime-stabilized subgrade. A 64-mm AC overlay with a geofabric interlayer was placed in 1989.

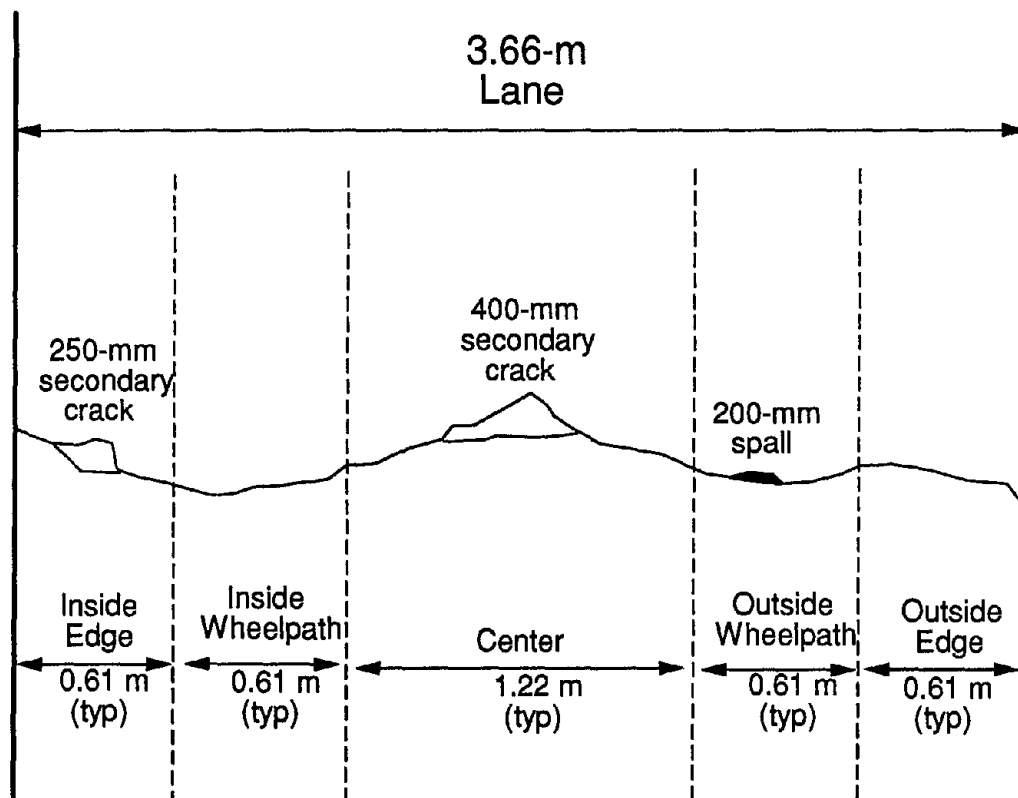
Figure 9. Initial inspection sketch of transverse crack.

At the crack-seal sites, a detailed inspection of experimental cracks 3 through 10 in each test section was performed. This inspection involved sketching the general pattern of each crack and recording the location(s) of deteriorated segments as a function of lane position (see figure 9). A similar, less-intensive inspection was done on experimental cracks 5 through 12 in each section at the crack-fill site. Since the longitudinal cracks were much straighter and more deteriorated, only the excessively wide or potholed crack segments were identified and recorded.

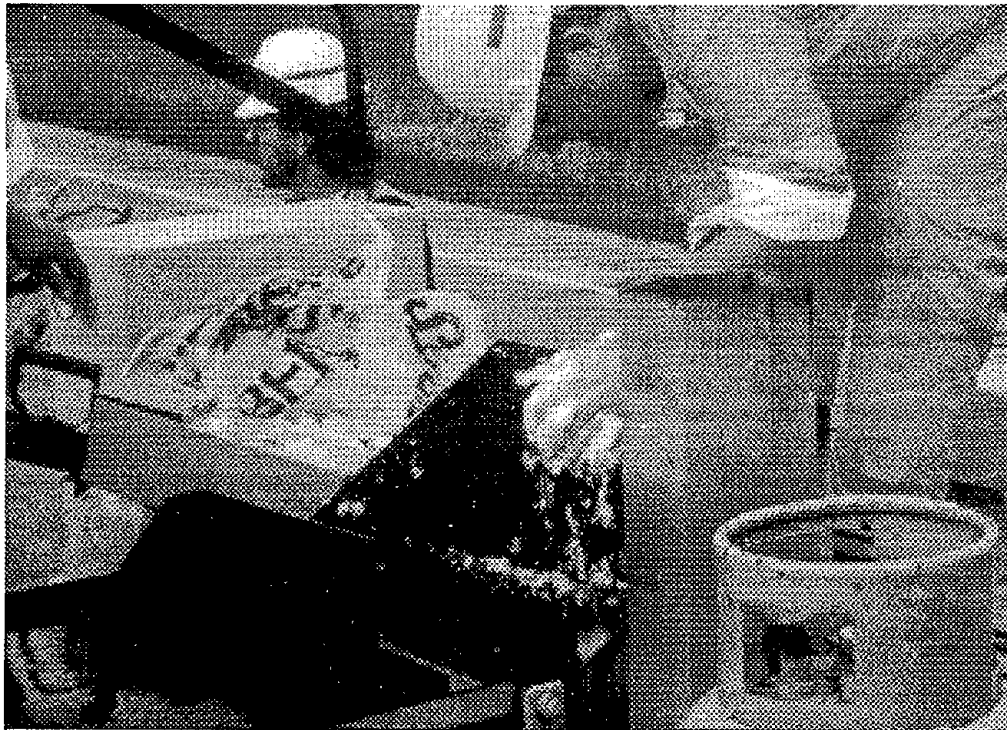
Figure 12. Addition of BoniFiber polyester fibers to asphalt cement.

Polyester fiber came packaged in 9.1-kg bags, three per box. The fiber was pre-weighed (5 percent by weight of asphalt) at the maintenance yards and added on site to the asphalt cement, which was kept heated in the kettles (see figure 12). The entire process of adding the fibers, thoroughly mixing the components, and heating to the application temperature usually took between 1 and 2 hours, depending on the melter unit agitation system. Units with full-sweep agitation capabilities greatly expedited preparation.

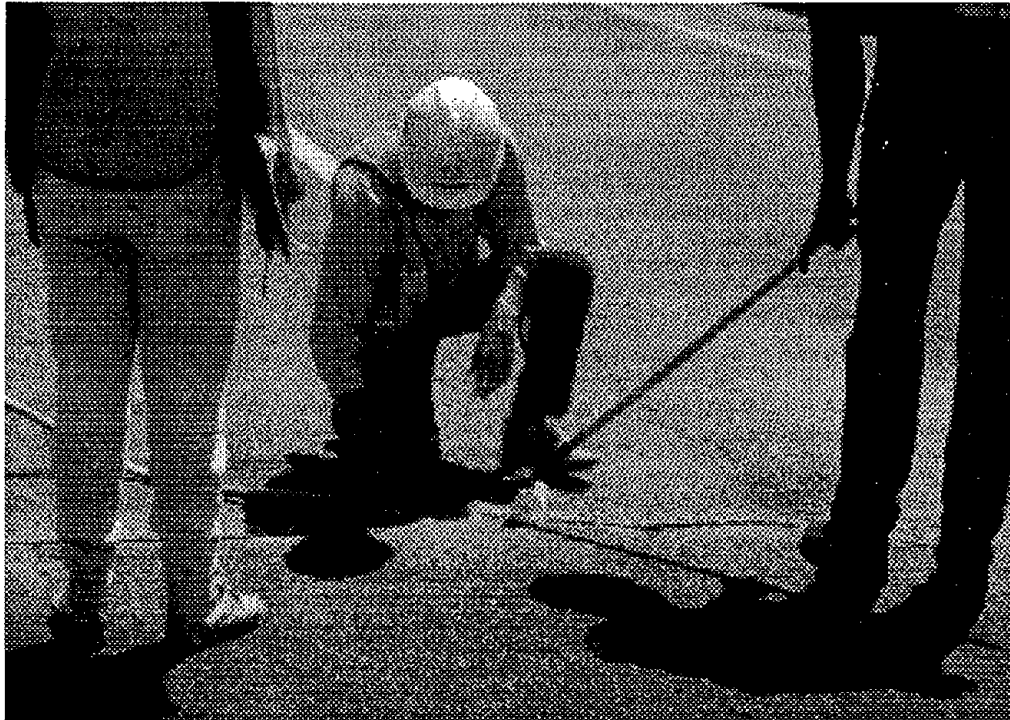
Figure 13. Backer rod installation.

1. Light sandblasting of the crack reservoirs.
2. Airblasting with compressed air.
3. Placement of backer rod at a nominal depth of 16 mm.
4. Installation of sealant, recessed 6 mm below the pavement surface.

The backer rod used in the experiment was 22-mm-diameter closed-cell Sof[®] Rod. A roller-type insertion tool was used to install the backer rod below the pavement surface. Figure 13 shows backer rod installation.

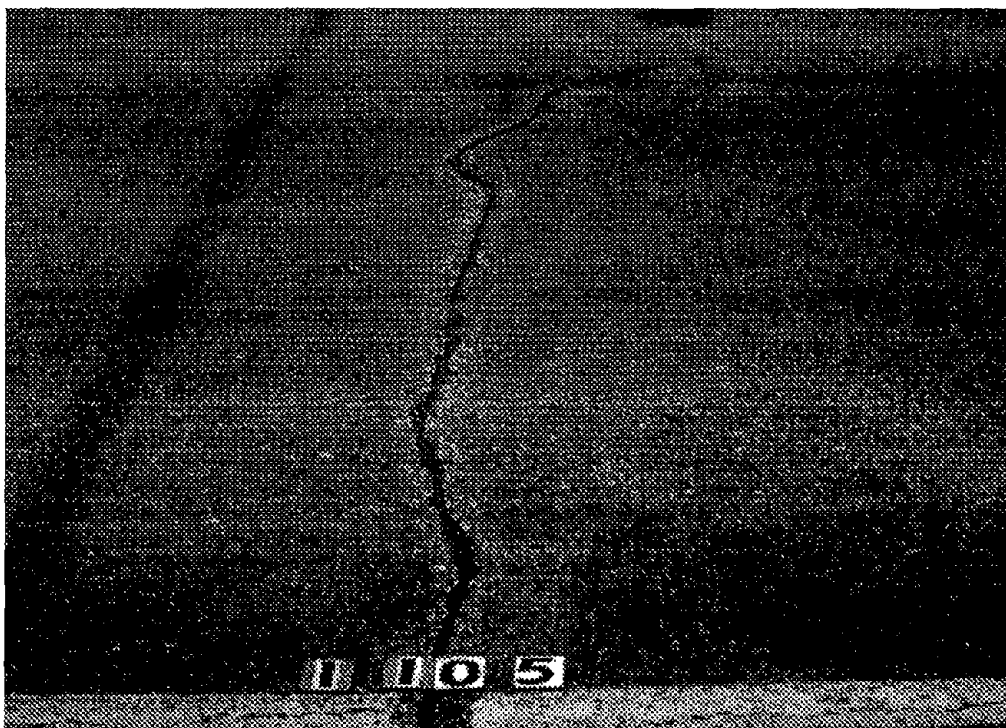
Figure 14. 890-SL deep reservoir-and-recess configuration (configuration E).

Because of the small amount of material required for the experiment, 857-mL cartridges of 890-SL were purchased instead of the 151-L drums typically used in sealing projects. Both manual and air-powered caulking guns were used to dispense the silicone into the cracks. Figure 14 shows the in-place, recessed silicone.

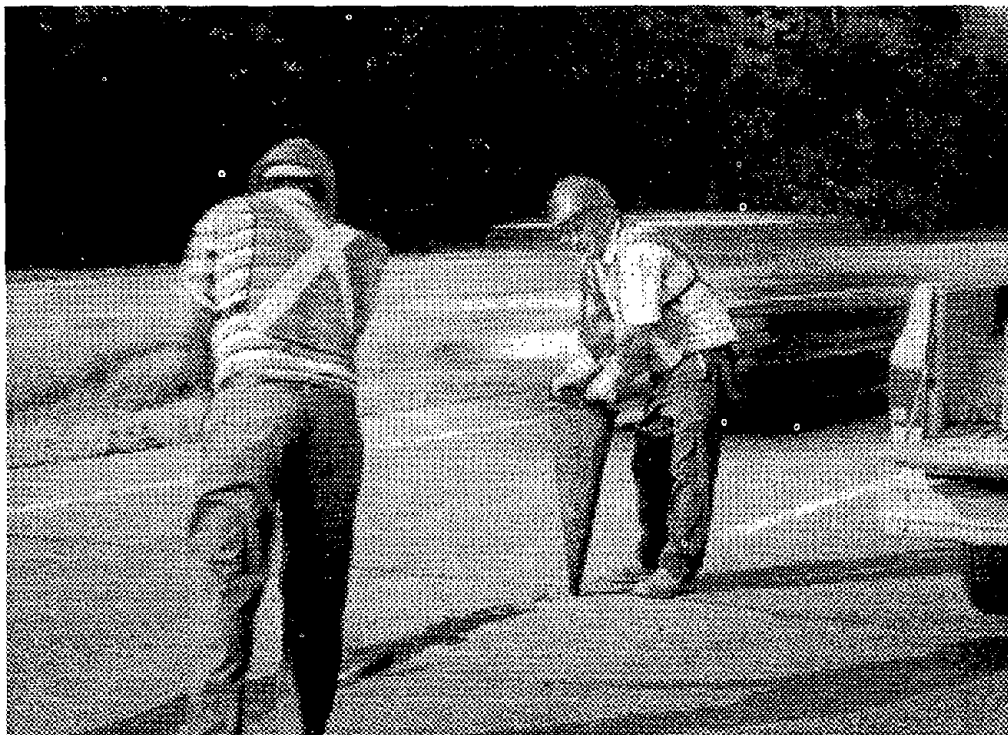
Figure 15. Placement of CRF in flush-fill configuration (configuration G).

Two replicate sections of CRF were installed in the experiment. In these sections, crack cleaning was accomplished by conventional airblasting, hand-held pour pots were used to place the emulsion into the cracks, and a flush squeegee was used to strike off excess material. Figure 15 shows the placement of CRF in the flush-fill configuration.

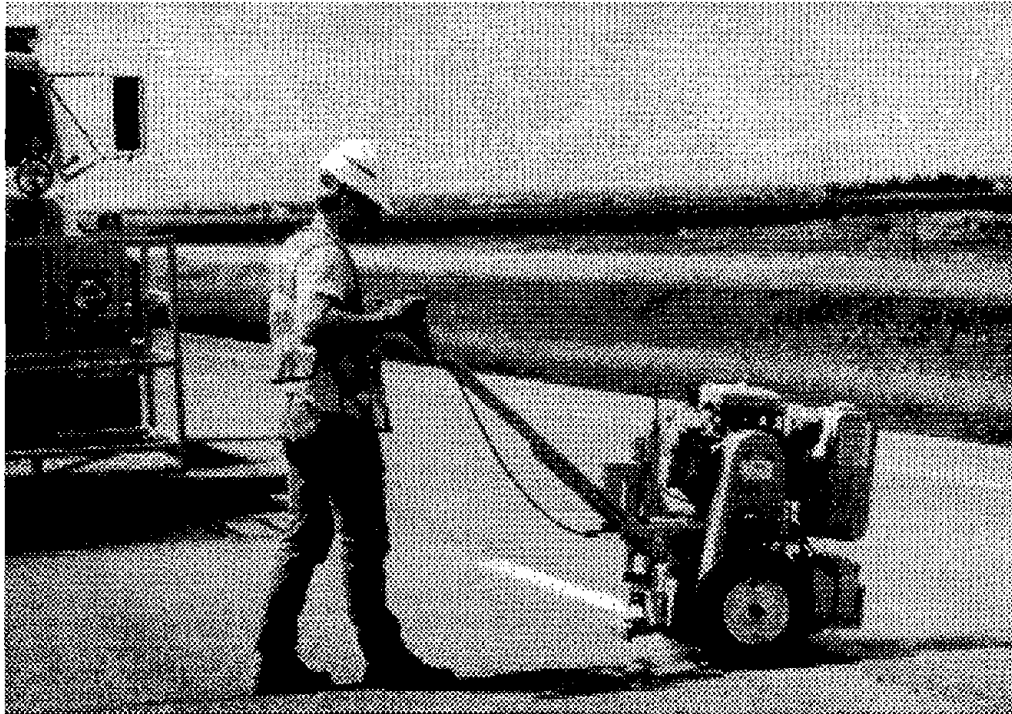
Figure 16. Carbide-tipped rotary-impact router.

With the exception of configurations A and B at the two Wichita subsites, rotary-impact routers manufactured by Crafcro were used to create reservoirs for the hot-applied materials at each crack-seal site. Pressed with a considerable amount of crack cutting and only one available router, it was decided at Wichita that two Cimline random crack saws, equipped with 203-mm diamond blades, would be used to facilitate the cutting operations. These saws were not quite as productive as the routers, but they provided smoother reservoir sidewalls, the effect of which will be assessed in future analyses. Figures 16 and 17 show the rotary-impact router and diamond blade dry saw used at the two Wichita subsites.

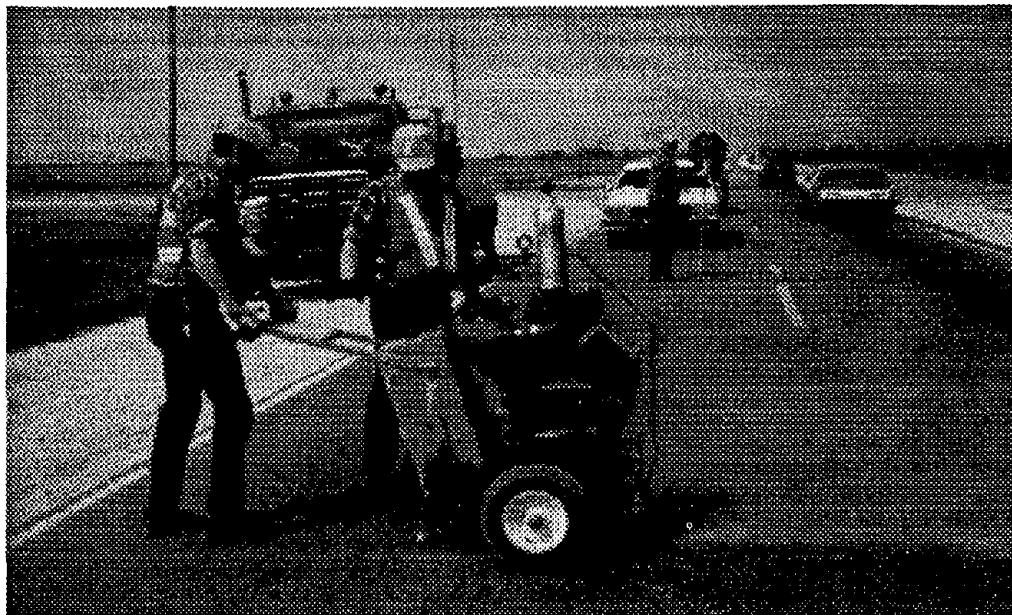
Figure 17. Random crack saw with 200-mm diamond blade.

For the wirebrush-airblast cleaning procedure specified at Des Moines, a commercial power-driven brush was not available. As a substitute, a random crack saw, specially equipped with a 200-mm wirebrush, was used. The wirebrush was somewhat stiff and had an occasional tendency to spall the crack-reservoir edges.

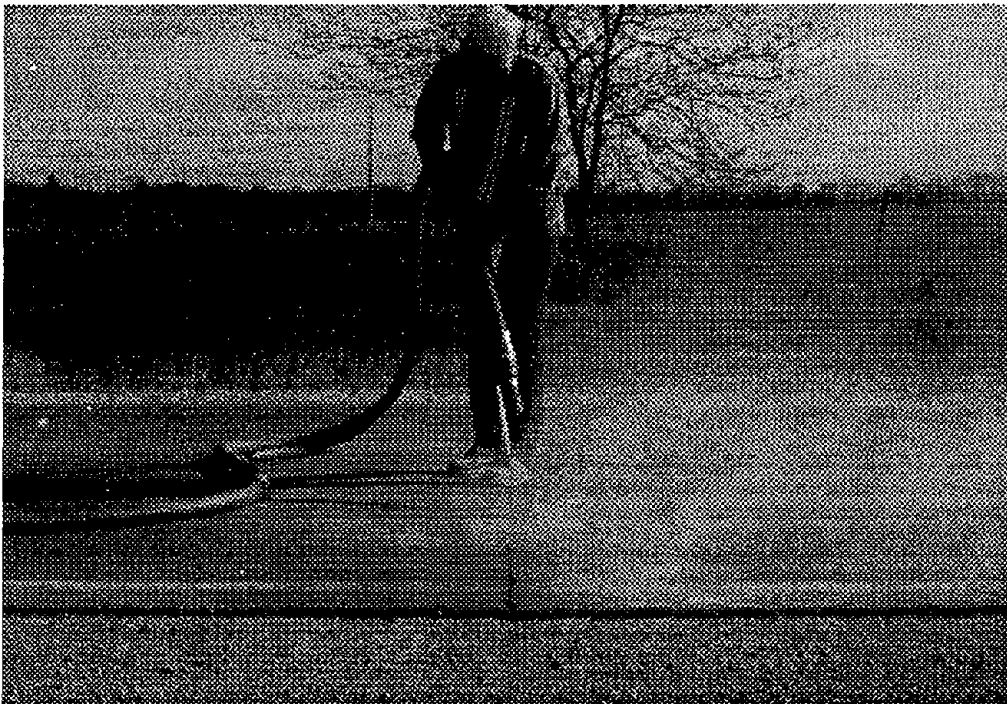
Figure 19. Light sandblasting using wand with attached wooden guide (crack preparation procedure 5).

Most sandblasting operations were conducted using Clemco blast machines connected to portable air compressors. Typically, one pass was made with the sandblaster along each side of a crack reservoir. A short time later, the reservoir and adjacent roadway were cleaned by airblasting. Sandblasting wands were held approximately 100 to 200 mm from the reservoir. At Wichita, a wooden rod was attached to the wand to help direct the blast against the crack sidewalls (figure 19).

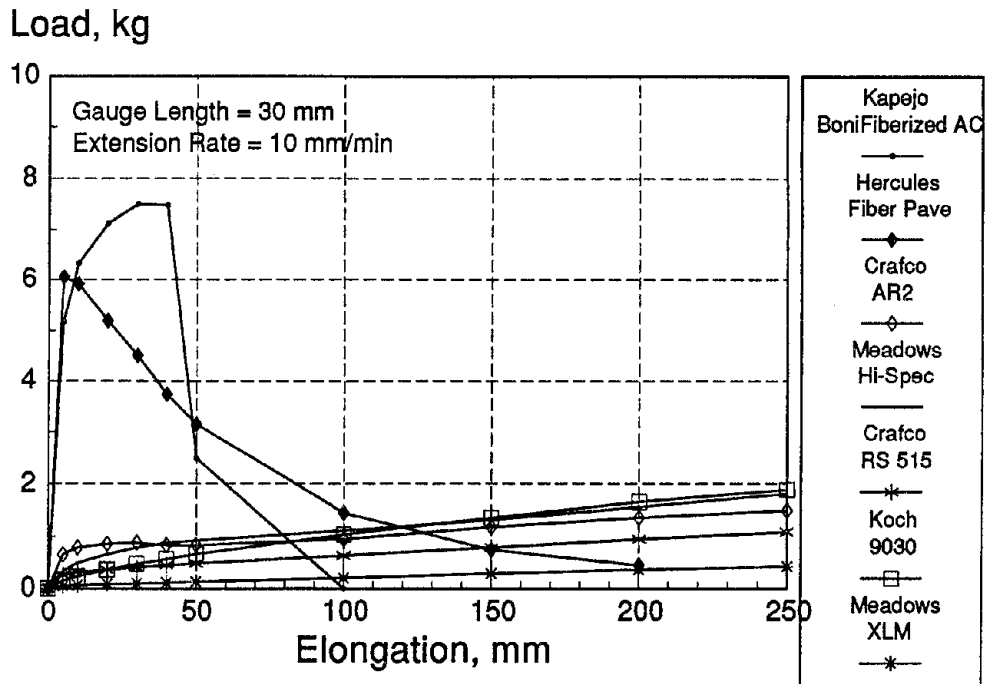
Figure 20. Force-ductility load-elongation curves for various primary materials.

The force-ductility test, a modified version of the ASTM D 113 ductility test, was conducted at 4°C. In the test, briquette material specimens were pulled apart at a rate of 10 mm/min until ultimate rupture. Load-deformation plots were generated from each run. Results from the test showed XLM incurred the lowest buildup of force through 150 percent elongation, followed by RS 515, 9030, AR2, Hi-Spec, and the two fiberized materials (see figure 20).

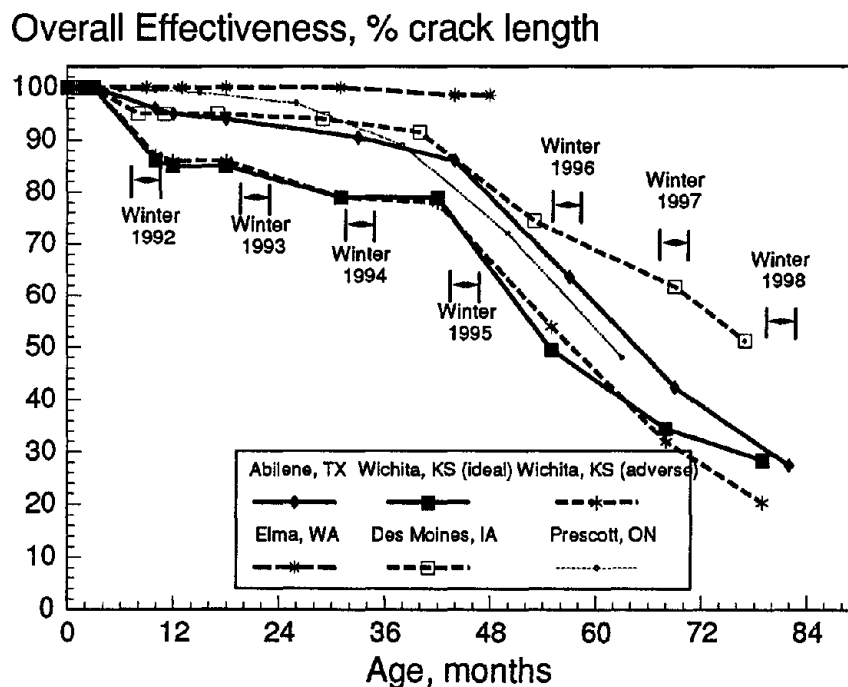
Figure 27. Overall performance trends of primary experimental treatments by site.

Though not each test site was evaluated the planned 10 times, the overall performance trend for each site can be seen in figure 27. Each test site performance trend is represented by the time-series effectiveness values of primary treatments placed at the site. As can be seen, small to moderate drops in treatment performance were experienced in the first three winters at Wichita, Abilene, Des Moines, and Prescott, followed by major reductions in performance in the fourth, fifth, and sixth winters.

At the Elma site, where temperatures are fairly moderate year-round and the traffic level is low, only slight decreases in performance were experienced throughout the entire 4 years of service. Crack fillers at the Prescott site held up fairly well the first two winters, but began incurring substantial failures after the third winter.

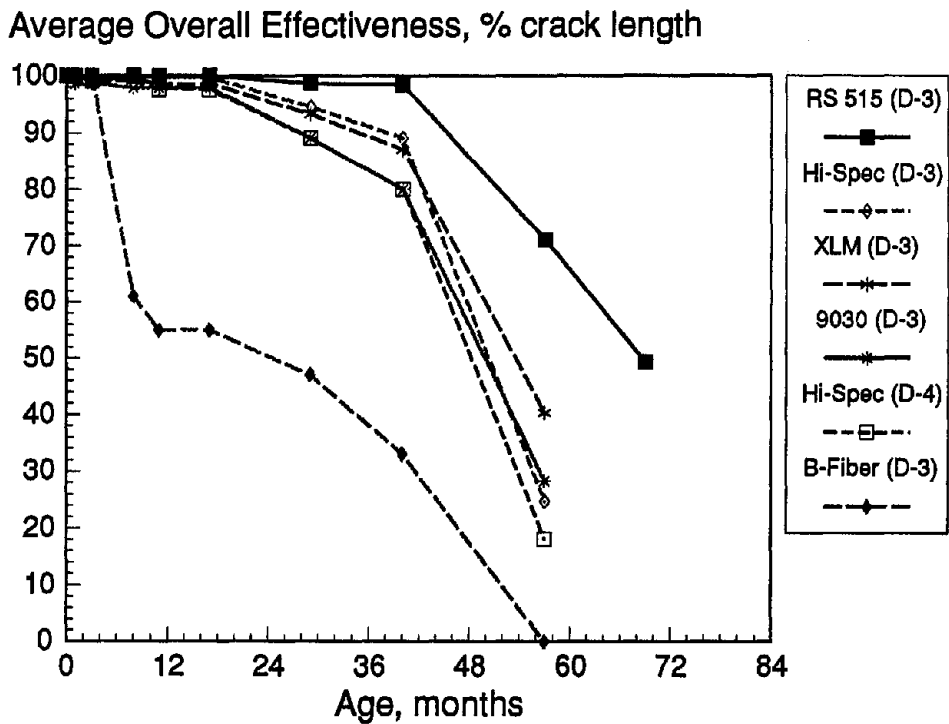
Figure 28. Time-series effectiveness trends of Abilene, TX crack-seal treatments.

Figures 28 through 32 show the time-series effectiveness trends of the crack-seal treatments placed at Abilene, Elma, Wichita, and Des Moines. Excluding the treatments at Elma, only 9 of the 61 treatments exhibited greater than 80 percent overall effectiveness after the final round of evaluations. Moreover, 32 of the 61 treatments reached “failed” status (<50% effectiveness).

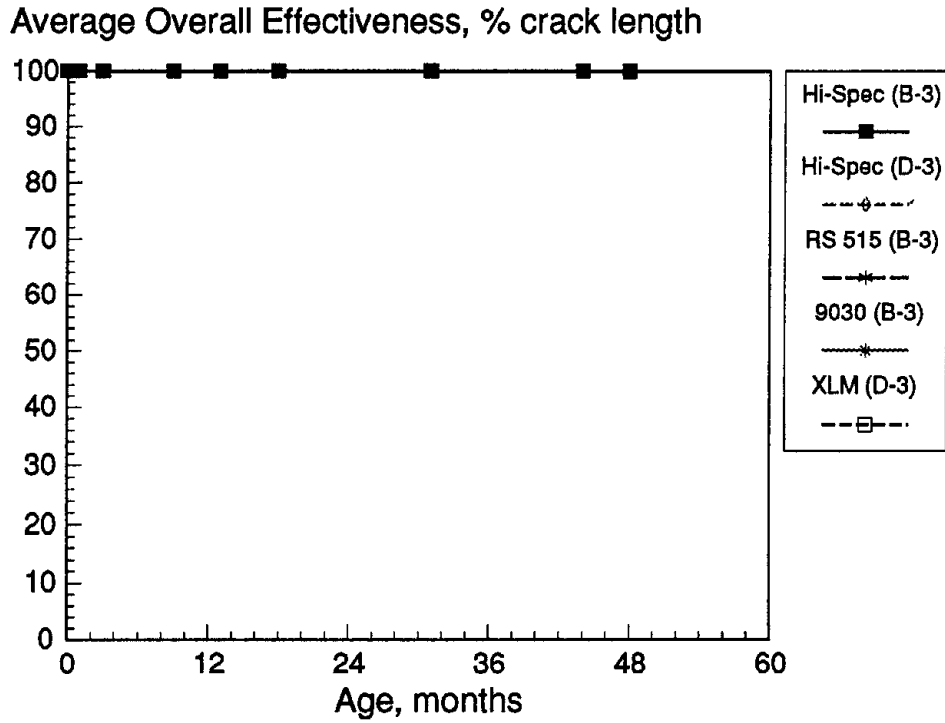
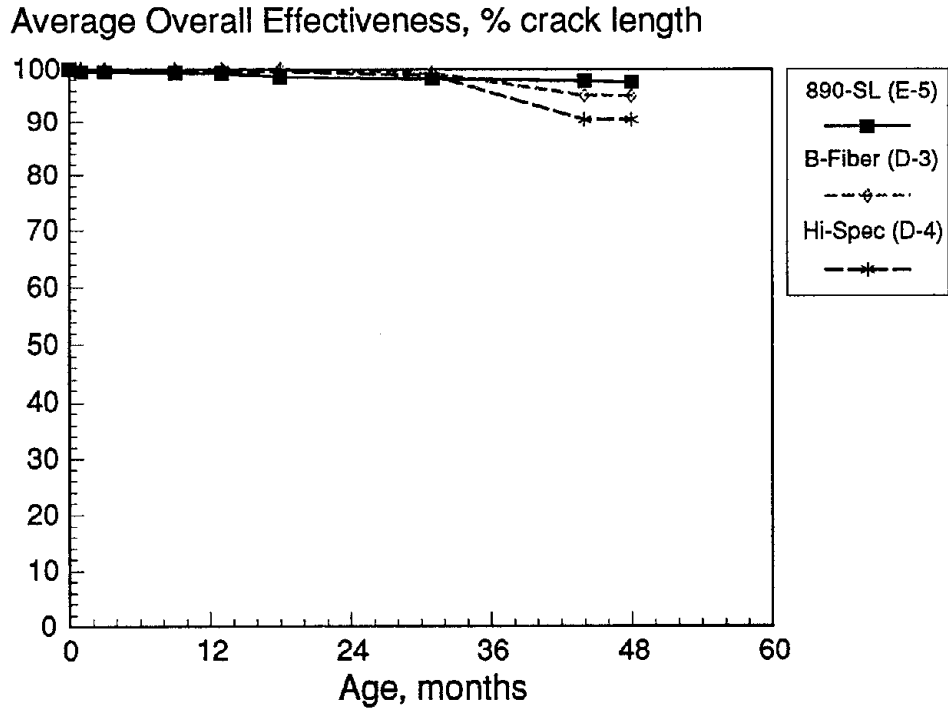
Figure 29. Time-series effectiveness trends of Elma, WA crack-seal treatments.

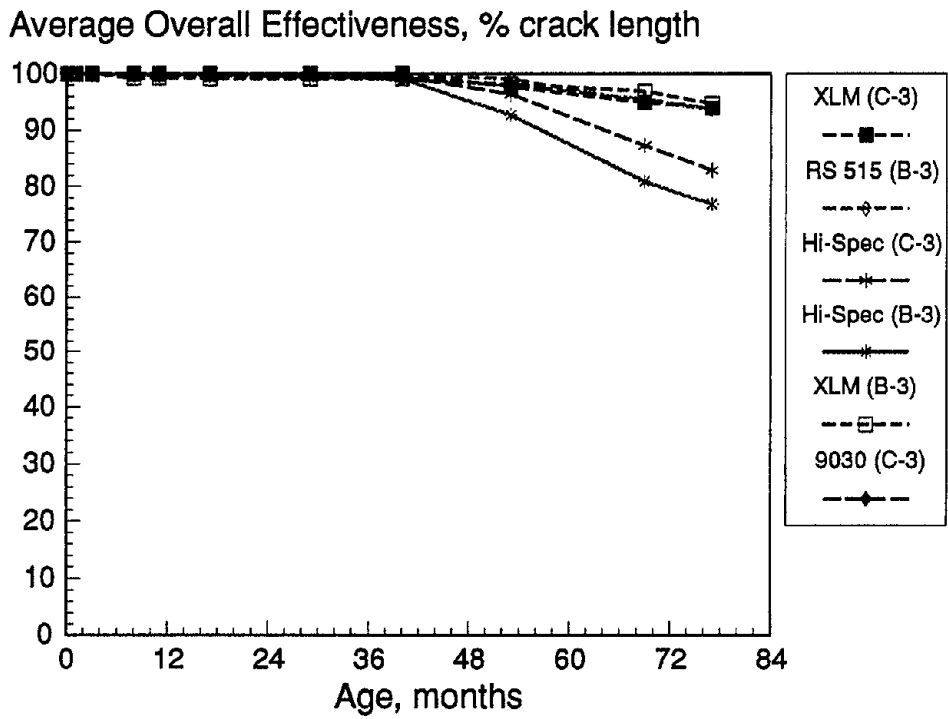
Figure 32. Time-series effectiveness trends of Des Moines, IA crack-seal treatments.

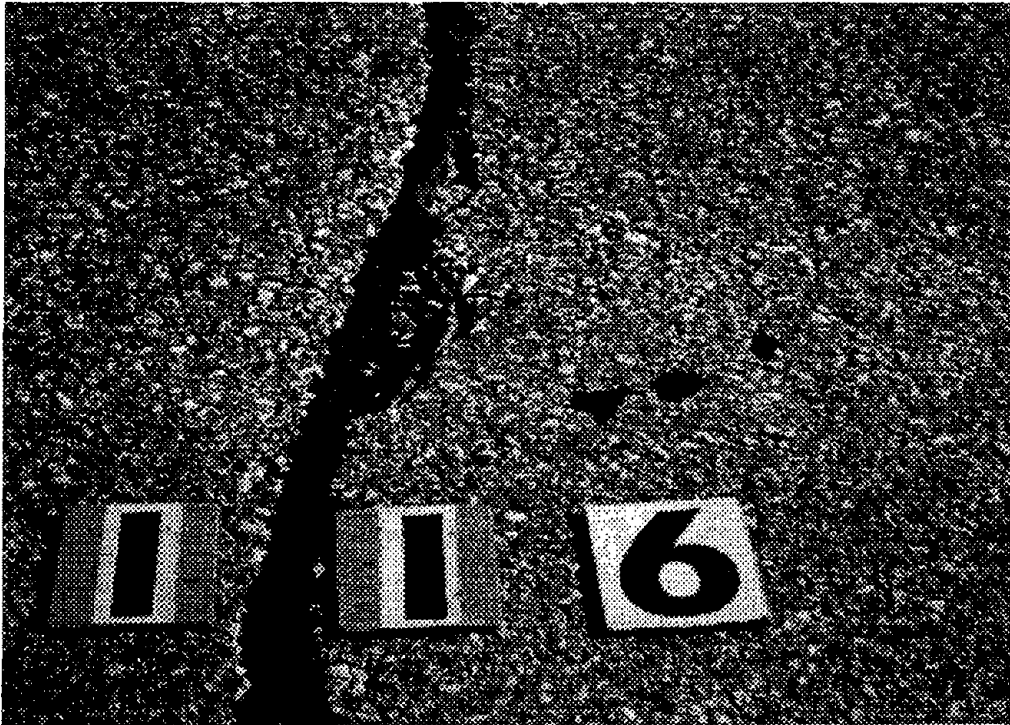
Figure 35. Typical spall and secondary crack adjacent to 890-SL silicone seal.

Finally, for the silicone seals, the primary mode of failure was edge deterioration. Over half of the failure in this treatment was the result of high-severity edge deterioration, largely stemming from low-severity spalls and secondary cracks created by saw-cutting operations during installation. Figure 35 shows a typical spall and secondary crack associated with an 890-SL silicone seal placed at Abilene.

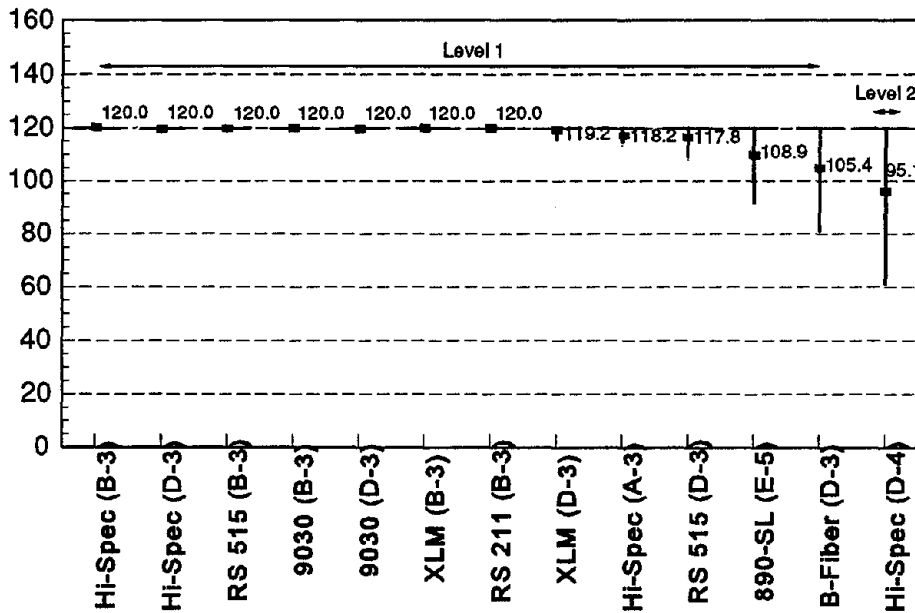
Figure 42. Tukey analysis of estimated treatment service lives at Elma.

The results of the Tukey comparisons of estimated treatment service life are illustrated in figures 39 through 44. These figures graphically show the estimated service life statistics of the treatments installed at the various test sites, in conjunction with the resulting Tukey performance groupings. The mean service life of each treatment is displayed and is represented by the solid square symbol. The corresponding variation in service life, in terms of one standard deviation above and below the mean, is depicted by the vertical line through the mean service life symbol.

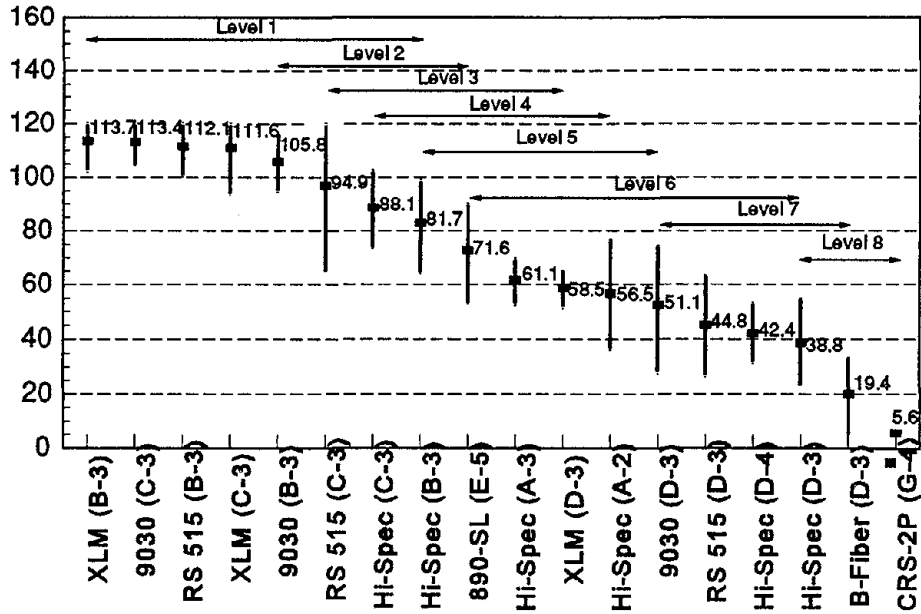
Figure 43. Tukey analysis of estimated treatment service lives at Des Moines.

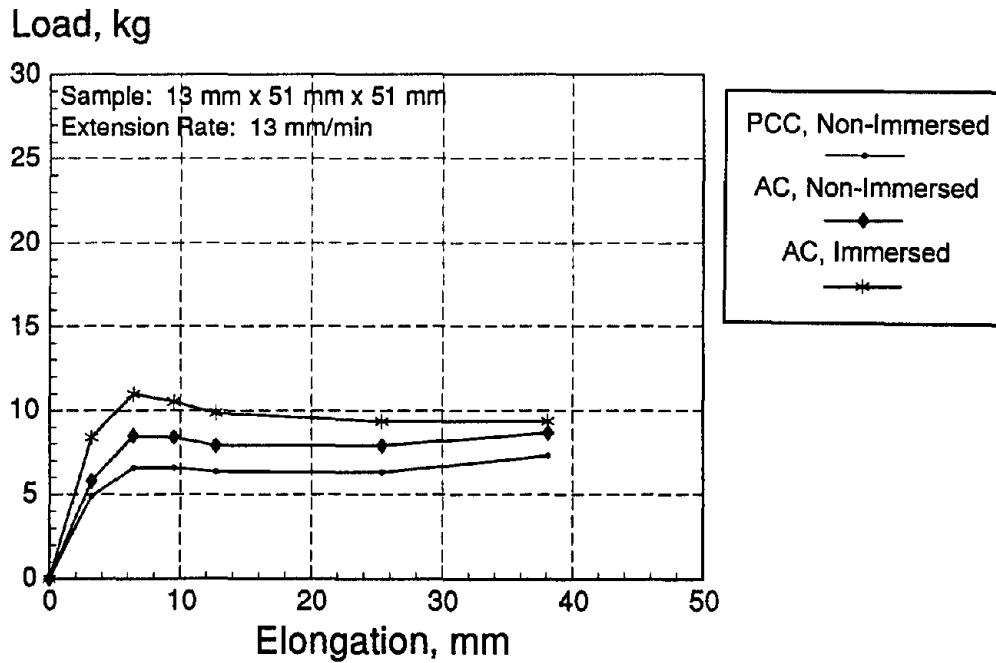
Figure C-6. ASTM D 3583 load-deformation curves for Hi-Spec.

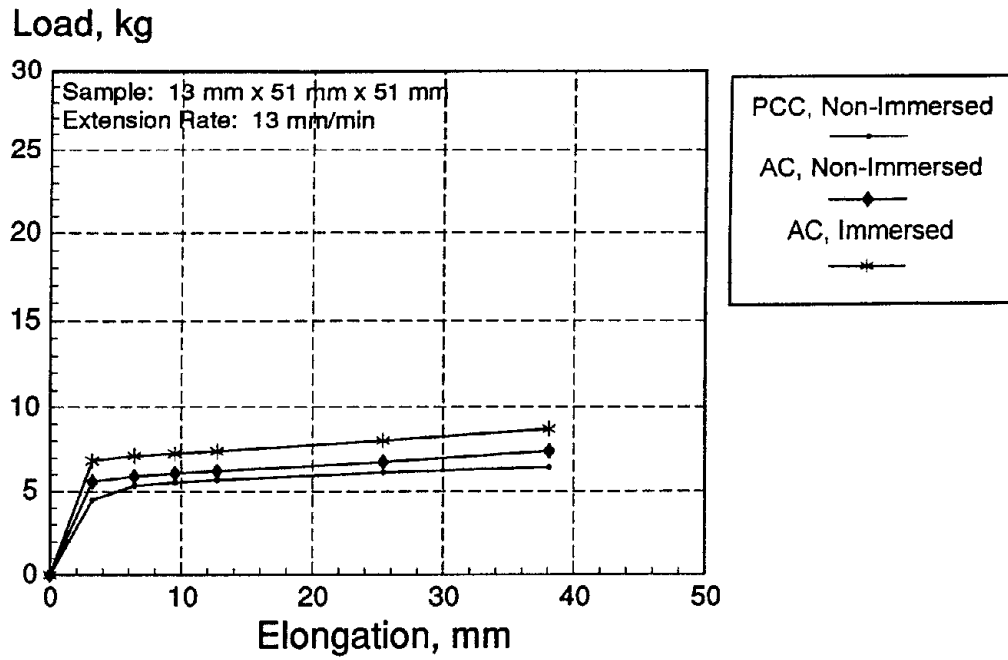
Figure C-7. ASTM D 3583 load-deformation curves for RS 515.

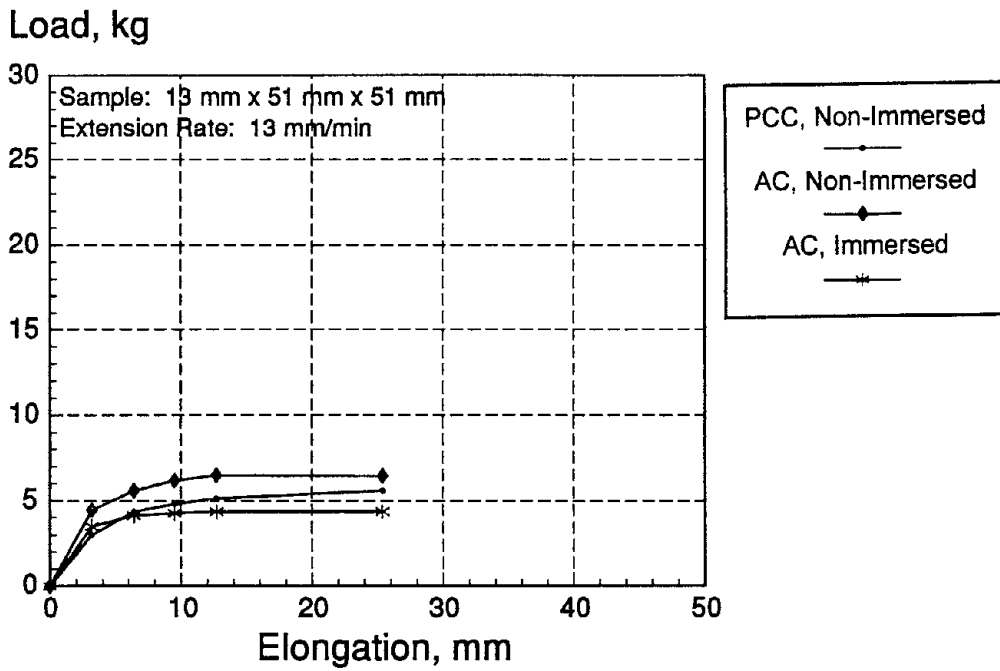
Figure C-8. ASTM D 3583 load-deformation curves for 9030.
