1. Report No. FHWA-HIF-12-022	2. Government Acco	ession No.	3. R	ecipient's Catalog No.
Title and Subtitle Alkali-Silica Reactivity Field Ide		eport Date mber 2011		
				erforming Organization Code

This field identification handbook provides guidance in identifying alkali-silica reactivity (ASR) in concrete field structures, such as bridges and pavements. The handbook also provides fundamental information about ASR, including the requirements for ASR to take place and the chemical reaction that leads to the formation of ASR gel. Furthermore, this handbook provides images to assist the reader in identifying ASR in the field under several scenarios, such as the effect of moisture on ASR-affected structures, ASR in combination with other concrete distresses, and non-ASR related distresses. A section is also dedicated to assist the reader in managing ASR-affected structures.

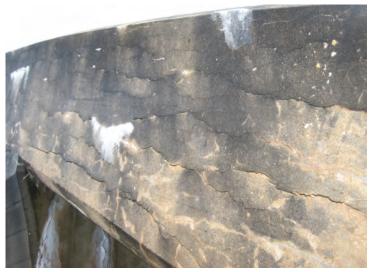
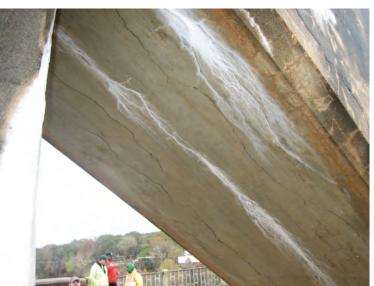
Figure A9. Severe cracking of reinforced-concrete bridge.
Cracks are orientated in the longitudinal direction of the Y-shaped columns and the horizontal girder. Note there are signs of corrosion (rust spots) on the edge beam.
Figure A10. Very severe cracking of column foundation in bridge shown in Figure A9.
Note that the cracks are orientated randomly in the foundation block as there are lesser amounts of steel and no principle orientation of the steel.

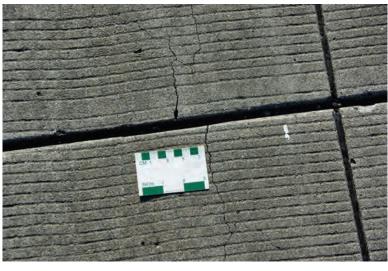
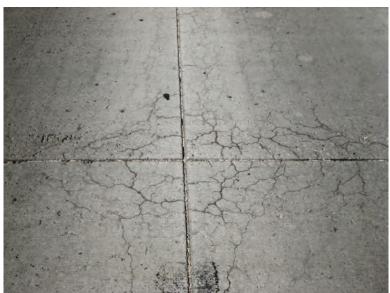
As ASR advances, the cracks spread around the perimeter of the slabs and there is often little or no cracking in the center of the slab. The reason that the region around the joints is more prone to cracking is because (a) there is often more moisture available at the joints, (b) there is less restraint to expansion close to the joints, and (c) mechanical stresses to vehicular loading are higher at the joints.

This photograph shows durability or D-cracking, and the pattern of the cracks is similar to that shown in Figure B3 above. However, the mechanism is very different as D-cracking results from the expansion of frost-susceptible aggregates.

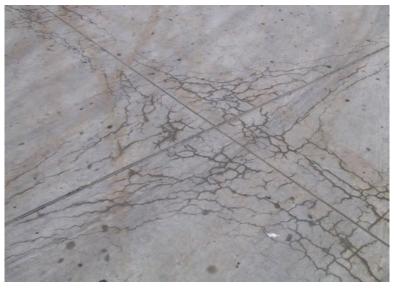
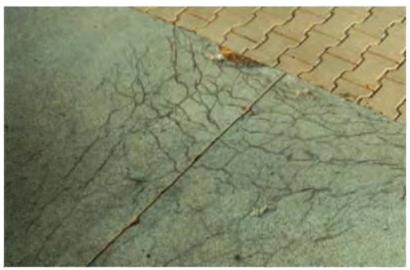
Figure B5. Severe cracking of a concrete pavement.					
As ASR advances, the whole surface of the concrete pavement exhibits cracking. Usually the cracks become oriented in the longitudinal direction.					
Figure B6. Severe map cracking in a concrete pavement.					
Although it is usual to observe preferred orientation of cracks in pavements with advanced ASR, map-cracking is often observed. It is possible, in such cases, that drying shrinkage at the pavement surface contributes to the pattern of cracking.

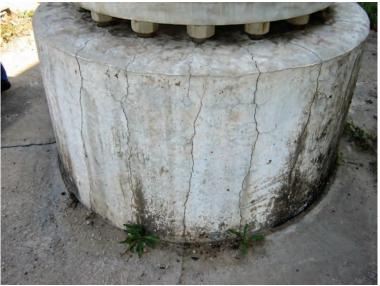
Figure C8. Minor cracking of curb.

Preferred orientation in the horizontal direction due to restraint.
