Evaluation and Monitoring of Seepage and Internal Erosion

Interagency Committee on Dam Safety (ICODS)

FEMA P-1032 / May 2015

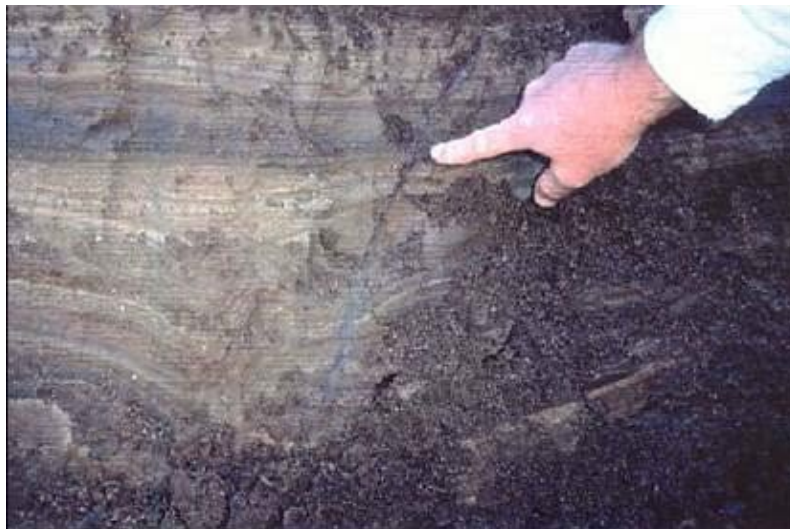
Figure 3-3.—Suspected hydraulic fracture at Ochoco Dam near the intake tower that was subsequently filled with reservoir sediments.

Hydraulic fracturing has been suggested to possibly have played a role in the failure of Teton Dam, which featured a very narrow, steep-sided cutoff trench backfilled with low plasticity soil.² It is believed that an example of hydraulic fracturing occurred at Ochoco Dam in Oregon (figure 3-3)³. The suspected hydraulic fracture was observed in an excavation near the intake tower and upstream portion of the outlet works conduit during dam safety modifications in the 1990s.

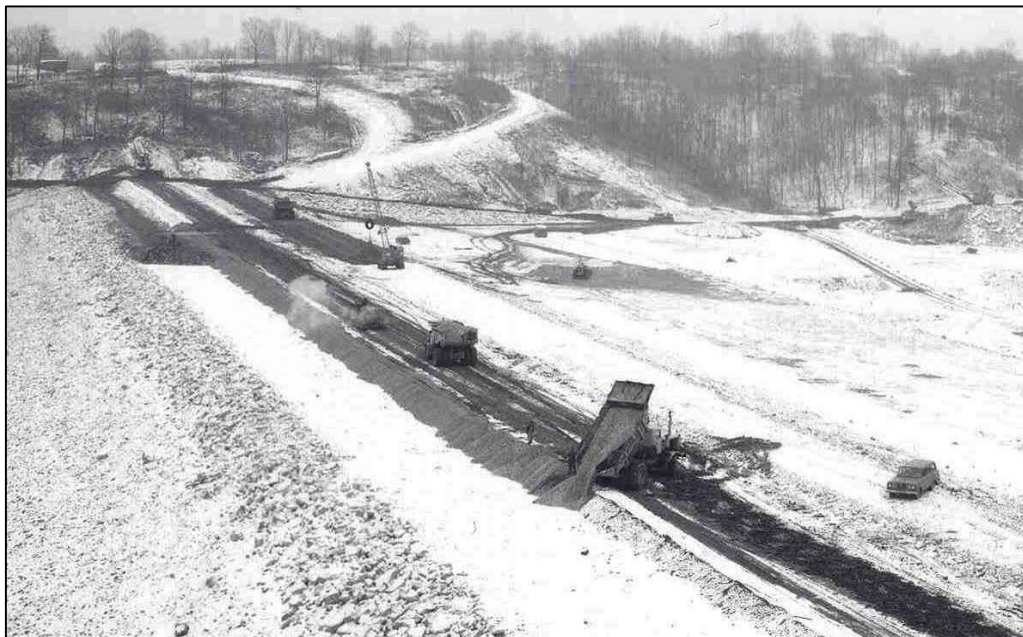
Figure 3-4.—Examples of winter construction at embankment dams prior to removal of snow and ice contamination. (Top) Blue blanket is insulated to prevent freezing of underlying soils. (Bottom) Placement of fill on improperly prepared frozen ground, snow, and ice.

In some cases, construction during winter is unavoidable. Similar to *Interruption in Fill Placement* described above, if the top lifts are allowed to freeze, a defect in the earthfill can result. Freezing may occur during temporary shutdown when the contractor chooses not to work until warmer weather returns or during winter shutdown when work is stopped for several months. Earthfill correctly placed and compacted originally will be damaged due to freezing action and will no longer have the properties of the specified lift. Ice and snow may also become mixed with the surface lifts of soil. Frost-damaged and ice-contaminated materials should be removed and replaced when better weather conditions return. Frost-susceptible soils such as silts and fine sands are of particular concern because ice lenses may form within them. Frost-damaged soils may be prone to development of preferential seepage paths and concentrated leaks. Examples of winter construction are shown on figure 3-4.

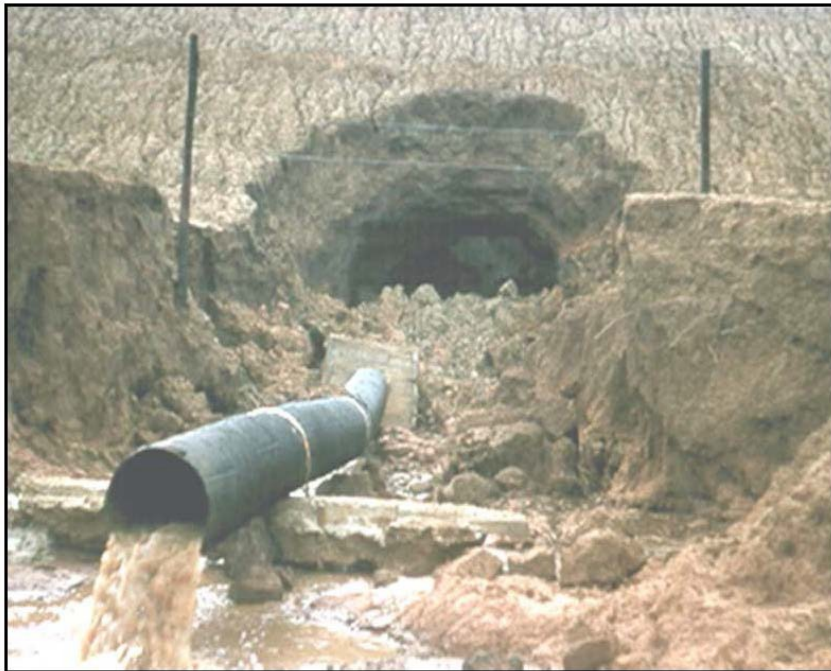
Figure 4-6.—Example of a dam that experienced gross enlargement, but the reservoir drained before erosion progressed to the point of crest collapse.

- *Gross Enlargement*: If the erosion pathway, or “pipe,” connects to the reservoir, rapid erosion and enlargement of the pipe could develop until the crest collapses into the pipe. If the amount of crest drop is greater than the available freeboard, overtopping of the embankment could quickly lead to a breach. It is also possible that if overtopping does not occur, the embankment could be severely damaged and breach could still occur by concentrated flow through cracks. Examples of gross enlargement include Teton Dam and Anita Dam.⁸ Figure 4-6 shows a dam that experienced gross enlargement, but the reservoir drained out before the pipe enlarged enough to cause the crest to collapse. If the likely breach mechanism for a PFM is breach by gross enlargement, as opposed to sinkhole development or sloughing, a breach is generally more likely to occur. If the downstream shell is unable to support a roof, sloughing/unraveling would be the more likely breach mechanism.

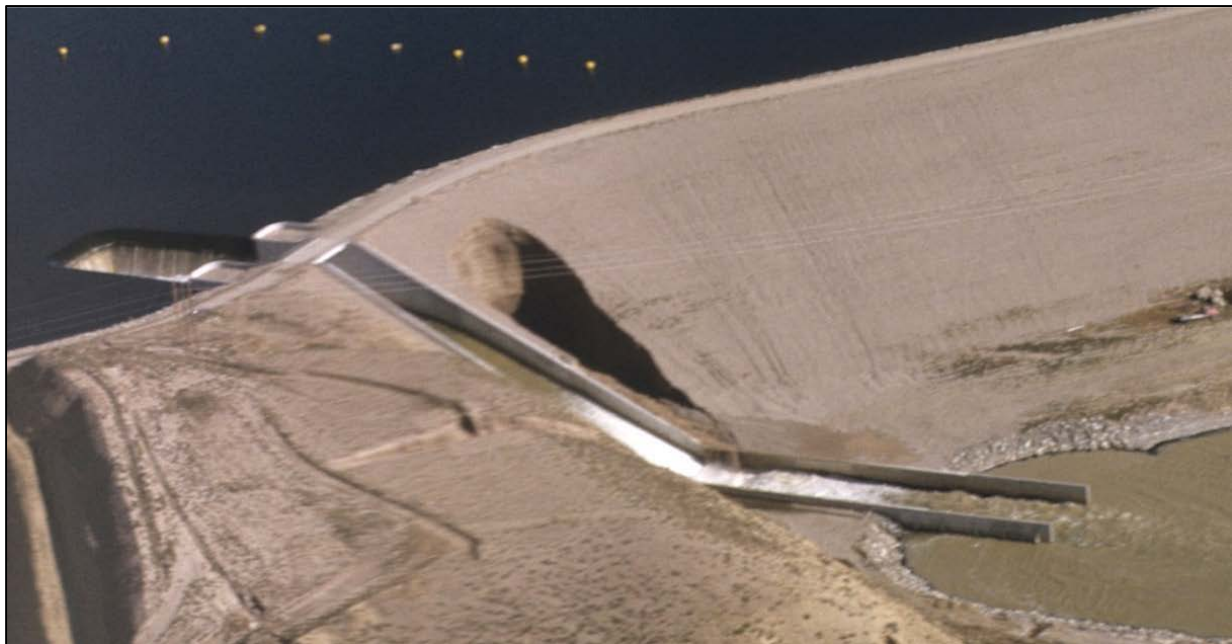
Figure 4-7.—Fontenelle Dam, which nearly breached by sloughing.

Reclamation's Fontenelle Dam in Wyoming nearly breached in 1965 by sloughing (figure 4-7), but the breach process occurred slowly enough so that the reservoir water surface was able to be lowered over the span of several days and arrest the breach. In contrast, Hell Hole Dam, a rockfill structure in California, failed from overtopping during construction in 1964, but handled a flow of about 13 cubic feet per second per foot before small slides and erosion began to progressively occur at the toe. Once this began, failure occurred within about 3½ hours (Leps 1973). The core of Reclamation's Minidoka Dam overtopped during construction (1904 to 1906), and the downstream rockfill zone withstood flows estimated up to 1,000 cubic feet per second. The water surface elevation was 8 feet below the normal water surface when the core overtopped. Figure 4-8 shows the maximum section of Minidoka Dam, which is approximately 80 feet high.

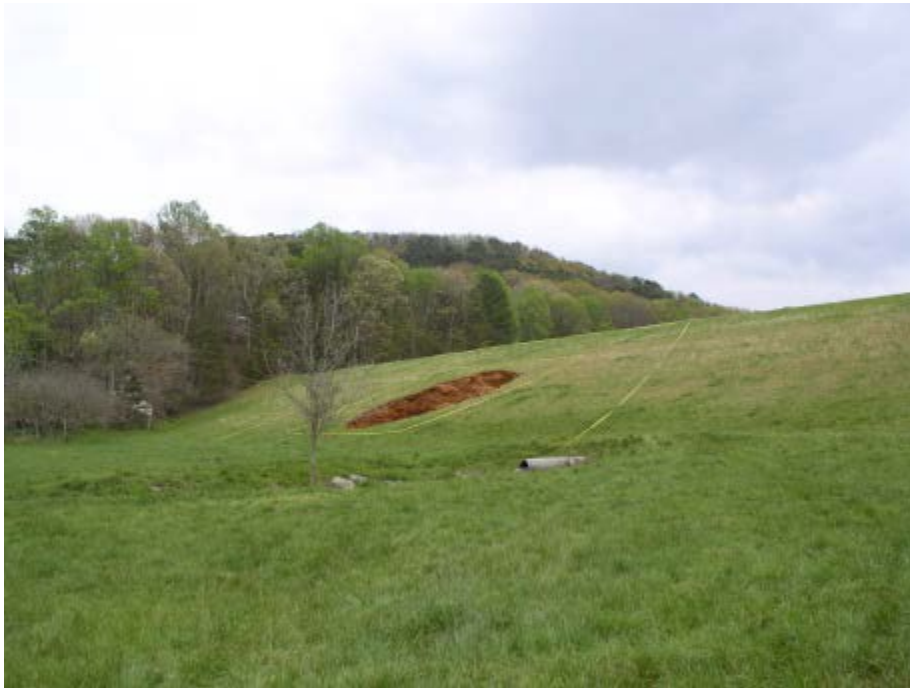
Figure 4-9.—Sallacoa Dam experienced a large sinkhole from internal erosion into a karst foundation.

- Sinkhole Development:* This mechanism refers to stoping of material upward, creating a sinkhole or depression in the crest that drops below the reservoir level. For breach to occur, the sinkhole would need to be large enough to lead to overtopping. USACE’s Wolf Creek Dam⁹ was constructed over karst features and has experienced numerous sinkholes. Due in part to concern that sinkholes may lead to potential breach, major mitigation measures have been undertaken. Sallacoa Dam¹⁰ also experienced formation of a large sinkhole for similar reasons (figure 4-9).

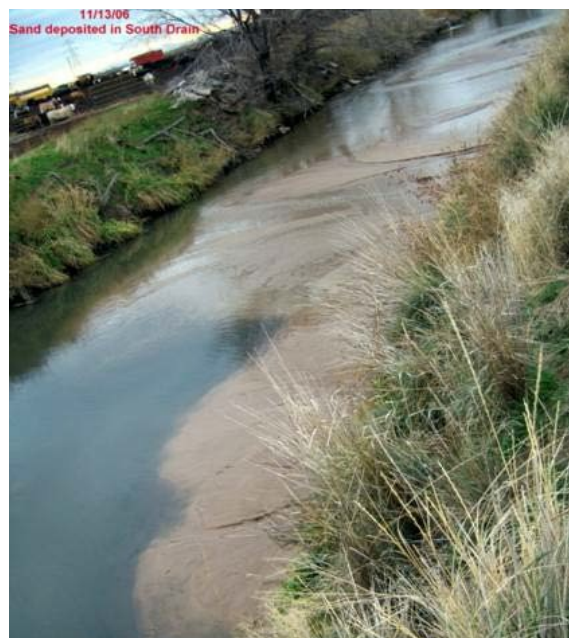
Figure 6-1.—Visual observation of failure mode in progress.

In November 2006, a local landowner riding a horse noticed seepage and soils exiting from the cut slope of the south drain on the A.V. Watkins Dike¹ in northern Utah (Demars et al. 2009). He called authorities, and the Bureau of Reclamation began emergency drawdown of the reservoir and 24-hour monitoring. Figure 6-1 illustrates the failure mode that was in progress when the first responders arrived.

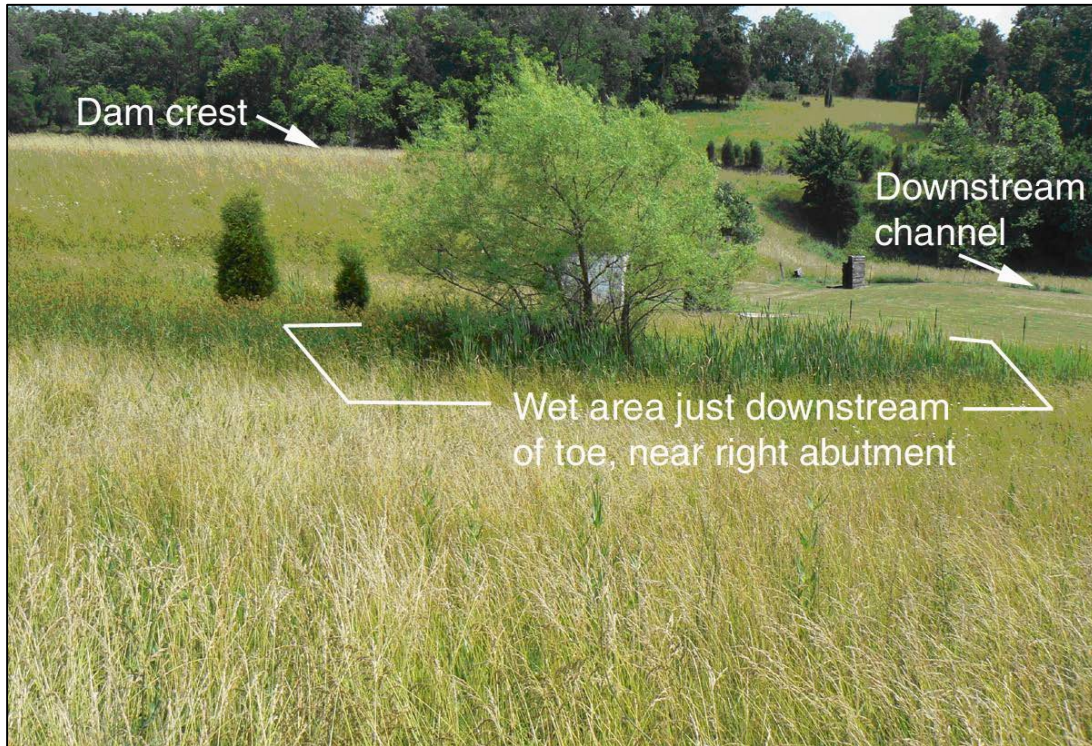
Figure 6-3.—Presence of phreatophytic vegetation (willow trees and cattails) in an established seepage discharge location approximately 200 feet below the downstream toe.

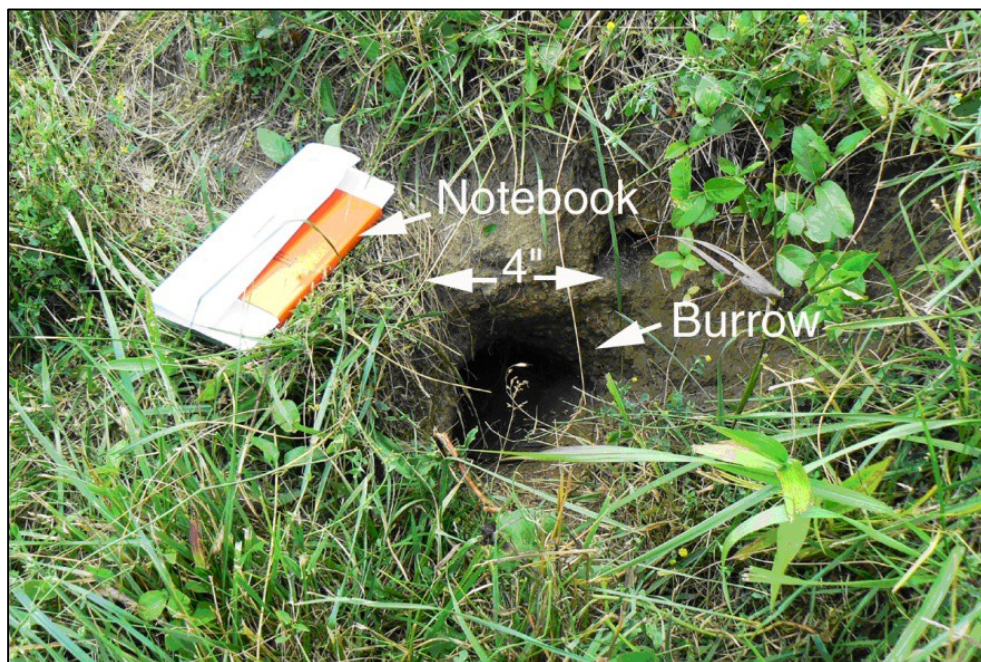
Figure 6-7.—Surface deformation indicative of animal activity observed on the downstream slope.

Figure 6-7 illustrates a small rodent burrow found in the downstream shell of an embankment dam. Figure 6-8 illustrates surface-erosion features (gullies) that also were not caused by internal seepage processes but could eventually become a preferential flow path if not repaired. A series or group of rodent holes may be an indication of low stress or cracked zones in the fill, as rodents tend to dig where it is easiest.

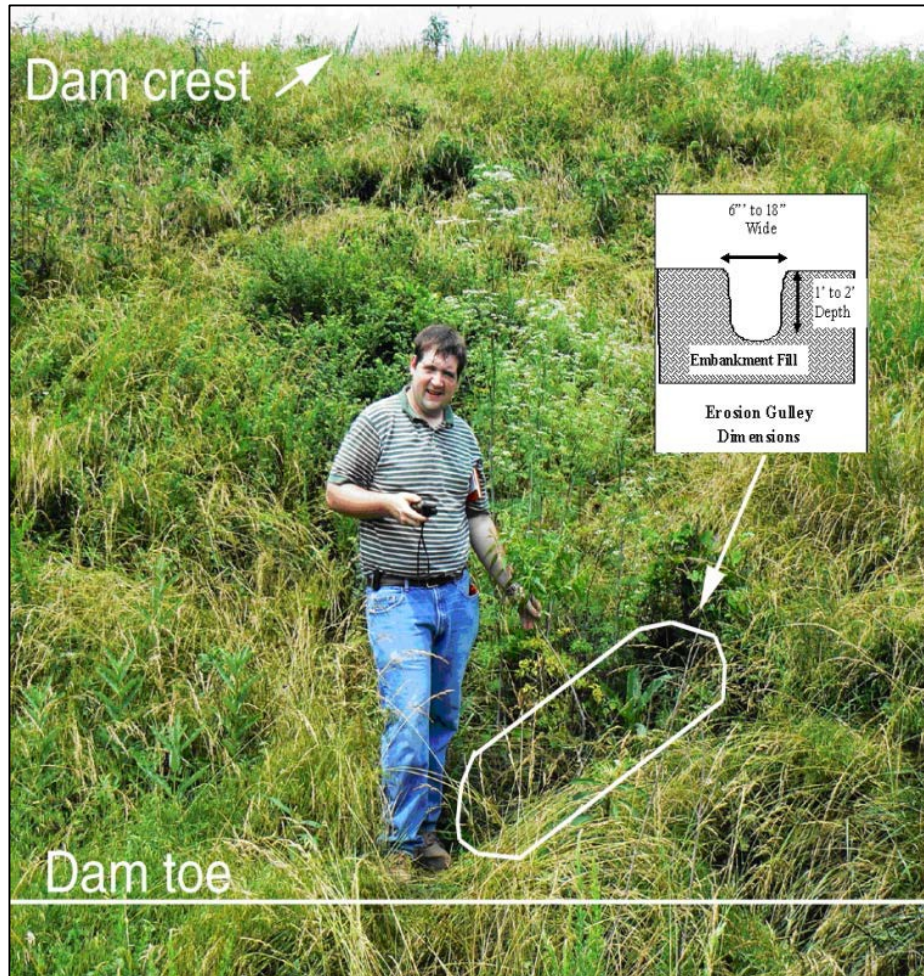
Figure 6-8.—Surface erosion (gully).

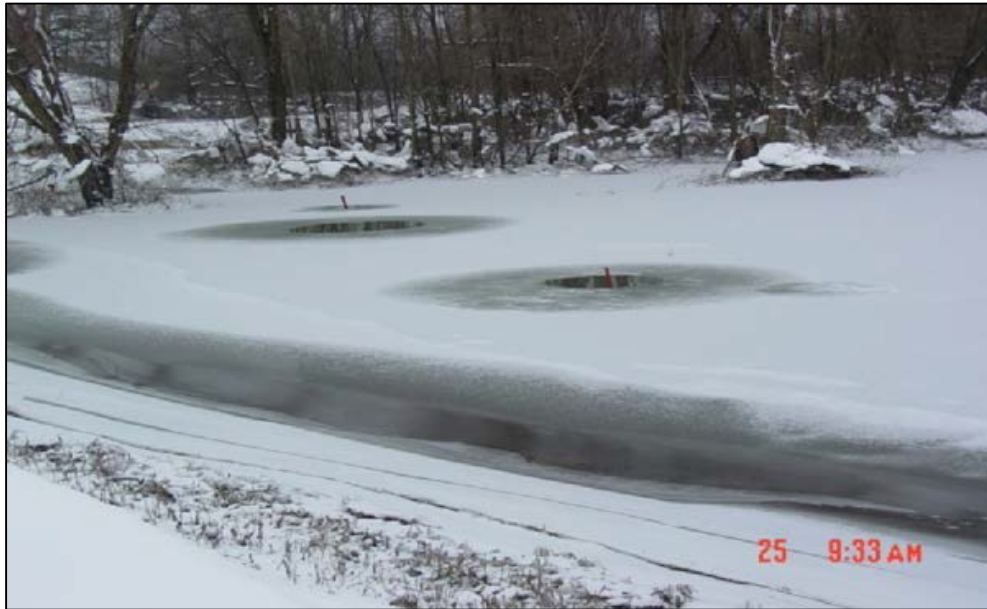
Figure 6-11.—Seepage water discharge locations (flagged with red markers) are more evident during the winter due to water temperature differences.

As water flows from its supply source into the dam or foundation materials, its temperature will change. Typically, deeper water is insulated from air temperature changes and remains at a relatively constant temperature. Influx of water from rivers or lakes will be reflected by temperature changes. Figure 6-11 shows seepage discharge locations that are easily identified during wintertime when the temperature difference between surface water and subsurface seepage is highest.

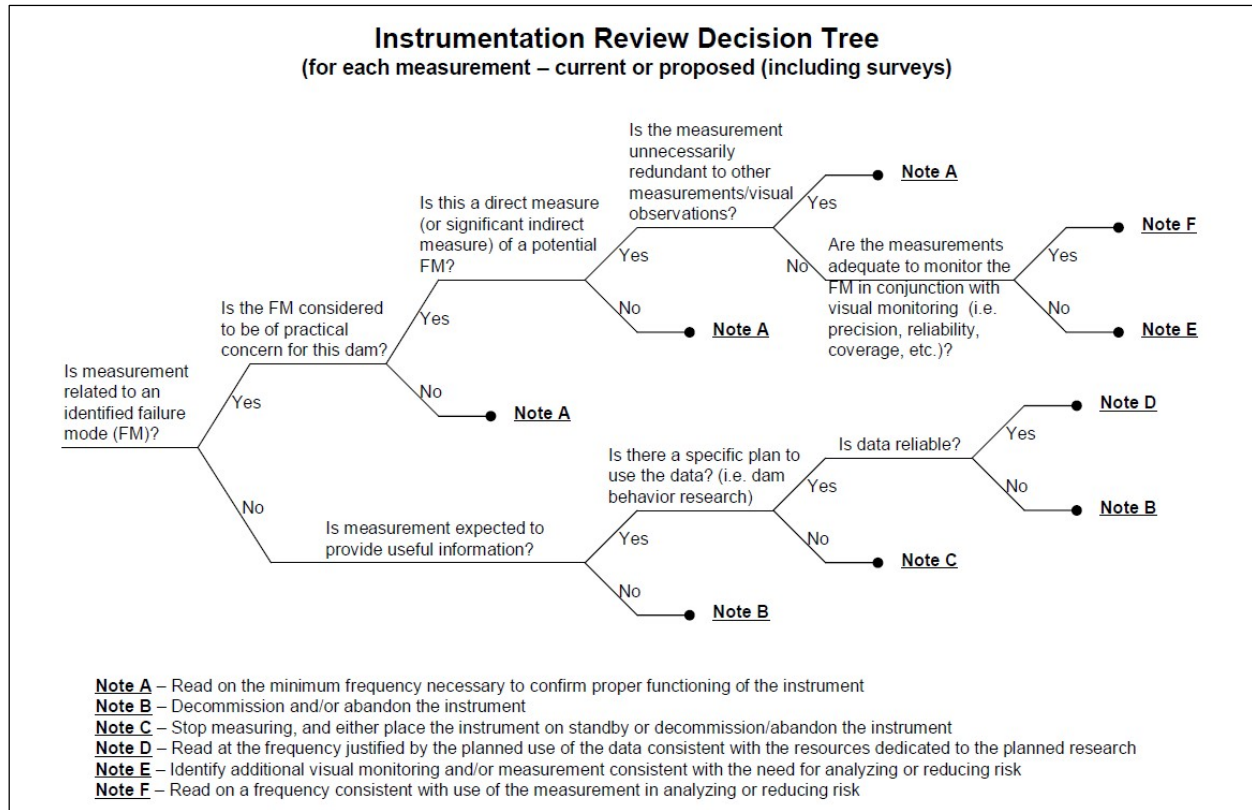
Figure 7-1.—Reclamation’s decision tree for instrumentation review (Reclamation 2009).

is gained in the performance of a dam. The Bureau of Reclamation (Reclamation) utilizes a decision tree to assist with periodic assessments of instrumentation programs (figure 7-1) that incorporates risk.

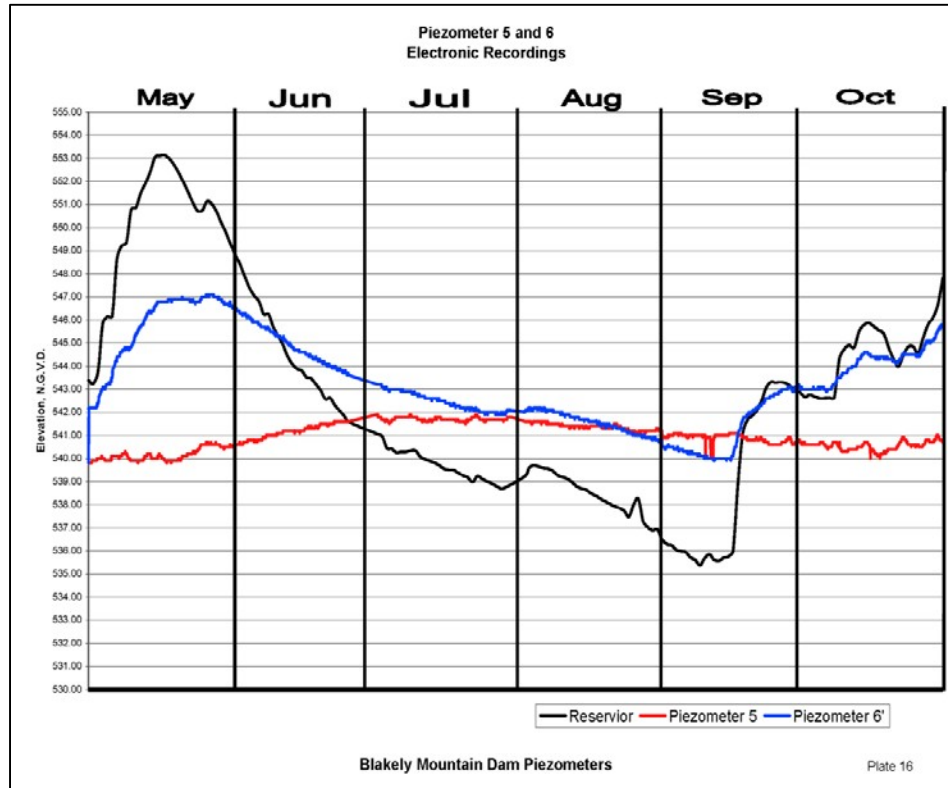
Figure 8-2.—Time history plot of reservoir level overlaid with piezometer 5 and 6 data. In this plot, the pore pressures measured by piezometer 5 (in red) are not influenced by changes in reservoir levels, but are related to changes in regional groundwater. In contrast, the pore pressures measured by piezometer 6 (in blue) show minimal time lag response to reservoir level changes.

A time history plot displays time versus the parameter value. Parameters such as water level, seepage flow rate, pore water pressure, deformation, water quality (temperature, turbidity, and dissolved solids concentrations) can be plotted as functions of time. Figure 8-2 illustrates a time history plot of piezometric head seasonal variations. Dual Y-axis time history plots allow the additional plotting of a second parameter such as pool elevation, tail water elevation, or rainfall amount. Smaller positional plots are often used to show time histories at particular locations. Locations of where data are collected typically are indicated with cross-section, profile, or plan views.

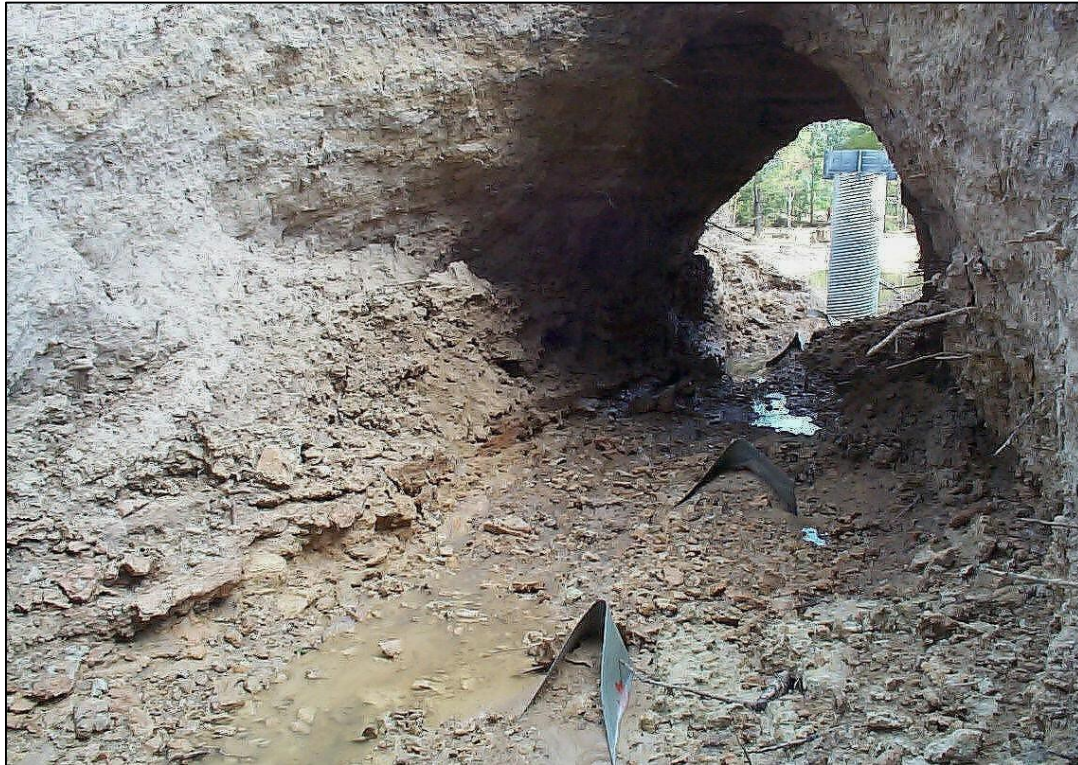
Figure 10-8.—Failure of an earth embankment in Louisiana along the principal spillway conduit, looking upstream toward riser. Notice damaged anti-seep collars on conduit. (Photo courtesy of NRCS, Louisiana)

Figure 10-8 shows the failure of a small dam in Louisiana consisting of dispersive soil, presumably due to cracking and concentrated leak erosion in the vicinity of the principal spillway conduit. Failure occurred during the first filling. It is noteworthy that metal anti-seep collars were used on the original conduit instead of a filter diaphragm. An opening was excavated through the embankment to access the conduit, and a filter diaphragm was installed around the conduit. The diaphragm extended across the full width of the opening and was successful in mitigating the problem.

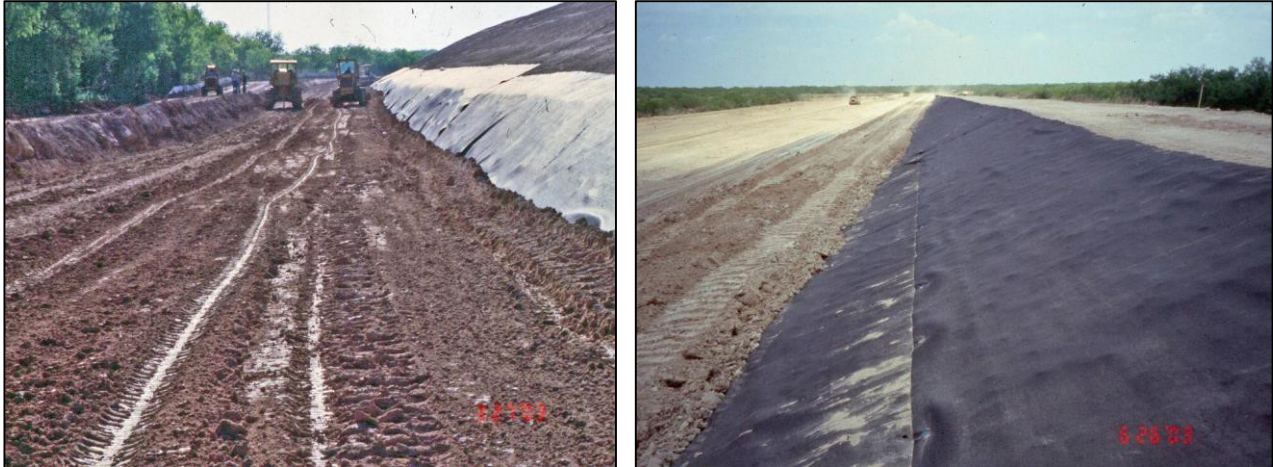
Figure 10-18.—Construction of geotextile barrier in Olmitos-Garcias No. 2 Dam in south Texas. The downstream side of the embankment is shown. Left – geotextile being backfilled in foundation trench. Right – geotextile on back slope of dam prior to backfilling. (Photos courtesy of NRCS, Texas)

Under certain circumstances, barriers for remediation have also been constructed using geotextiles in place of granular filter materials (Doerge 2010). If a geotextile is used as the sole element in the barrier, then it must be designed to be able to span any open cracks in the fill. Figure 10-18 shows a geotextile barrier under construction in the Olmitos-Garcias No. 2 Dam⁷ in south Texas. A heavy (16 ounce per square yard) non-woven geotextile was used in this project.

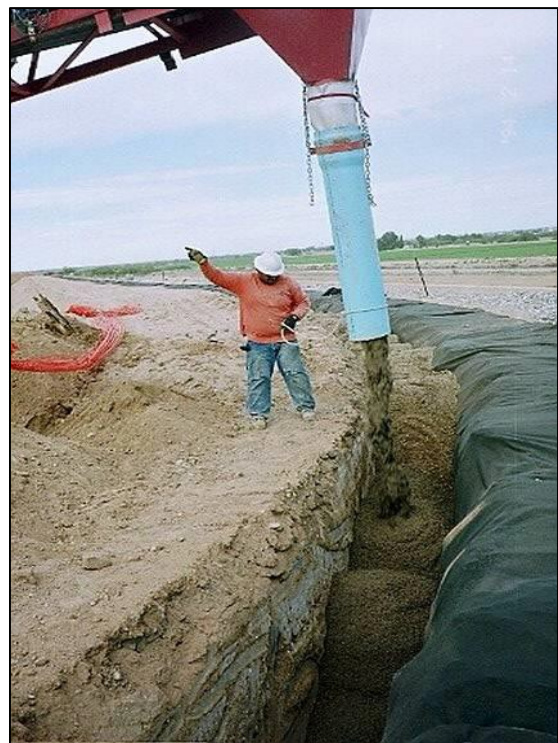
Figure 10-19.—Construction of a geotextile/aggregate chimney filter in Florence Dam in Arizona. Geotextile drape is on right (downstream) side of trench. (Photo courtesy of NRCS, Arizona)

To overcome the problems illustrated on figure 10-17, a geotextile can be used in conjunction with a granular chimney filter. In Florence Dam⁸ in southern Arizona (Doerge 2010), a geotextile was draped on the downstream face of the centerline trench prior to backfilling the trench with appropriately graded granular filter material (figure 10-19). In this case, the

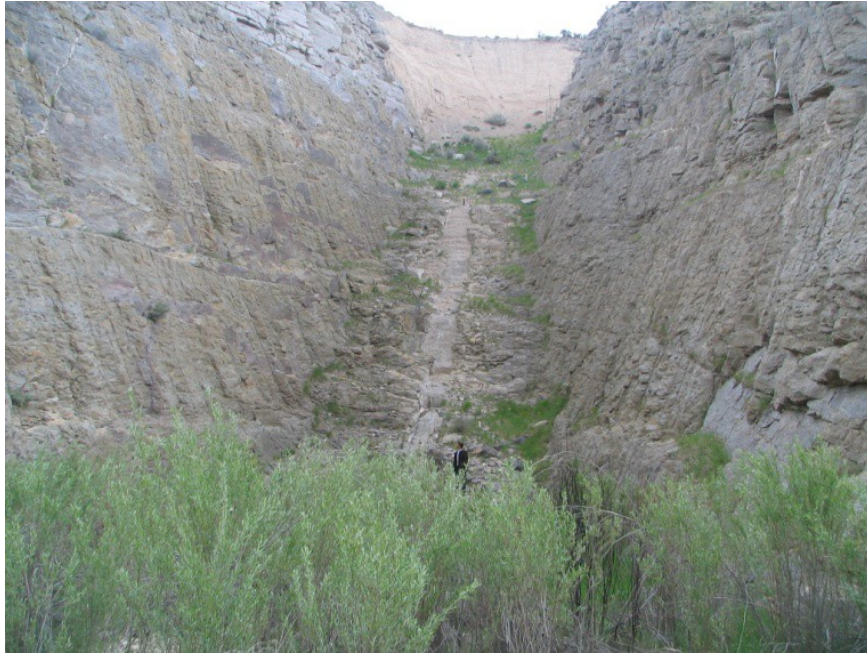
Figure 4.—Narrow, 70-ft-deep abutment cutoff trench. Man shown for scale (photo courtesy of James Wright 2007).

A 70-ft-deep excavation was made in the bedrock at the right abutment for the cutoff trench. There was a lack of foundation shaping and treatment in the cutoff trench. No shotcrete, dental concrete, or slush grout was used in the floors or walls of the cutoff excavation. Widely open joints were sealed with bucket grouting, and a grout cap was placed along the cutoff trench floor for installation of the grout curtain. Fine materials used in the core of the dam were placed against untreated bedrock. A grout curtain was installed the full length of the dam with grout holes on a single line. Grout holes of the primary curtain were spaced 10 ft apart. The grout curtain extended to depths of as much as 300 ft, and split spacing was used where needed.

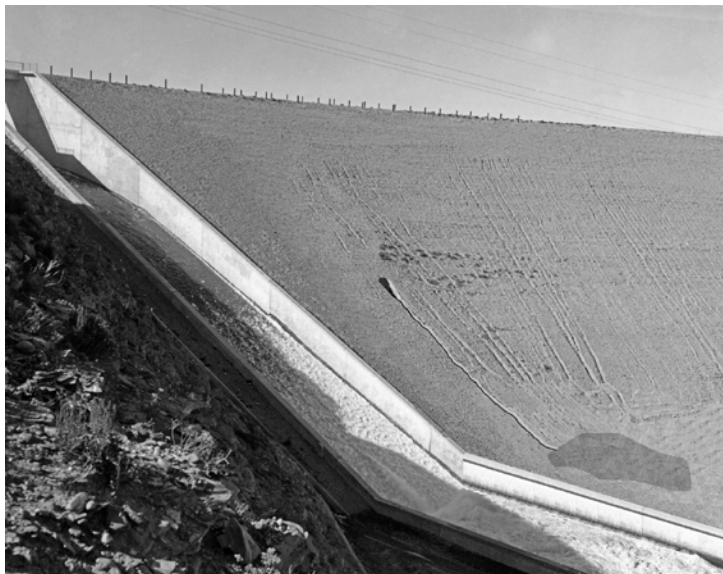
Figure 3.—First appearance of sinkhole, with drainage.

On the morning of September 3, 1965, a wet spot appeared near the left side of the spillway on the downstream slope of the embankment at about mid-height at elevation 6458 (figure 3). The reservoir filled rapidly under flood conditions and was about 1.6 ft above the spillway crest at the time. By mid-afternoon, water was flowing from the area, causing erosion and sloughing. By evening, the flow from the wet area of the embankment was estimated at 5 ft³/s.

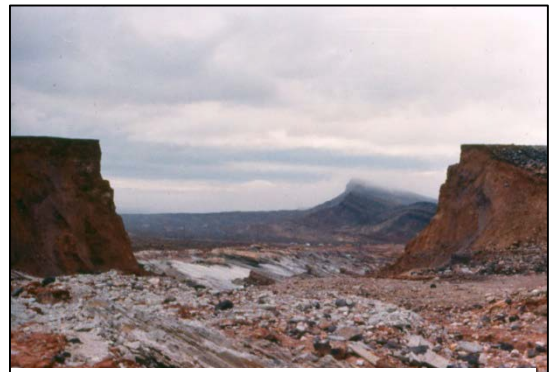
Figure 1b.—Breach through Quail Creek Dike.

The maximum height of the dike is about 78 ft with a crest width of 20 ft and an overall length of about 1,980 ft. The breach was approximately 140 ft wide and 80 ft deep (figure 1b). The foundation for this earthen dam consisted of dipping beds of sedimentary rock that strike almost perpendicular to the axis of the dike (figure 2). The construction of Quail Creek Reservoir took place in 1984, about 8 yr after the failure of Teton Dam, yet there were few additional measures taken to address the potential for concentrated leakage from constructing an earthen embankment on a rock foundation. The dam was constructed as a zoned earth embankment with a 10-ft cutoff trench (figure 3).

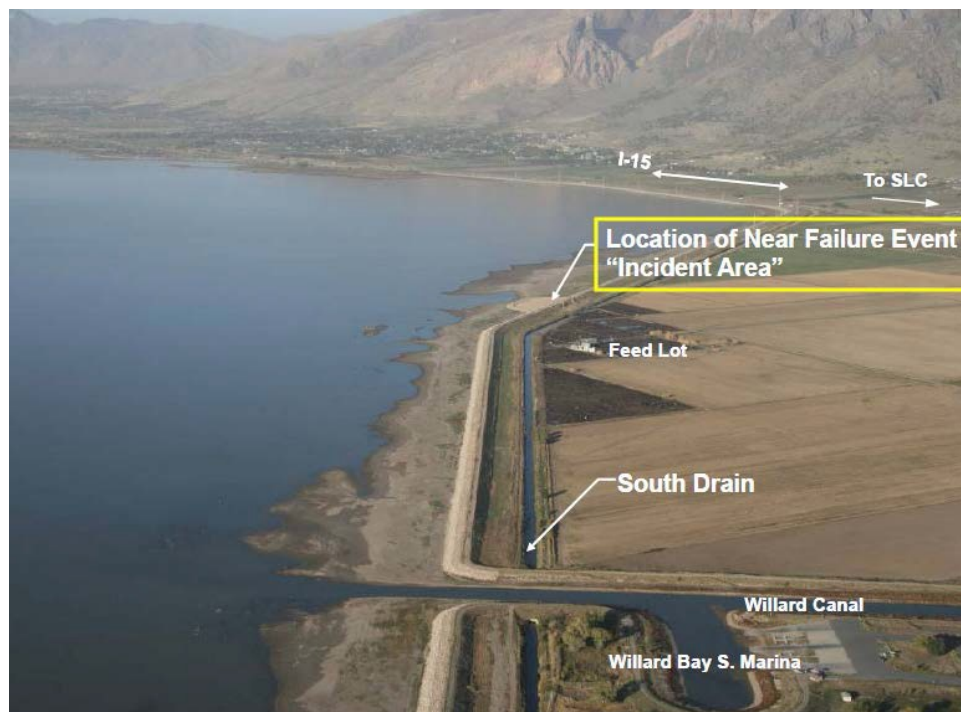
Figure 4.—Aerial view of the western portion of the dam showing the incident location in relation to the South Drain and feedlot.

In November 2006, a local landowner riding a horse noticed seepage and soils exiting from the cut slope of the South Drain. He called authorities, and Reclamation began emergency drawdown of the reservoir and 24-hr monitoring. Figure 2 illustrates the failure mode that was in progress when the first responders arrived, and figure 3 shows sediments eroded into the South Drain. Figure 4 is an aerial view of the western portion of the dam that indicates the incident location.

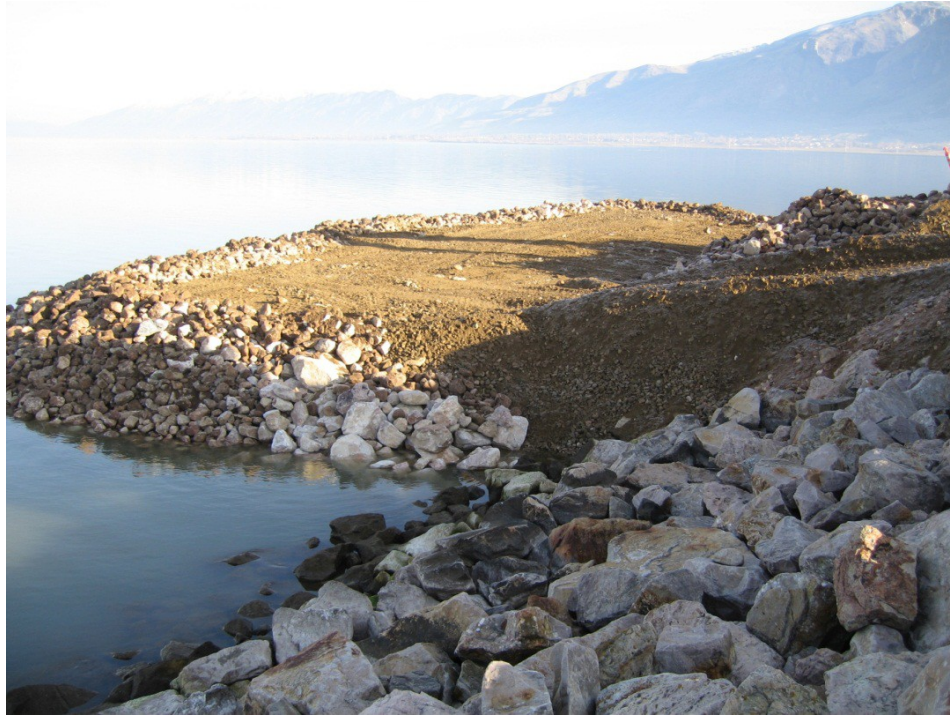
Figure 5.—Erosion into the South Drain did not stop until an upstream berm of gravel and pit-run material was pushed into reservoir.

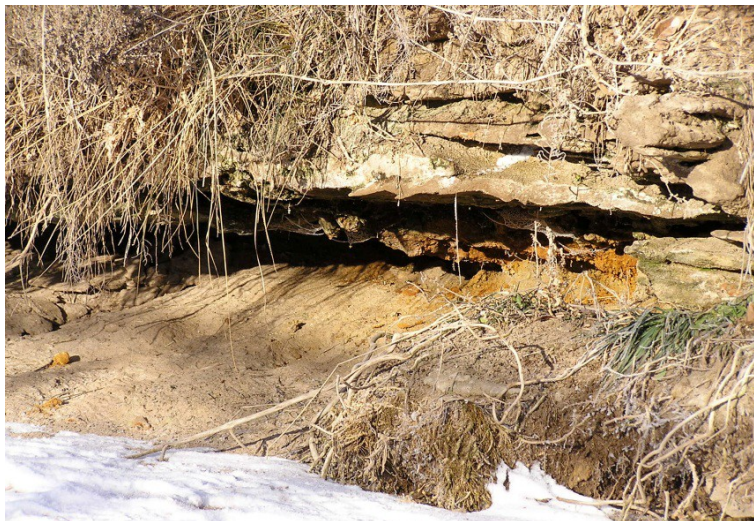
Figure 6.—Hardpan that formed a roof for the developing pipe.

- (3) **Hardpan:** Layers of carbonate and carbonate-cemented sand known as “hardpan” exist in the upper 3 m (10 ft) of fine to silty sand deposits (figure 6). The hardpan is at least partially continuous in the southeast reach of the dam. In the immediate area of the incident, there are two distinct layers of hardpan that are generally only 5 to 10 cm (2 to

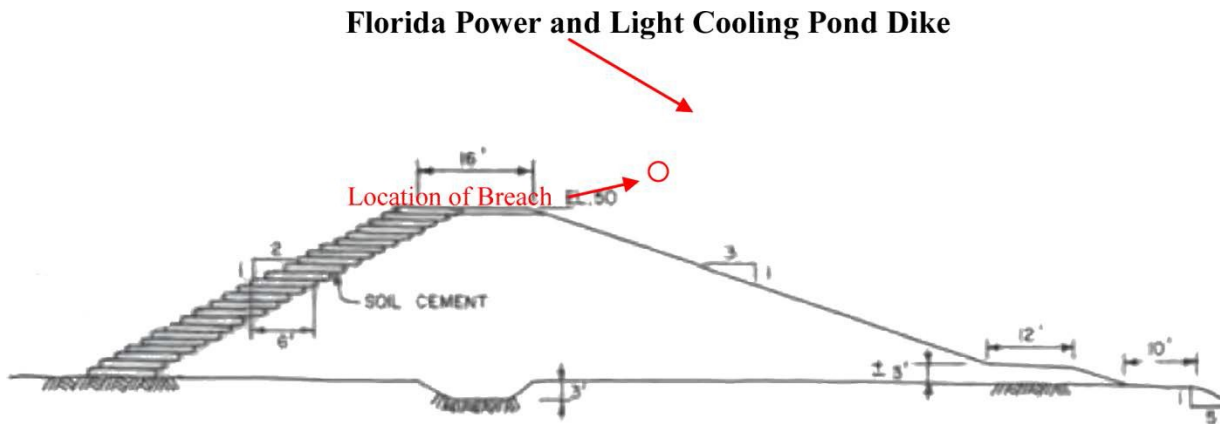
Figure 2.—Typical section of the FPL cooling pond dike (Schmertmann 2012).

A case history similar to the A.V. Watkins Dam is the failure of the FPL cooling dike in 1979. The FPL cooling pond is located between Indiantown, Florida, and Lake Okeechobee (figure 1) and was constructed in 1977. The 7,000-acre pond is approximately 4.75 mi long and 3.2 mi wide and is impounded by a 17.5 mi-long ring dike. The dike is approximately 35 ft high with a crest elevation of 50.0 ft. The upstream slope is 2H:1V and is protected with horizontal slabs of soil-cement. The downstream slope is 3H:1V. The dike is a homogenous embankment without filters and is composed of compacted earth made up of sand. There is a 12-ft-wide, 3-ft-high stability berm at its downstream toe. A 3-ft-deep drainage ditch with 5H:1V side slopes is located 10 ft beyond the stability berm. The dam is keyed 3 ft into the foundation. A section of the embankment is shown on figure 2.

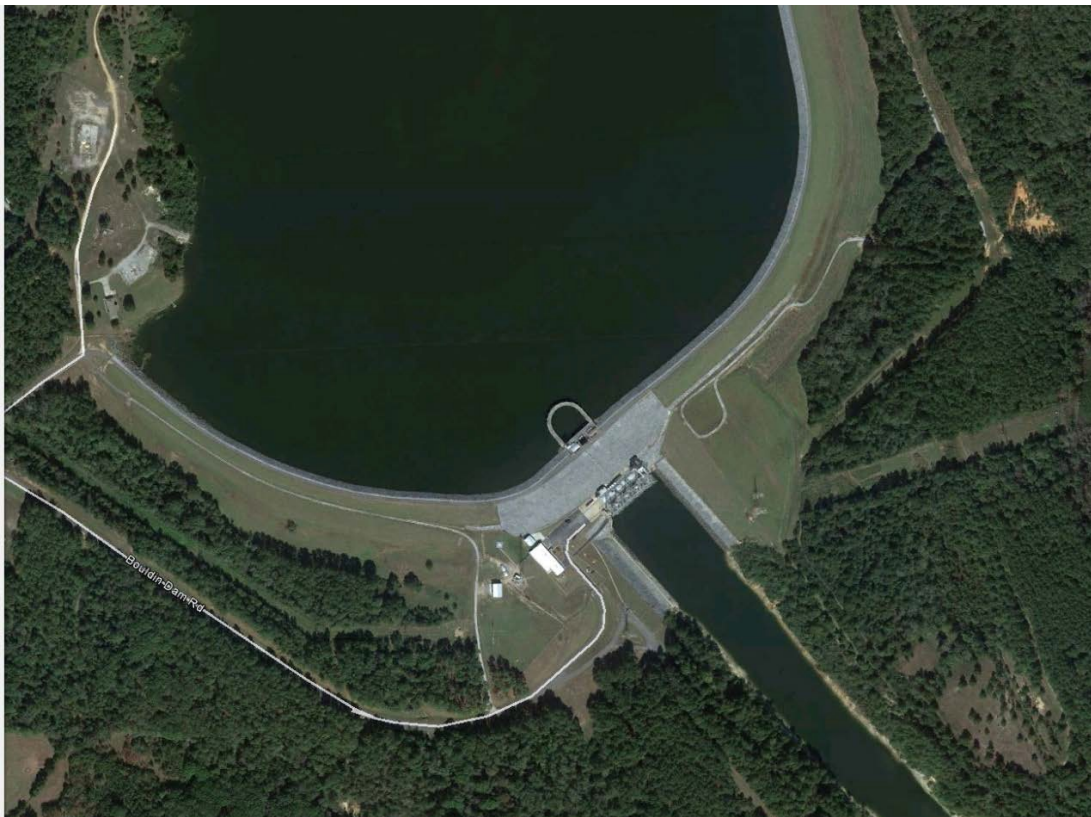
Figure 1.—Walter Bouldin Dam, intake, powerhouse, and tailrace canal (Google Earth, November 1, 2014).

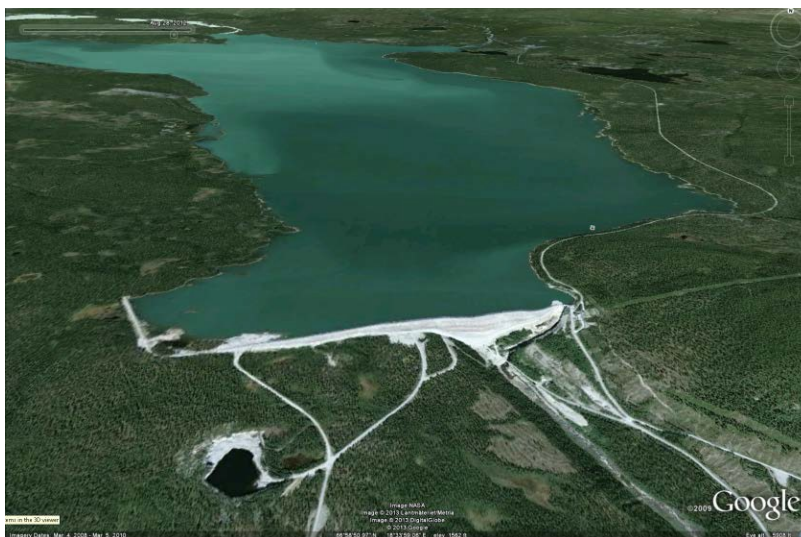
Figure 1.—The Seitevare Dam consists of a powerhouse, overflow spillway, main dam, and saddle dike. The right abutment was constructed on a glacial moraine.

Seitevare Dam, located in northern Sweden, impounds water for the Seitevare Power Plant (figure 1) in the highest reaches of the river Lilla Lule älv. The dam is 1,450 m long with a maximum height of 106 m. At the time the dam was constructed (late 1960s), it was becoming common practice in Sweden to construct new embankment dams with a curved form in plan view (Nilsson 1967); hence, Seitevare has a horizontal radius of 2,000 m. The right abutment is located on pervious glacial deposits. A 540-m-long, 10-m-high saddle dike is close to the right terminus of the main dam. The dam impounds 1,750 million m³ over an area of 82 square km at maximum pool.

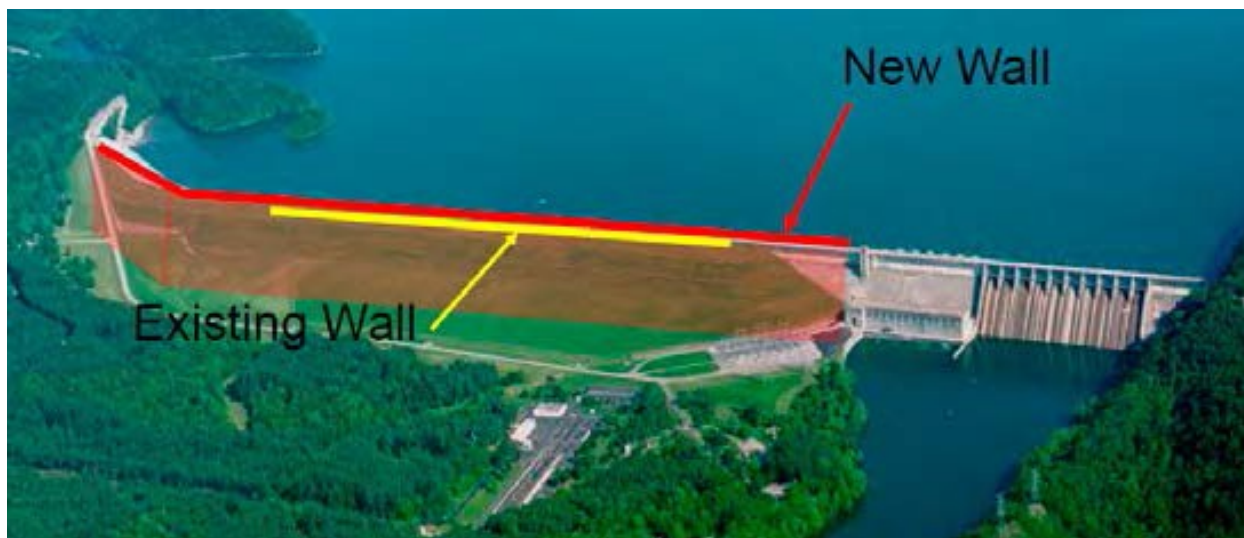
Figure 2.—Overall view of the dam showing extent of the existing and new cutoff walls.

turbines rated at 45,000 kW each. From the end of the concrete gravity section, a non-zoned compacted clay embankment with a maximum height of 215 ft above top of rock extends 3,940 ft across the valley to the right abutment. U.S. Highway 127 traverses the dam. There are limited outlets (six penstocks and six sluices) for emergency drawdown of the reservoir. An overview of the dam is shown on figure 2.

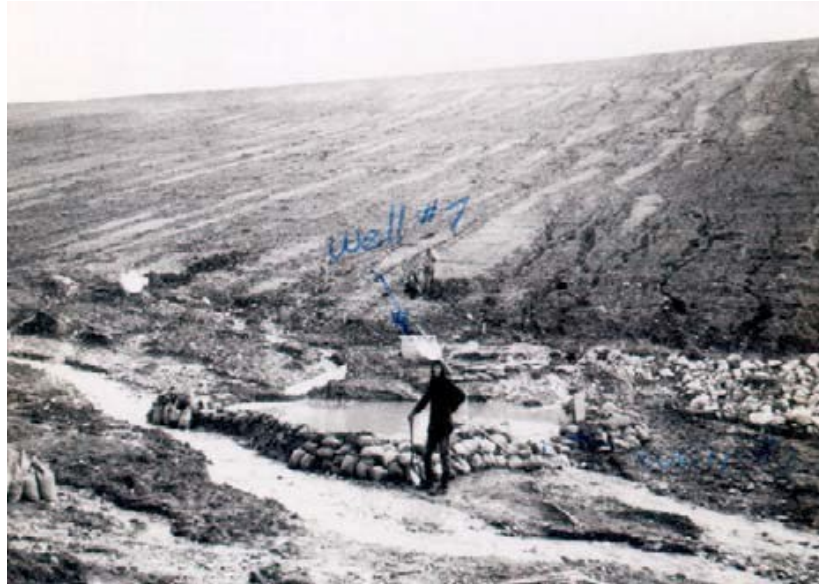
Figure 5.—Conditions during the boil event of 1966.

During the course of 2 weeks, the pool reached its highest elevation to that point (elevation 741.9), and the boil had become 12- to 14-in diameter. During this time, muddy water and mud balls ranging from a 3/8- to 1/2-in diameter were carried by a flow of 20–25 gpm (figure 5). Seepage was also noted in a gravel pit located approximately 400 ft downstream from the embankment toe. An area of approximately 2 acres on the right riverbank about 700 ft downstream from the toe was saturated with seepage water.

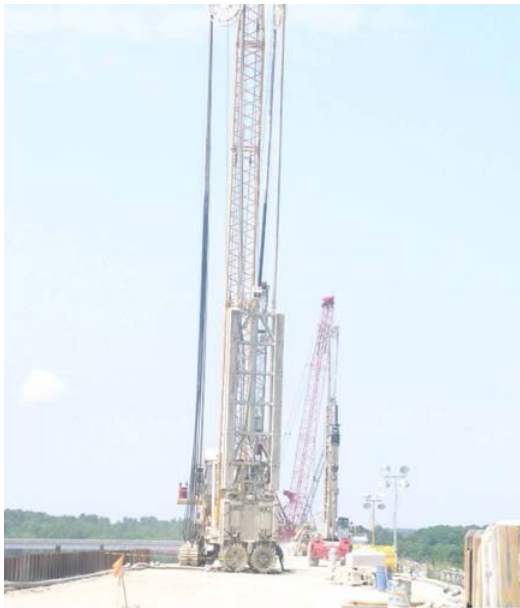
Figure 9.—Typical hydromill configuration.

Two principal pieces of excavation equipment were used during cutoff wall construction: a clamshell and a hydromill (figure 9). The clamshell rig was a CMV TL50 80-ton crawler crane with a 150-ft telescoping-kelly Casagrande KRC 2-180 Hydraulic Clamshell Grab. The clamshell bucket was capable of making a 10-ft by 30-in bite. An 8-ft by 30-in bucket was also available for closure panels. About 0.5 ft was removed per bite. The excavation rate was approximately 20 feet per hour, but decreased

Rock excavation was performed using a Casagrande K3L hydromill. Weighing in at approximately 35 tons, the 50-ft-long hydromill was a two-part assembly mounted to a 100-ton crawler crane. The lower portion contained the hydraulic motors, cutting wheels, and slurry return Soletanche suction pump. The upper portion functioned as a guide frame for alignment. The four cutting wheels were paired (two each) with a drive chain, allowing for independent rotational speed and torque control of the wheel pairs. Arrayed on the cutting wheels were shank-mounted carbide tip cutting teeth. Worn teeth were replaced at regular intervals, typically twice a shift, but at least once a shift. The configuration, number, and style of teeth could be changed to suit rock conditions. Milling rates were very dependent upon rock conditions ranging from highs in decomposed to highly weathered Liston Creek to lows in unweathered, high chert-content Liston Creek. At times, the hydromill was used in both overburden and rock. This machine was prone to breakdowns without significant preventative maintenance. With an experienced operator, this machine was capable of maintaining excellent verticality in overburden or rock.

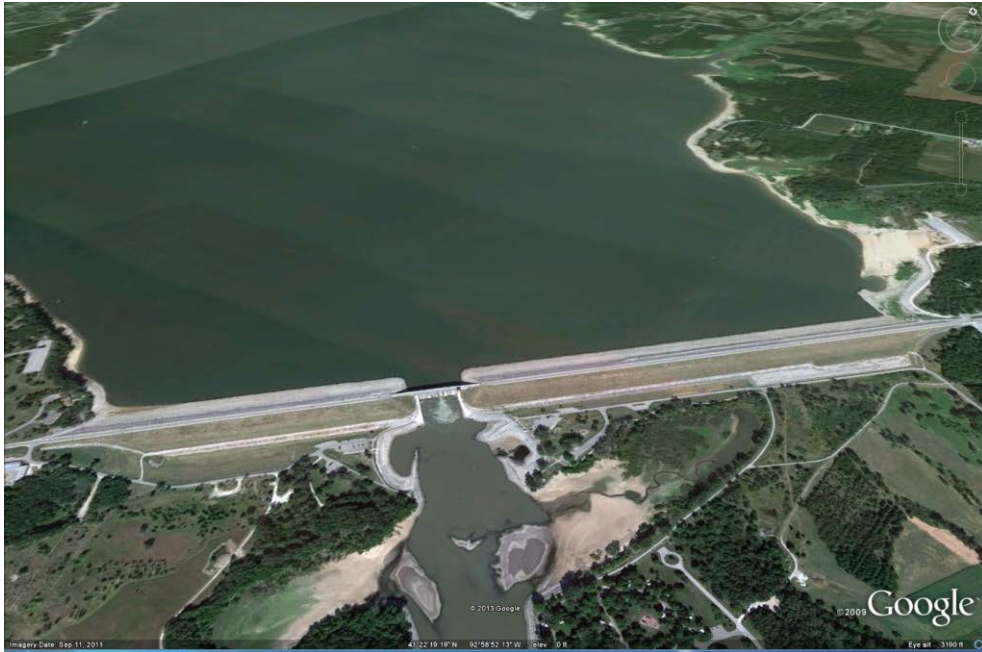
Figure 1.—Oblique view of Red Rock Dam (Google Earth, September 11, 2011).

The Lake Red Rock Project was constructed in 1969 on the Des Moines River as a flood control project by the USACE and is located in Marion County near Pella, Iowa. The dam consists of a 5,700-ft, 110-ft-high, rolled earth embankment with an integral gated spillway (figure 1). The dam impounds a 1,624,970-acre-ft reservoir from a drainage area of 12,323 mi².
