Evaluation and Monitoring of Seepage and Internal Erosion

Interagency Committee on Dam Safety (ICODS)

FEMA P-1032 / May 2015

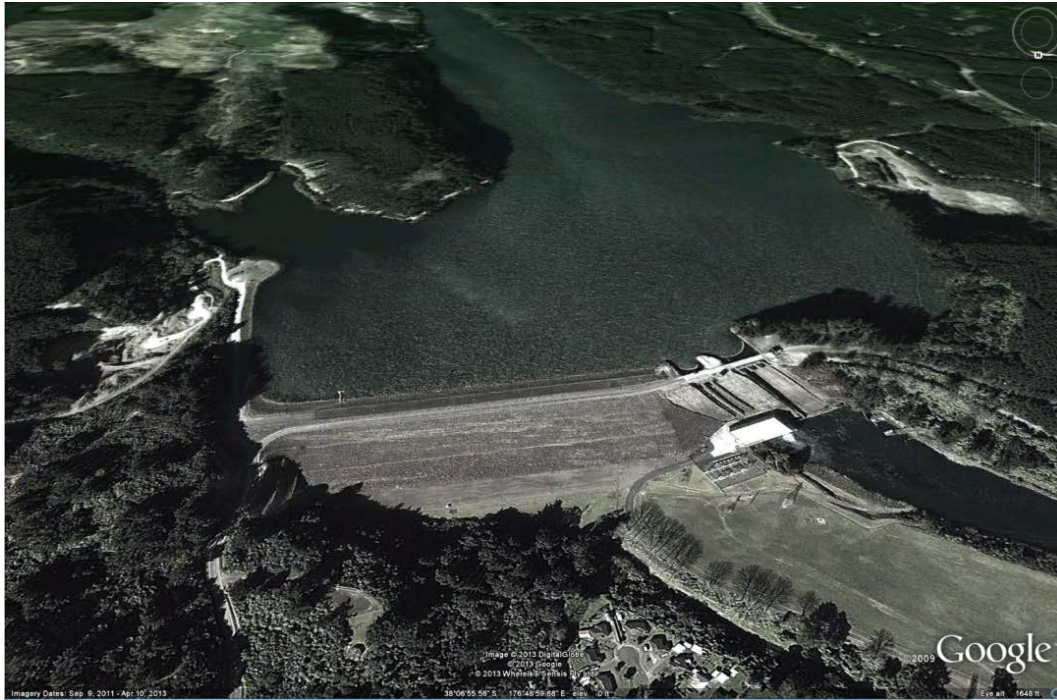
Figure 1.—Oblique view of Matahina Dam (Google Earth, September 9, 2011).

Matahina Dam is an 86-m-high, 400-m-long zoned earth and rockfill dam constructed in 1966 (figures 1 and 2). The dam is located upstream of the small community of Lake Matahina, on the Rangitaiki River, North Island, New Zealand. The project is also equipped with a spillway, penstocks and powerhouse, and diversion and dewatering tunnels. These features are located on a rock spur that makes up the left abutment of the dam. The rock spur contains two drainage tunnels and a grout curtain (Gillon 1988).

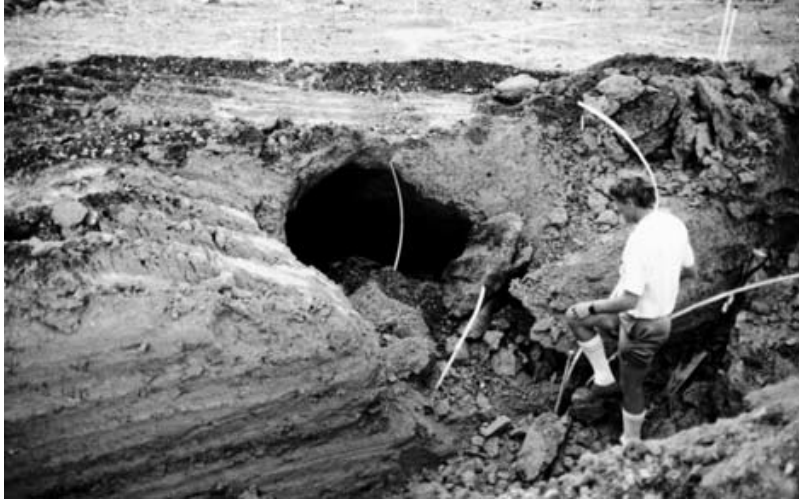
Figure 4.—Internal erosion in the dam core (Amos and Gillon, 2007).

With the use of trench investigations, transverse cracking was found to be shallow, and a large cavity in the same area of the right abutment as the 1967 sinkhole was discovered in line with the foundation anomaly but upstream of the core (figure 4). After discovery of the new cavity, two shafts were drilled to investigate the previous repairs to the right abutment. The sinkhole discovered on December 17, 1987, about 9 months after the earthquake, confirmed that internal erosion had occurred and was continuing (Centre for Energy Advancement through Technological Innovation [CEATI] 2010). After four inclined borings were drilled into the left abutment, high inflows downstream from the core were found. Twelve piezometers were installed in the left abutment, and anomalously high pore pressures were measured. Surveys confirmed that there was continuing settlement of the dam and left abutment spur several weeks after the earthquake (Gillon 1988). Seepage from the left abutment increased four-fold immediately following the earthquake and continued to rise for at least 8 months. The conclusion drawn from the investigations was that the core in the left abutment had experienced cracking and erosion similar to that experienced previously in the right abutment, although it could not be determined with certainty if the condition existed prior to the earthquake (Gillon 1988).

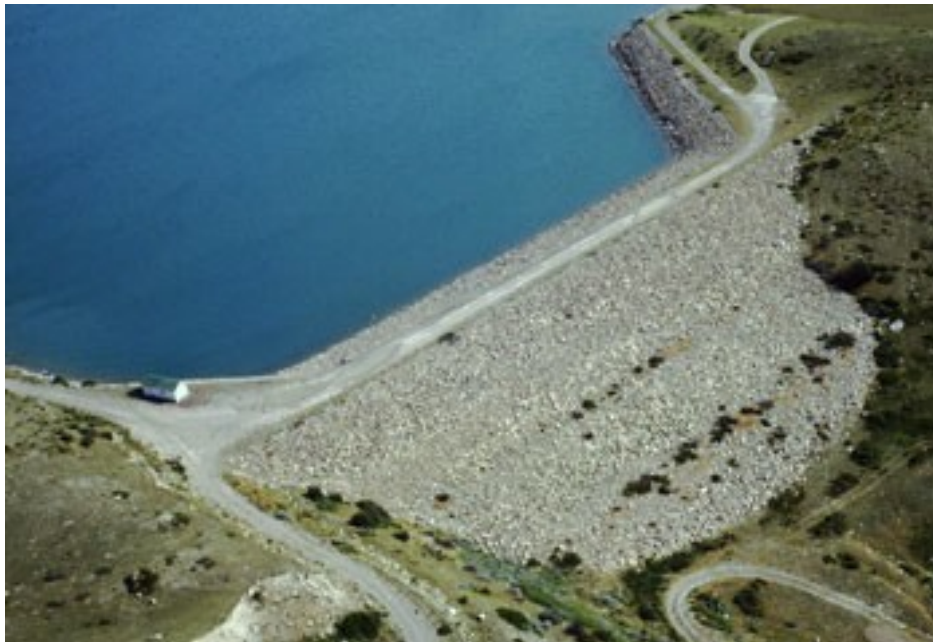
Figure 1.—Photograph of the Willow Creek Dam and gate house (Reclamation).

Willow Creek Dam is an earthfill structure on Willow Creek near Augusta, Montana (figure 1). In addition to storing water from Willow Creek, the reservoir is fed from the Sun River through the Willow Creek Feeder Canal. The structure is 93 ft high, has a crest length of 650 ft, and contains 275,000 yd³ of material. An open spillway channel 700 ft wide at the ground surface has a capacity of 10,000 ft³/s. The outlet works tunnel runs through the right abutment. The reservoir has a capacity of 32,400 acre-ft of water. Geology at the dam site consists of Cretaceous age bedrock of the Two Medicine Formation (horizontal bedded, decomposed to soft shales and siltstones prone to slaking, and fine-grained sandstones) overlain by Pleistocene glacial moraine deposits and recent alluvium and colluvium along the channel of Willow Creek. The sandstones are moderately hard to hard, and high-angle jointing is prominent and leads to formation of blocky, tabular fragments. Glacial moraine deposits in the area are quite coarse and generally consist of sand and gravel with minor amounts of cobbles, boulders, and silt and clay fines. Alluvium along the creek channel is a highly variable mixture of material ranging in size from clay fines to boulders. A thin layer of material at the base of the dam, identified as alluvium, is composed of mostly cobbles and gravel with almost no fines. Glacial deposits form the foundation of the dikes and spillway.

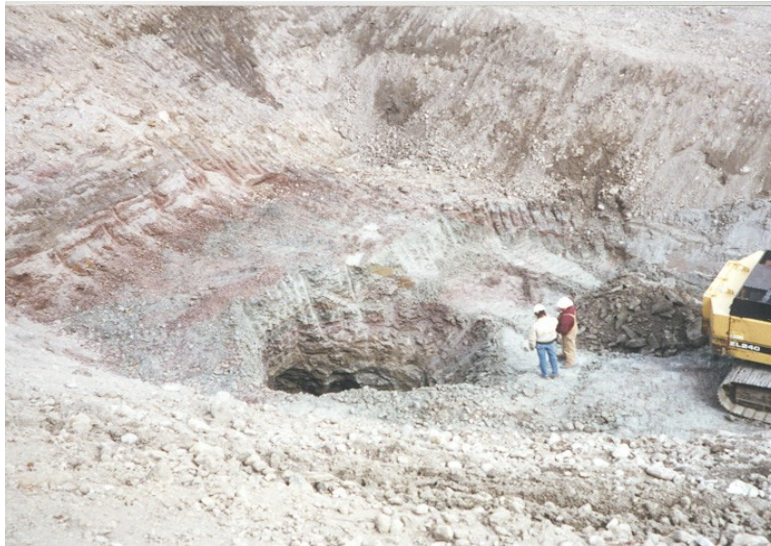
Figure 3.—View from top of dam after excavation was complete.

As part of the process to repair the sinkhole in 1996, the reservoir was drawn down, and a portion of the right abutment was excavated to within about 12 ft of the crown of the tunnel in the vicinity of the sinkhole. A layer of fractured sandstone separated the excavation from the tunnel crown. A total of 374 yd³ of lean concrete grout was tremied into the void around the tunnel and brought up to about elevation 4087. After letting the grout set up, lean backfill concrete was placed to fill the excavation to the foundation surface at elevation 4110. Pressure grouting of the bedrock was also performed along an 80-ft length of the tunnel. A total of 32 grout holes, with an average length of 35 ft each, were drilled, water tested, and grouted at mostly low pressures of around 5 lb/in², with an average grout take of 0.2 bag per linear ft. Filter sand was placed over the exposed bedrock surface in the bottom of the excavation, and the excavated embankment fill was replaced and recompacted. As a precaution, an upstream berm was constructed to provide 100-yr flood protection in the event the embankment construction could not be completed before winter. The berm extended 240 ft across the right abutment groin,

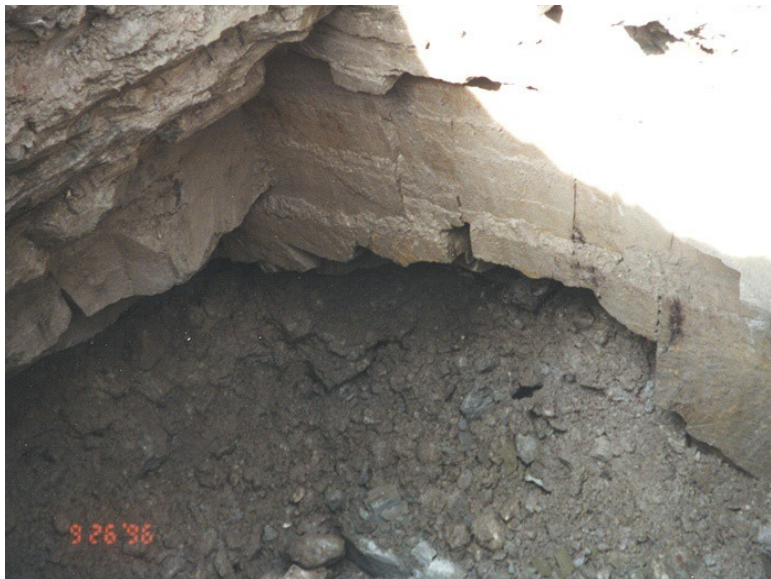
Figure 4.—Looking into sinkhole from foundation contact.

On June 28, 1996, a sinkhole was discovered on the crest of Willow Creek Dam about 50 ft downstream from the gate house (Reclamation 2013). Emergency investigations determined that embankment material had been piping into a large cavity surrounding the outlet works tunnel at the location of a tunnel collapse in 1958 (figures 3 and 4). In addition, some material had been piping into the tunnel through weep holes drilled through the concrete lining to provide pressure relief. Emergency repairs were undertaken in the fall of 1996 to excavate the right abutment area, backfill the sinkhole cavity with grout, pressure grout the foundation, place a filter on the dam foundation contact, replace the embankment, and construct an upstream berm to provide a longer seepage path through the abutment. Designs were also undertaken to repair the outlet works, including the addition of a new air vent (constructed in June 1997), a partial tunnel lining (constructed in August 1997), a new trashrack structure, a new gate house, and guard gate repairs.

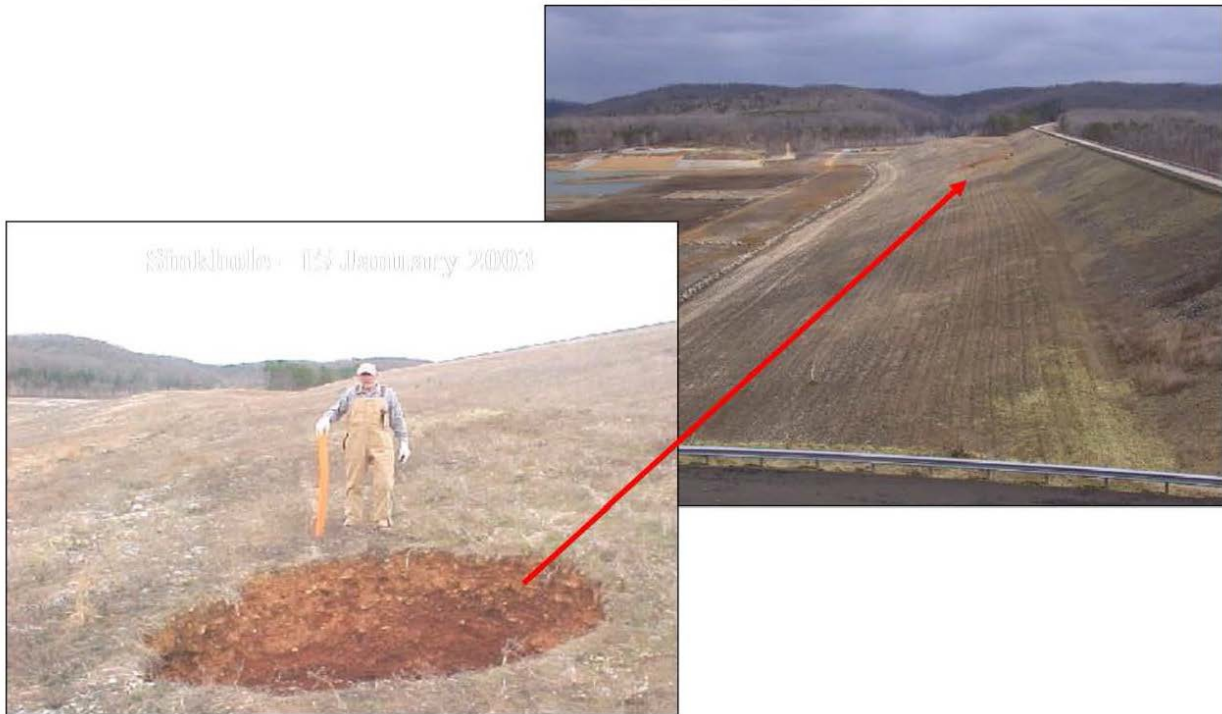
Figure 5.—Sinkhole through upstream impervious blanket.

The reservoir experienced the pool of record in May 2002. The following January in a period of low pool, a sinkhole (figure 5) opened up on the upstream embankment face above the pool elevation. It is believed that the sinkhole pipe developed below the dental treatment through a karst feature that was originally soil filled but over time was cleaned out by erosion (figure 6). It is also possible the pipe eroded the core above the dental treatment into an untreated feature and bypassed the treated cutoff trench. Following the incident, the dam was placed under a pool restriction until major repairs could be implemented.

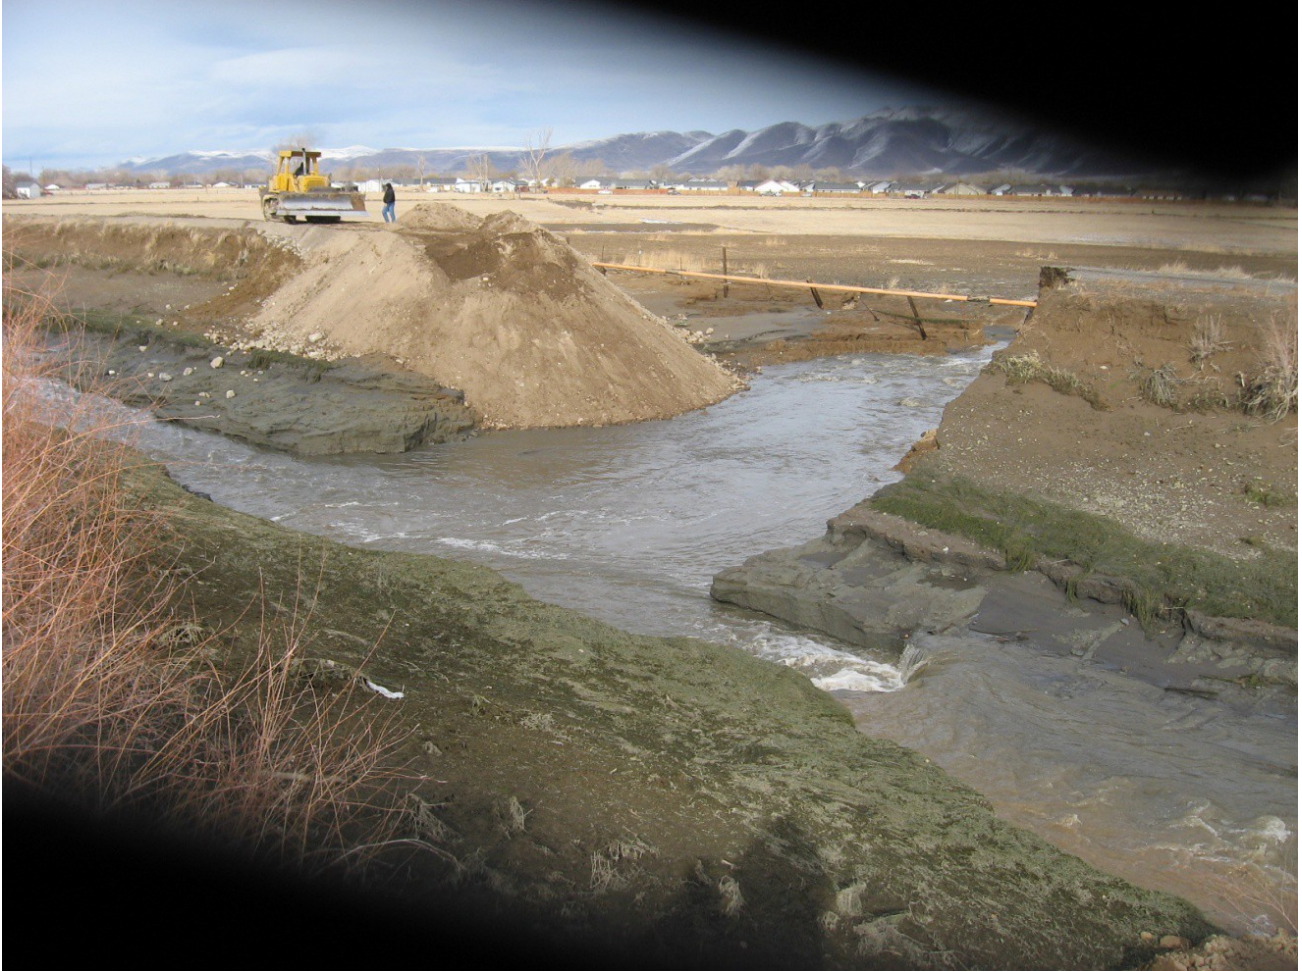
Figure 1.—Photo of the breach during early phases of temporary breach repair on the morning of January 5, 2008. Normal canal flow is from left to right in this photo. The breach is being filled by pushing fine-grained soil into the gap in the canal embankment. Some of the scour of the canal bottom can be seen along with some scour of the area immediately downstream from the breach. The pipeline shown is an abandoned natural gas pipeline that had been buried in the canal embankment. The pipe remained in place after the breach despite eroding all support provided by the original embankment.

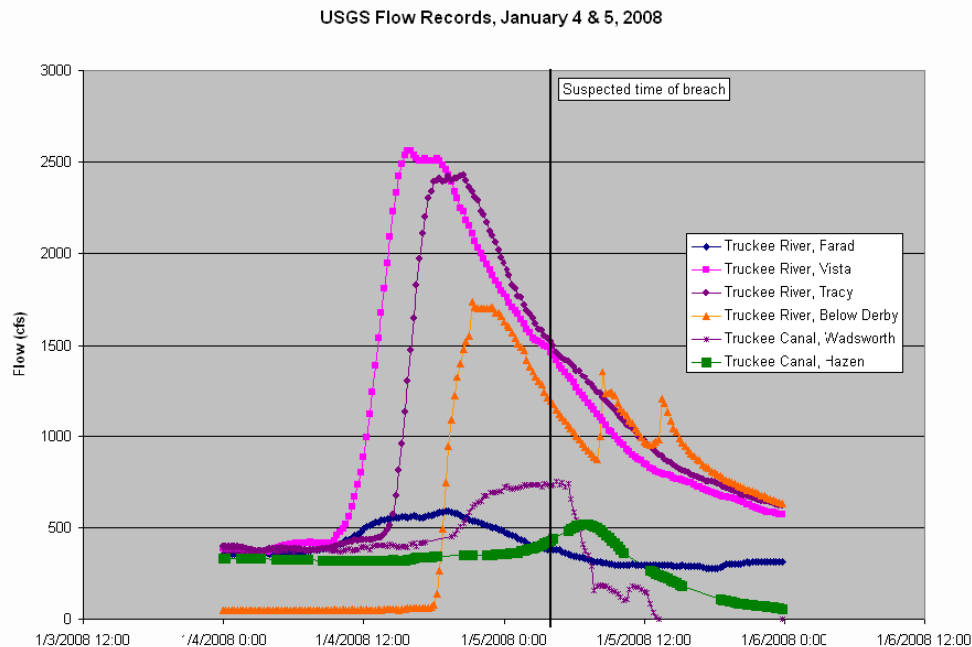
Figure 2.—Flow observations at USGS gages during event. The flow gage at Wadsworth is the gage apparently considered by TCID as the one that gives the flow history closest to the 2008 breach site.

As shown on figure 2, for about 2 months prior to the January 5, 2008, failure, a base flow of about 350 ft³/s was being diverted into the canal. No substantial irrigation releases were being made anywhere along the canal.

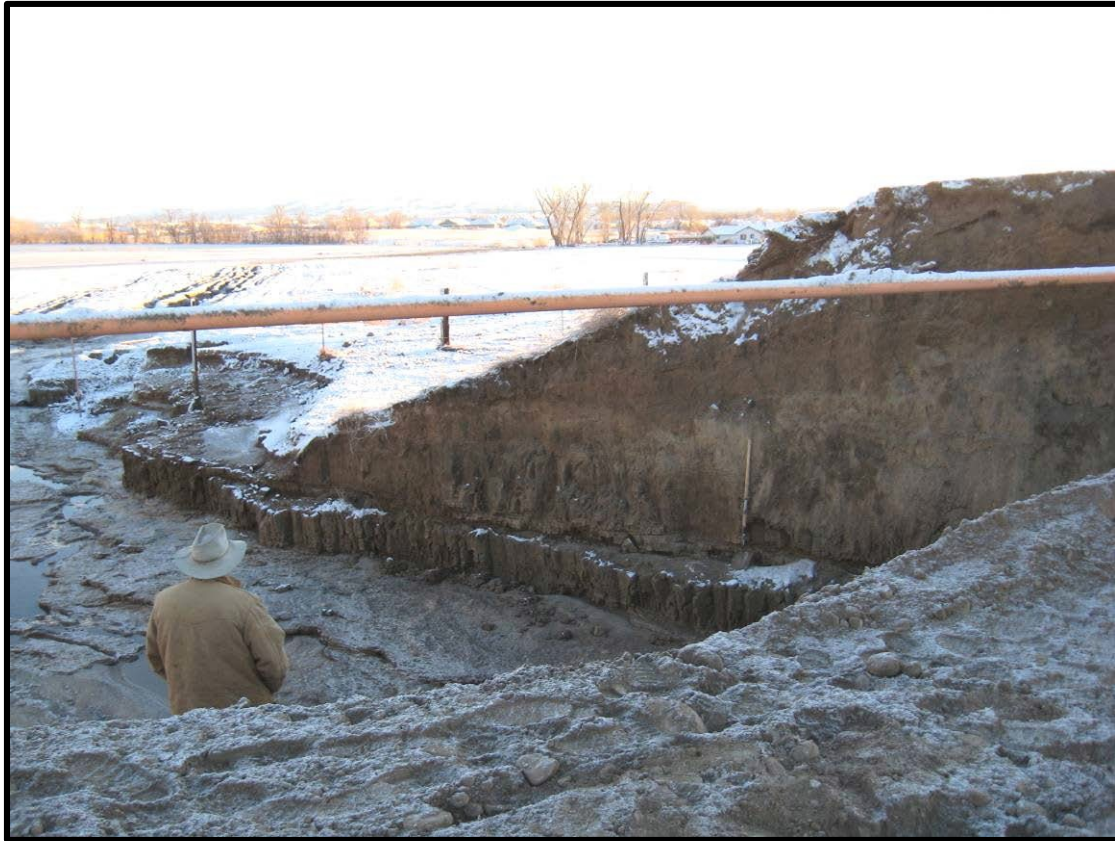
Figure 3.—View through the breach toward Fernley, Nevada. The downstream breach face cut into the left canal embankment is 17½ ft high.

During the breach event, water from the Truckee Canal flowed from both upstream and downstream in the canal through the breach for at least 9 hr. Water eroded through the left embankment of the canal (which was about 8 ft high in this area) and downcut into the foundation beneath the embankment an additional 9½ ft, for a total erosion depth of about 17½ ft (figure 3).

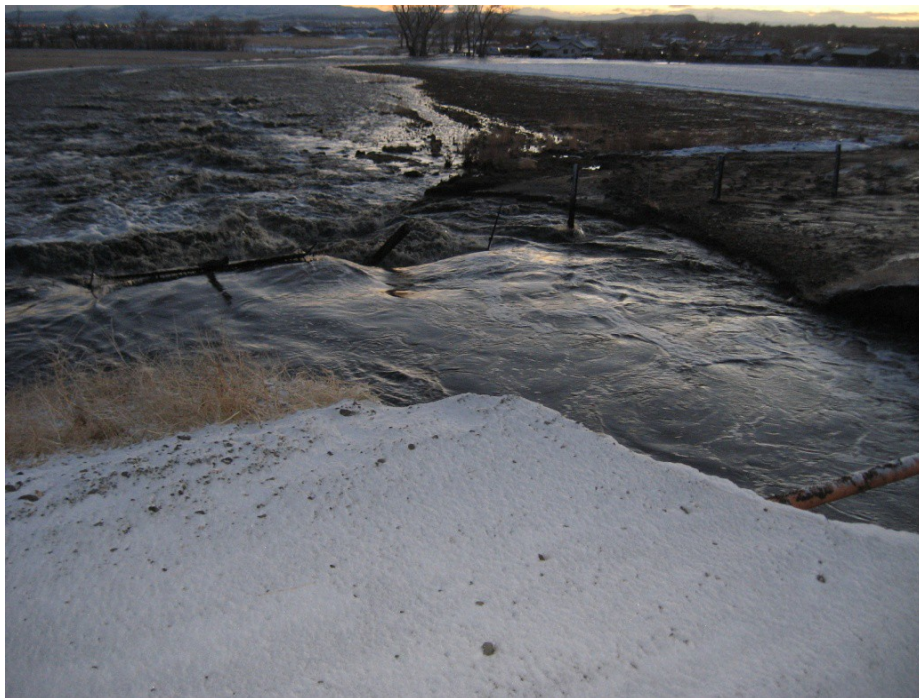
Figure 5.—Earliest photos showing breach (estimated time about 6:30 a.m. on January 5, 2008) (photos by Walt Winder, TCID).

Based on the verbal report of the project engineer, the dimensions shown on figure 6 were substantially wider than that first noticed upon his arrival at the breach site at least 45 minutes after the breach had occurred (figure 5), which would suggest the widening to the final size occurred sometime between 4:45 and 6:30 a.m.

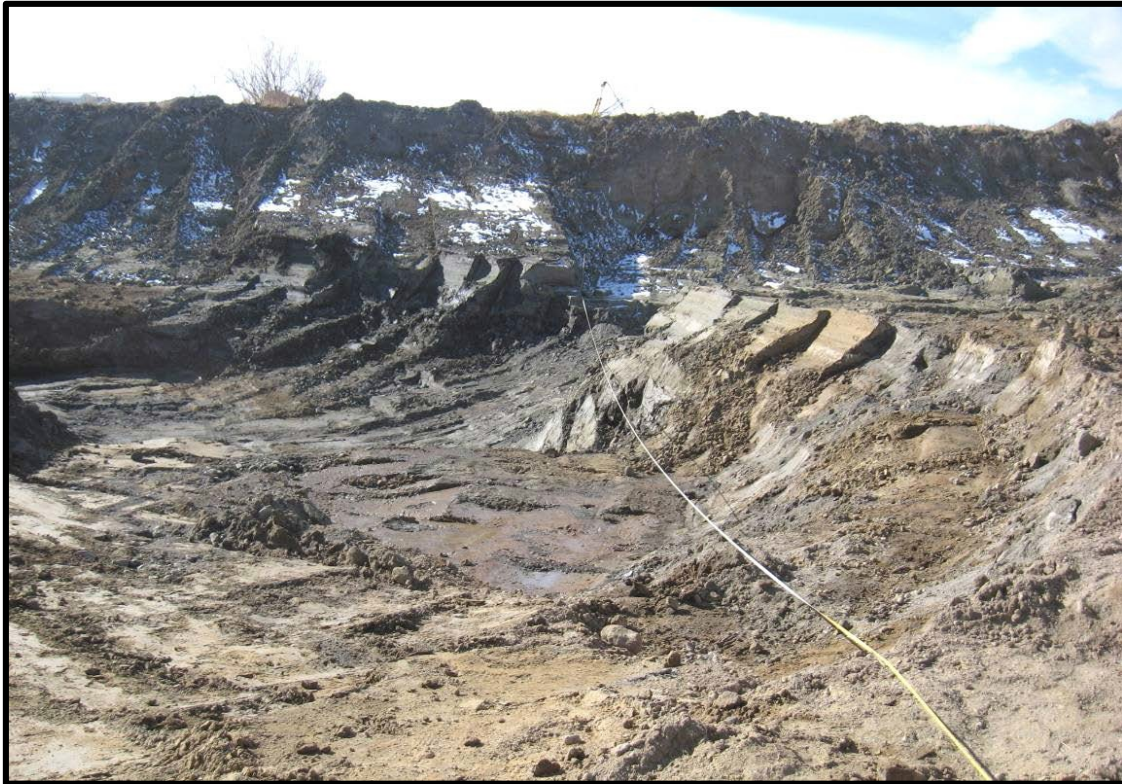
Figure 8.—View to the southwest (toward the right side canal embankment) of the final excavation of the scour hole site.

There are two distinct geologic units exposed in the final excavation at the scour hole area. The upper unit is fine-grained Lahontan Lakebed Sediment (Q1b) composed mostly of high-fines content silt and clay with minor sand and is estimated to have a low to very low relative permeability. Underlying the lakebed sediment are coarse alluvial fan deposits (Qf) composed mostly of poorly graded gravel with sand and cobbles (figure 8). The coarse deposits are estimated to have a moderate to high relative permeability.

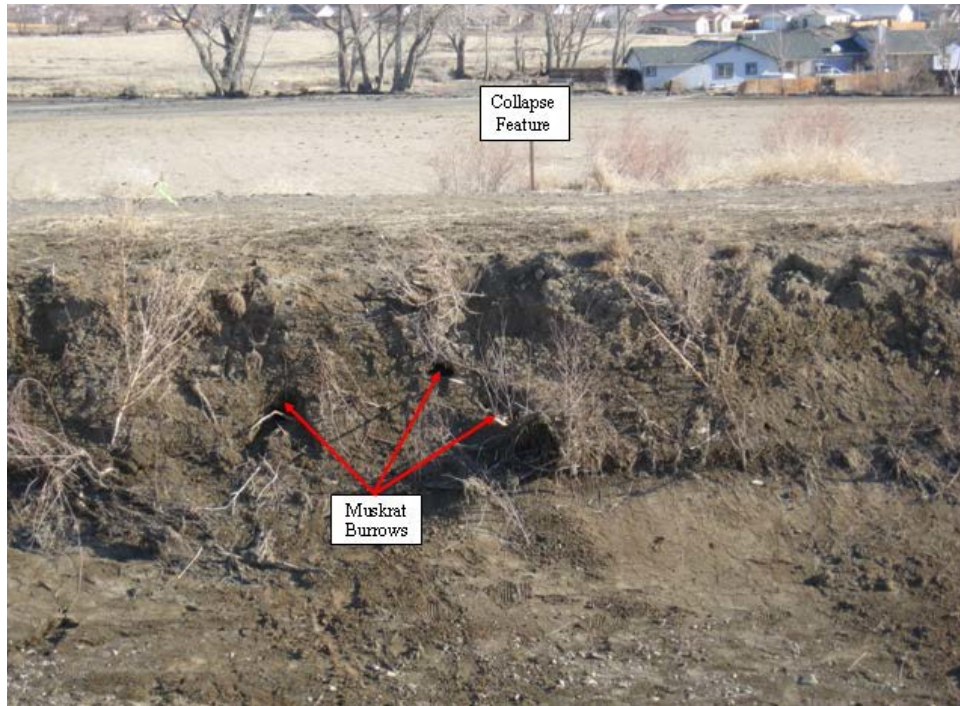
Figure 11.—View of canal embankment prior to investigations showing three muskrat burrow entrances on the waterside and the location of a collapse feature (feature not visible) on the landside. The burrow entrance appeared to be located a foot or so below the approximate 350 ft³/s flow line.

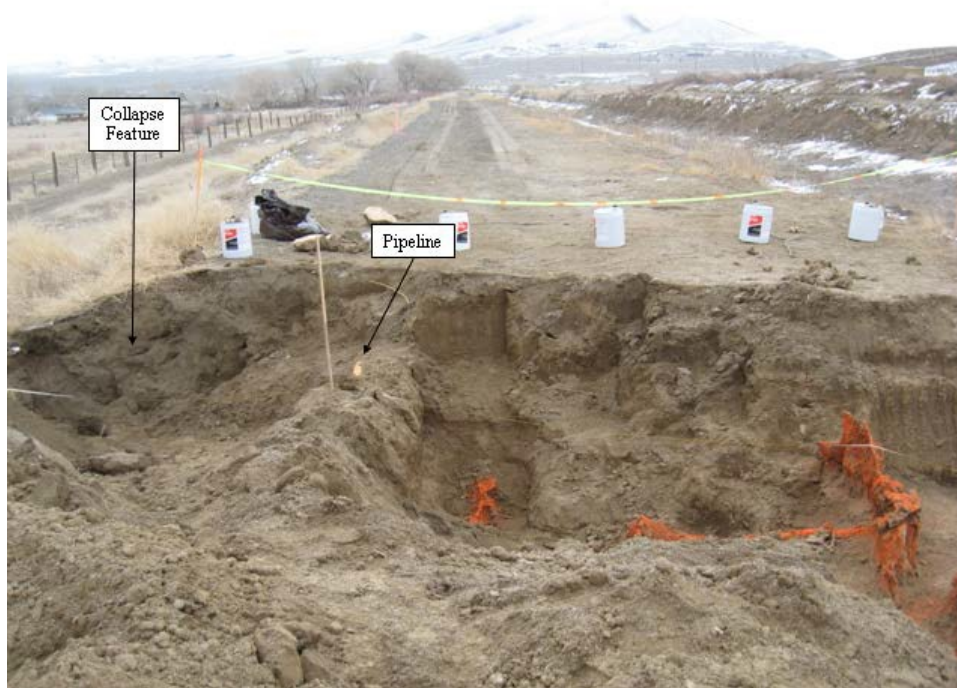
Figure 10.—View of partial excavations of canal embankment crest following grouting with Stratathane™. Features that were found grouted have been painted with orange paint.

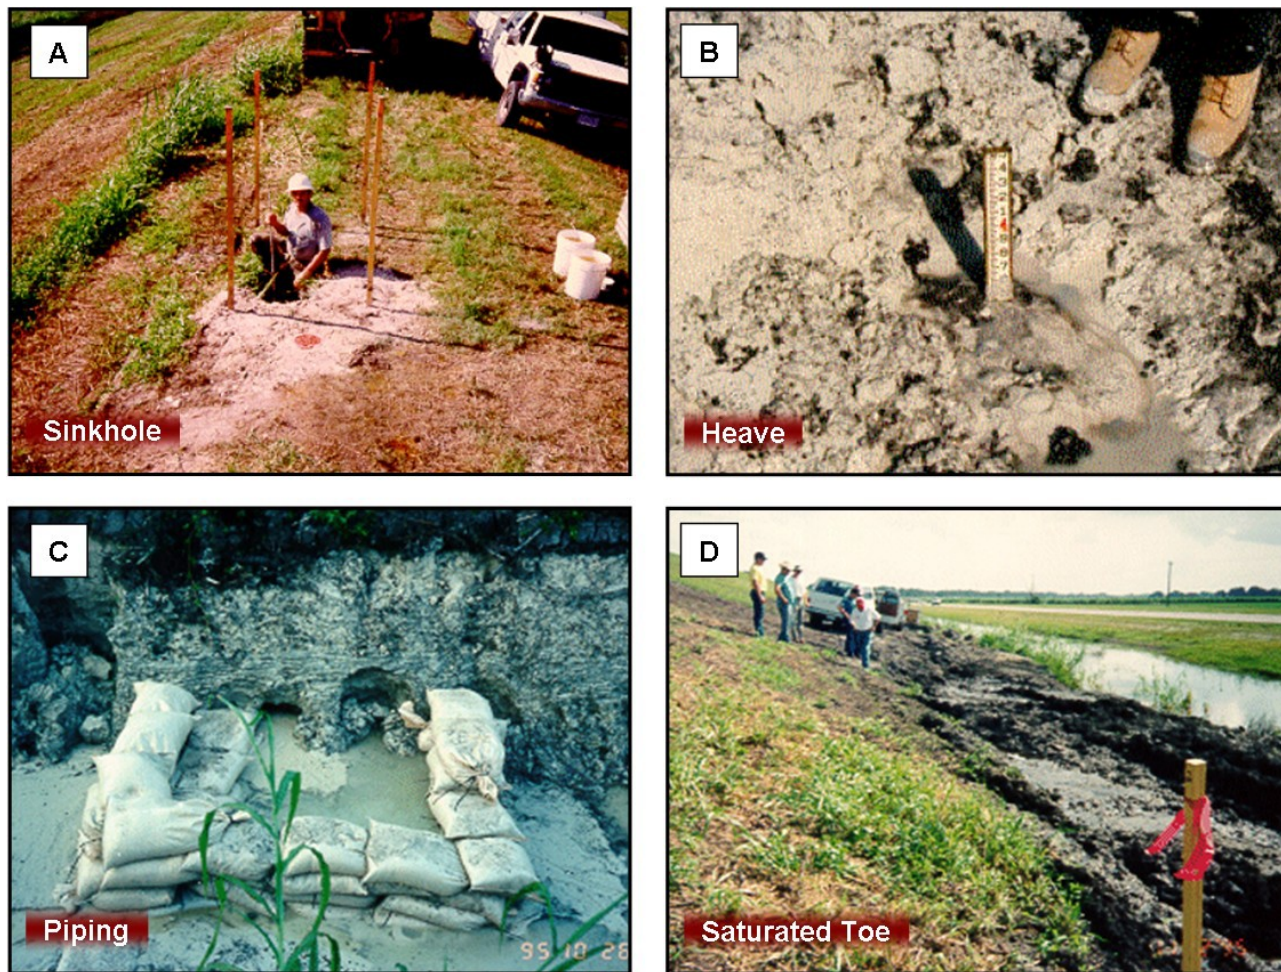
Figure 3.—Representative photographs of prior seepage erosion conditions at HHD near Lake Harbor. Downstream area seepage distresses were observed during events having a ~30-yr return period: (A) sinkhole formation in crest, (B) heave of downstream toe caused by upward seepage flow - surveyrod was easily embedded 4 ft deep, (C) piping at downstream toe of dike, and (D) saturation of landward toe and embankment slope.

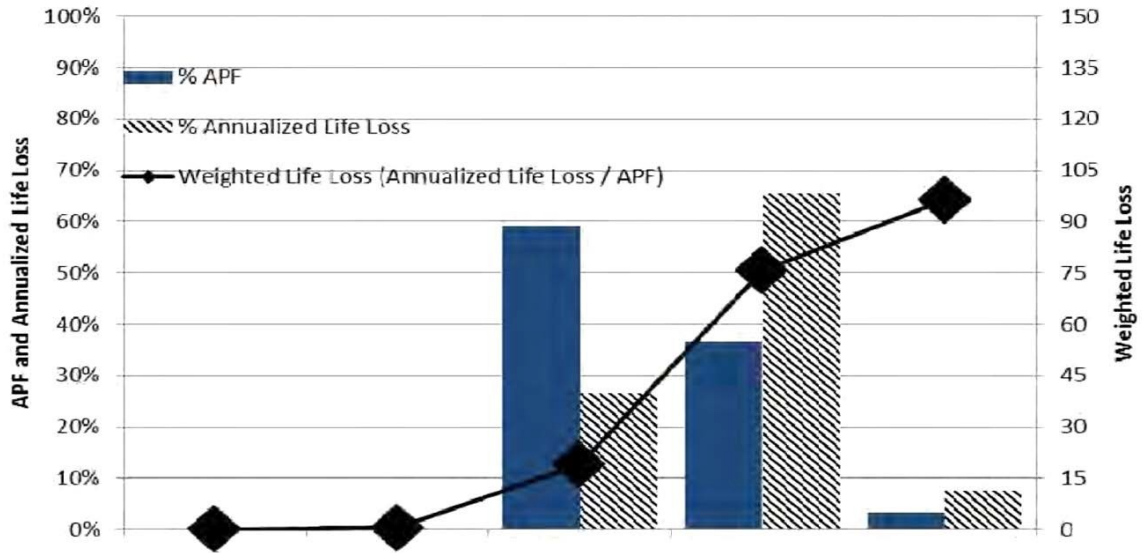
Risk Contributions by Reservoir Range
 Reach 3 Segment 1
 PFM R3-3 Internal Erosion Through Embankment (FIA)

Figure 7.—Typical risk contribution by reservoir range.

Another way to visualize the contribution of reservoir load to the risk is shown on figure 7, which is a bar chart showing the percentage of the total that each reservoir level contributes to the total APF and annualized loss of life risk for a particular failure mode. Also shown is the “weighted life loss”⁴ that indicates the increasing consequences of increasingly large floods and subsequent inundations depths.

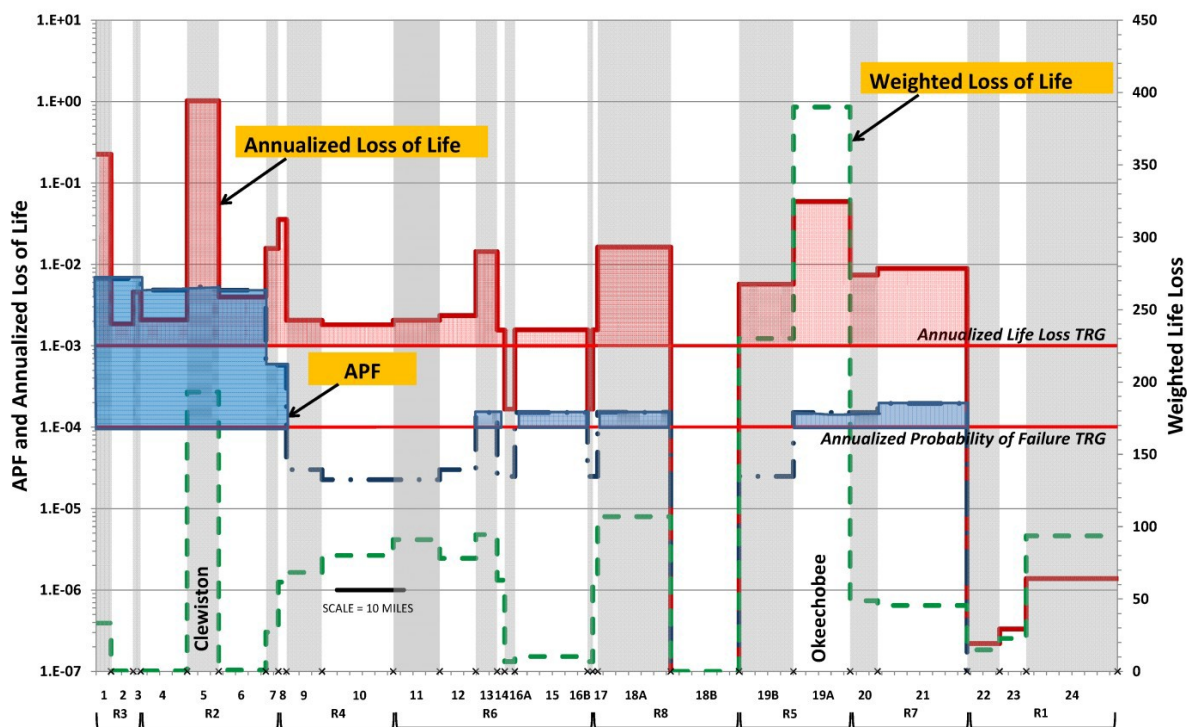
Figure 9.—Risk analysis results by segment along dam alignment.

Figure 9 presents the variations of three values along the dam alignment: APF, annualized loss of life (“risk”), and weighted loss of life.⁵ The weighted loss of life was computed by dividing the total annualized loss of life by the APF, thus producing a weighted average for all reservoir levels. As can be seen on figure 9, baseline risk estimates for 21 of the 26 segments exceed the defined TRGs for either APF or annualized loss of life risk. Risk was very sensitive to consequence estimates and boundaries. Several of the segments were more heavily influenced by life loss estimates than by the condition of the dam. This is demonstrated where APFs are below the TRG, while annualized life loss exceeded the TRG.

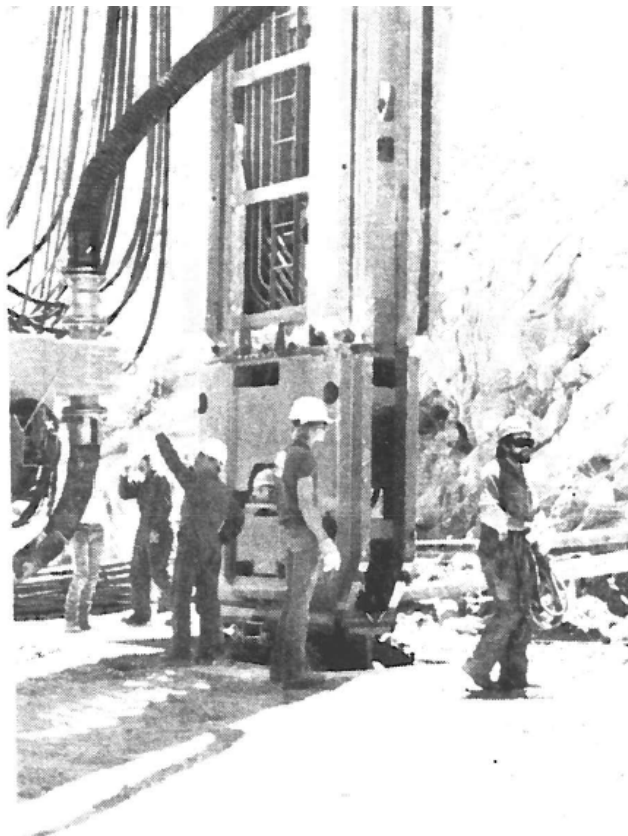
Figure 4.—View of Hydrofraise being maneuvered and lowered for panel excavation.

A 436-ft-long, 400-ft (maximum) deep, and 32-in nominal width concrete diaphragm wall was installed in the left abutment to cutoff seepage. The wall was constructed in 8-ft panels by using a "Hydrofraise" (rock mill) (figures 3 and 4) to excavate a slurry-filled trench to the specified length and depth and then backfilling the panel by introducing concrete at the bottom (figure 5) of the trench until it was filled with concrete. At the time (1987-88), the Hydrofraise used at Navajo Dam was the largest ever built. The Hydrofraise was 90 ft tall, which was 40 ft taller than previous models, and weighed 30 tons. Some 28-day compressive strengths for the diaphragm concrete reached 5,000 lb/in². The typical concrete mix (per yd³) was: water at 207 lb; cement at 363 lb; and pozzolan at 155 lb; sand at 1,261 lb; and gravel (aggregate) at 1,915 lb. The concrete diaphragm wall was intended to control or drive the seepage deeper into the abutment at the contact between the impervious core and the foundation sandstone. This modification greatly reduced the potential for internal erosion of the impervious core material into the fractured sandstone. Piezometer readings and seepage measurements show that this has occurred. The seepage rate through the left abutment has been greatly reduced from pre-wall conditions and the seepage pressures downstream from the concrete diaphragm wall are significantly less than pre-wall conditions.

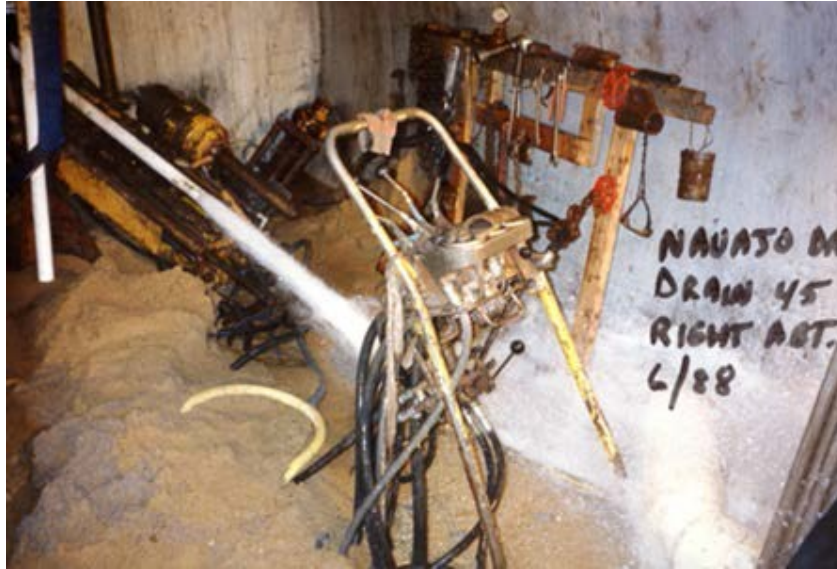
Figure 8.—High flows and sand washing into drain hole No. 45.

the drains consist of only the slotted PVC pipe. High seepage flows (up to 750 gpm) were encountered when drilling the last 15 drains (drain Nos. 32 to 46 located toward the left end). In one instance, large amounts of sand were washed into the hole (figure 8). Because of the very large seepage inflows washing sand and shale particles from the holes, four holes were grouted off and one was fitted with a valve and its flow shut off. An additional four holes were not drilled.

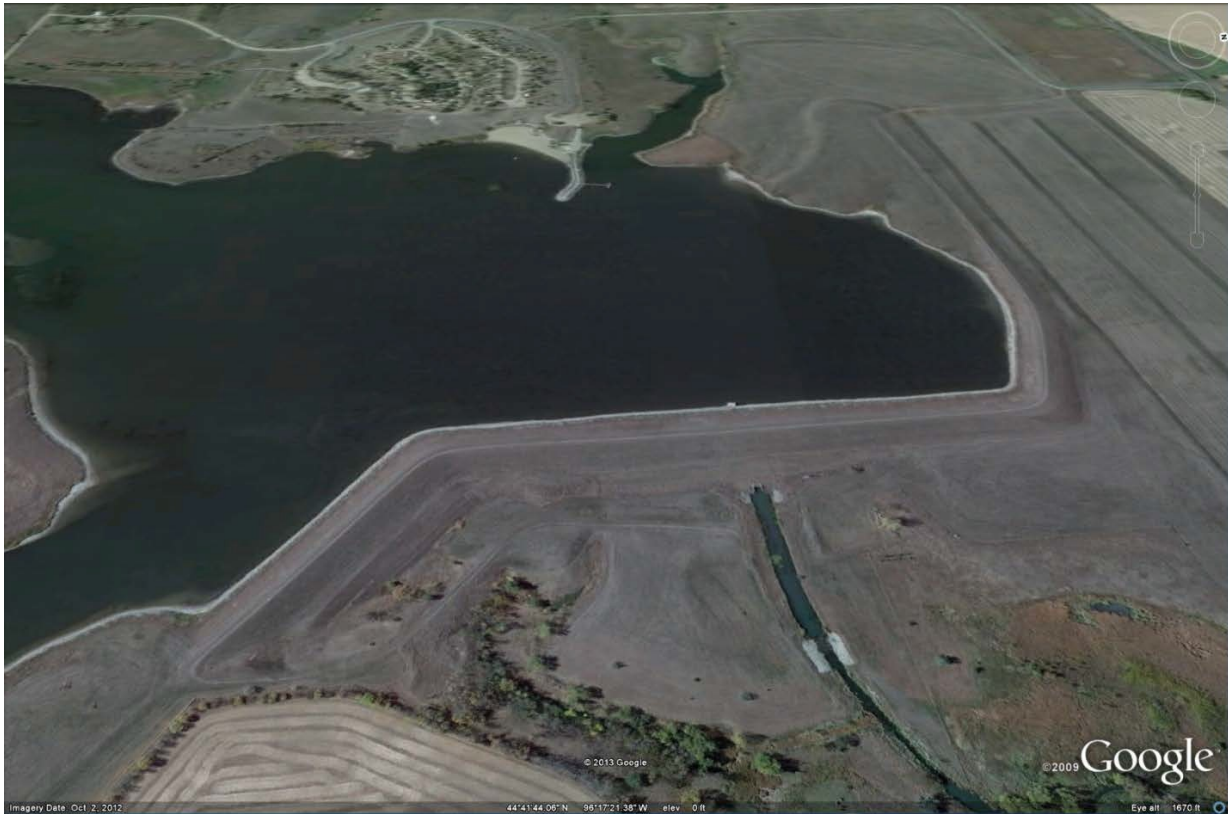
Figure 1.—Oblique view of Canby Creek, R-1 Dam (Google Earth, October 2, 2012).

Canby Creek, R-1 Dam (figure 1) is an NRCS-designed dam constructed in 1985, with a maximum structural height of 70 ft, in a glacial outwash area of Yellow Medicine County, Minnesota. The dam impounds a reservoir with a maximum storage capacity of 6,100 acre-ft from a drainage area of 26 mi².

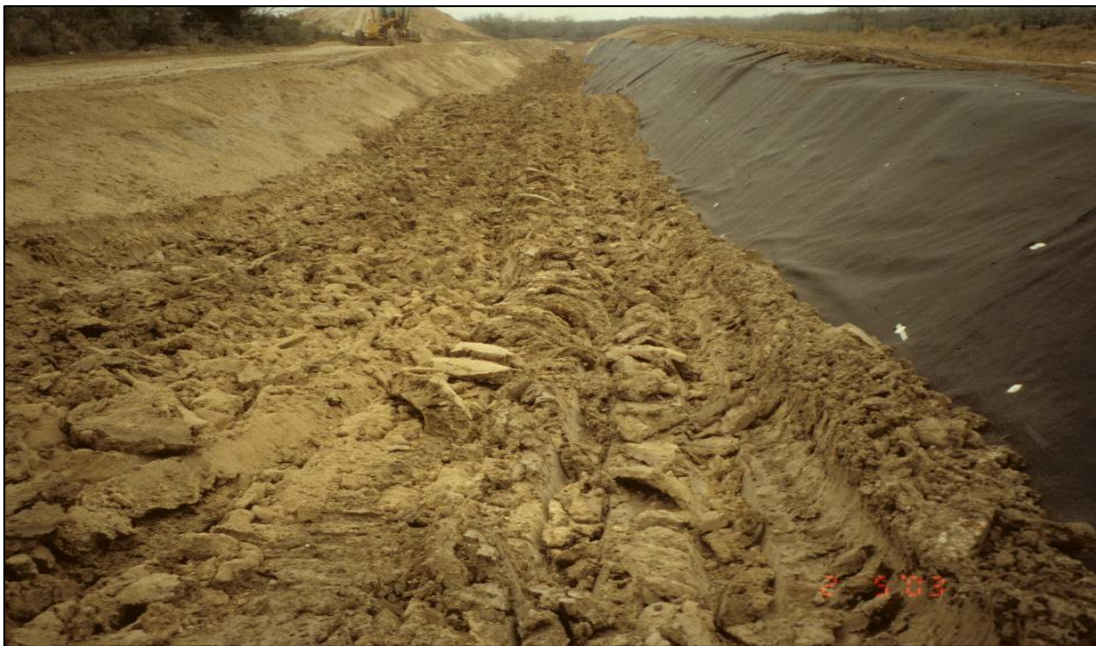
Figure 5.—Backfilling foundation trench, Olmitos-Garcias No. 2 Dam.

The outside 12 ft (measured horizontally) of the 2.5H:1V downstream slope were removed, and a trench with a 12-ft bottom width was excavated down to competent claystone. The subgrade for the geotextile was smoothed by dragging a flat metal frame over the slope surfaces using a tractor and cables (figure 4). Then, the geotextile was placed on the slope, beginning at the bottom of the foundation trench and extending to within 1 ft of the top of the dam. Finally, the trench was backfilled, and the slope and stability berm were constructed with compacted earthfill (figures 5 and 6). In the vicinity of the principal spillway conduit, the geotextile within the foundation trench was replaced with a vertical trench filled with flowable fill (figure 7).

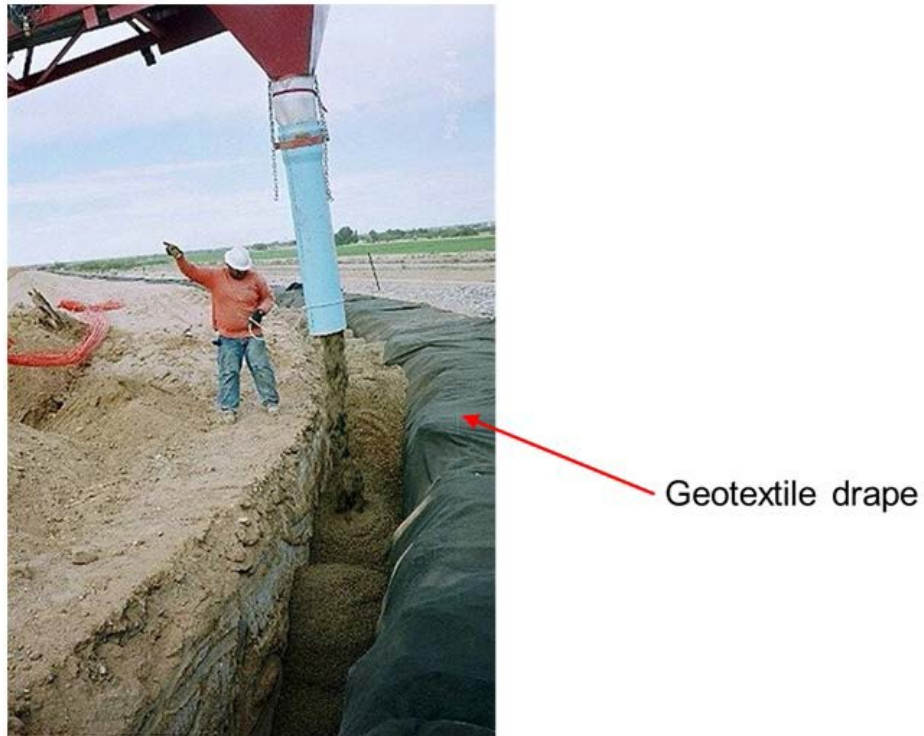
Figure 5.—Placing filter material with tremie, Florence Dam.

of the filter material in the trench to within 1 ft of the top, and (4) placement of 1 ft of compacted earthfill over the trench and covering the embankment crest with 3 in of gravel. The two major challenges with construction were excavation of the 25-ft-deep trench in dry, partially cemented earthfill and blending and placing the broadly graded filter material without segregation. The trench was successfully excavated with both hydraulic excavators (figure 3) and a Case CX 290 trencher. No instability of the trench occurred between trench excavation and placement of the filter material. The gradation of the filter material was equivalent to a 50-50 mix of ASTM C33 Fine Aggregate for Concrete and ASTM C33 No. 57 gravel. The grading and blending of the filter material was accomplished using a screening machine and an auger-type mixer/elevator (figure 4). Placement of the filter material in the trench was performed using a tremie pipe to control segregation (figure 5). An 18-in overlap between adjacent sections of geotextile was used.

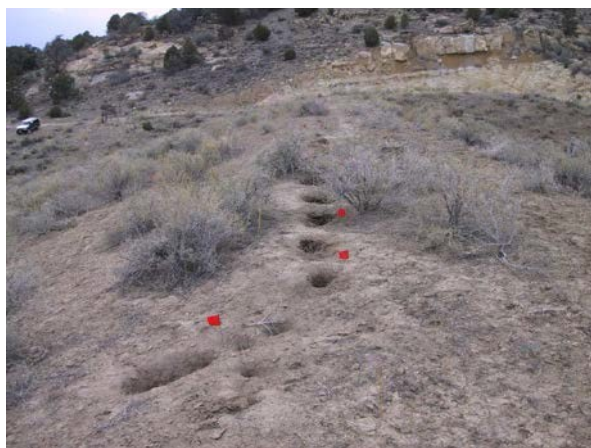
Figure 2.—Holes observed in crest.

Beneath the large holes on the embankment surface (figure 2), cracks were found to be as much as 5 in wide (figure 3), and to the depths investigated, virtually all cracks maintained their widths. Consolidation of the collapsible foundation material was believed to be the source of the cracks, and it was confirmed that these cracks did not extend through the collapsible material. The compaction effort was within the requirements of the original specifications. Though the dam site had experienced years of drought, desiccation cracking was found to be insignificant.

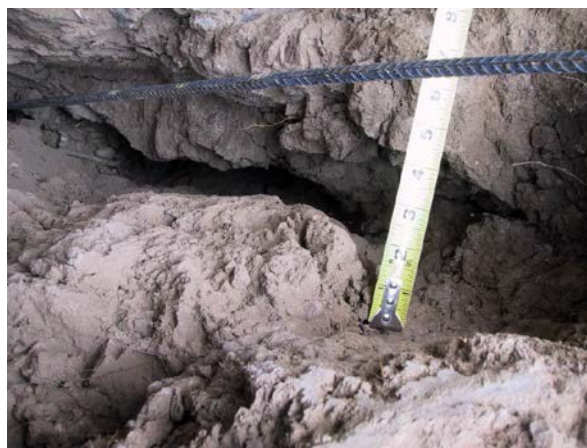
Figure 3.—Up to 5-in-wide cracks under holes.

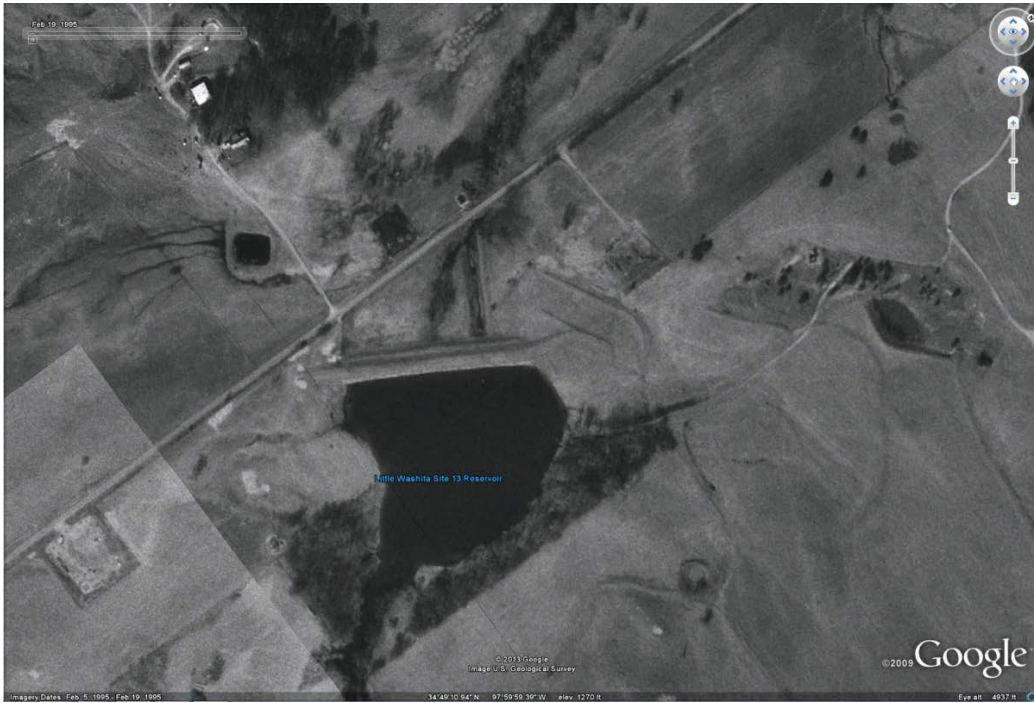
Figure 1.—Little Washita No. 13 (Google Earth, February 5, 1995).

Little Washita No. 13 Dam is 34 ft high and 1,150 ft long (figure 1). It is located on Charlie Creek in Grady County, Oklahoma. It impounds up to 282 acre-ft of storage. Construction of the Little Washita River No. 13 was completed in April 1978. The site periodically exhibited signs of deteriorating conditions caused by solutioning of gypsiferous foundation soils.

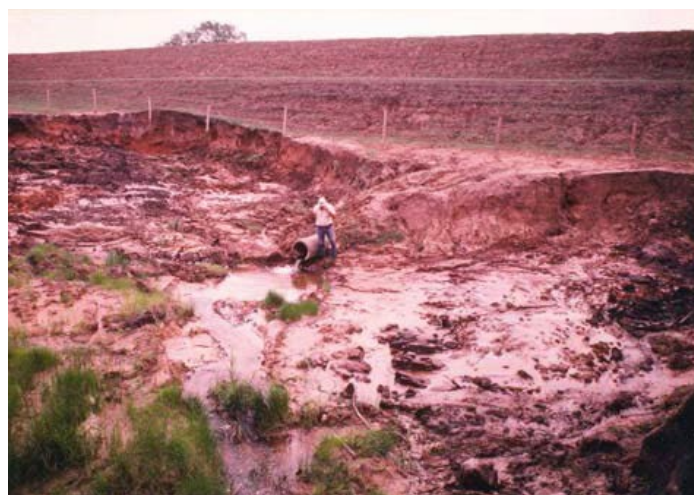
Figure 3.—Sloughing of downstream area near plunge pool.

The sloughing problem reoccurred, and problems were noted in a trip report by Mavis Jones, dated May 4, 1979. Figures 2–4 show the problems observed in May 1979. After this, the area downstream was apparently reworked, and a more extensive foundation drain was installed. Documentation is lacking on the details of the repairs done at this time, but apparently the main effort was directed at providing a drain on the right side of the plunge pool, extending up the right abutment. The drain may have wrapped around the plunge pool and may have extended some distance to the left of the pool. The pictures of the failure shown below indicate that the damaged foundation area was to the right of the plunge pool, but documentation on this repair is minimal. It is well known that a drain was added on the left side of the flood plain area in the 1993 repair discussed in following sections.

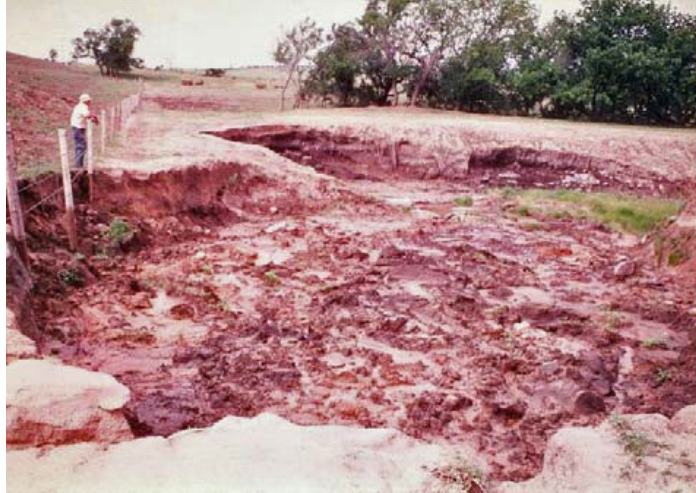
Figure 4.—Sloughing of downstream area observed in May 1979.

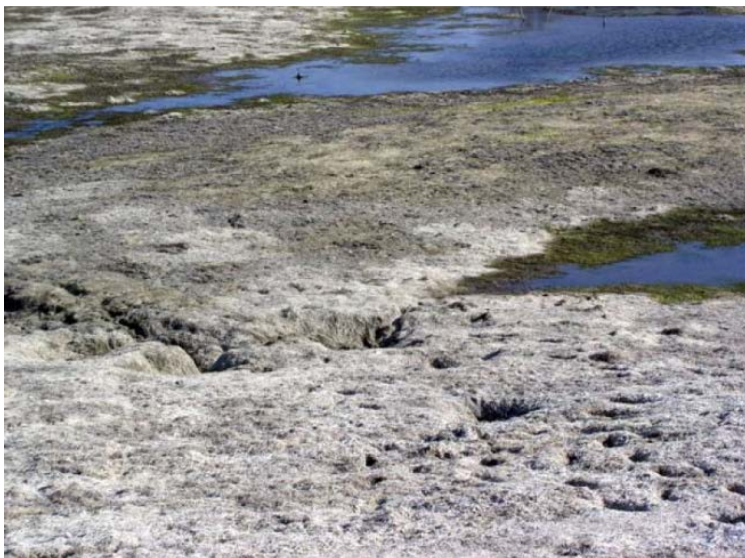
Figure 9.—Sinkholes in reservoir bottom.
