Evaluation and Monitoring of Seepage and Internal Erosion

Interagency Committee on Dam Safety (ICODS)

FEMA P-1032 / May 2015

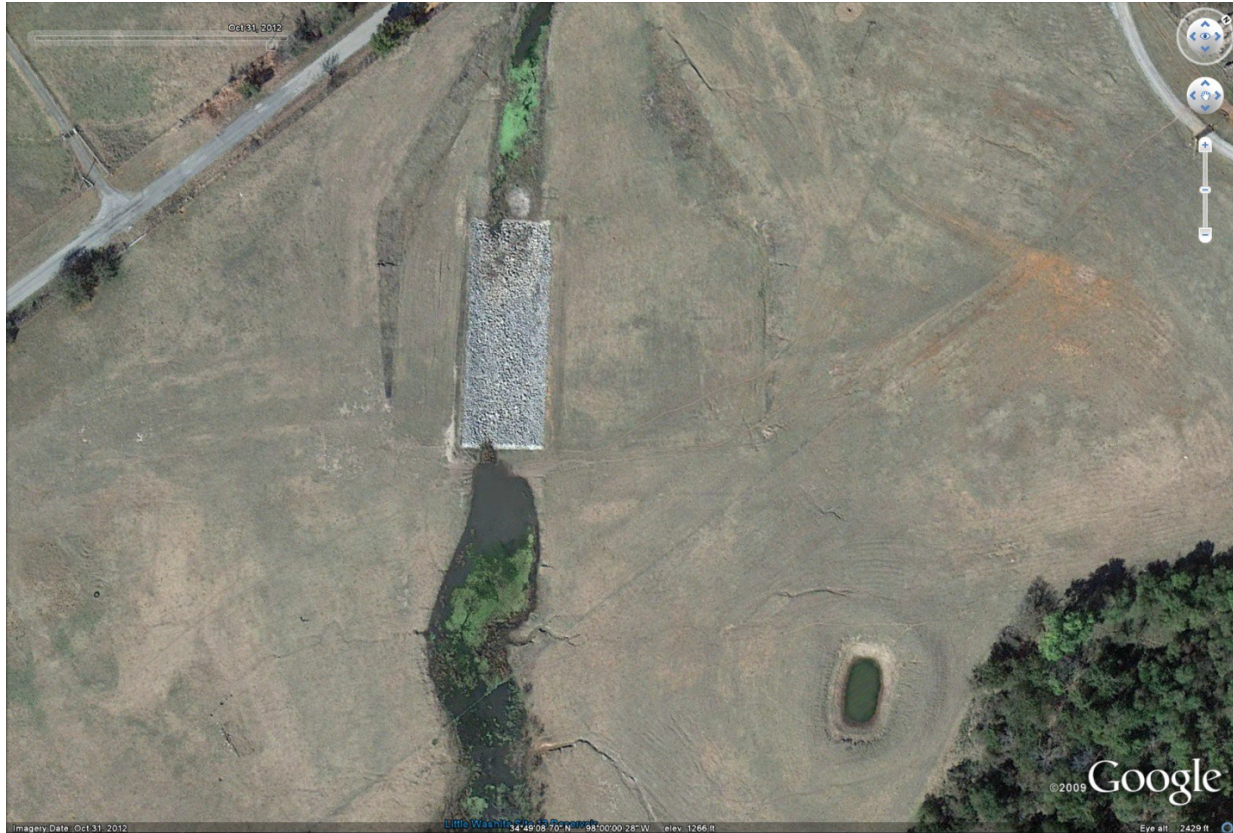
Figure 11.—Little Washita No. 13 site today (Google Earth, October 31, 2012).

The dam was eventually decommissioned and the damaged channel area stabilized with stone (figure 11).

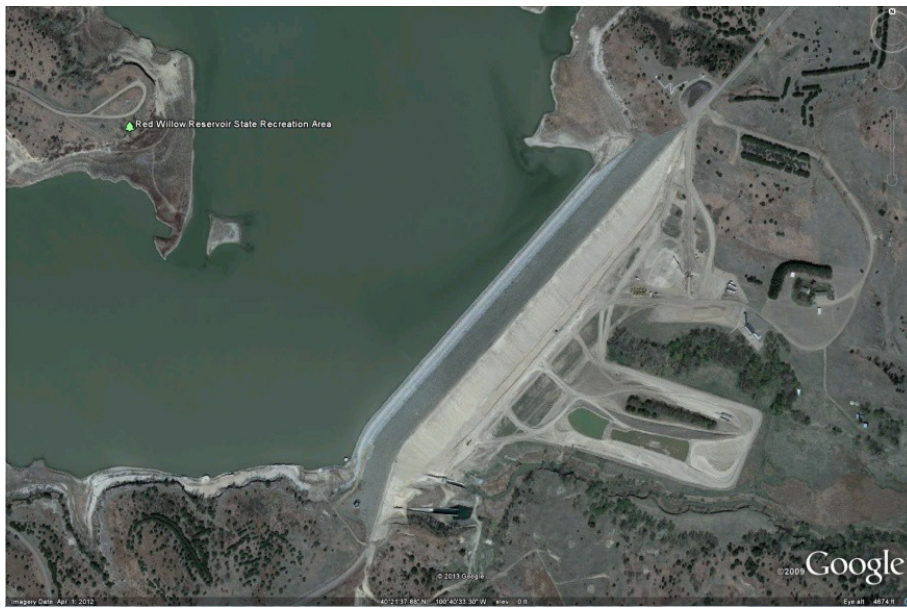
Figure 1.—Red Willow Dam.

Red Willow Dam is located on the confluence of Red Willow Creek and Spring Creek in southwestern Nebraska. The dam was constructed between 1960 and 1962 and modified between 2011 and 2013. The primary features of the design and construction of Red Willow Dam include the embankment, outlet works, and spillway (figure 1). The dam crest is 3,159 ft long with a structural height of 126 ft. The upstream face slopes at 2.5H:1V from the crest to elevation 2600.0, then at 3H:1V to a 20-ft-wide berm at elevation 2550.0, then at 4H:1V to the reservoir floor. The upstream dam face is protected by 2½ to 3 ft of riprap on 12 in of gravel bedding. The dam impounds a reservoir of 27,303 acre-ft to the active storage level and has a total storage capacity of 78,829 acre-ft.

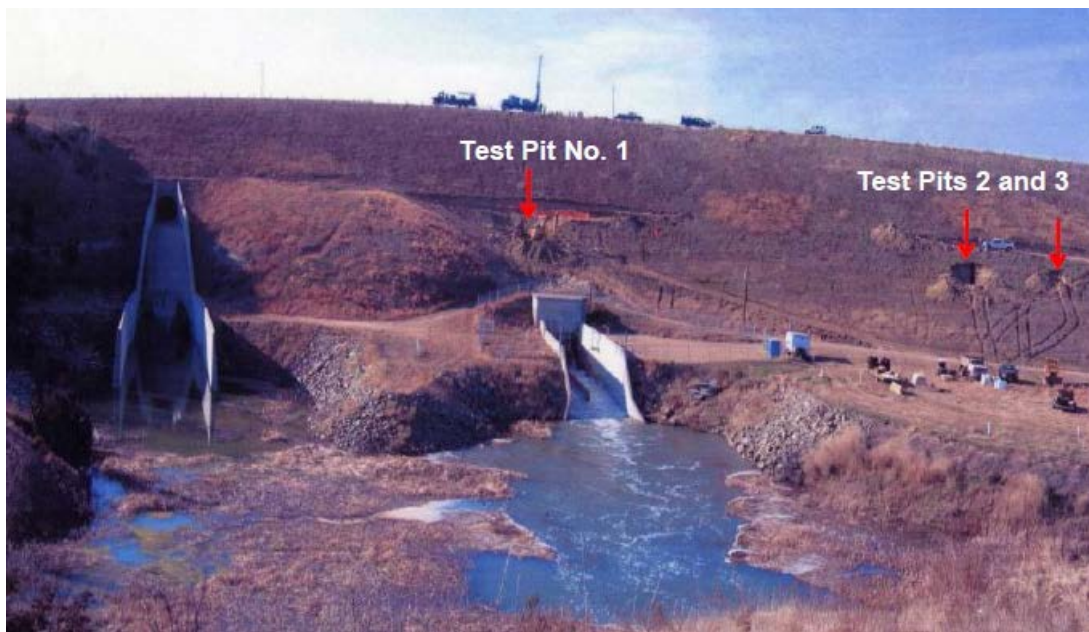
Figure 4.—Photo showing locations of observed cracking in the embankment.

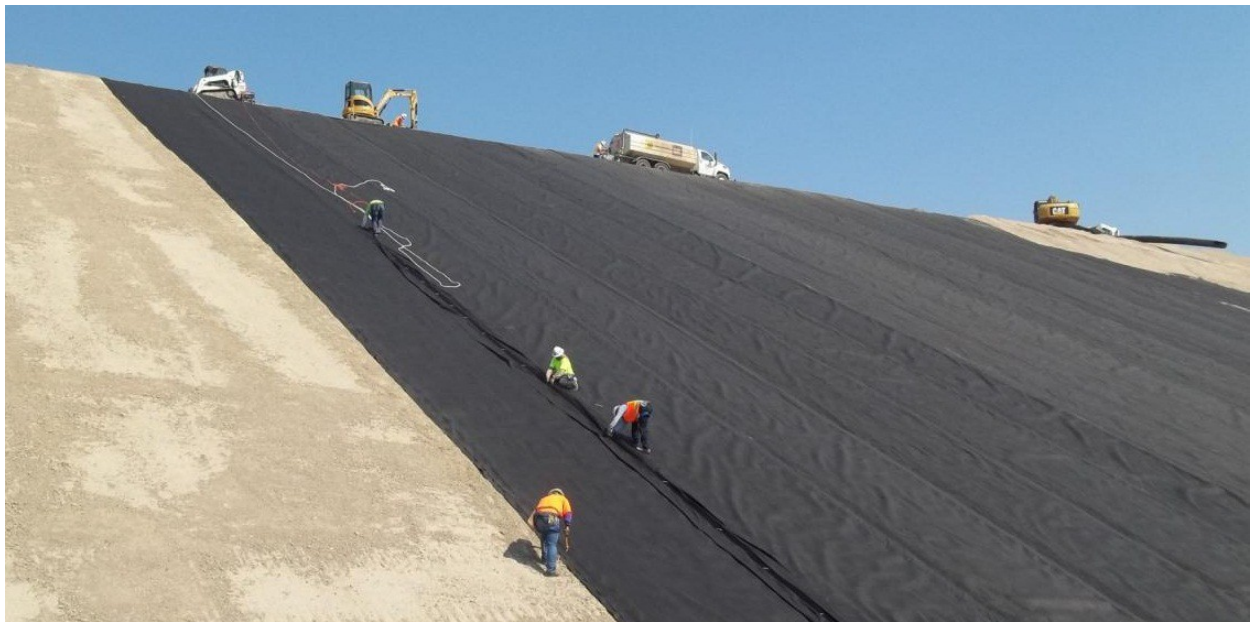
Figure 9.—Typical installation of geo-net composite on downstream face of embankment.

The double-sided geo-net composite was installed over the entire excavated slope for the full length of the embankment. The material was anchored into a trench along the crest and then rolled down the excavated slope to the base of the excavation. Figure 8 below is a photo of the geo-net composite used in the modifications, and figure 9 shows the typical installation, rolling the panels from the dam crest.

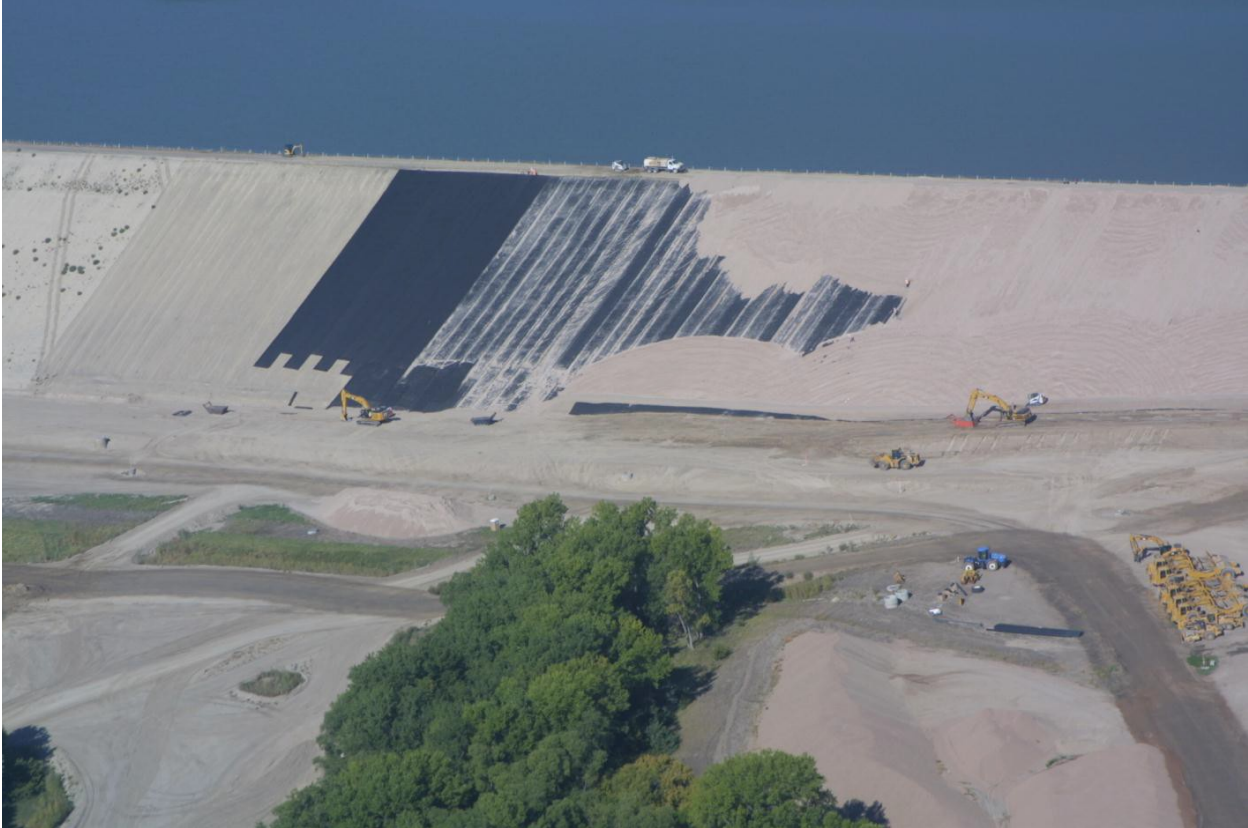
Figure 11.—Aerial photo of Red Willow Dam showing geo-net installation and protection with sand.

The use of geo-net composite materials in Reclamation dams is not common practice. Red Willow Dam is the first Reclamation dam to use the geo-net composites as identified. Federal guidelines prohibit the use of geosynthetics as a primary filter/drain. For this reason, a two-stage filter/drain was constructed below elevation 2615 to serve as the primary filter/drain. The use of a geo-net composite as the primary filter/drain above elevation 2615 is unconventional, but due to the low likelihood of the reservoir exceeding this elevation, the designers decided there was very little risk in not continuing the chimney filter/drain above this elevation. Because the drain materials were imported from a long distance, stopping the two-stage filter at this elevation also had an economic benefit for the project – by limiting quantities, a cost savings was achieved. A total of 70,000 square yards of geo-net composite was installed of the downstream excavation as shown on figure 11 below.

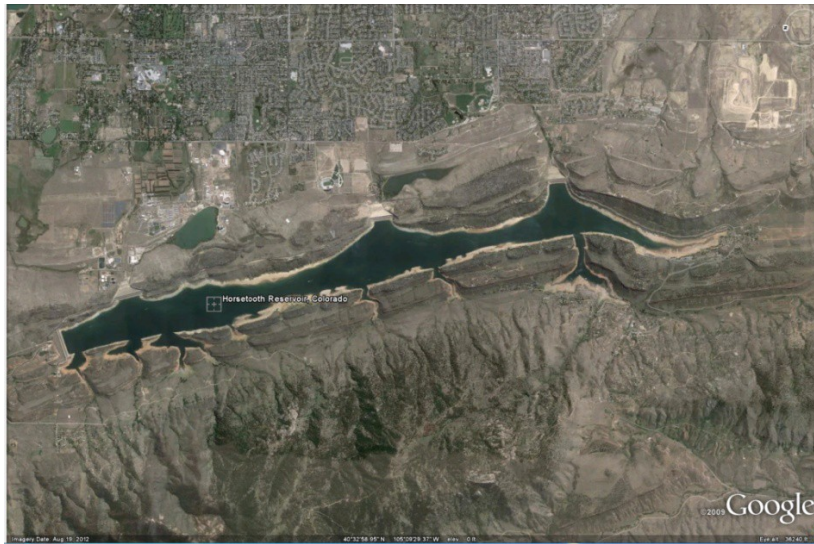
Figure 1.—Horsetooth Reservoir. Horsetooth Dam is the dam at the far left end of the reservoir in the above photograph.

Horsetooth Reservoir is situated in a narrow north-south valley between hogbacks of the front range just west of Fort Collins, Colorado (figure 1). The reservoir contains 156,735 acre-ft of water and is 6.5 mi long. The project consists of five embankments: Horsetooth Dam (figure 2), Satanka Dike, Soldier Canyon Dam, Dixon Canyon Dam, and Spring Canyon Dam. The project has no spillway but is equipped with two low-level outlet works (one at Horsetooth Dam and a much smaller one [90 ft³/s at normal pool] at Soldier Canyon Dam). The outlet works have a combined discharge capacity of 2,590 ft³/s at normal pool.

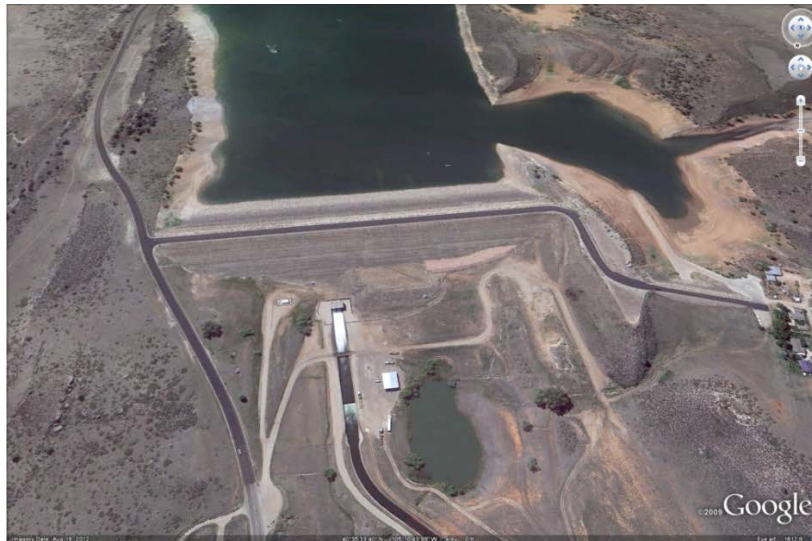
Figure 2.—Oblique view of Horsetooth Dam and Satanka Dike (looking south).

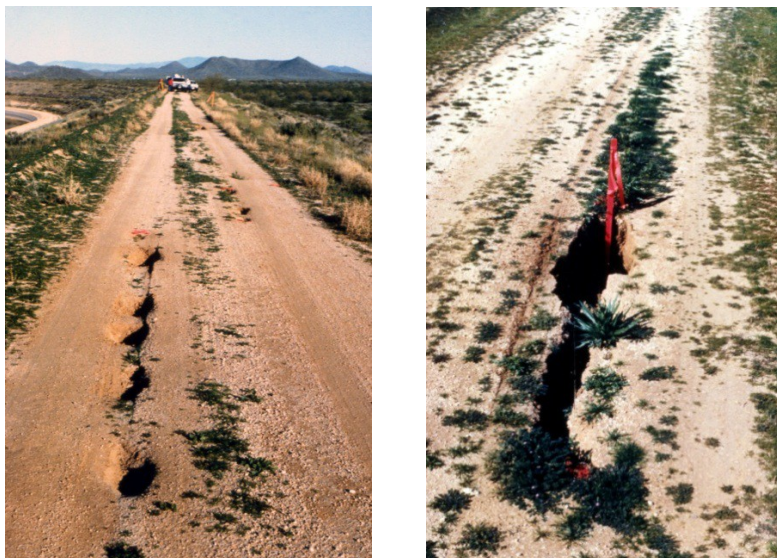
Figure 2.—Typical longitudinal cracking observed on crest of Reach 11 Dikes.

Over the life of the dikes, very significant transverse and horizontal cracking has been seen along the crest of the dikes, especially Dikes 1, 2, and 3. In addition, large sinkholes have formed along the alignment of these cracks, and erosion outlet tunnels have appeared on the slopes of the dikes. Figures 2 and 3 illustrate show the observed features. Typically, these features have been seen after significant rainfall events, which have temporarily stored up to 8 ft of water against the dikes, and the water was allowed to evaporate and/or infiltrate into the foundation. Field investigations have revealed that some of these cracks extended completely through the dike embankments. Laboratory testing of dike and foundation materials also revealed that approximately 40% of the soils tested were classified as D-1 dispersive soils. Vertical strains over 20% were seen in laboratory tests of foundation samples at the effective vertical overburden stress imposed on the soils by the embankment. According to research done on the prediction of field collapse of soils due to wetting, in the basin and range provinces of the Southwest, collapsible soil deposits are primarily wind deposited, weakly cemented silty sands, sandy silts, and clayey sands of low plasticity. The majority of the basin fill deposits under Dikes 1, 2, and 3 fit these soil types.

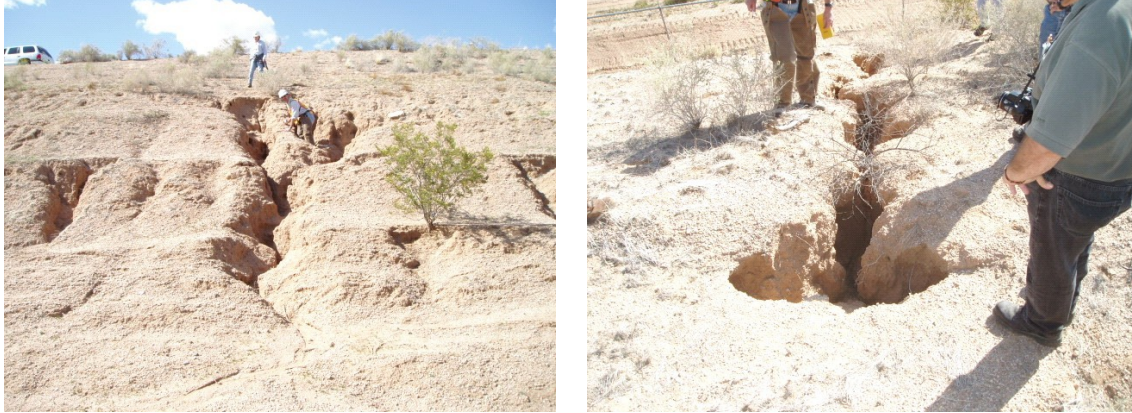
Figure 3.—Typical severe erosion of dispersive embankment soils comprising Reach 11 Dikes.

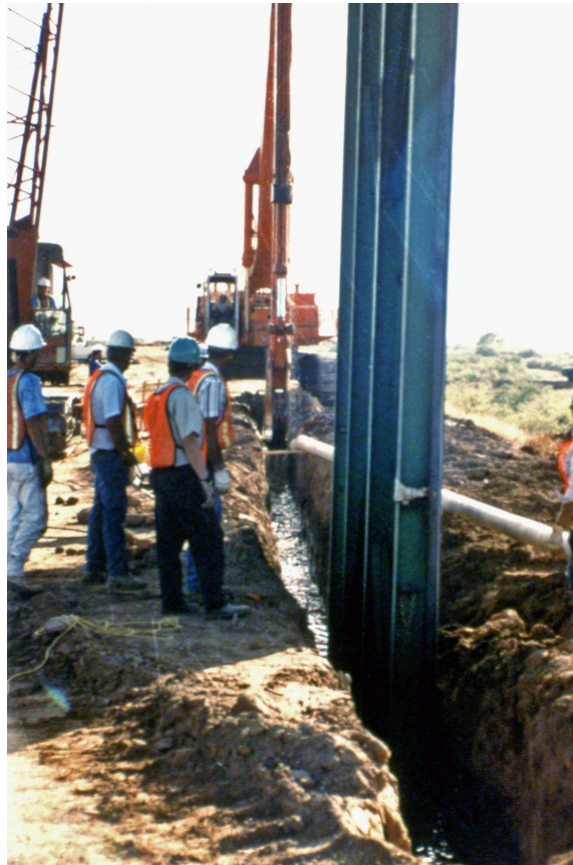
Figure 7.—Excavation of trench using biopolymer slurry. Steel frame was used to install the geomembrane panels.

Excavation and placement of filter zone materials was accomplished by the slurry trench method. A biodegradable slurry was selected to prevent contamination of the filter zone material with residual materials that would occur with conventional slurry (typically bentonite). A biodegradable slurry, such as a natural guar gum or a synthetic biopolymer, will break down naturally over time or can be chemically broken down using a weak chlorine solution and flushed out of the filter zone material, leaving a free-draining filter zone in place.

There also was concern for high seepage gradients across the vertical filter zone that could wash filter material into a downstream crack. To prevent this, a vertical barrier wall was included against the upstream wall of the trench. The vertical barrier wall material selected for installation in the trench was an interlocking, jointed HDPE geomembrane, commonly referred to as a curtain wall. The curtain wall was installed in the biopolymer trench before placement of the filter zone material. Each panel consisted of a 26-ft-wide, 80-mil-thick HDPE section attached to 160-mil-thick joint sections. Panels were installed by being placed onto steel frames that were then lifted vertically by crane so that each panel could then be inserted into the biopolymer-supported trench alongside the previous panel with the use of an interlocking joint section (figure 6). Each joint section contained an expandable hydrophilic seal extending the full depth of the panel. The full continuity of each joint was verified through copper wiring within each joint extending the full length of the panel. When the panel was fully inserted, an electrical circuit was created when the wires made contact at the bottom of the trench. The electric circuit could be verified by instrumentation at the crest of the dike. The backfill in the trench is ASTM C-33 concrete sand, which was tremied into the slurry-filled trench. The sand meets filter gradation requirements for the embankment and foundation materials. Figures 7–9 are construction photos.
