# North Atlantic Coast Comprehensive Study: Resilient Adaptation to Increasing Risk

## PHYSICAL DEPTH DAMAGE FUNCTION SUMMARY REPORT

January 2015

US Army Corps  
of Engineers®

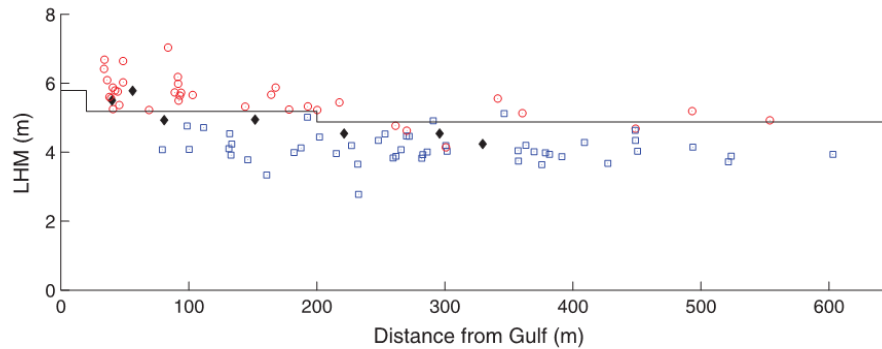
(Color) Survival and destruction with increasing distance from the Gulf of Mexico shoreline in the Biscayne, Salt Cedar/Johnson Crawford areas; (○) surviving houses; (□) destroyed houses; (◇) houses surviving with noted wave damage; the elevation of wave damage for these houses was typically 0.25–0.3 m above the lowest horizontal structural member (LHM) elevation shown here; solid line gives the approximate 1993 FEMA BFE with distance inland

**Figure 4. Survival and failure of structures in relationship to FEMA BFE**

An evaluation of 128 wood-framed, single-family structures in a localized V-zone area with a BFE of 16- or 17-ft showed that all of the homes in a newer subdivision survived the storm with roof and walls largely remaining, while the majority of homes in the older subdivisions were destroyed. Most of these failures were determined to be the result of surge and waves destroying the superstructure above the pilings. The great majority of the homes that survived had a lowest horizontal structural member (LHM) elevation at or above the FEMA BFE. The extent of the damage decreased with proximity to the shoreline. Homes with LHMs below the BFE did not survive within 250 meters of the shoreline. Beyond 250 meters, several such homes did survive, but the vast majority failed (Figure 4).

"A very clear divide can be seen between the surviving houses, which were invariably more highly elevated, and houses destroyed by the storm, which were generally lower." (Kennedy, A.M.ASCE, et al. 2011) See Figure 4.

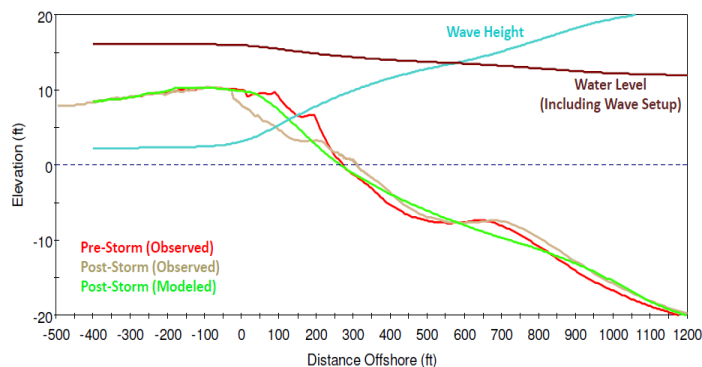
Figure 6. S-Beach Profile 27, modelled and observed at Beach 126th Street, Rockaway

Available S-Beach models show the storm surge, wave height, and pre- and post-storm shoreline in the same area as the destroyed structures (see Figure 6). The total water level, including wave set up,<sup>9</sup> was recorded at 16' NAVD, resulting in a water level upwards of 5' above grade at the structures, with wave heights at 3-4 ft. The majority of buildings, such as in Figure 7, appear to have been destroyed by wave action, which is not unexpected given the surge height and ground elevations. As seen in Figure 8, some structures were impacted by both waves and erosion.

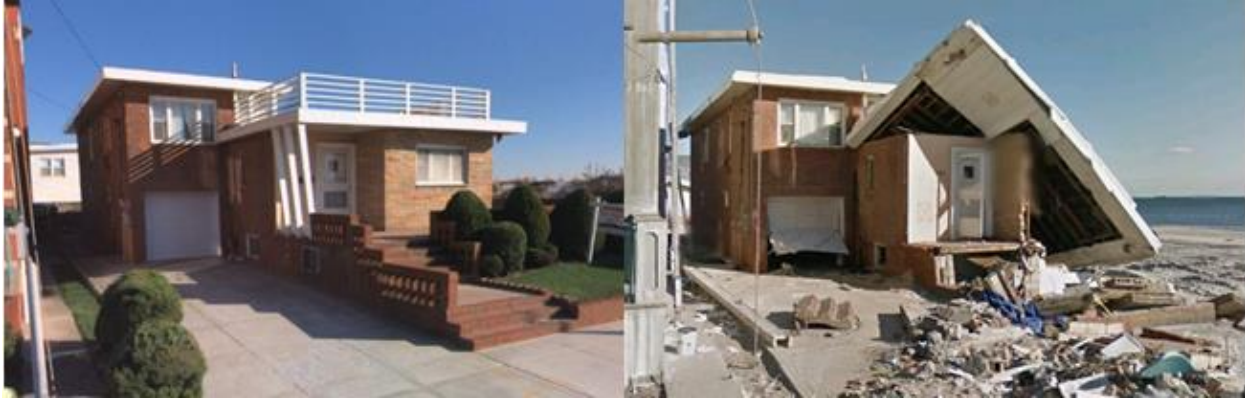
Figure 8. Wave and Erosion Damage, Rockaway Beach, NY.

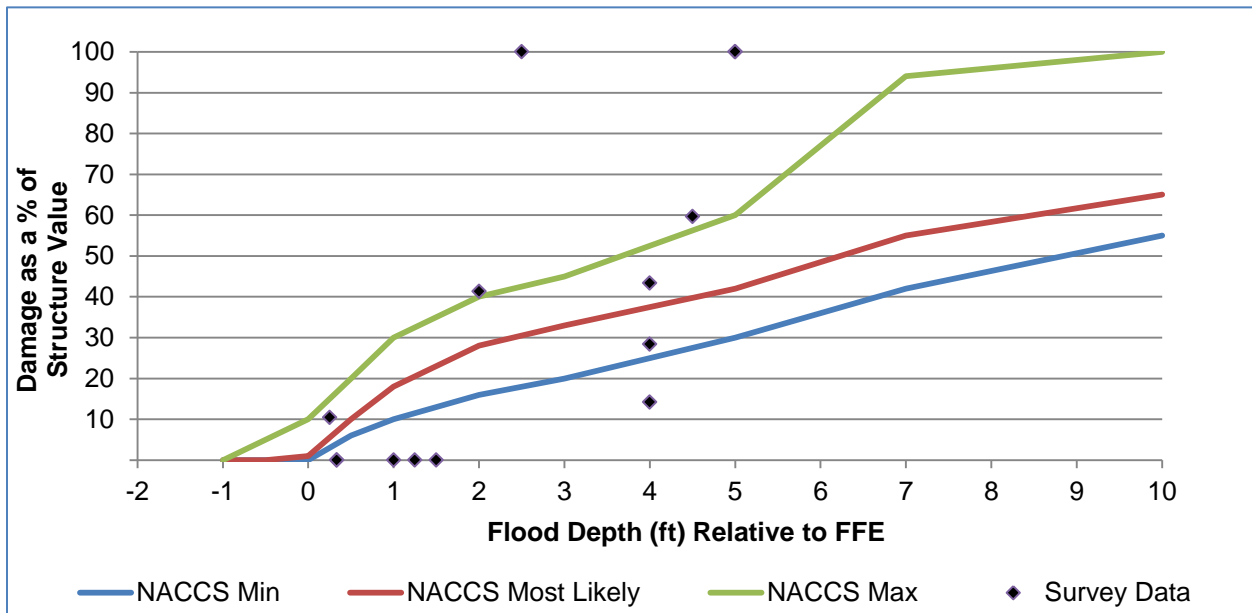
Figure 11. Comparison – Structural Damage from Inundation: NACCS Prototype 5A Single Story Residence, No Basement vs. Survey Data for Single-Story Residences without Basements

Figure 11 shows that the damage information collected during the field surveys for single – family residences without basements reported flooding depths up to five feet above the first floor

elevation. At flood depths up to 1.5 feet several respondents indicated they suffered no structural damage to their homes, while the elicitation damage functions indicated damage would begin at depths from (-)1 feet.

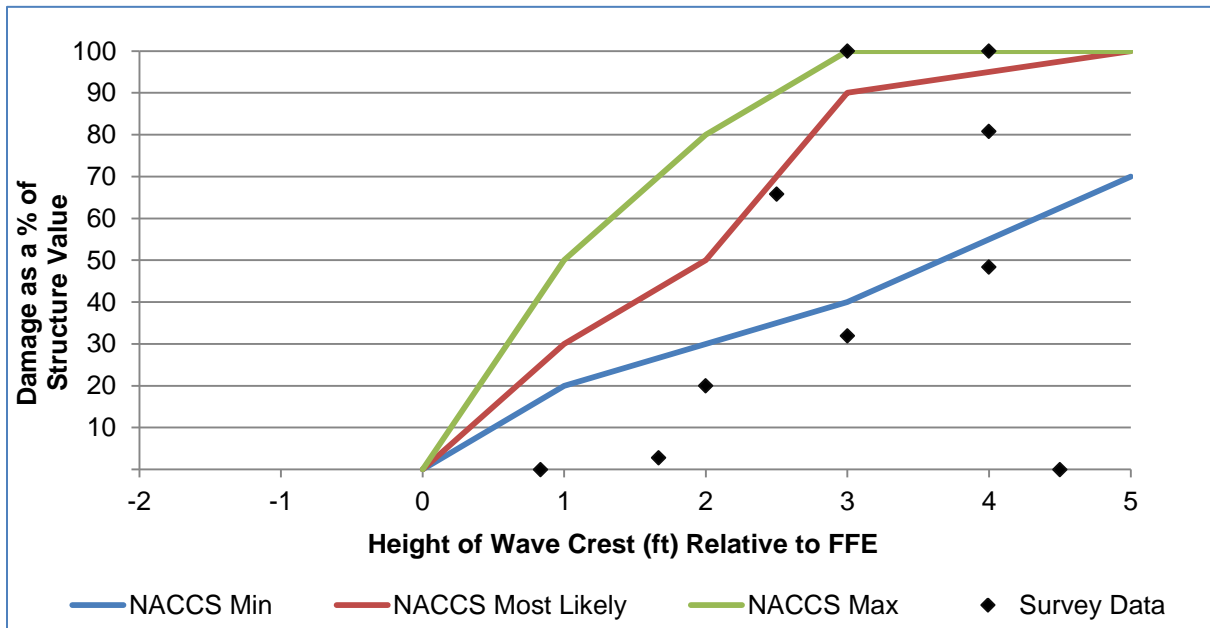
Figure 12. Comparison – Structural Damage from Waves, Slab Foundation: NACCS Prototype 5A Single Story Residence, No Basement vs. Survey Data for Single-Story Residences without Basements

The damage information collected during the field surveys generally follows the elicitation damage functions in Figure 12. However, the minimum damage functions assumed higher damage at each level. Several respondents reported minimal damage, below 20% of the structure value while reporting wave crests up to 2 feet above the first floor elevation. It is possible these structures were constructed with methods and materials more resistant to the reported storm wave action, or that the structure was exposed to non-breaking waves, which are not as destructive as breaking waves.<sup>13</sup> At wave crests more than 3 feet above the first floor the elicitation damage functions and the reported damages more closely follow. It is important to reiterate that structures destroyed by waves are likely to be under-represented in the field samples.

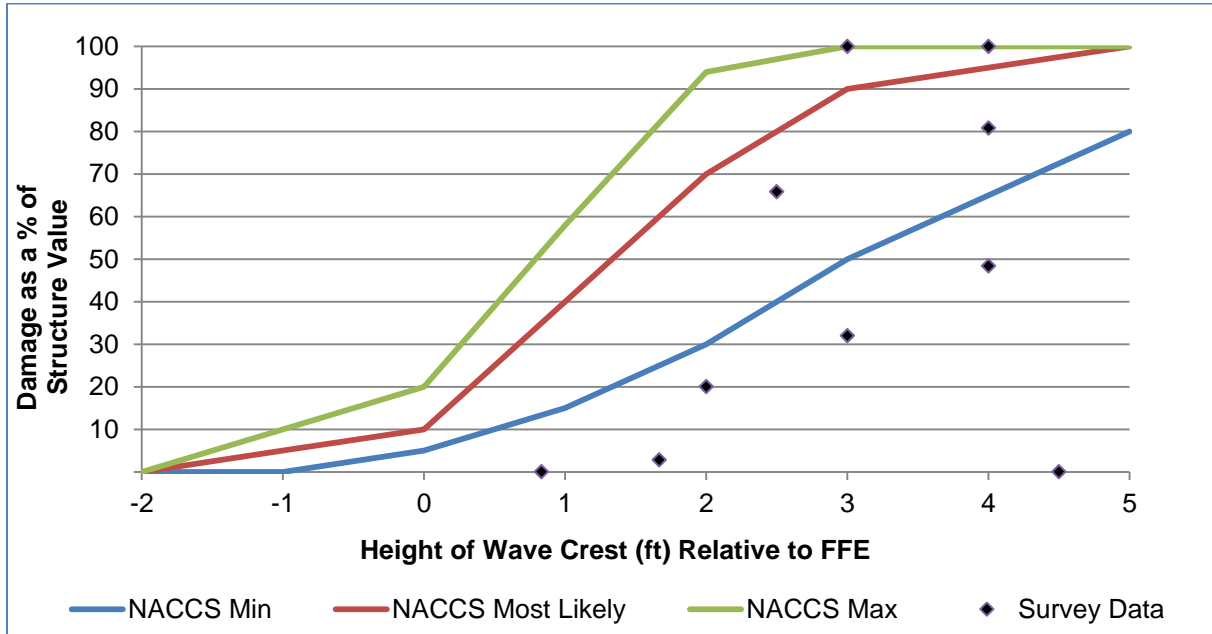
Figure 13. Comparison – Structural Damage from Waves, Extended Foundation Wall: NACCS Prototype 5A Single Story Residence, No Basement vs. Survey Data for Single-Story Residences without Basements

Figure 13 shows that the damage information collected during the field surveys generally follows the elicitation damage functions, however, the minimum damage functions from the elicitation estimate higher damage than reported at a number of structures. Several respondents reported limited damage, below 20% of the structure value, while reporting wave crests up to 2 feet above the first floor elevation

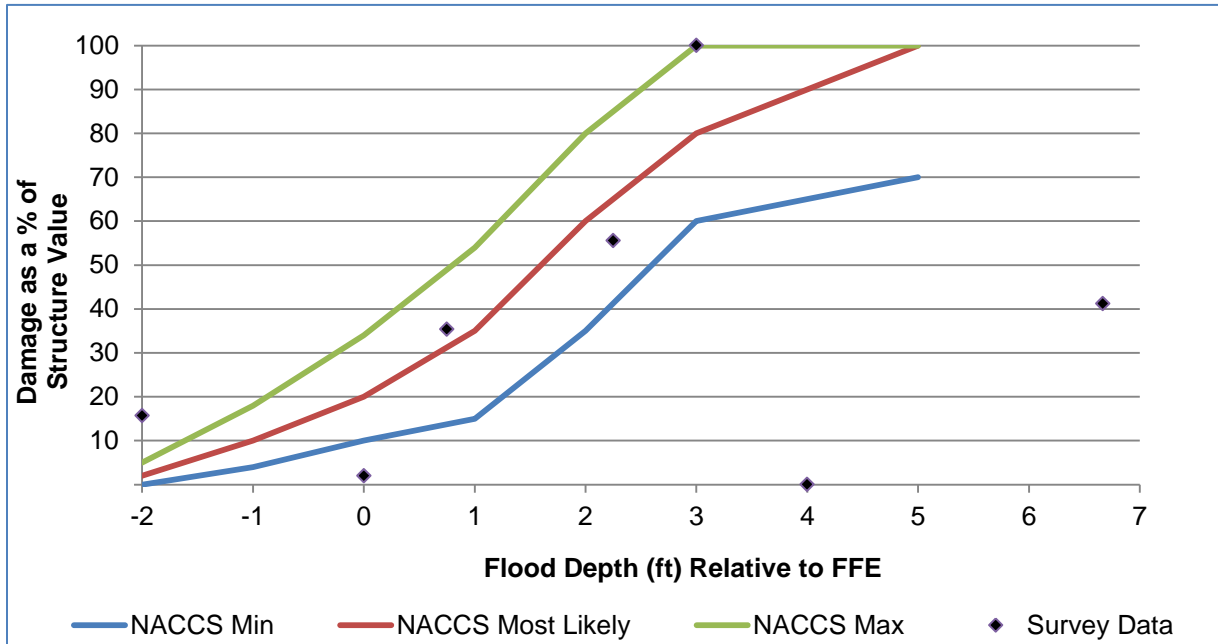
Figure 17. Comparison – Structural Damage from Waves: NACCS Prototype 6B Two-Story Residence, with Basement vs. Survey Data for Multi-Story Residences with Basements

The elicitation damage functions in Figure 17 generally follow the damages reported during the field surveys. One respondent confirmed damage at a wave crest elevation below FFE.

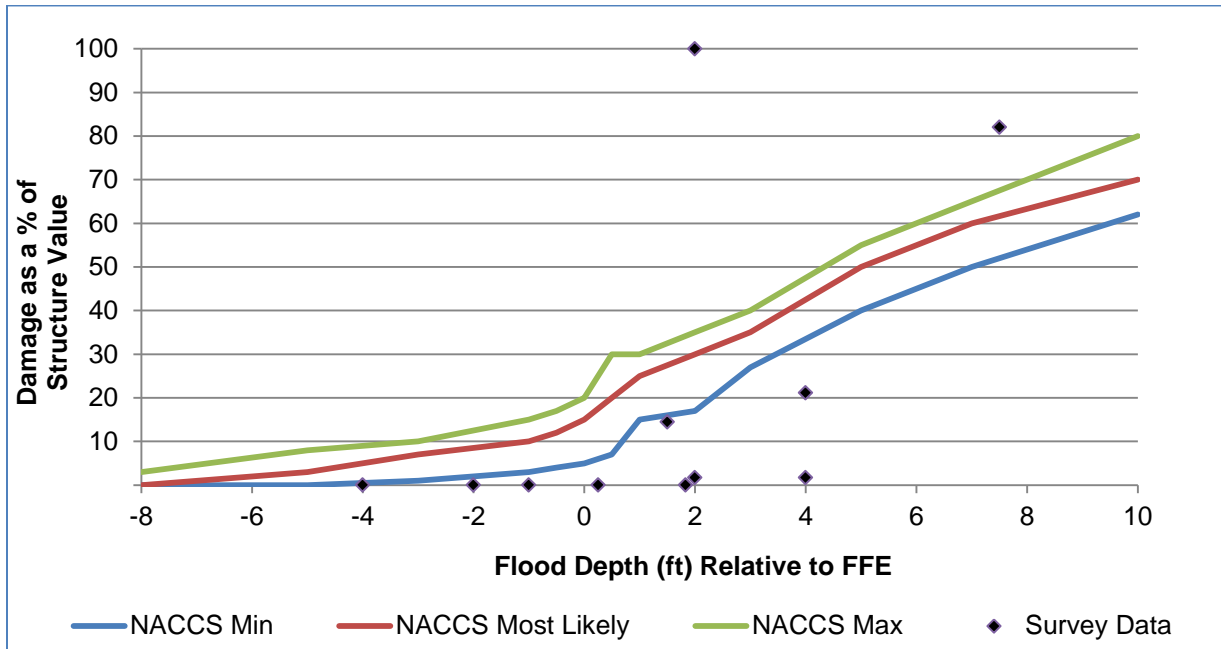
Figure 18. Comparison – Structural Damage from Inundation: NACCS Prototype 6B Two-Story Residence, with Basement vs. Survey Data for Multi-Story Residences with Basements

The elicitation damage functions in Figure 18 are generally higher than the damages reported during the field surveys. This appears to be from under reporting of damage by the homeowner. Several homeowners reported no damage with up to 4 feet of water above the first floor. Other respondents reported 100% damage with 2 feet of water and 82% damage with 8 feet of water above the first floor.

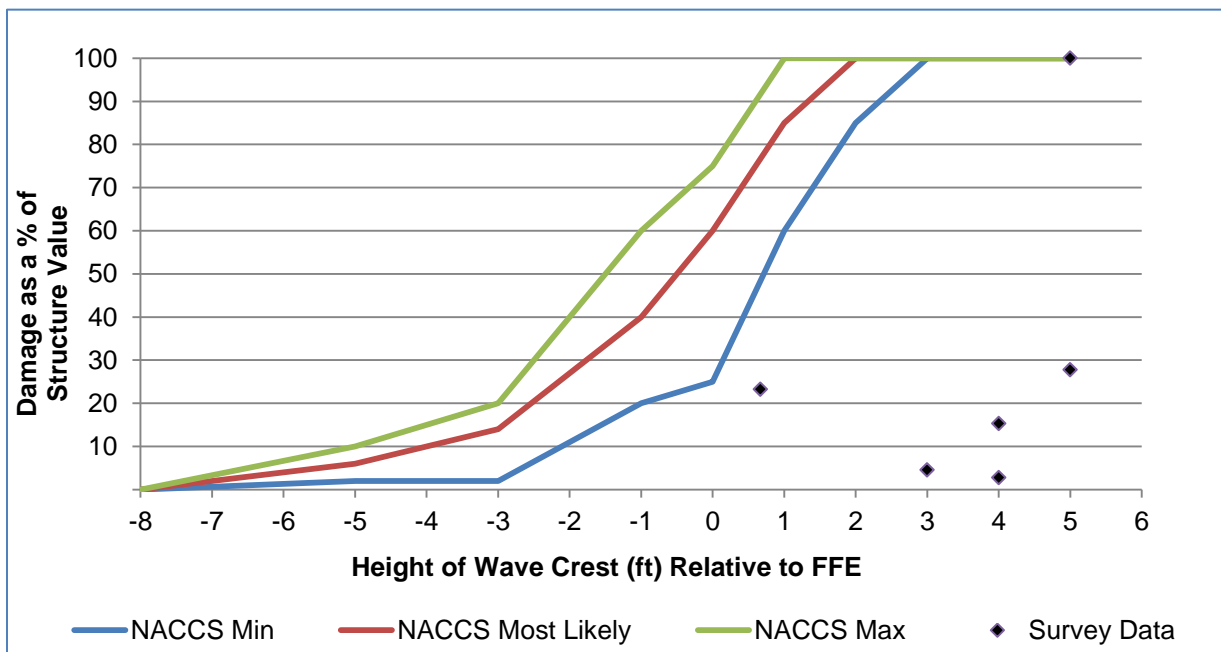
Figure 19. Comparison – Structural Damage from Waves: NACCS Prototype 7B Buildings on Pile Foundation with Enclosures vs. Survey Data for Buildings on Pile Foundations with Enclosures

Figure 19 shows the elicitation damage functions show a higher amount of damage at each elevation than the survey data indicated. It is suspected that the level of the enclosure was assigned as the first floor elevation during the field survey. A shift in the survey points to the left 8 or 9 feet would produce a better fit.

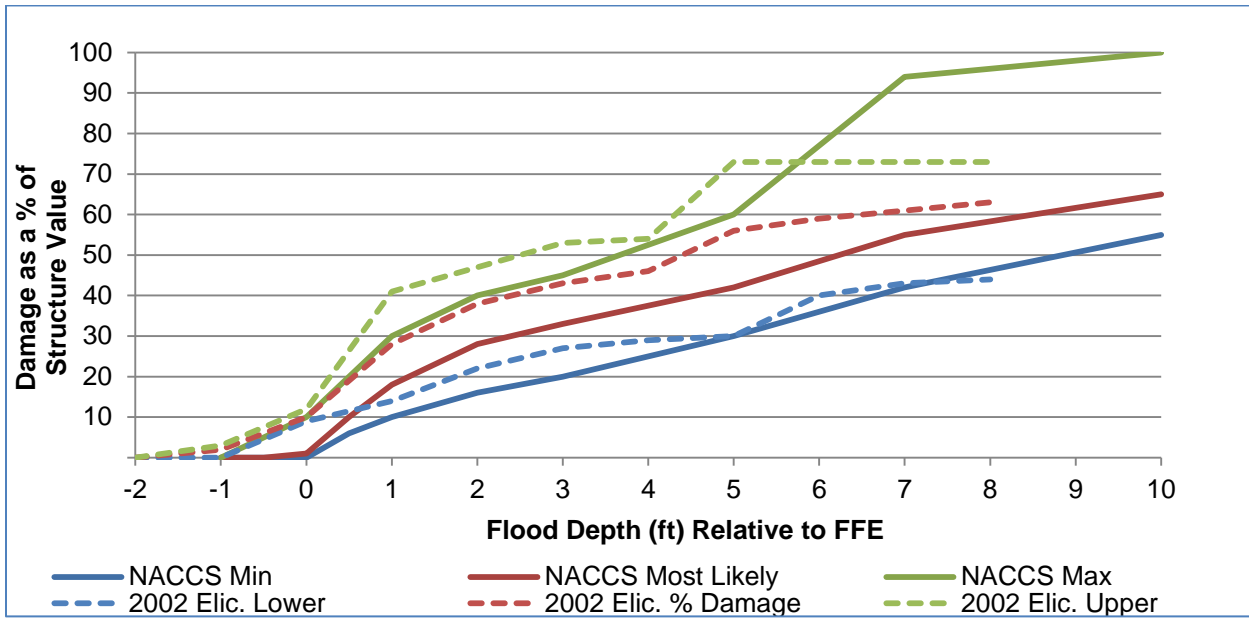
Figure 21 shows that the NACCS elicitation damage functions for structure damage as a percent of structure value are generally lower than the 2002 elicitation damage functions with a wider band of uncertainty than 2002. The current uncertainty reflects a greater understanding of the effects of mold on structures.

Figure 21. Comparison – Structural Damage from Inundation: NACCS Prototype 5A Single-Story, No Basement vs 2002 Elicitation Wood Frame without Piles

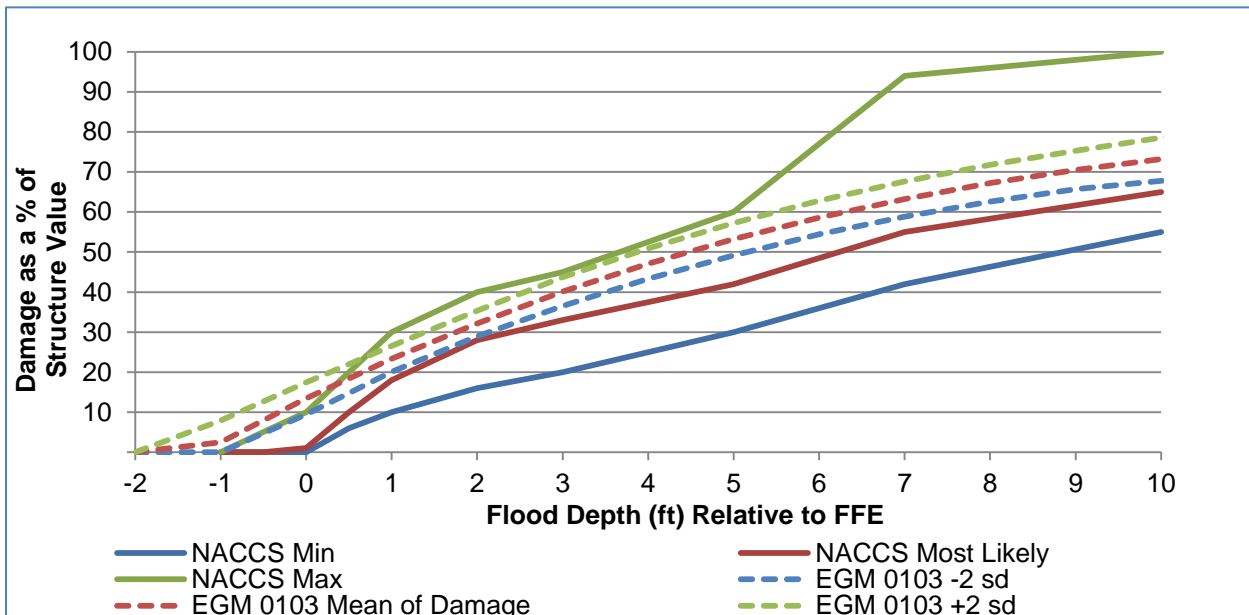
The elicitation damage functions in Figure 22 trend well with the damage functions presented in the Economic Guidance Memorandum (EGM) 01-03. Similar to the comparison to the 2002 elicitation damage functions presented in Figure 21, the expected damages are somewhat lower. As expected, the band of uncertainty for the elicitation damage functions is much wider. While somewhat lower, the damages from the most likely elicitation damage function compares well to the mean values from the EGM damage functions.

Figure 22. Comparison – Structural Damage from Inundation: NACCS Prototype 5A Single-Story, No Basement vs EGM 01-03 One Story, No Basement

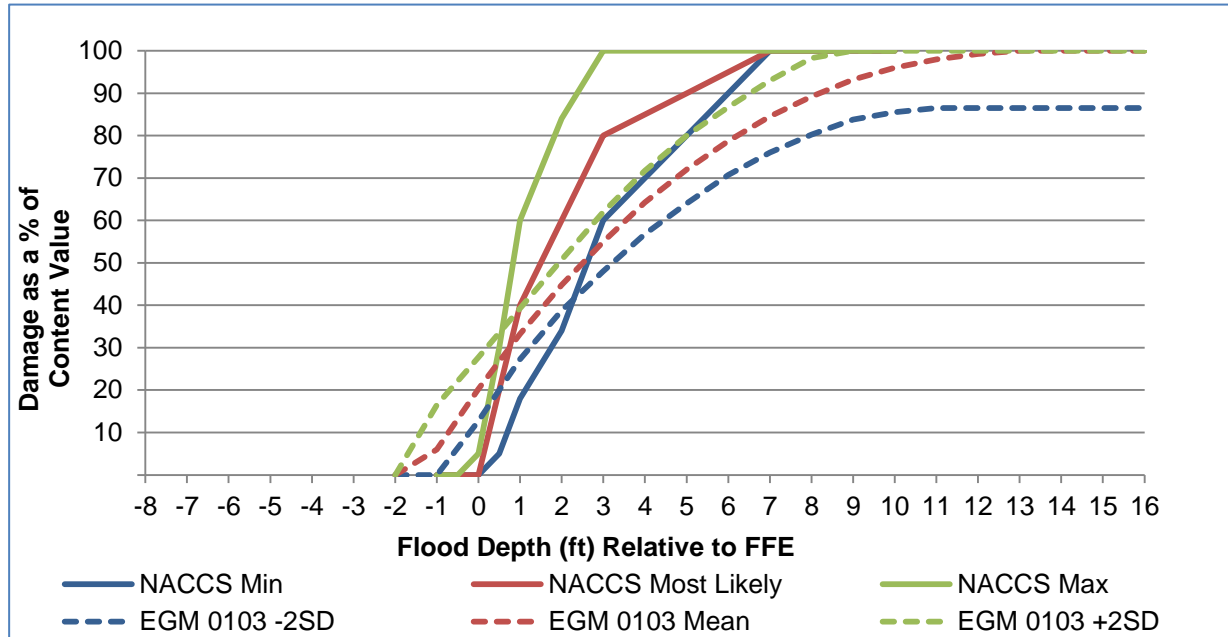
Figure 23 presents a comparison of the NACCS Prototype 5A Single-Story, No Basement damage function with the EGM 01-03: One Story, No Basement damage function. A CVSR of 0.40 was applied to the EGM damage function to convert the EGM values from a percent of

structure value to a percent of contents value. The NACCS damage function shows 100% contents damage occurring at a flood depth of 7 feet above the first floor elevation, and 75% of the contents damage occurs at approximately 3 feet. The EGM damage function shows the median content damage reaching 100% at 13 feet above the first floor elevation; 75% of the damage occurs at approximately 5 feet. One major reason for higher damage levels in the NACCS damage function is the damaging effect of mold, which was discussed by the panel at length.

Figure 23. Comparison – Content Damage from Inundation: NACCS Prototype 5A Single-Story, No Basement vs. EGM 01-03: One Story, No Basement

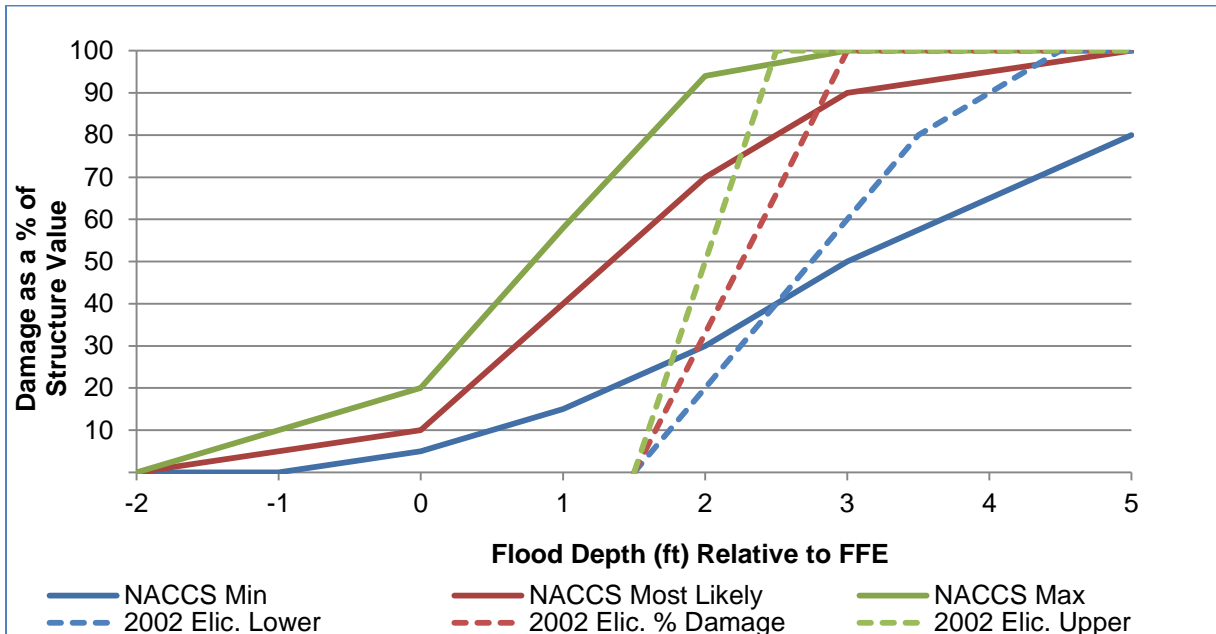
Figure 24 presents the wave damage comparison for Prototype 5A, a single-story residence on a crawl space to the 2002 elicitation results for a structure not on piles. While the 2014 elicitation measured the height of the wave crest relative to the FFE, the 2002 elicitation measured the height of the wave crest relative to the bottom of the lowest horizontal member. To account for this difference, the x-axis for the 2002 elicitation has been shifted up 1.5 feet.

Figure 24. Comparison – Structural Damage from Waves, Extended Foundation Wall: NACCS Prototype 5A Single-Story, No Basement vs 2002 Elicitation Structure not on Piles

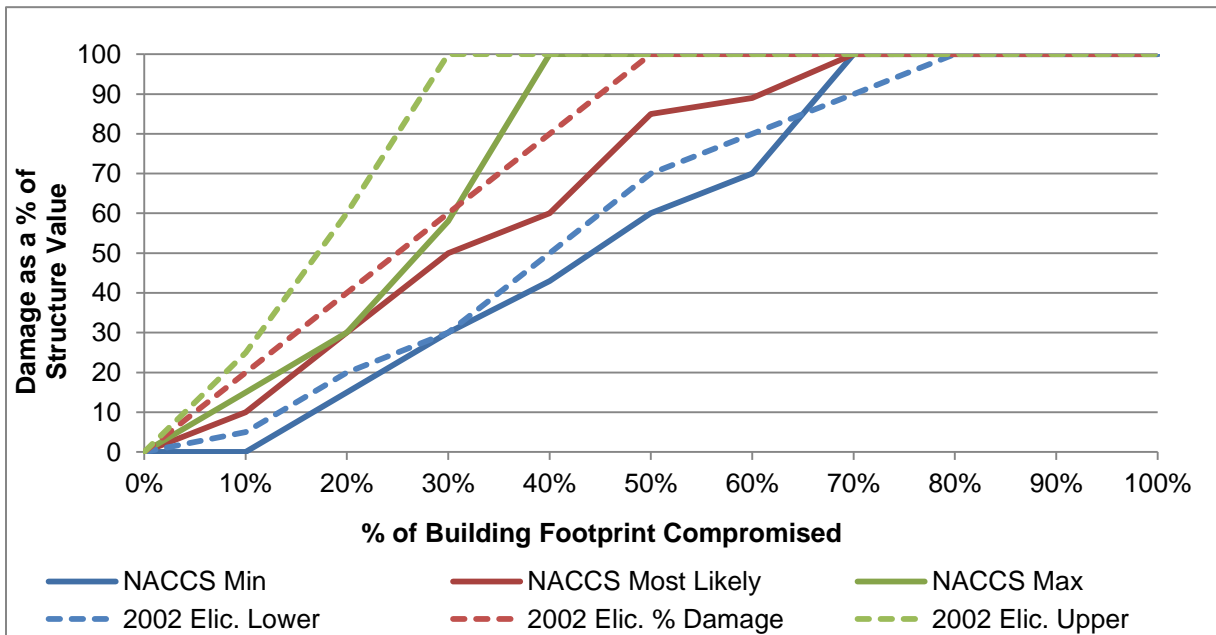
In Figure 25, both the NACCS and the 2002 damage functions depict structure damage as a percent of building footprint compromised by erosion. The damage functions are similar except for higher max damages for the 2002 maximum.

Figure 25. Comparison – Structural Damage from Erosion: NACCS Prototype 5A Single-Story, No Basement vs 2002 Elicitation Shallow Foundation

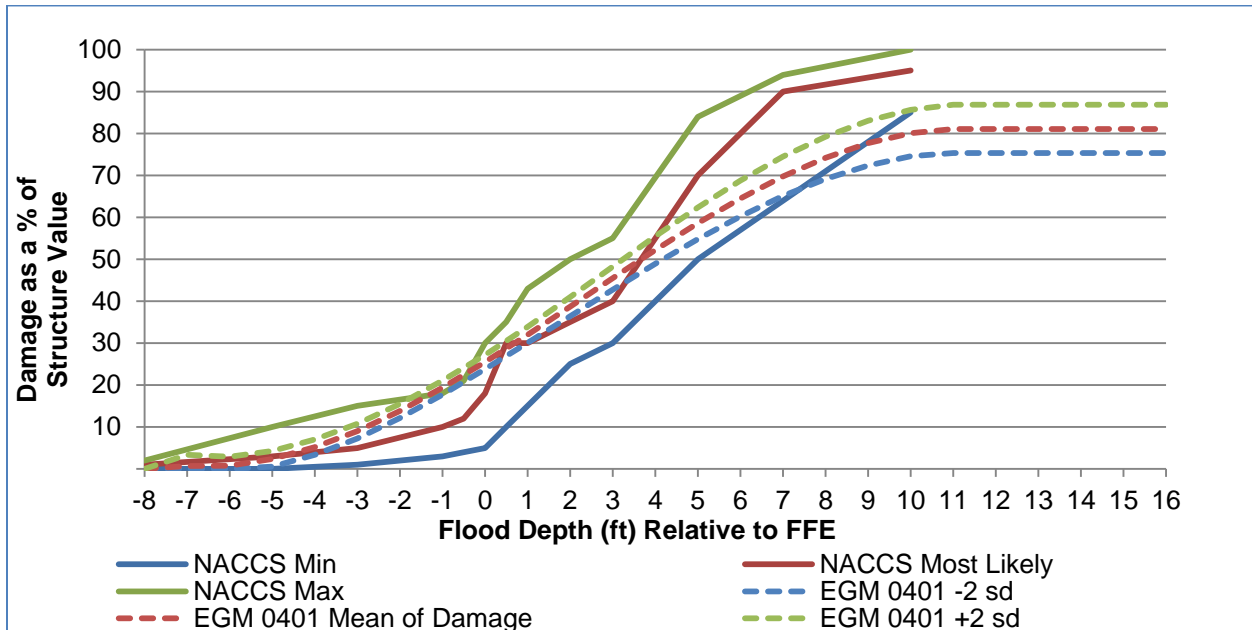
The inundation damage functions in Figure 28 are similar. The NACCS damage functions have much a wider band of uncertainty, which can be expected when comparing minimum and maximum scenarios to +/- 1 standard deviation.

Figure 28. Comparison – Structural Damage from Inundation: NACCS Prototype 6A One Story, with Basement vs EGM 04-01 One Story, with Basement

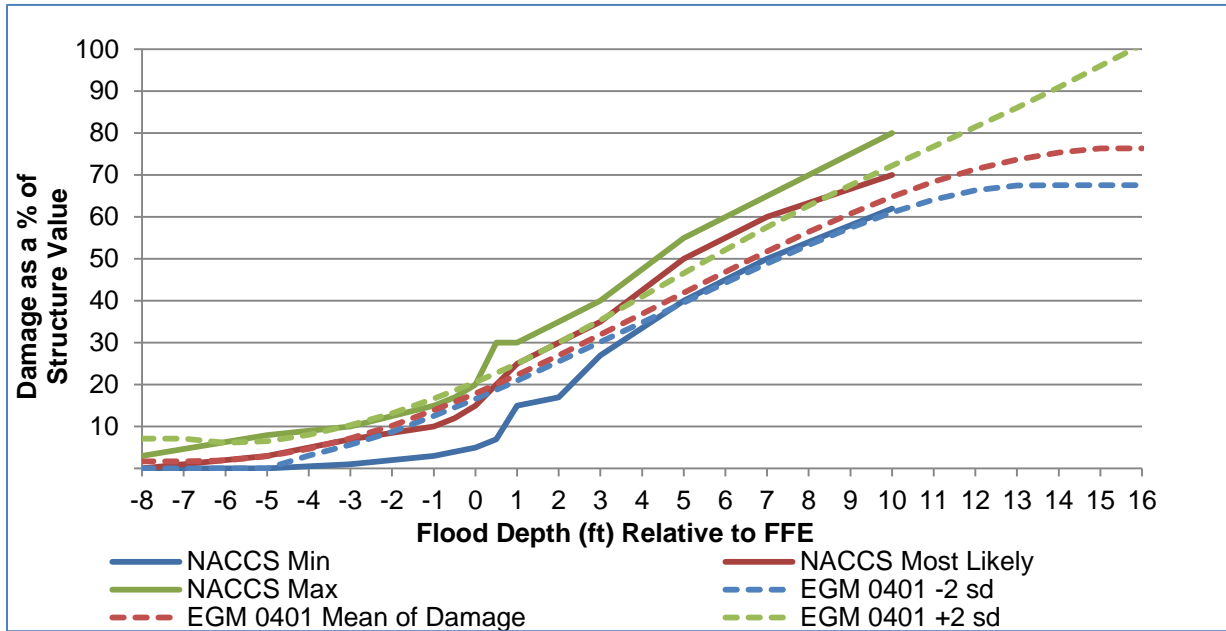
The trend on each of the damage functions in Figure 30 is similar, with the expected wider band of uncertainty for the NACCS damage functions.

Figure 30. Comparison – Structural Damage from Inundation: NACCS Prototype 6B Two Story, with Basement vs EGM 04-01 Two or More Stories, with Basement

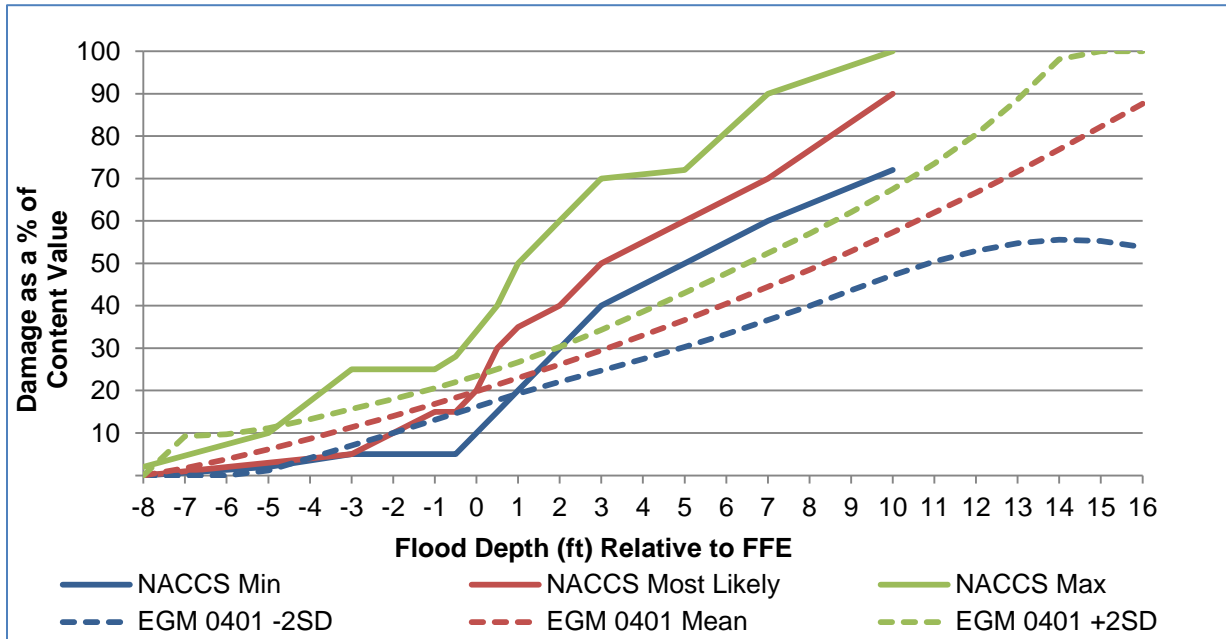
The NACCS most likely estimate and the EGM 04-01 Mean of Damage estimate in **Error! Reference source not found.** Table 31 are similar with regard to below-grade storage; however, the NACCS most likely damage curve reaches its maximum amount of damage at 10' above FFE, whereas the EGM 04-01 mean damage curve reaches its maximum at 16' above FFE. A major reason for higher damage levels in the NACCS damage function is the destructive effect of mold on contents, which was discussed by the panel at length.

Figure 31. Comparison – Content Damage from Inundation: NACCS Prototype 6B Two Story, with Basement vs EGM 04-01: Two or More Stories, with Basement

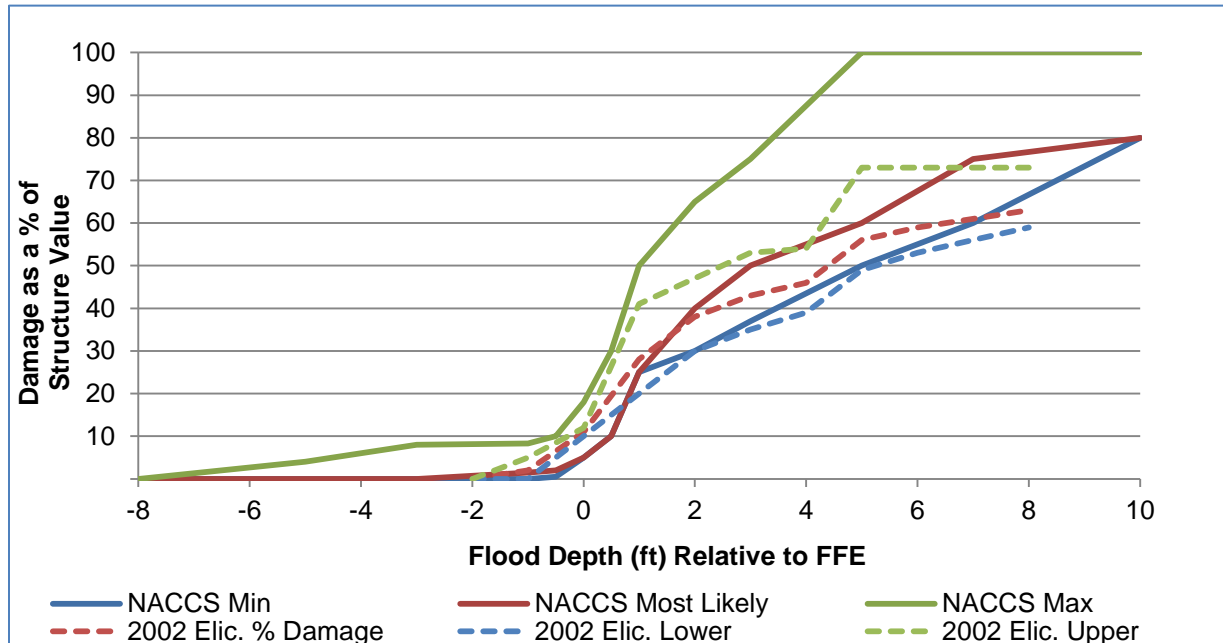
Figure 32 shows the NACCS inundation damage function slightly higher than the 2022 inundation damage function. The upper bound of the NACCS damage function includes increased damage reflecting the lower level entrance structure, as well as some exposed utility connections.

Figure 32. Comparison – Structural Damage from Inundation: NACCS Prototype 7A Building on Open Pile Foundation vs 2002 Elicitation Wood Frame with Piles, No Enclosure

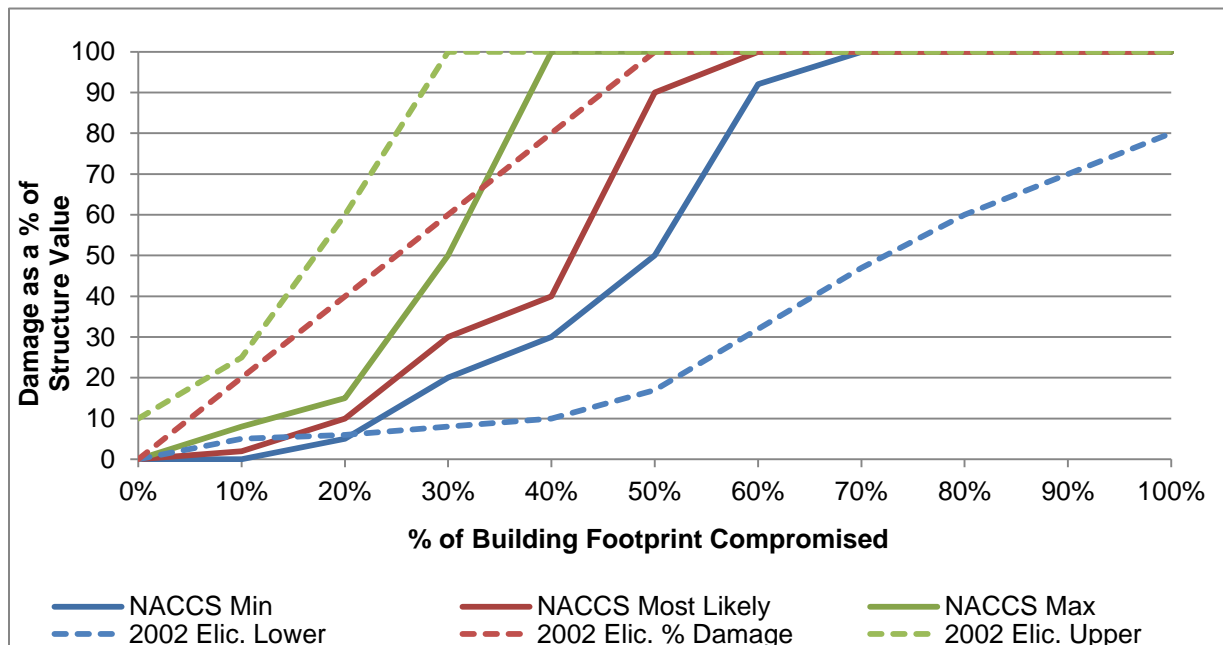
The NACCS damage functions in Figure 33 have a significantly narrower uncertainty band than the 2002 elicitation damage functions, however, the expected 100% damage points are similar (within 10% of the footprint compromised) for the most-likely and maximum damage scenarios.

Figure 33. Comparison – Structural Damage from Erosion: NACCS Prototype 7A Building on Open Pile Foundation vs 2002 Elicitation Pile Foundation

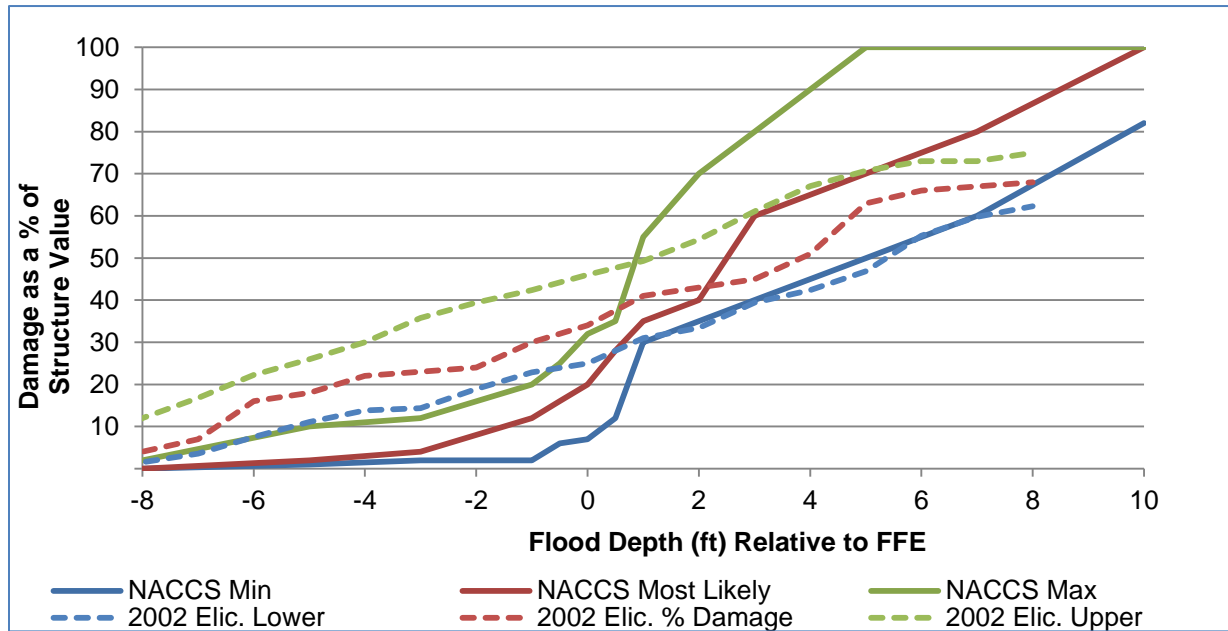
In Figure 34, the NACCS elicitation damage function shows inundation causing a lower amount of damage below the finished floor elevation (FFE) than the 2002 elicitation damage function.

Figure 34. Comparison – Structural Damage from Inundation: NACCS Prototype 7B Building on Pile Foundation, with Enclosures vs 2002 Elicitation Wood Frame with Piles, Full Enclosures

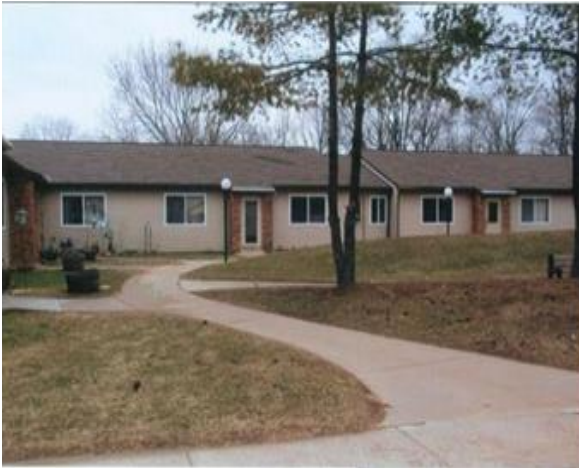
6.5 Prototype 1A-1: Apartments – 1 Story – No Basement

**Most Likely Building Characteristics:** The prototype building is of unreinforced masonry construction on a slab foundation. It is one story. Utilities are located on the first floor. Ceiling height is 8'-0". Age range is between 15 and 30 years old. The FFE is 1'-0" above grade.

**Minimum-Damage Building Characteristics:** The prototype building is a newer building of steel or reinforced concrete construction on a slab foundation. It is one story. Utilities may be protected. The first floor elevation is 2'-0" above grade.

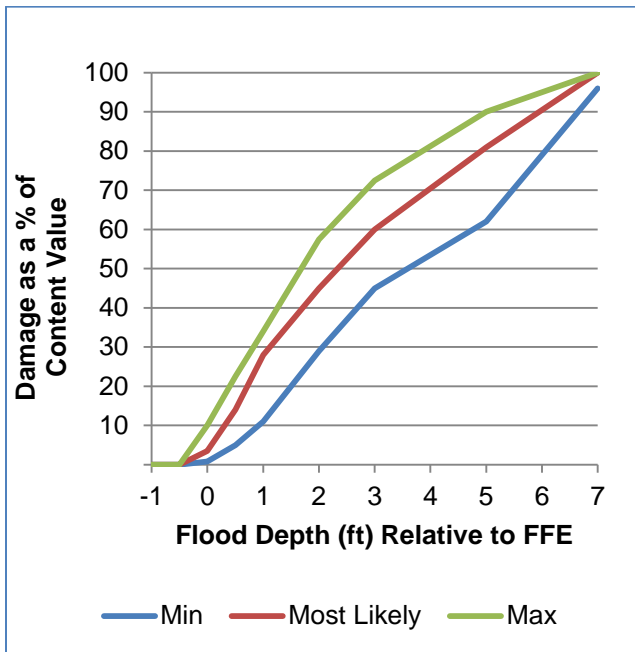
Figure 39. Prototype 1A-1: Apartments – 1 Story – No Basement, Inundation Damage – Content

Table 12 through Table 20 provide the Prototype 1A-1: One-Story Apartments- No Basement; Inundation Damages, Erosion Damages, Wave-Slab Damages, and Wave-Wall Damages for structures and contents. Figure 38 through Figure 46 provide the corresponding damage functions.

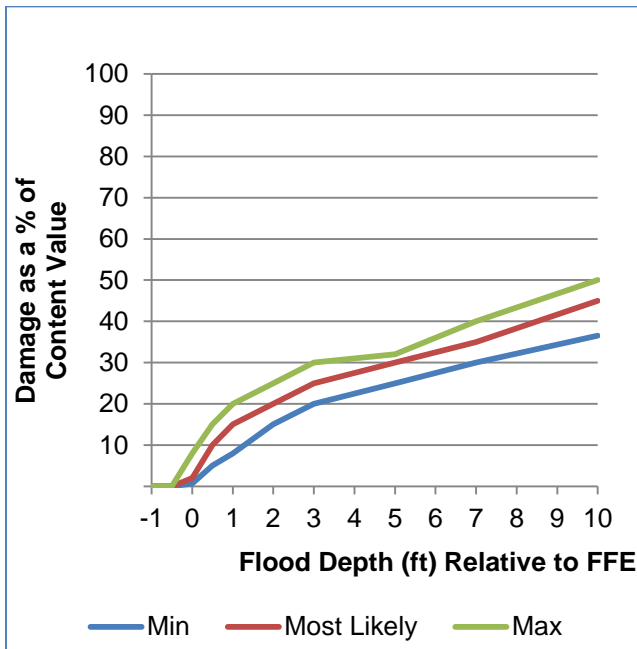
Figure 48. Prototype 1A-3: Apartments – 3 Stories – No Basement, Inundation Damage – Content

Table 22 and Table 23 are presented below. Figure 47 and Figure 48, present the corresponding damage functions.

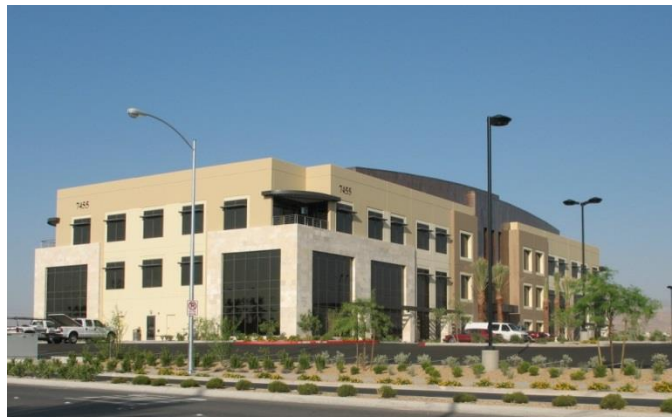
6.7 Prototype 2: Commercial – Engineered

**Most Likely Building Characteristics:**

The building has a steel frame with precast infill.

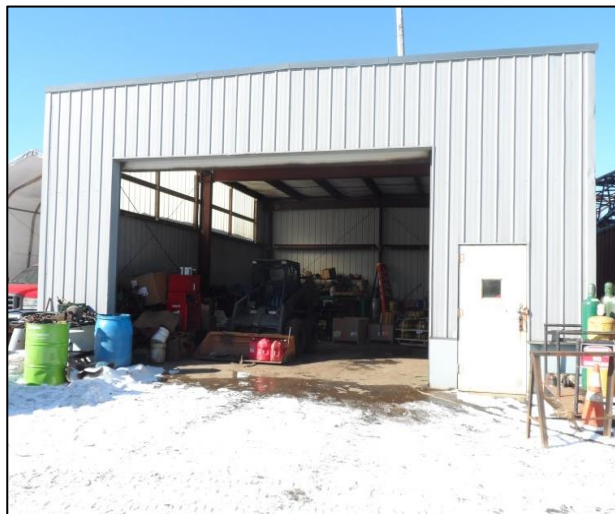
**Most Likely Building Characteristics:** The building has a steel or light metal frame and a slab foundation. The finished floor is 1'-0" above grade.

**Minimum-Damage Building Characteristics:** The building has a steel frame with masonry infill, and a slab foundation. The finished floor is 1'-0" above grade.

**Higher-Damage Building Characteristics:** The building has a wood or light metal frame and is elevated above grade on a crawl space. The finished floor is 3'-0" above grade.

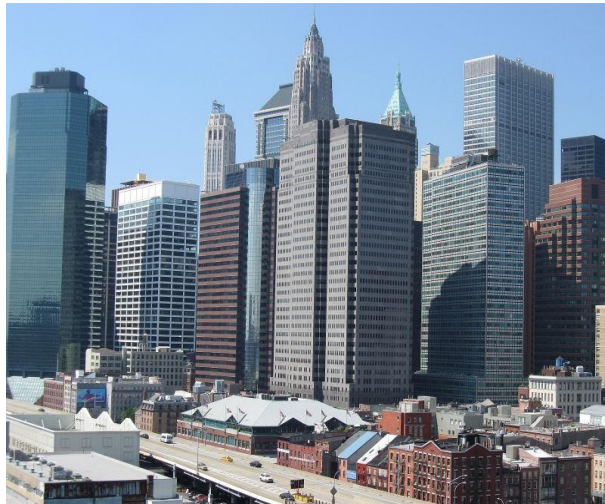
**Most Likely Building Characteristics:** The building is between 15 and 30 years old, and has a full basement with parking and Mechanical/Electrical/Plumbing (MEP) equipment. The first (ground) level has an open lobby layout with limited finishing. Upper levels are apartments. MEP equipment constitutes 40% of the building’s total value.

**Minimum-Damage Building Characteristics:** The building is between 0 and 10 years old, with minimal MEP equipment in the basement. The first (ground) level has an open lobby layout with limited finishing. Upper levels are apartments. MEP equipment constitutes 35% of the building’s total value.

**Higher-Damage Building Characteristics:** The building is older. It has multiple basements with extensive Mechanical/Electrical/Plumbing (MEP) equipment. The first (ground) level houses retail establishments. Upper levels are apartments. MEP equipment constitutes 50% of the building’s total value.

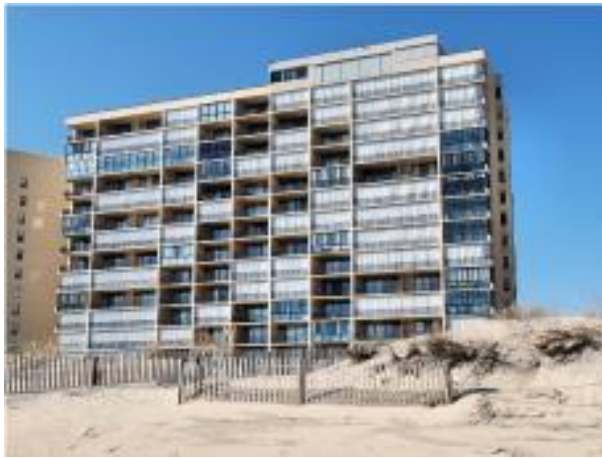
**Most Likely Building Characteristics:** The building is between 15 and 30 years old. The first (ground) level is a mix of apartments and parking space, and also houses some of the building’s MEP equipment. Upper levels are apartments.

**Minimum-Damage Building Characteristics:** The building is between 0 and 10 years old. The first (ground) level is used for parking only. No MEP equipment is housed on the lower level. Upper levels are apartments.

**Higher-Damage Building Characteristics:** The building is older. The first (ground) level houses living space, and all of the building’s MEP equipment. Upper levels are apartments.

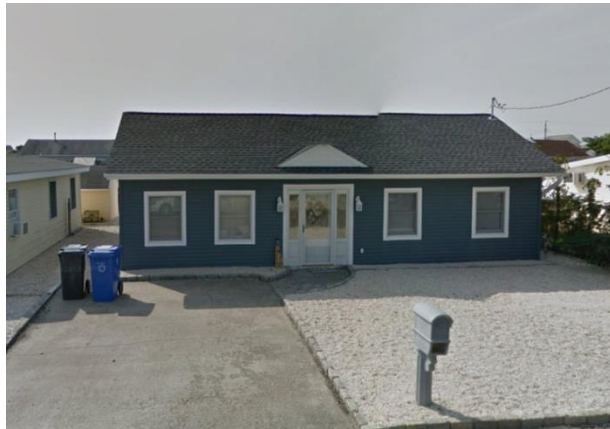
**Most Likely Building Characteristics:** The prototype building is of wood frame construction. It is 15 to 30 years old, and is in fair to good condition. The building is on a slab. The finished floor is 1'-0" above grade.

**Minimum-Damage Building Characteristics:** The prototype building is of masonry construction that is reinforced per code. It is 0 to 10 years old, and is in good condition. The building is on a slab. The finished floor is at grade level.

**Higher-Damage Building Characteristics:** The prototype building is of wood frame construction. It is older, and in poor condition. It is not known if the building was built to code. The building is elevated above grade on a crawl space. The finished floor is 3'-0" above grade.

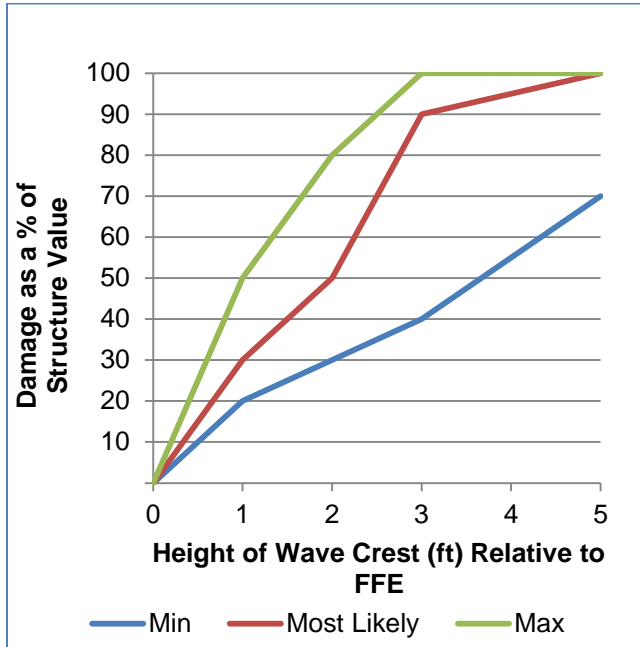
Figure 80. Prototype 5A: Single Story Residence, No Basement, Wave Damage, Slab Foundation - Structure

Table 60. Prototype 5A: Single Story Residence, No Basement, Wave Damage, Slab Foundation - Structure

Wave Crest	Min	Most Likely	Max
0	0	0	0
1	20	30	50
2	30	50	80
3	40	90	100
5	70	100	100

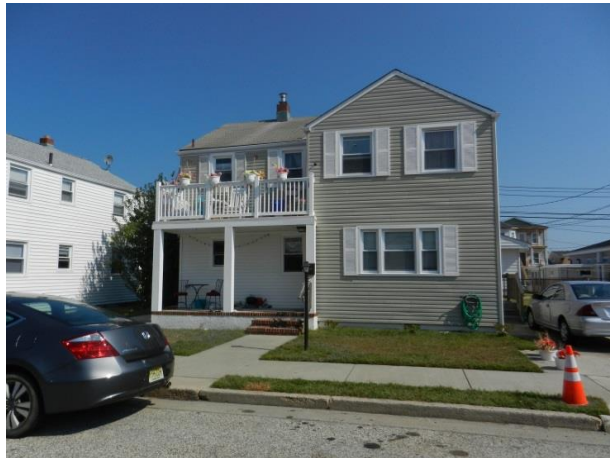
**Most Likely Building Characteristics:** The prototype building is of wood frame construction. It is 15 to 30 years old, and is in fair to good condition. The building is elevated above grade on a crawl space. The finished floor is 3'-0" above grade.

**Minimum-Damage Building Characteristics:** The prototype building is of masonry construction. It is 0 to 10 years old, and is in good condition. The building is on a slab. The finished floor is 1'-0" above grade.

**Higher-Damage Building Characteristics:** The prototype building is of wood frame construction. It is older, and in poor condition. It is not known if the building was built to code. The building is elevated above grade on a crawl space. The finished floor is 4'-0" above grade.

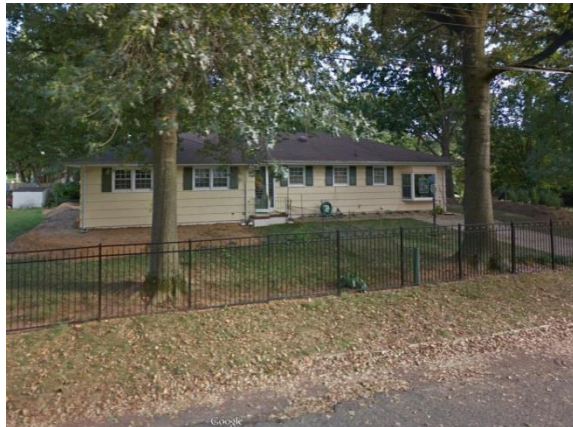
**Most Likely Building Characteristics:** The prototype building is of wood frame construction. It is 15 to 30 years old, and in fair to good condition. The basement is unfinished, used for storage, and contains various utilities. The building has a block foundation and the finished floor is 3'-0" above grade.

**Minimum-Damage Building Characteristics:** The prototype building is of masonry construction. It is 0 to 10 years old, and in good condition. The basement is unfinished. Utilities are elevated. The building has a reinforced concrete foundation and the finished floor is 1'-0" above grade.

**Higher-Damage Building Characteristics:** The prototype building is of wood frame construction. It is older, and in poor condition. It is not known if the building was built to code. The basement is finished. The building has a block foundation and the finished floor is 4'-0" above grade.
