# North Atlantic Coast Comprehensive Study: Resilient Adaptation to Increasing Risk

## PHYSICAL DEPTH DAMAGE FUNCTION SUMMARY REPORT

January 2015

US Army Corps  
of Engineers®

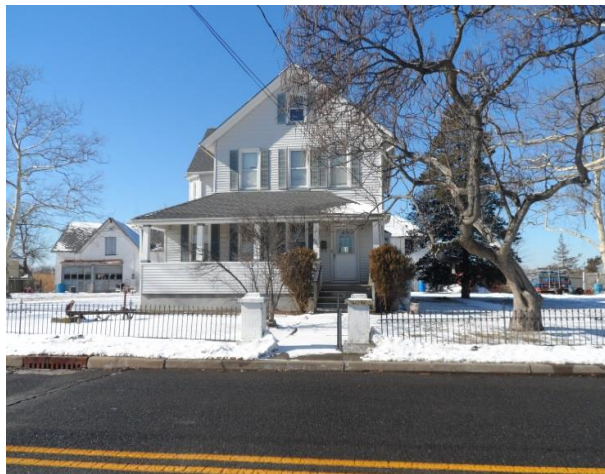
**Most Likely Building Characteristics:** The prototype building is of wood frame construction. It is 15 to 30 years old, and in fair to good condition. The basement is unfinished, used for storage, and contains various utilities. The building has a block foundation and the finished floor is 3'-0" above grade.

**Minimum-Damage Building Characteristics:** The prototype building is of masonry construction. It is 0 to 10 years old, and in good condition. The basement is unfinished. Utilities are elevated. The building has a reinforced

concrete foundation and the finished floor is 1'-0" above grade.

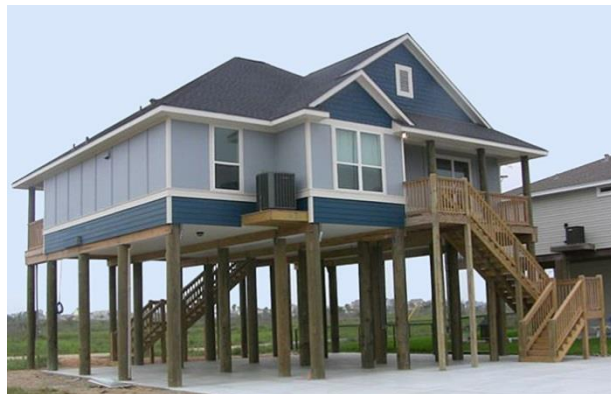
6.15 Prototype 7A: Building on Open Pile Foundation

**Most Likely Building Characteristics:** The prototype building is 15 to 30 years old. Piles are 8” to 10” in diameter, and the connections are in fair condition. Utilities are elevated. Post-flood mold propagation is possible.

**Minimum-Damage Building Characteristics:** The prototype building is 0 to 10 years old. Piles are 10” to 12” in diameter, and the connections are in good condition. Utilities are elevated.

**Higher-Damage Building Characteristics:** The prototype building is older. It is not known if it was built to code. Piles are 6” in diameter or helical, and the connections are in poor condition. Utilities are located below the building.

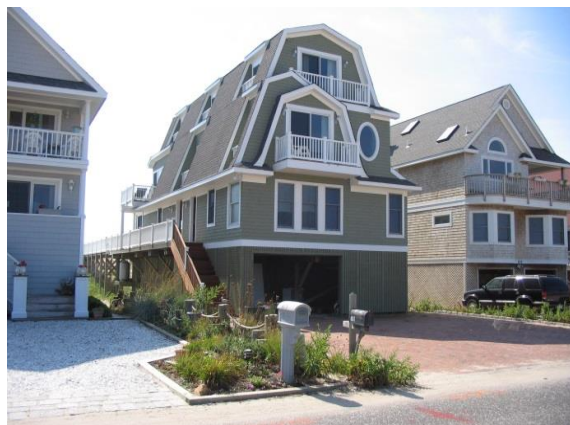
6.16 Prototype 7B: Building on Pile Foundation with Enclosures

**Most Likely Building Characteristics:** The prototype building is 15 to 30 years old. The enclosure walls are not “break-away” walls, but they will break under some flooding circumstances. The enclosed space is used for parking, storage and access to utilities, which are located below the building. Piles are 8” to 10” in diameter, and the connections are in fair condition.

**Minimum-Damage Building Characteristics:** The prototype building is 0 to 10 years old. The enclosure walls are of “break-away” construction.

The enclosed space is used for access to the building, and for parking. Piles are 10” to 12” in diameter, and the connections are in good condition. Utilities are elevated.

**Higher-Damage Building Characteristics:** The prototype building is older. It is not known if it was built to code. The enclosure walls are not “break-away” walls, and may not break at all under flooding circumstances. The enclosed space is used as living space. Piles are 6” in diameter or helical, and the connections are in poor condition. Utilities are located below the building.

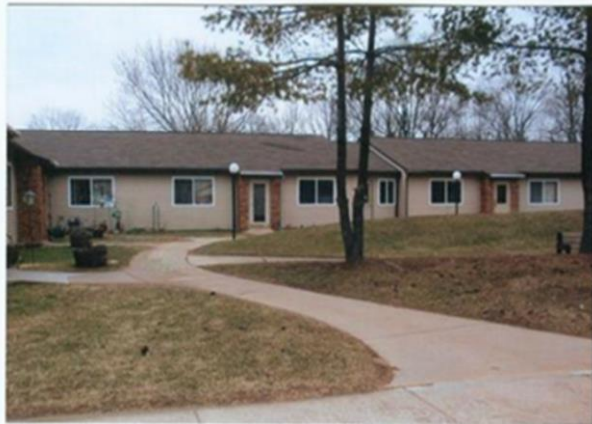
Prototype 1A-1: Apartments – 1 Story – No Basement

The prototype building is of unreinforced masonry construction on a slab foundation. It is one story. Utilities are located on the first floor. Ceiling height is 8'-0". Age range is between 15 and 30 years old. The FFE is 1'-0" above grade.

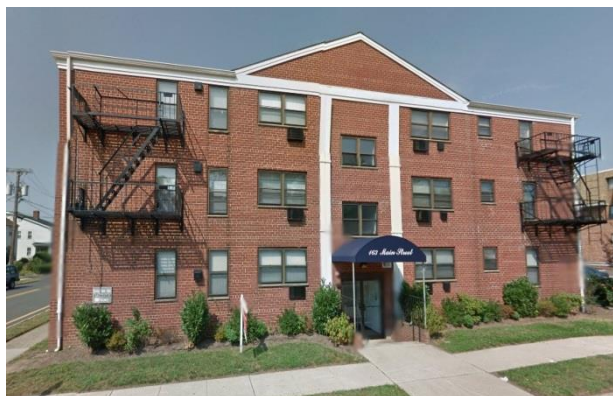
Prototype 1A-3: Apartments – 3 Stories – No Basement

The prototype building is of unreinforced masonry construction on a slab foundation. It has three stories. Utilities are located on the first floor. Ceiling height is 8'-0". Age range is between 15 and 30 years old. The finished floor is 1'-0" above grade.

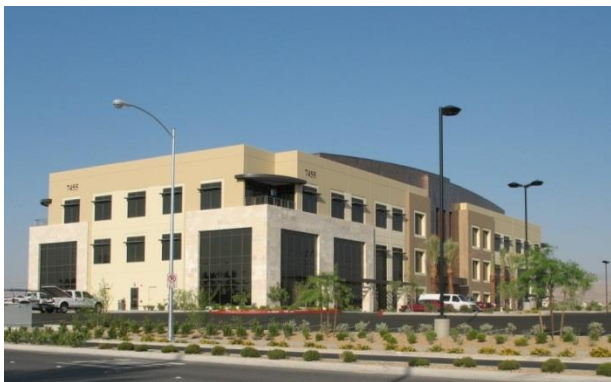
Prototype 2: Commercial – Engineered

The building has a steel frame with precast infill.

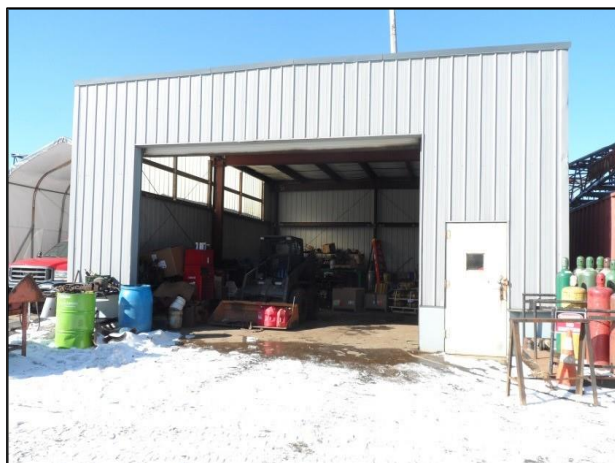
Prototype 3: Commercial – Non-Pre-engineered

The building has a steel or light metal frame and a slab foundation. The finished floor is 1'-0" above grade.

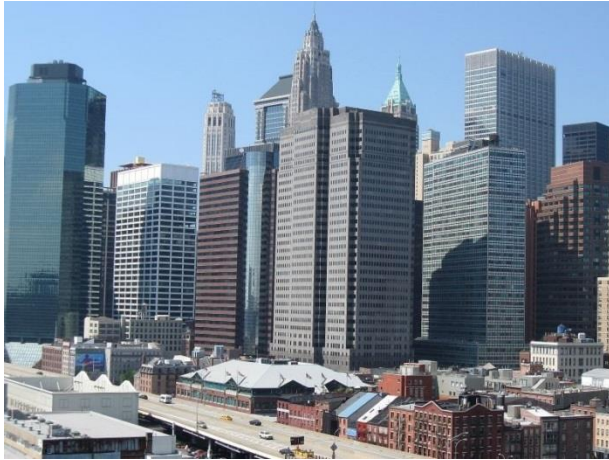
Prototype 4A: Urban High Rise

The building is between 15 and 30 years old, and has a full basement with parking and Mechanical/Electrical/Plumbing (MEP) equipment. The first (ground) level has an open lobby layout with limited finishing. Upper levels are apartments. MEP equipment constitutes 40% of the building's total value.

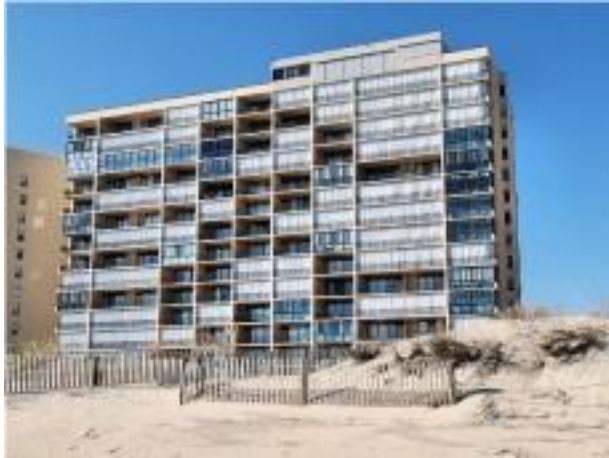
Prototype 4B: Beach High Rise

The building is between 15 and 30 years old. The first (ground) level is a mix of apartments and parking space, and also houses some of the building's MEP equipment. Upper levels are apartments.

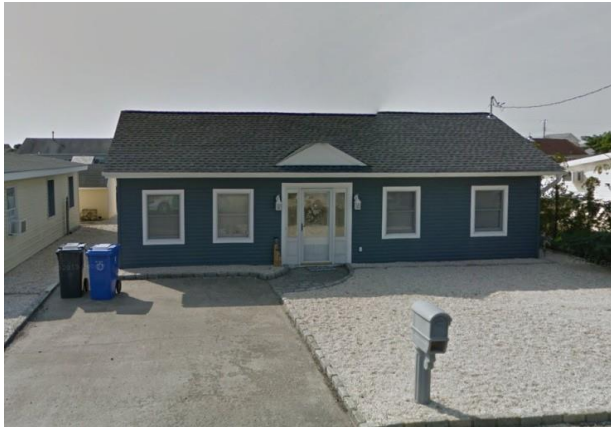
Prototype 5A: Single-Story Residence, No Basement

The prototype building is of wood frame construction. It is 15 to 30 years old, and is in fair to good condition. The building is on a slab. The finished floor is 1'-0" above grade.

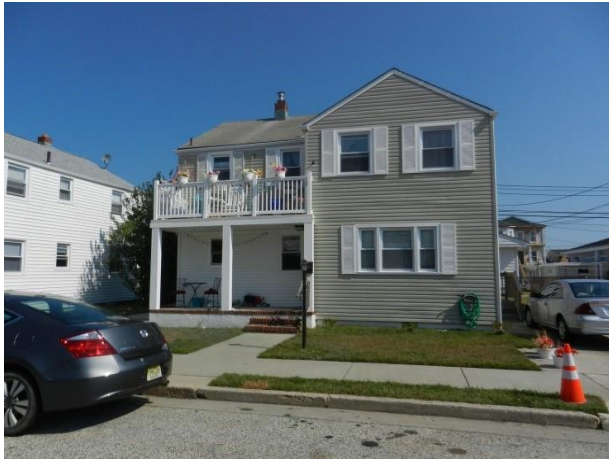
Prototype 5B: Two-Story Residence, No Basement

The prototype building is of wood frame construction. It is 15 to 30 years old, and is in fair to good condition. The building is elevated above grade on a crawl space. The finished floor is 3'-0" above grade.

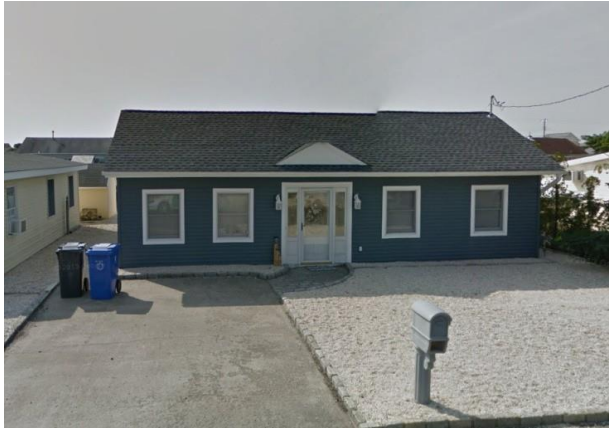
Prototype 6A: Single-Story Residence with Basement

The prototype building is of wood frame construction. It is 15 to 30 years old, and in fair to good condition. The basement is unfinished, used for storage, and contains various utilities. The building has a block foundation and the finished floor is 3'-0" above grade.

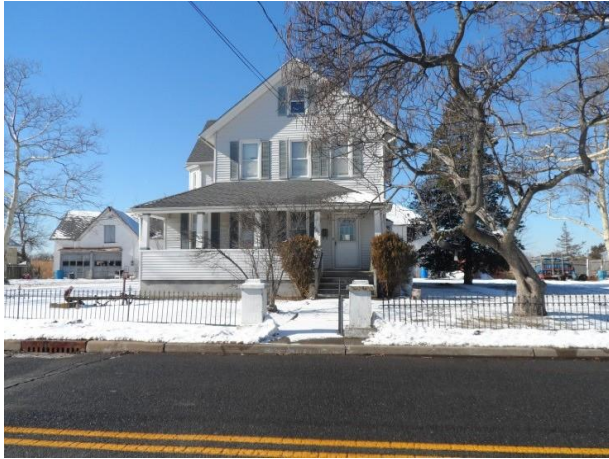
Prototype 6B: Two-Story Residence with Basement

The prototype building is of wood frame construction. It is 15 to 30 years old, and in fair to good condition. The basement is unfinished, used for storage, and contains various utilities. The building has a block foundation and the finished floor is 3'-0" above grade.

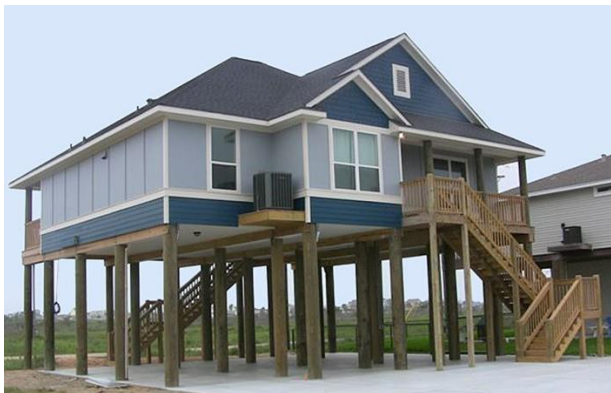
Prototype 7A: Building on Open Pile Foundation

The prototype building is 15 to 30 years old. Piles are 8” to 10” in diameter, and the connections are in fair condition. Utilities are elevated. Post-flood mold propagation is possible.

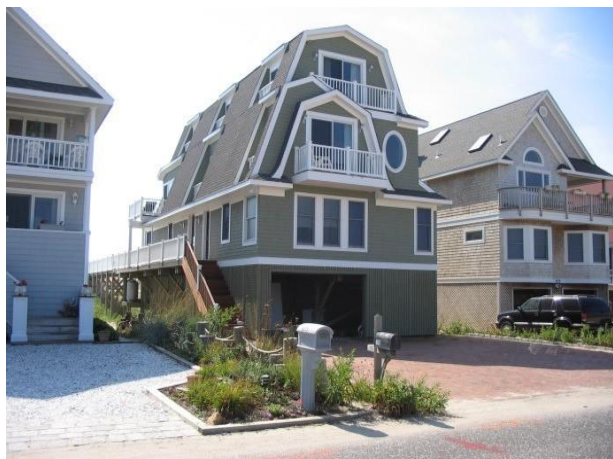
Prototype 7B: Building on Pile Foundation with Enclosures

The prototype building is 15 to 30 years old. The enclosure walls are not “break-away” walls, but they will break under some flooding circumstances. The enclosed space is used for parking, storage and access to utilities, which are located below the building. Piles are 8” to 10” in diameter, and the connections are in fair condition.

The prototype building is 0 to 10 years old. The enclosure walls are of “break- away” construction. The enclosed space is used for access to the building, and for parking. Piles are 10” to 12” in diameter, and the connections are in good condition. Utilities are elevated.

The prototype building is older. It is not known if it was built to code. The enclosure walls are not “break-away” walls, and may not break at all under flooding circumstances. The enclosed space is used as living space. Piles are 6” in diameter or helical, and the connections are in poor condition. Utilities are located below the building.

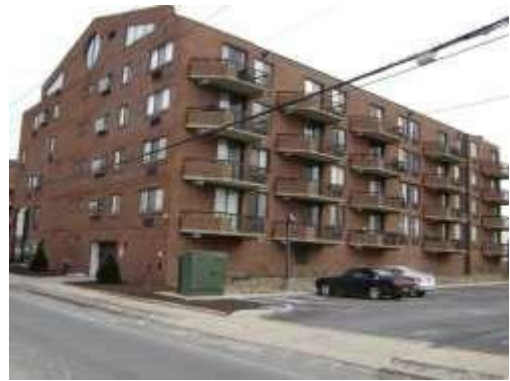
## BUILDING PROTOTYPE 1: APARTMENTS

The NACCS physical damage survey collected damage data and construction data for buildings impacted by Hurricane Sandy. For Prototype 1, these surveyed buildings included townhouses, condominiums and garden style apartments. The base prototype includes what are considered to be the most likely storm and building conditions.

The prototype building is masonry construction, with apartments on each of its finished floors. The lower/basement level contains limited utilities, parking, and storage. Age range is between 15 and 30 years old. The building is built to older codes and has no major construction defects. Utilities are most likely elevated to prevent flood damage.

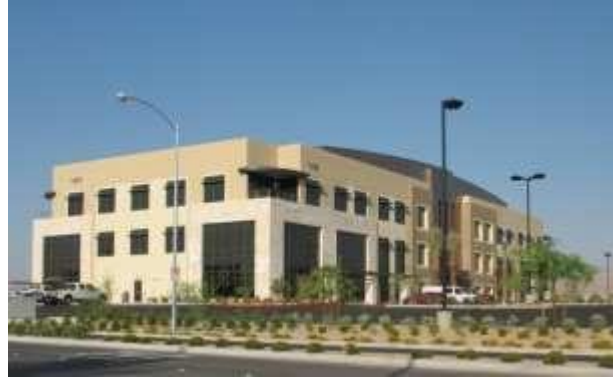
Commercial structures are split into engineered and non-engineered construction to reflect observed differences in vulnerability to storm damage.

The engineered commercial buildings are characterized by the following framing types: structural steel, reinforced concrete, masonry bearing walls, mill-type construction. The prototype structure is multiple stories and is used for office or retail. Content damages will be considered in two scenarios; one for occupancies containing non-perishable products, the second for occupancies containing perishable goods/ food products. The base prototype includes what are considered to be the most likely storm and building conditions.

The building contains a partial basement/lower level which includes some utilities or parking. Age range is between 15 and 30 years old. The building is built to older codes and has no major construction defects.

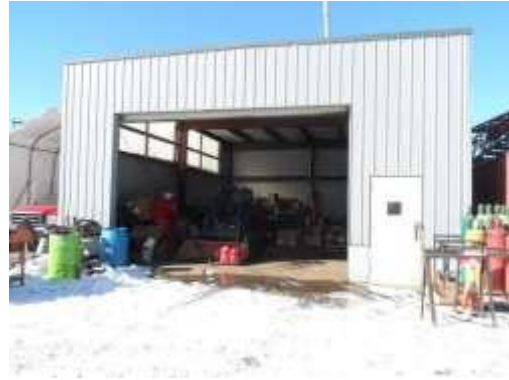
## **BUILDING PROTOTYPE 3: COMMERCIAL STRUCTURES – NON-ENGINEERED CONSTRUCTION**

The non-engineered commercial buildings' lighter construction makes them more vulnerable to flood damage or wave impacts. These buildings are characterized by wood/steel stud-frame or metal frame and walls. The prototype building has no basement and contains retail and dining establishments. Content damages will consider two scenarios; one for occupancies containing non-perishable products, the second for occupancies containing perishable goods/ food products. The base prototype includes what are considered to be the most likely storm and building conditions.

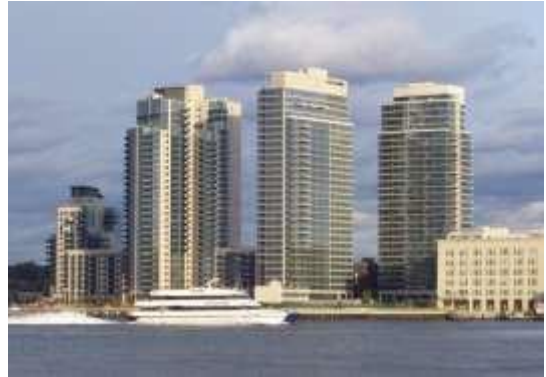
## BUILDING PROTOTYPE 4: HIGH RISE STRUCTURES

The NACCS Survey collected data on a limited number of high rise buildings that suffered damage during Hurricane Sandy. These buildings are characterized by structural steel or reinforced concrete frames and have more than five stories. The structures are supported on deep foundations. The base prototype includes what are considered to be the most likely storm and building conditions.

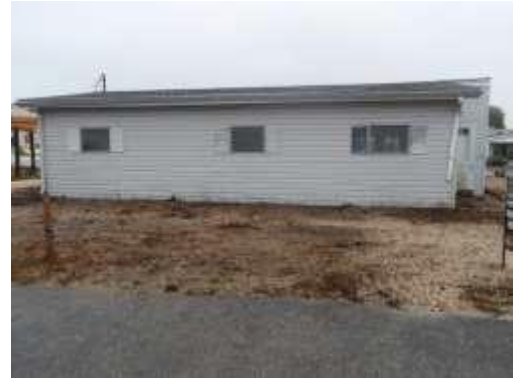
Prototype 5A is a one-story single-family home with no basement, approximately 1800 ft<sup>2</sup> in size. The vast majority of the residential structures included in the survey do not have a basement. This is typical of coastal areas that have high water tables. The base prototype includes what are considered to be the most likely storm and building conditions.

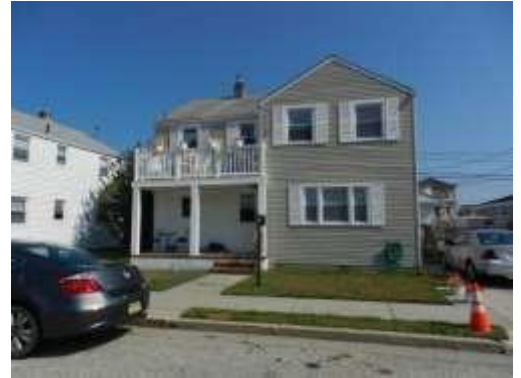
## **BUILDING PROTOTYPE 5B: MULTISTORY RESIDENCES WITHOUT BASEMENTS**

Prototype 5B is a two-story single-family home with a basement and a two-car garage, approximately 2400 ft<sup>2</sup> total. The vast majority of the residential structures included in the survey do not have a basement. This is typical of coastal areas that have high water tables. The base prototype includes what are considered to be the most likely storm and building conditions.

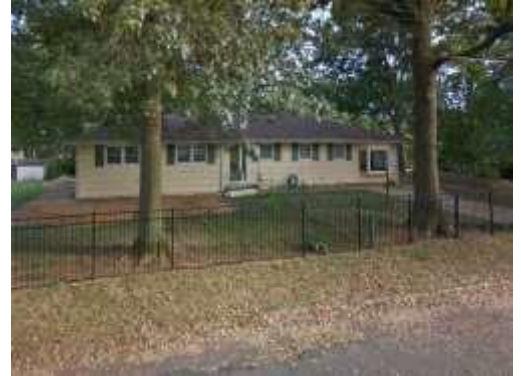
Prototype 5A is a one-story single-family home with no basement, approximately 1800 ft<sup>2</sup> in size. While the majority of the structures included in the survey do not have a basement, it is anticipated that some projects will need to evaluate the increased level of flood damage where a basement is present. The base prototype includes what are considered to be the most likely storm and building conditions.

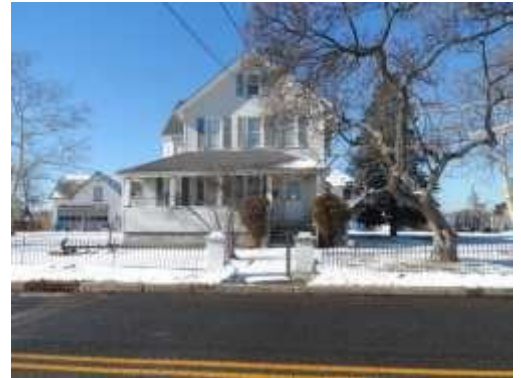
## **BUILDING PROTOTYPE 6B: MULTISTORY RESIDENCES WITH BASEMENTS**

Prototype 6B is a two-story single-family home with a basement and a two-car garage, approximately 2400 ft<sup>2</sup> total. While the majority of the structures included in the survey do not have a basement, it is anticipated that some projects will need to evaluate the increased level of flood damage where a basement is present. The base prototype includes what are considered to be the most likely storm and building conditions.

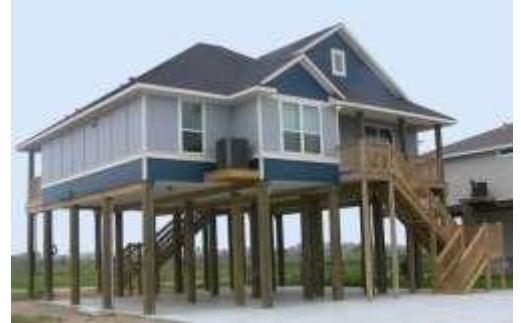
## BUILDING PROTOTYPE 7A: PILE FOUNDATION – OPEN

These buildings are usually single-family homes elevated on 8" to 10" diameter wood piles. The prototype structures may be one level or more, with the main living area on uppermost floor. The buildings utilities are elevated and there is no enclosed space below the building. The base prototype includes what are considered to be the most likely storm and building conditions.

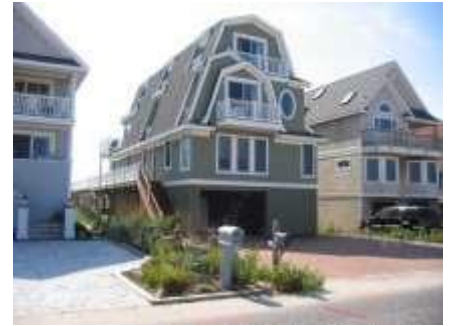
## BUILDING PROTOTYPE 7B: PILE FOUNDATION – WITH ENCLOSURE

These buildings are usually single-family homes elevated on 8” to 10” diameter wood piles. The prototype structures may be one level or more, with the main living area on uppermost floor. The space below the building is fully or partially enclosed. The base prototype includes what are considered to be the most likely storm and building conditions.

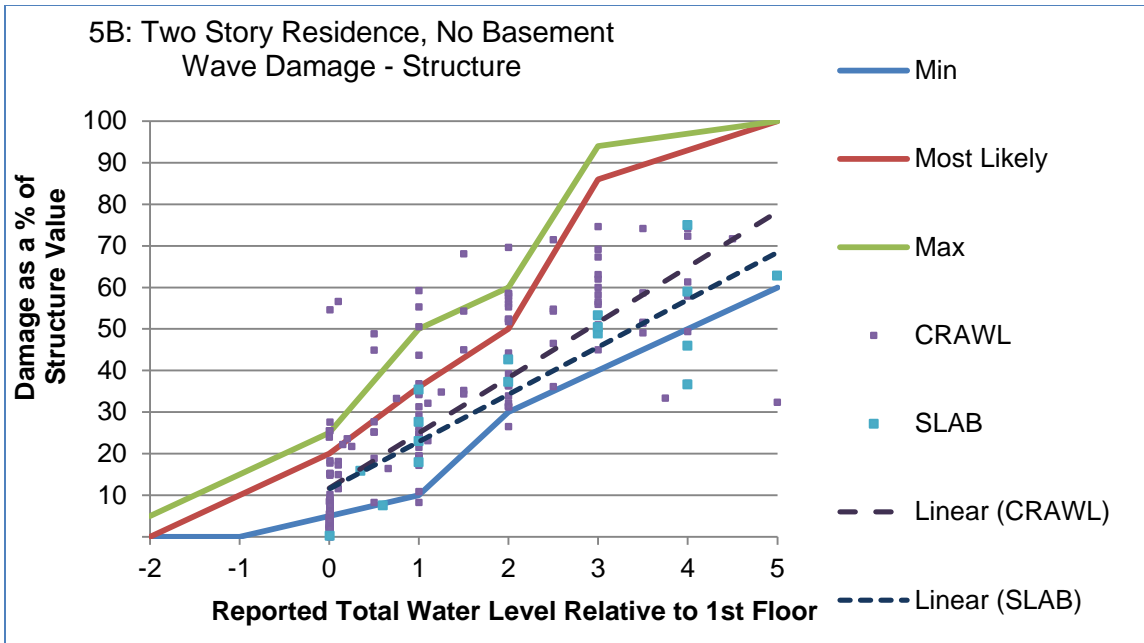
Figure 11. 5B: 2-Story Residence, No Basement Structure Comparison – Wave

The results of the Substantial Damage estimates for each prototype and damage mechanism are displayed on Figures 3 through 28, which also show the comparison to the NACCS expert elicitation results. The results were reviewed to identify how well the physical damage function for each prototype and damage mechanism conform to the Substantial Damage estimates.
