Mitigation Assessment Team Report

Hurricane Charley in Florida

Observations, Recommendations,
and Technical Guidance

FEMA 488 / April 2005

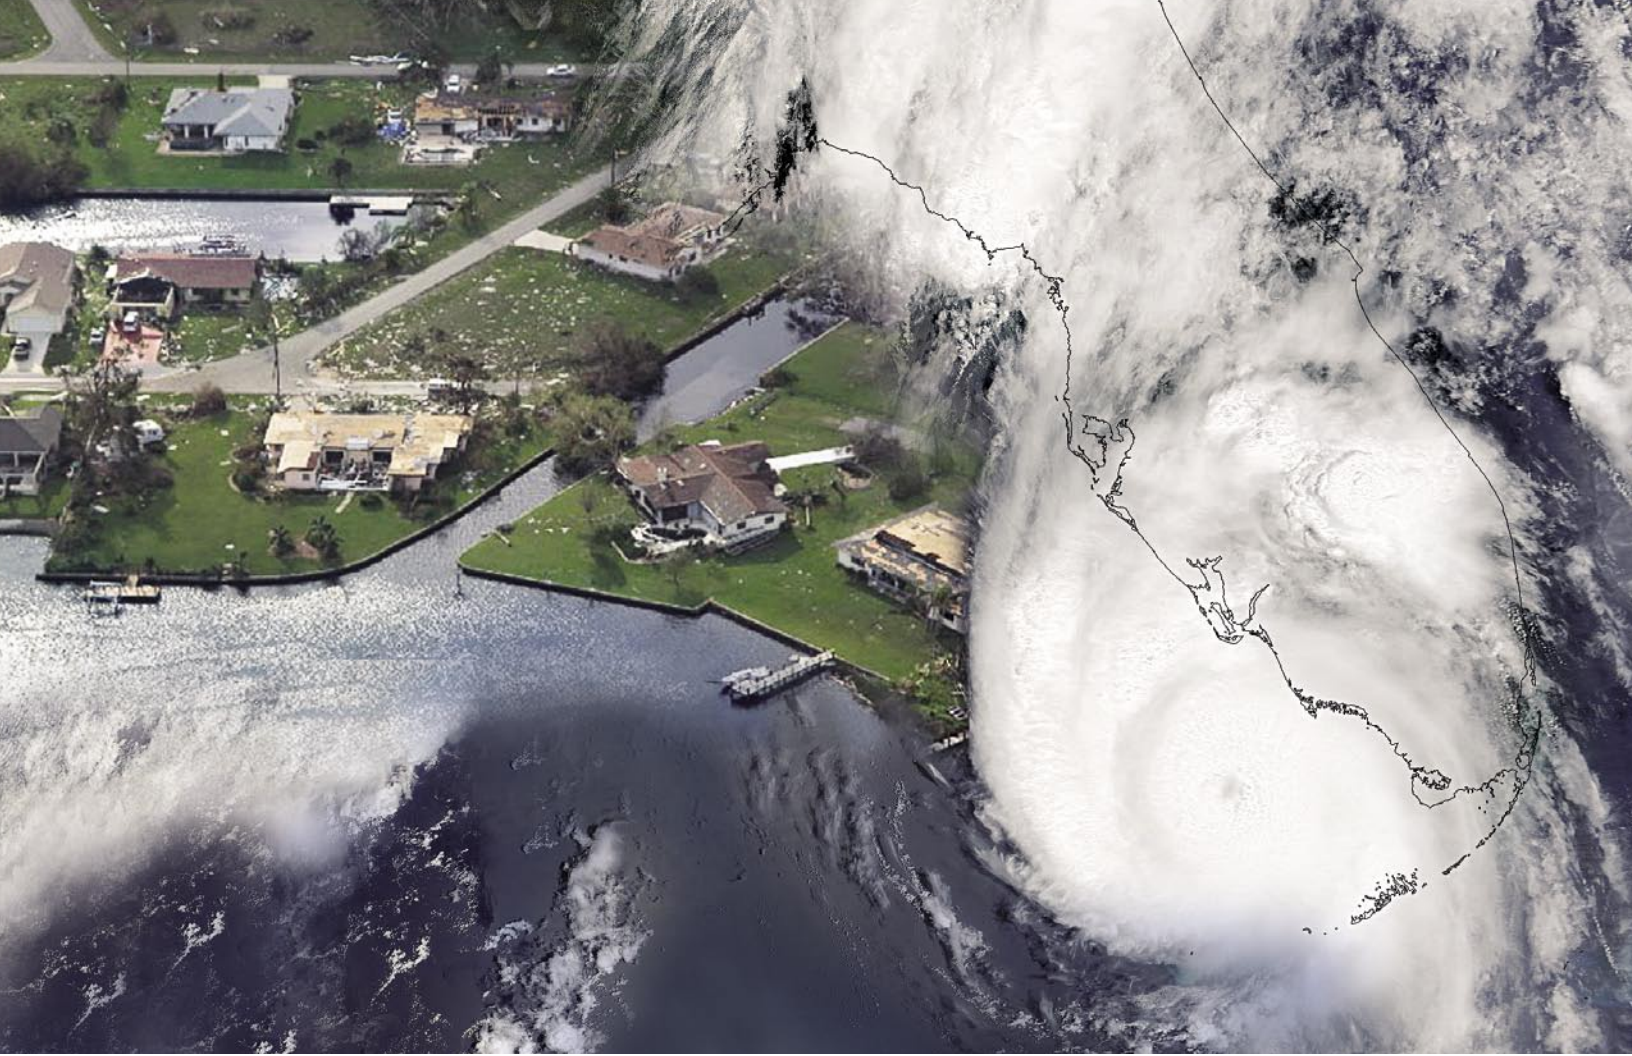
About the Cover

The photograph on the cover shows damage in Charlotte County, Florida, caused by Hurricane Charley on August 13, 2004. (Photograph courtesy of the Florida Division of Emergency Management and the State Emergency Response Team.) Superimposed on this photograph is an image of Hurricane Charley captured on August 13, 2004, at 12:35 p.m. Eastern Daylight Time by the Moderate Resolution Imaging Spectroradiometer (MODIS) sensor aboard the National Aeronautics and Space Administration's (NASA's) Terra satellite. At the time the image was taken, Charley was rapidly gaining strength and would reach Category 4 status just 90 minutes later. Maximum sustained winds at 2:00 p.m. were at 145 miles per hour (mph), and Charley was moving toward the north-northeast at 20 mph.
