**Investigation of Loss of Well Control  
Eugene Island Block 205, Well No. D-5  
OCS 0805  
28 May 2005**

Gulf of Mexico  
Off the Louisiana Coast

David Dykes – Chair  
Jack Williams  
Frank Pausina

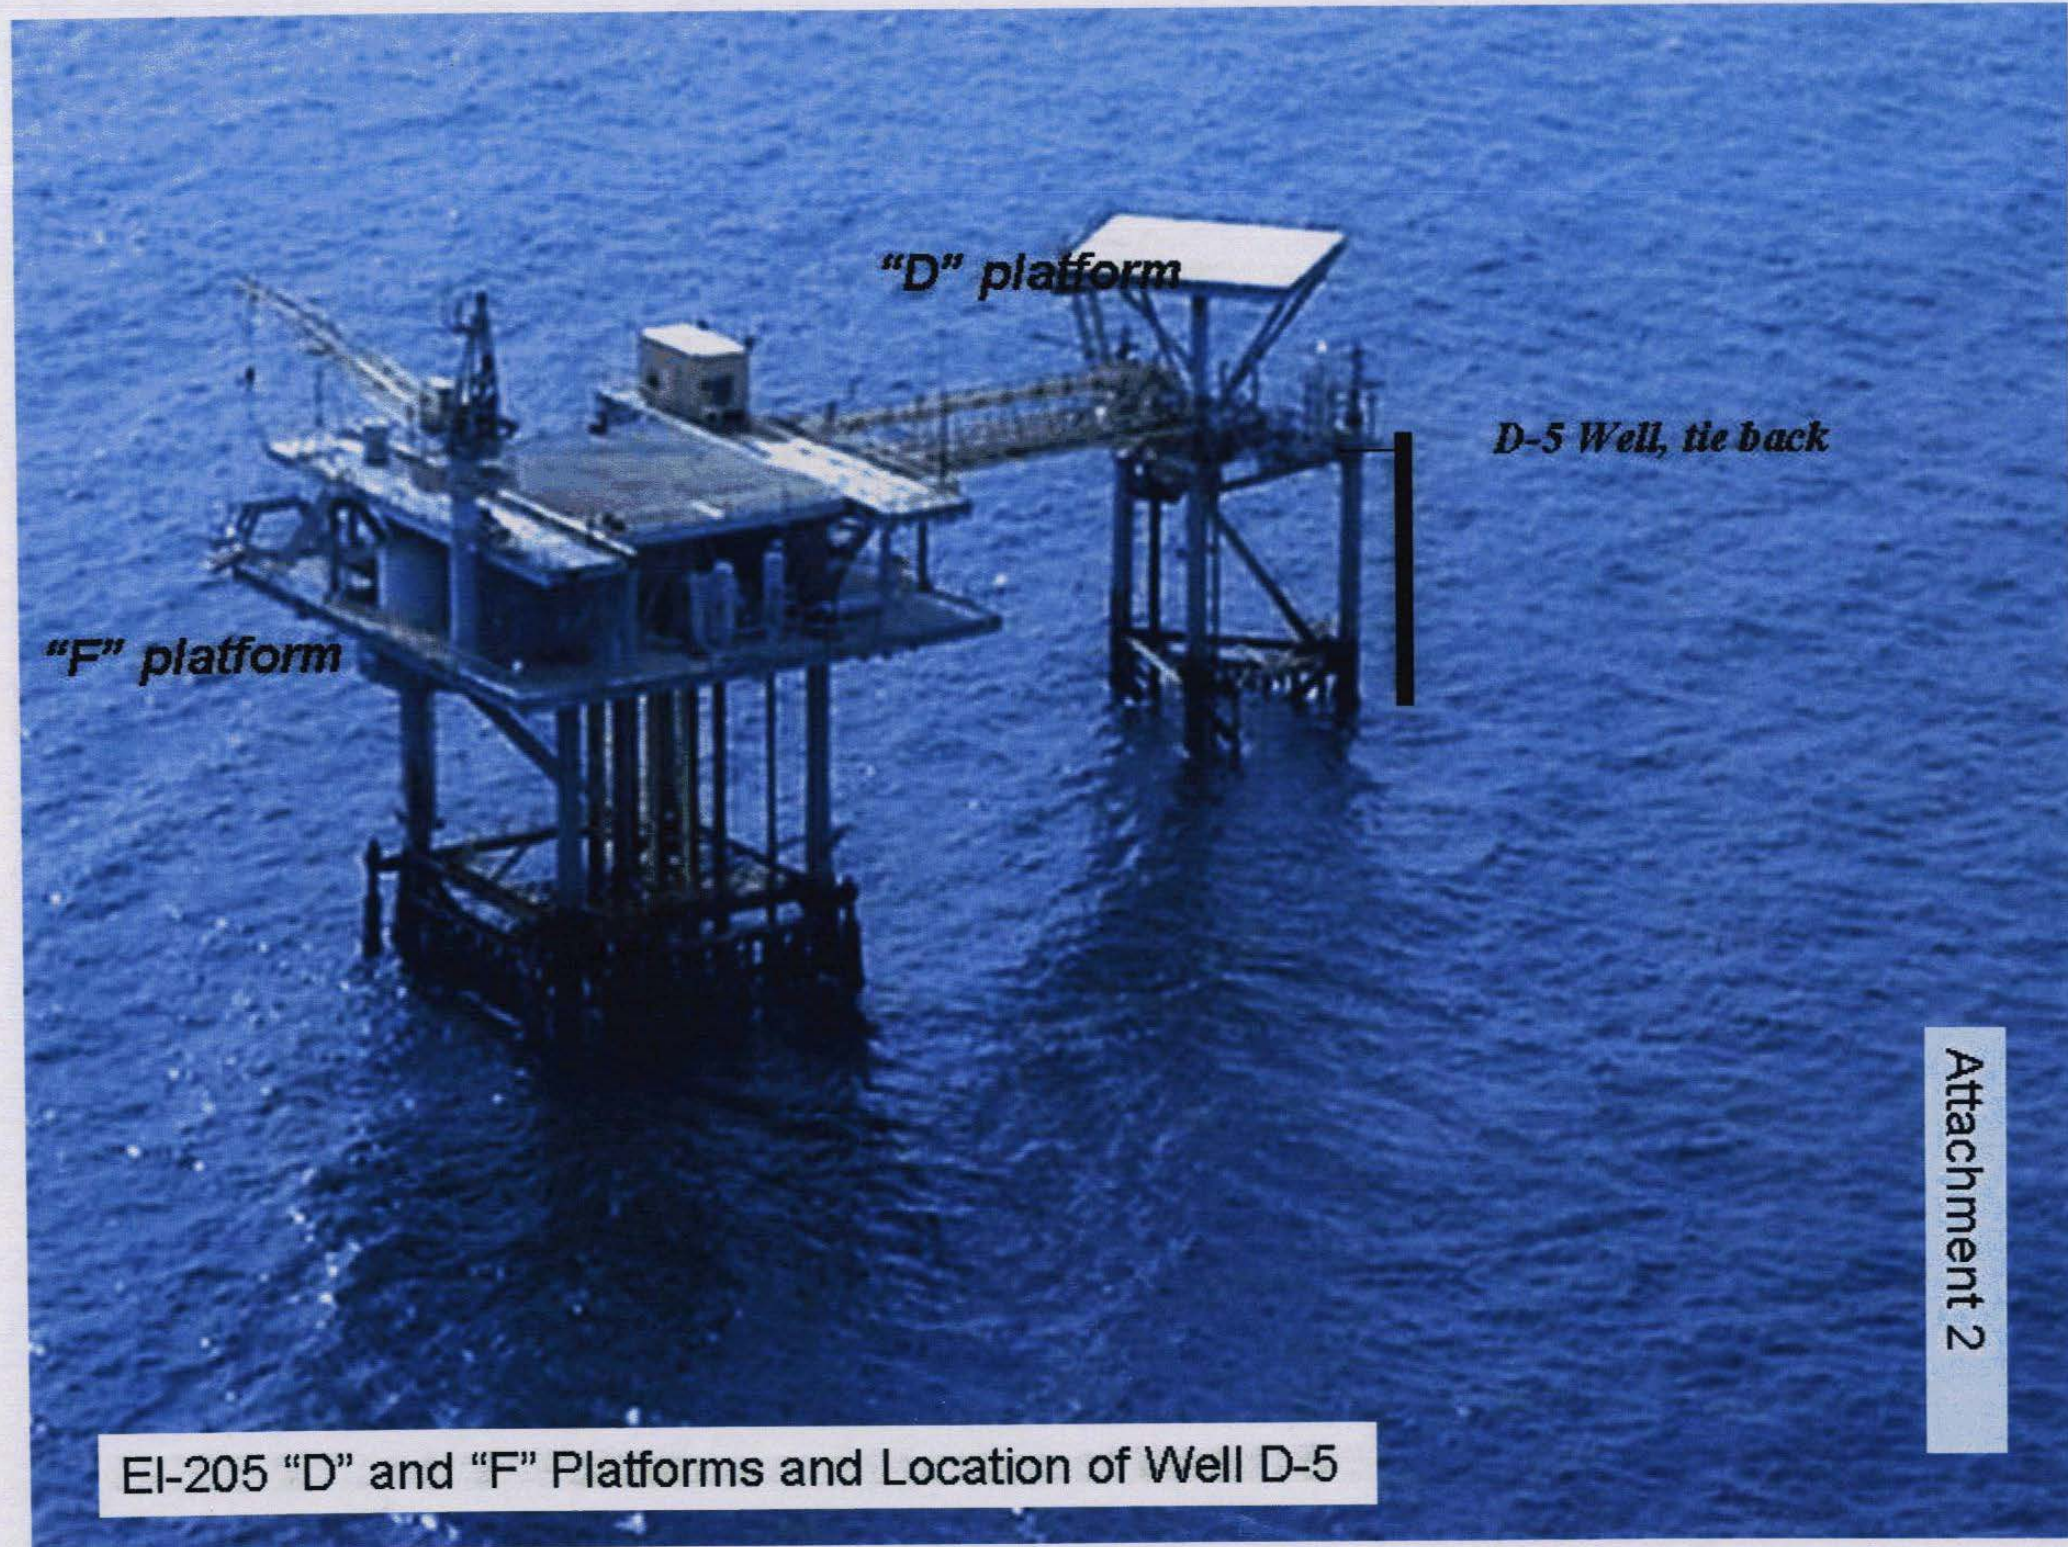
*"D" platform*

*"F" platform*

<b>Investigation and Report</b>	1
Authority	1
Procedures	2
<b>Introduction</b>	3
Background	3
Brief Description, Loss of Well Control	3
<b>Findings</b>	4
Preliminary Activities – Preparation of the Well Plan	4
Drilling Activities — Spud, Loss of Control, Regain Control	4
Previous Surface Hole Operations in the Immediate Area	5
Drilling Procedures and Kick Control	6
Geologic Review of Shallow Gas	7
<b>Conclusions</b>	8
<b>Recommendations</b>	9
<b>Appendix</b>	
Attachment 1 – Location of Lease OCS 0805, Eugene Island Block 205, Well No. D-5.	
Attachment 2 – EI 205 “D” and “F” Platforms and Location of Well D-5.

The seismic surveys and sparker survey data that were reviewed in preparing the well plan for the Well were older data shot before the installation of field infrastructure. The infrastructure included the “D” Platform and the nearby “F” platform and the associated wells, gathering lines, and pipelines. According to testimony, the Operator’s geologists and geophysicists found no indication of the presence of shallow gas during the review of the old seismic data and/or sparker surveys.
