# Intake Diversion Dam

## Fish Protection and Passage Concept Study Report II

Lower Yellowstone Project  
Yellowstone River, Montana

Bureau of Reclamation  
Technical Service Center  
Denver, Colorado

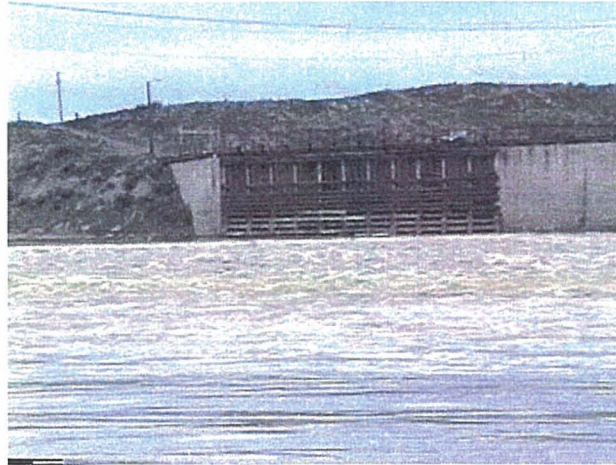
Figure 2 - View of Intake Dam and Main Canal Headworks.

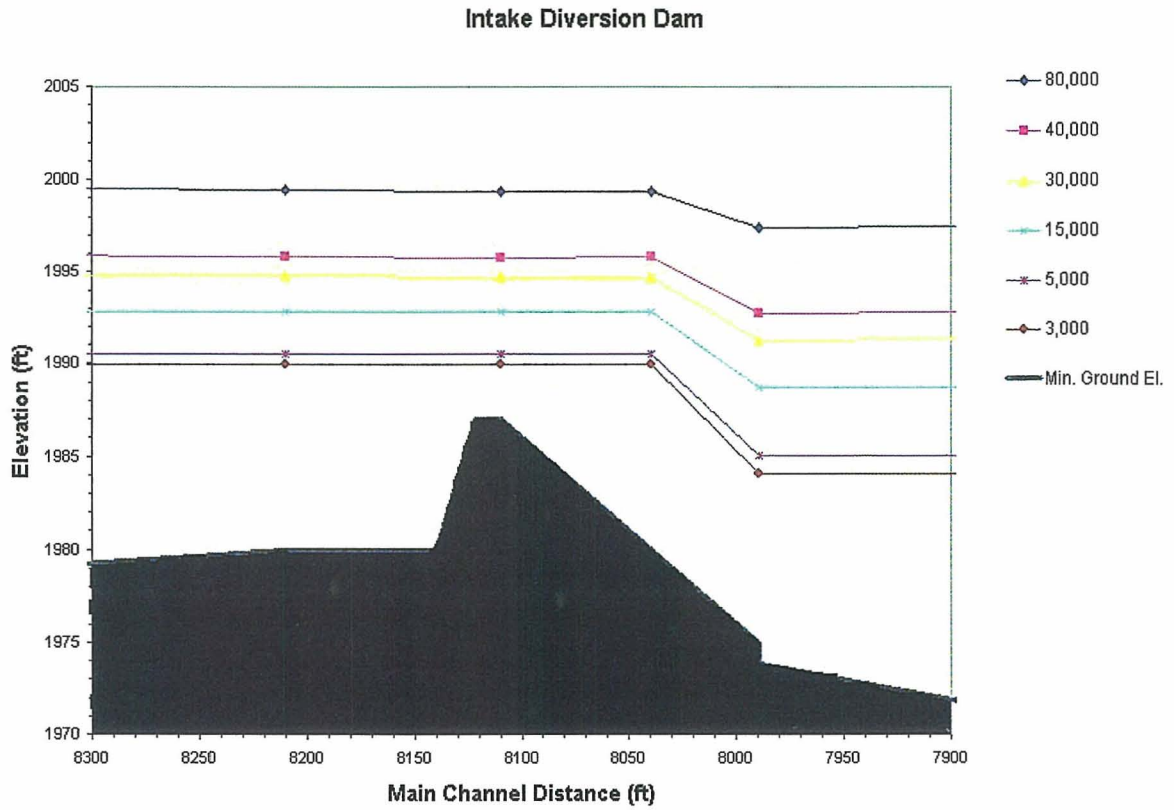
Figure 4 - Estimated water surface profiles across Intake Dam for river and canal flows (ft<sup>3</sup>/s) of:

River flow upstream of high flow channel	Canal diversion	Flow over dam	Flow in high flow channel
81,400	1,400	73,500	6,500
41,400	1,400	38,500	1,500
31,400	1,400	29,500	500
16,400	1,400	15,000	0
5,050	50	5,000	0

**Model output** - Flow simulations were conducted for a range of river flows with and without canal diversion. Figure 4 shows water surface profiles across the dam for each river flow modeled. For river flows above 30,000 ft<sup>3</sup>/s, the high flow channel that bypasses the dam to the south is assumed to flow as given in Figure 5. Table A1 gives estimated water surface elevations and related hydraulic data for a range of river flows. The estimated rise in the upstream water surface elevation caused by the dam is 5.5 feet to 2.0 feet for flows of 5,000 and 80,000 ft<sup>3</sup>/s, respectively.

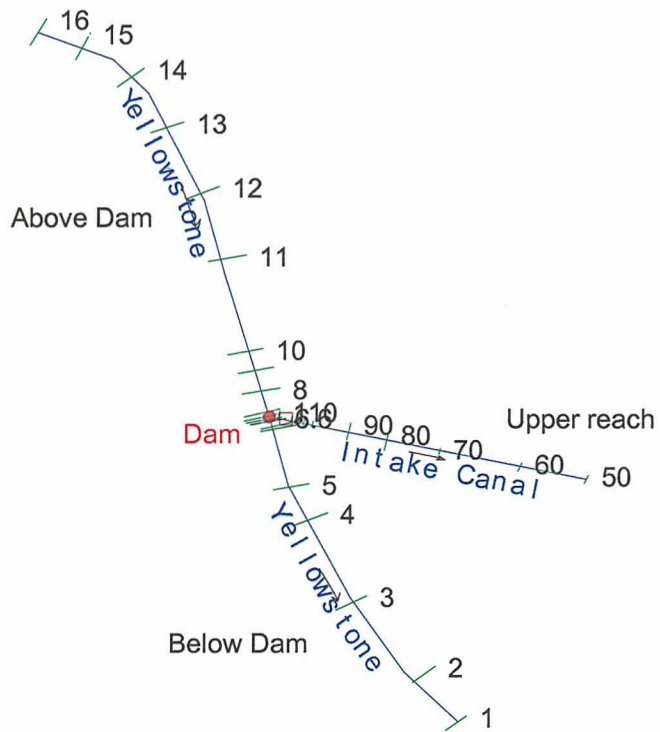
Figure A2 - Hec-Ras geometry plan showing cross-section locations within the reach of the Yellowstone River modeled

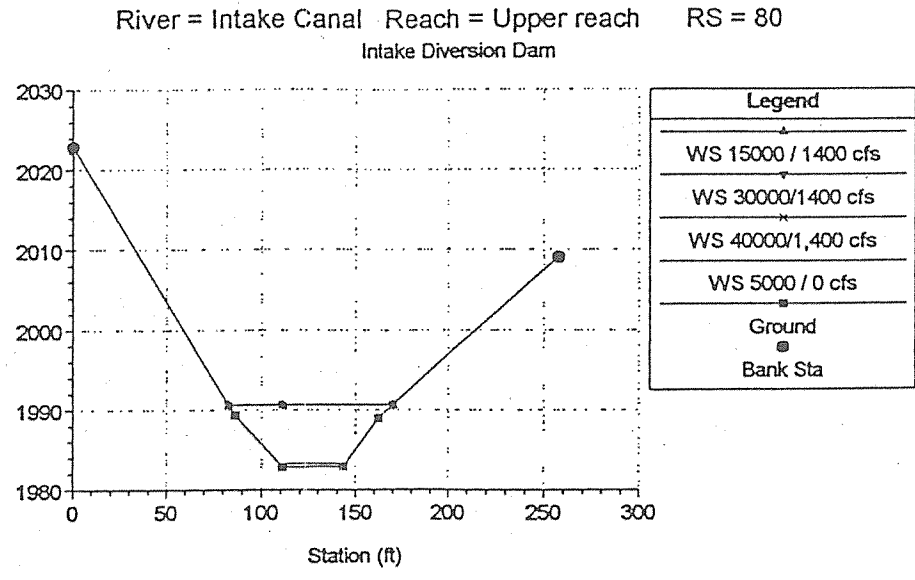
Figure A5 - Hec-Ras model output of Main Canal cross-sections downstream of canal headworks.

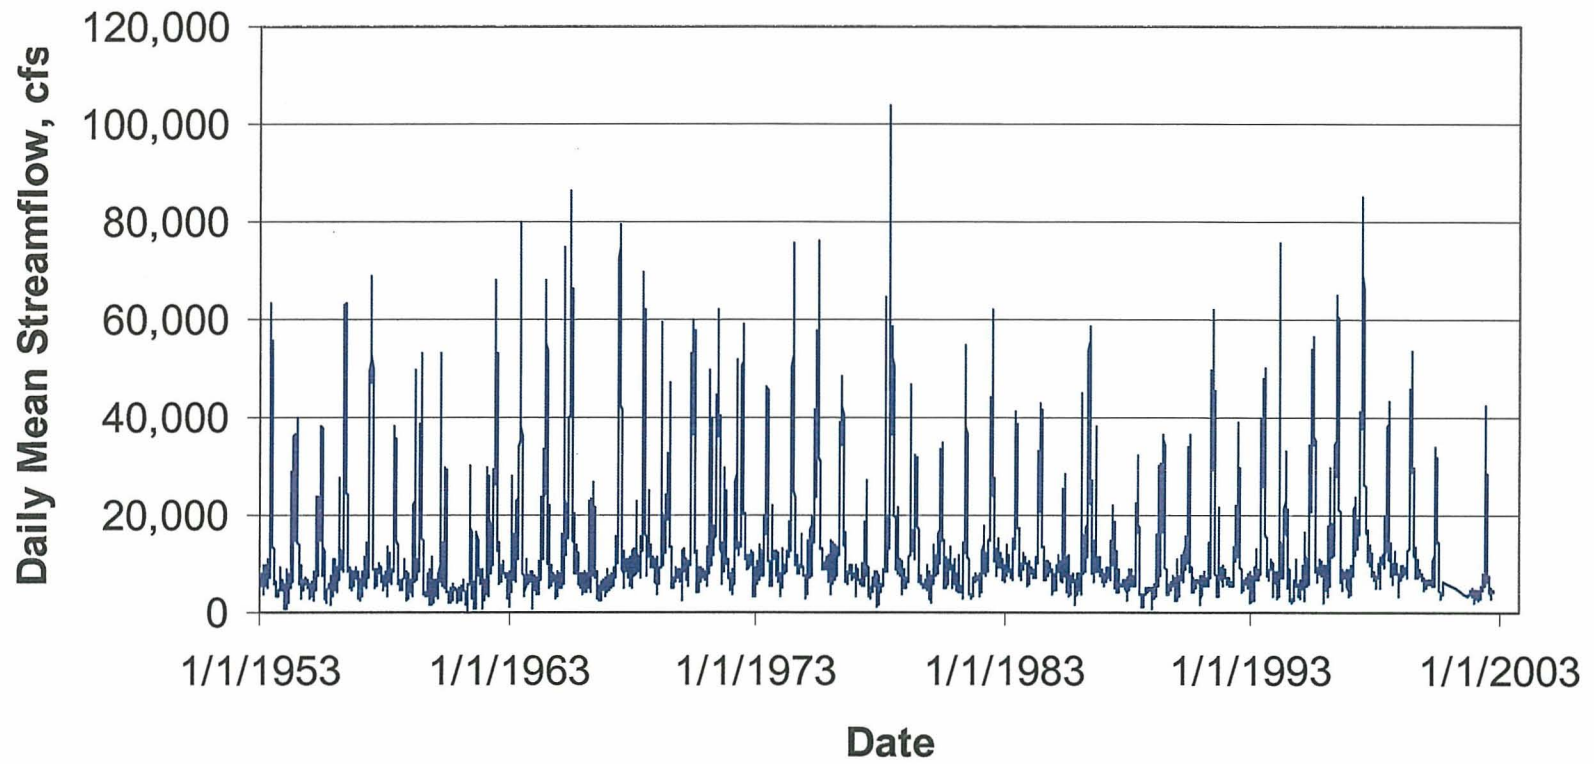
USGS Streamflow Gage discharge on Yellowstone River near Sidney  
Montana

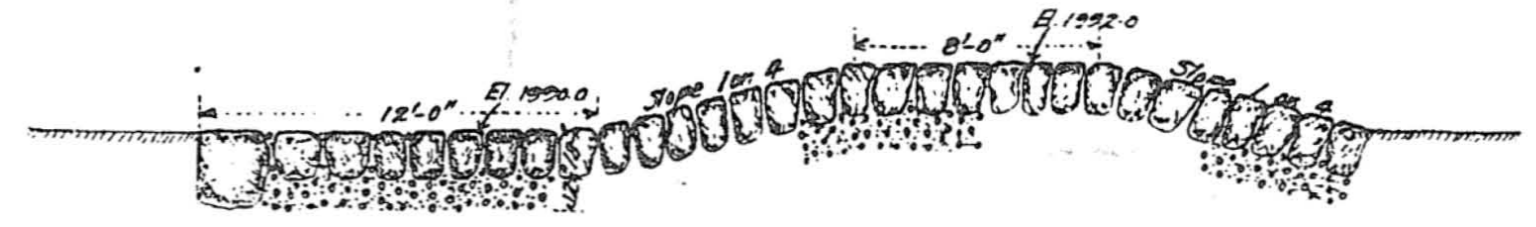
Typical Cross Section of Dike

Scale, 1/4" = 1'
