## Section 2.0 - Environmental Impacts

**Alamosa River Watershed  
Restoration Master Plan**

MWH in association with Agro Engineering,  
Lidstone and Associates, and SWCA

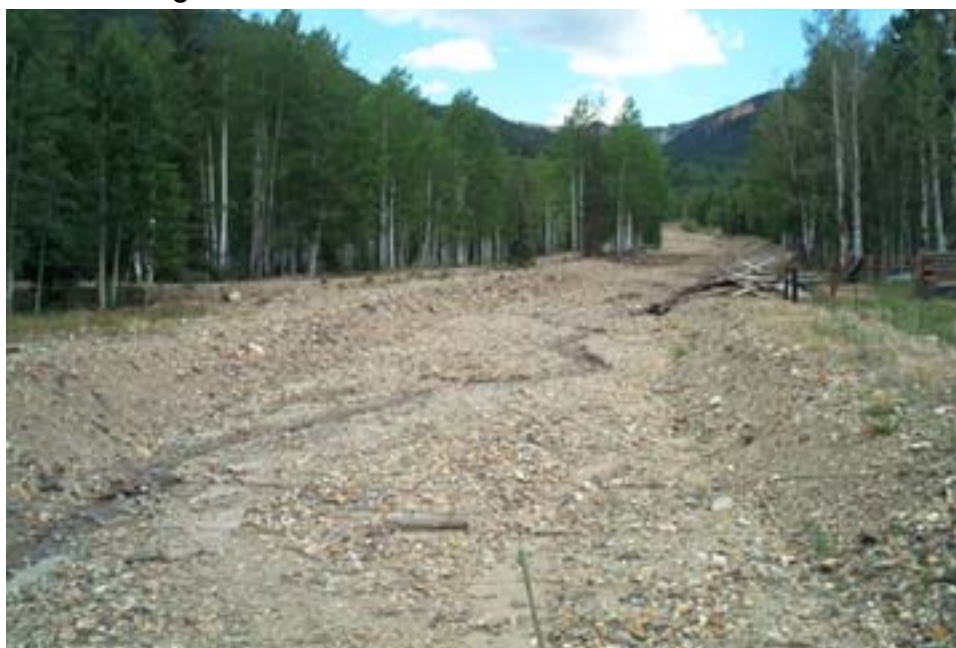
**Figure 2-8. Photo of Burnt Creek and Sediment Load**

Below Wightman Fork, the Alamosa River begins to meander within the confines of a 100-foot wide valley. The channel sinuosity of this reach is 1.3, and the stream has an average slope of 0.9%. Burnt Creek is a major tributary that enters this reach. The USGS quadrangle shows a 3,000-foot by 4,000-foot alluvial fan where Burnt Creek enters the Alamosa River. The large fan indicates a high sediment load carried by Burnt Creek, as shown in **Figure 2-8**. The alluvial fan may also restrict the extent of Alamosa River meandering in this area.

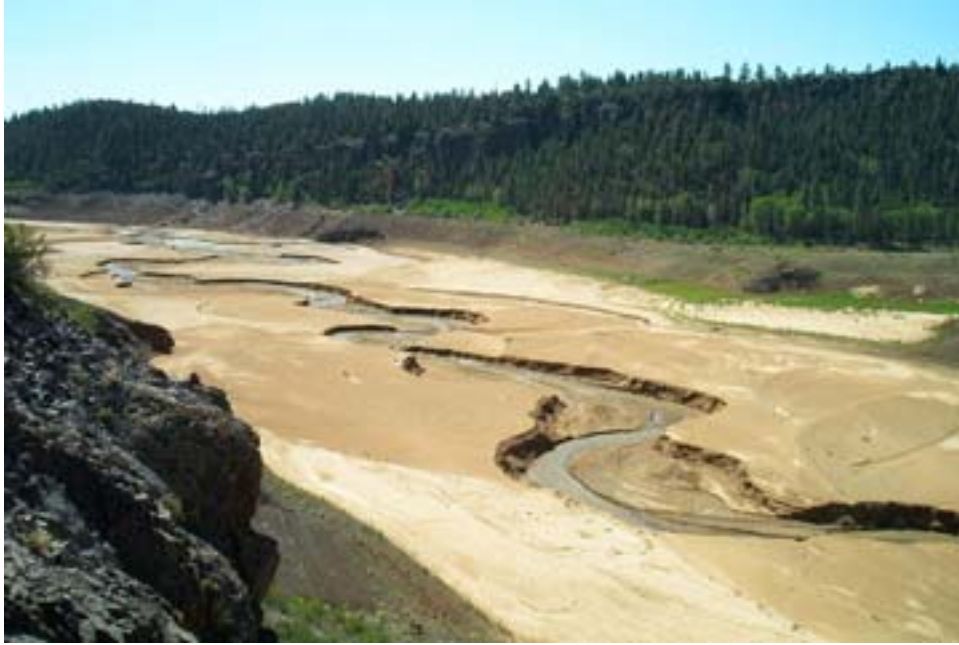
**Figure 2-9. Photo of Sediment Influences by the Backwater of Terrace Reservoir**

This reach is similar to the Wightman Fork to Beaver Creek reach. The river meanders within a 100-foot wide valley. The channel sinuosity of this reach is 1.3, and the stream has an average slope of 0.8%. Sediment begins to drop out as the channel enters the reservoir resulting in local channel aggradation. When Terrace Reservoir was drained in 2003, the channel re-entrenched into deposited sediments as the backwater condition was removed, as shown in **Figure 2-9**. When the reservoir is full this reach will once again aggrade as backwater condition flows allow sediment to drop out.

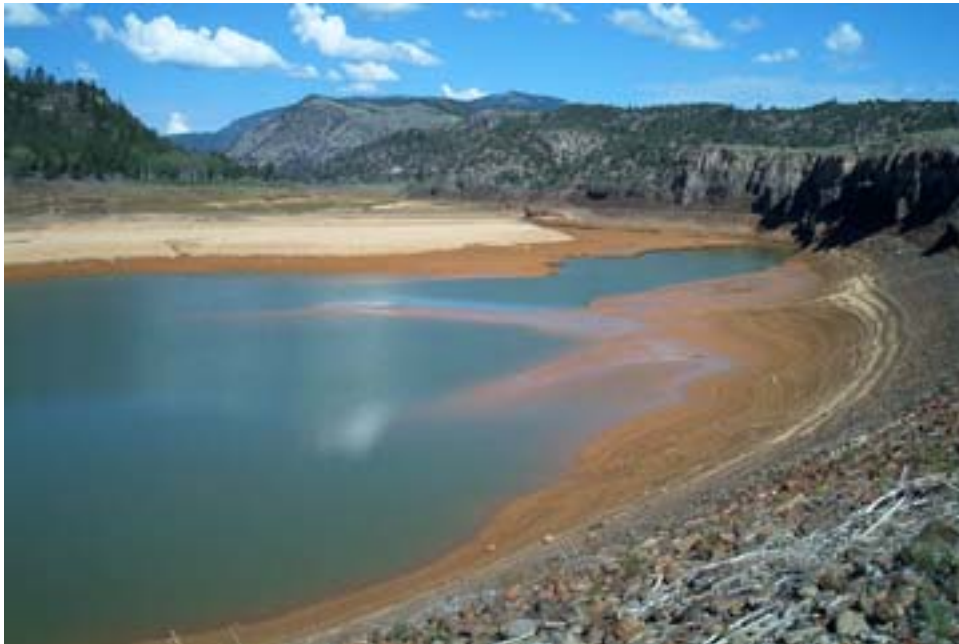
**Figure 2-10. Photo of Sediment Deposition in Terrace Reservoir**

Terrace Reservoir is an irrigation storage reservoir built in 1912 with a maximum capacity of about 15,200 acre-feet (Reinhardt, 2004). Terrace Reservoir serves as a sediment catch, reducing the amount of sediment being carried by the river to the downstream alluvial fan area. **Figure 2-10** shows a bar forming in Terrace Reservoir as sediment drops out.

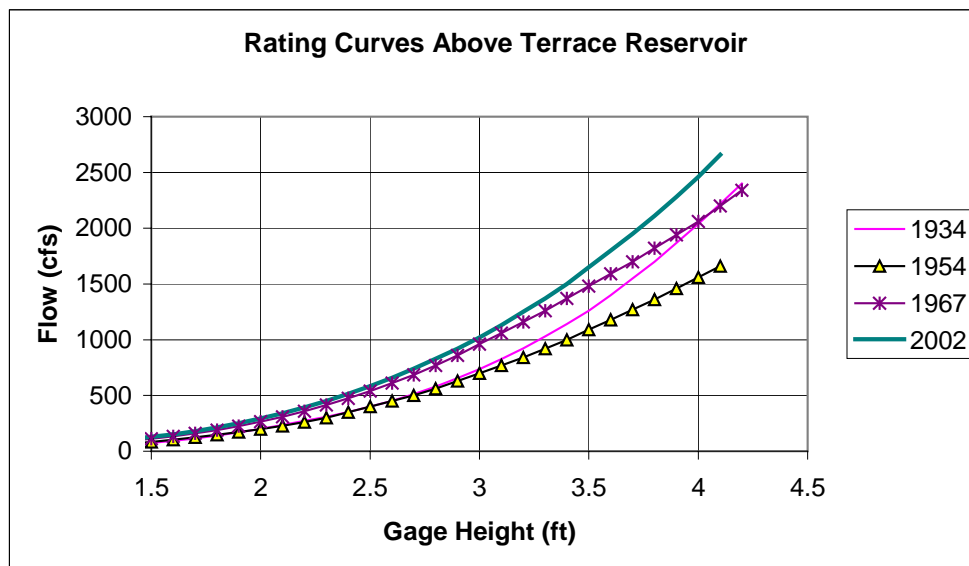
**Figure 2-11. Rating Curve Above Terrace Reservoir**

Available rating curves for gages on the Alamosa River were obtained to determine if the channel has aggraded or degraded over the period of record. There are two long-term gages on the Alamosa River which were used to determine historical changes. Long-term rating tables dating back to 1934 were obtained from the USGS and Colorado Division of Water Resources (CDWR) for the stream gages upstream and downstream of Terrace Reservoir. The rating curves upstream of the reservoir show the channel being relatively stable between 1934 and 1954 with slight degradation between 1954 and 2002 (Figure 2-11). This slight degradation indicates the gage may be far enough upstream (7,000 feet) to avoid being affected by the reservoir backwater conditions. Usually reservoir backwater conditions would cause aggradation due to settling of suspended sediment. The rating table downstream of the reservoir does not show the degradation expected below a reservoir (Figure 2-12). Usually the clear water from a reservoir outlet causes the stream to pick up sediment causing degradation, unless the channel is made of rock. The downstream rating table indicates channel aggradation between 1934 and 1956 and relatively stable conditions from 1956 to 1988. The channel bed aggradation suggests the river has picked up its sediment load by the time it reaches the gaging station which is located approximately 2,500 feet downstream of Terrace Reservoir.

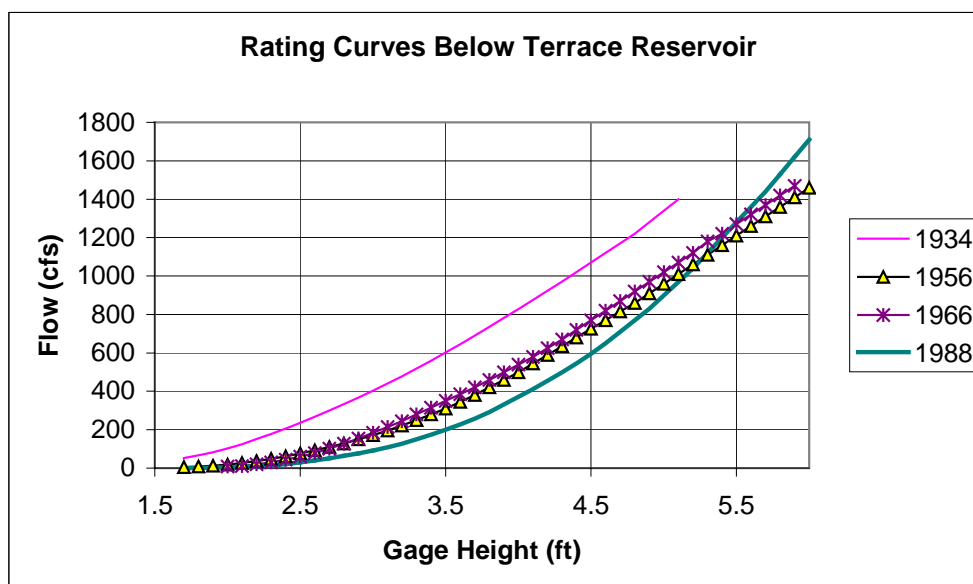
**Figure 2-12. Rating Curve Below Terrace Reservoir**

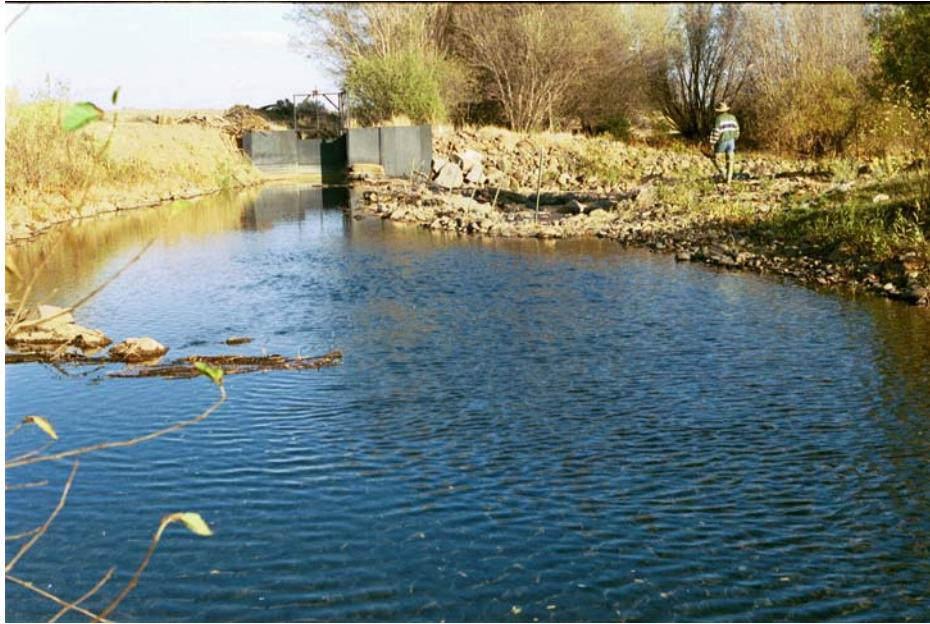
**Figure 2-13. Photo Above Irrigation Diversion (photo by Alan Miller)**

Analysis of the photo logs between Terrace Reservoir and Highway 285 (Agro Engineering, 2003, Black Creek Hydrology, 2002, and Rosgen, 1999) shows the channel changes at many of the diversion structures. Many photos, such as the following two (**Figure 2-13** and **Figure 2-14**), show unstable channels with eroded banks, and bed aggradation at the diversion structures. Adjustment in the Alamosa River channel geometry becomes more pronounced as more water is diverted from the river in the downstream reaches.

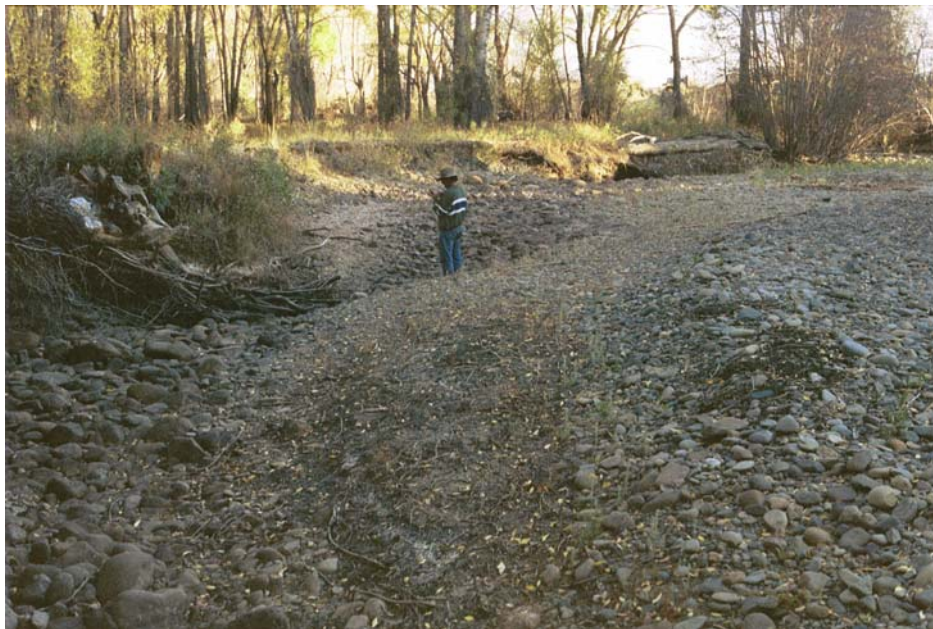
**Figure 2-14. Photo Below Irrigation Diversion (photo by Alan Miller)**

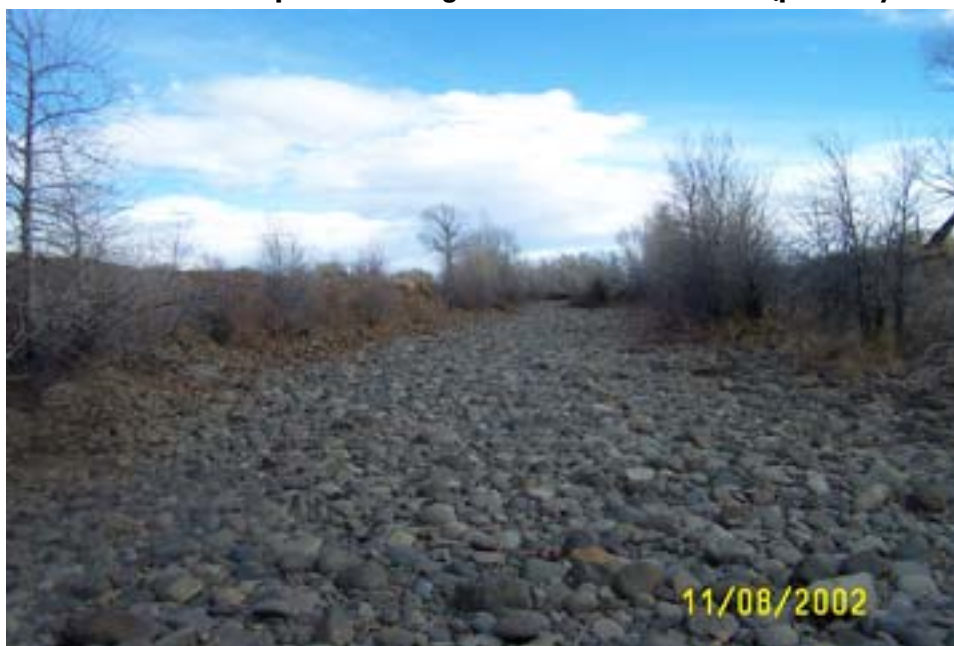
**Figure 2-15. Photo Near Capulin at Straightened Channel Section (photo by Alan Miller)**

The channel sinuosity of this reach is straighter than the previous two reaches at 1.2, but the average channel slope is the same at 0.8%. The extensive irrigation diversions and removal of channel flushing flows results in significant channel aggradation in the area. However, this has been counteracted by the channel straightening. The slope appears to have adjusted to match the upstream undisturbed slope, suggesting the channel is in the stage of channel evolution where channel aggradation typically occurs. The photo log and description of the area show aggradation through much of this reach. **Figure 2-15** shows significant aggradation. As the channel adjusts, the channel bed will continue to aggrade, the banks will erode, and eventually a meandering channel will form.

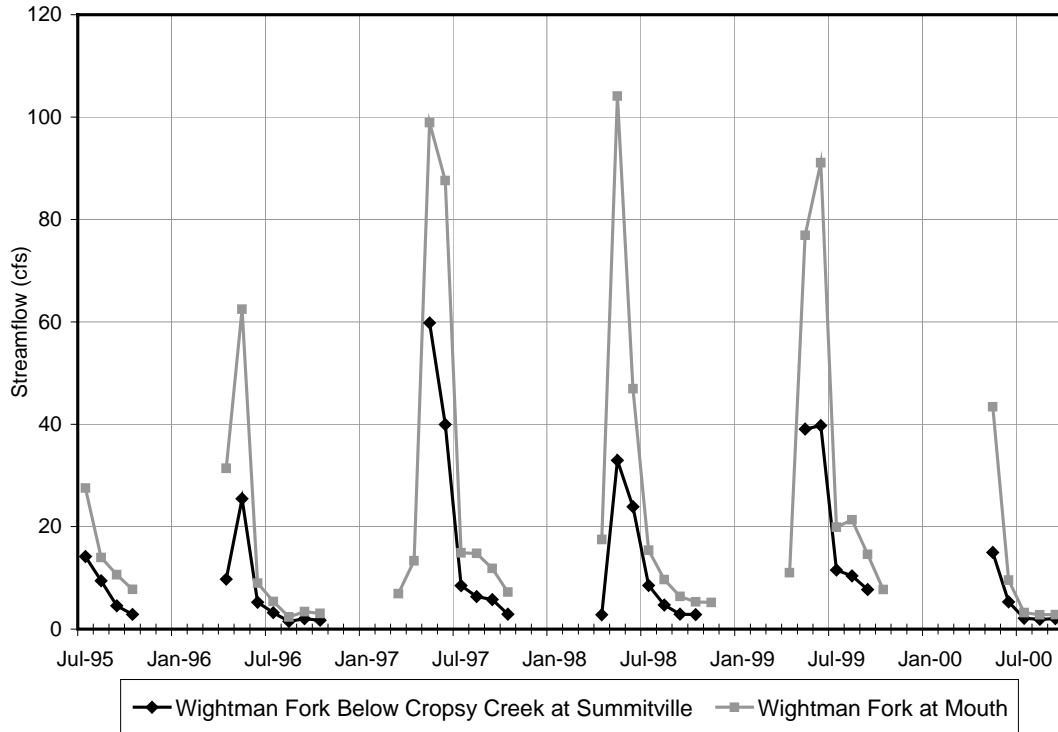
**Figure 2-19. Mean Monthly Streamflow in Wightman Fork**

Source: USGS and CDWR Gage Data

Streamflow data for Wightman Fork are available for 1995 to 2000. **Figure 2–19** shows the mean monthly streamflow for the period of record at two gages on Wightman Fork. The two gages are located approximately 4.5 miles apart. The “Wightman Fork below Cropsy Creek” gage has a drainage area of 4.4 square miles and the “Wightman Fork at Mouth” gage has a drainage area of 16.1 square miles. These data are seasonal due to icing that prevents measurements during the winter. Peak streamflow generally occurs in May and June. Peak streamflow at the “Wightman Fork below Cropsy Creek” gage varied from about 15 cfs to 60 cfs over the period of record. Peak streamflow at the “Wightman Fork at Mouth” gage varied from about 30 to 100 cfs.

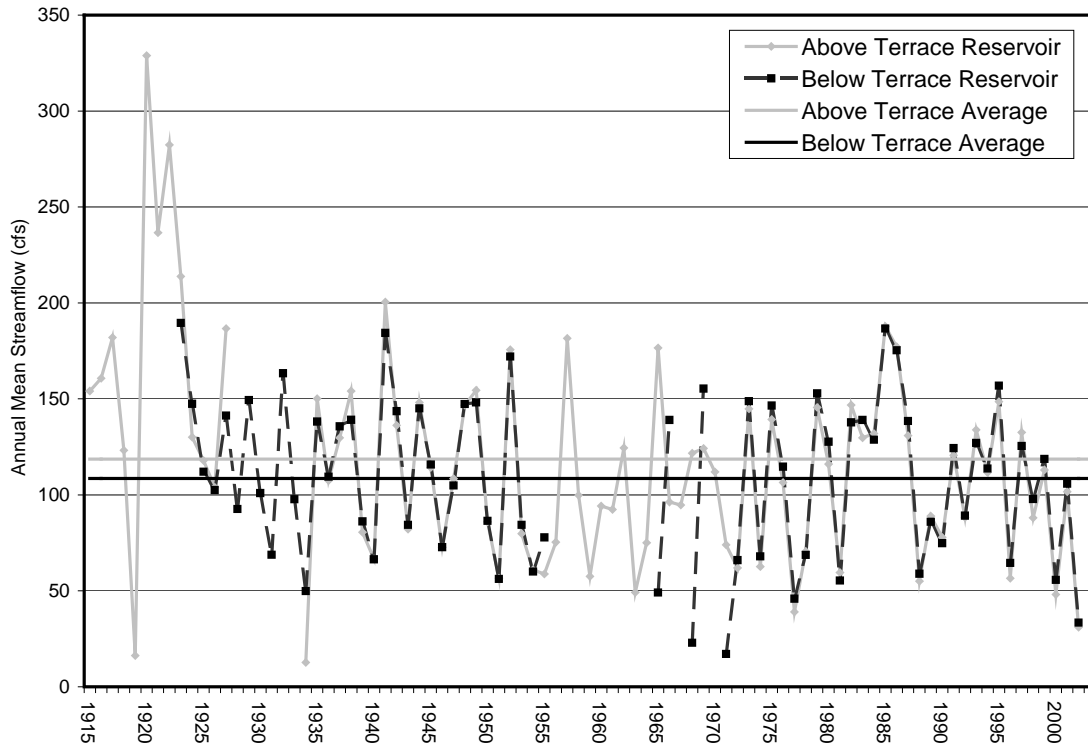
**Figure 2-21. Historical Flow – Alamosa River Near Terrace Reservoir**

Source: USGS Gage Data and CDWR Data (Above Terrace 1914–2002, Below Terrace 1923–2002)

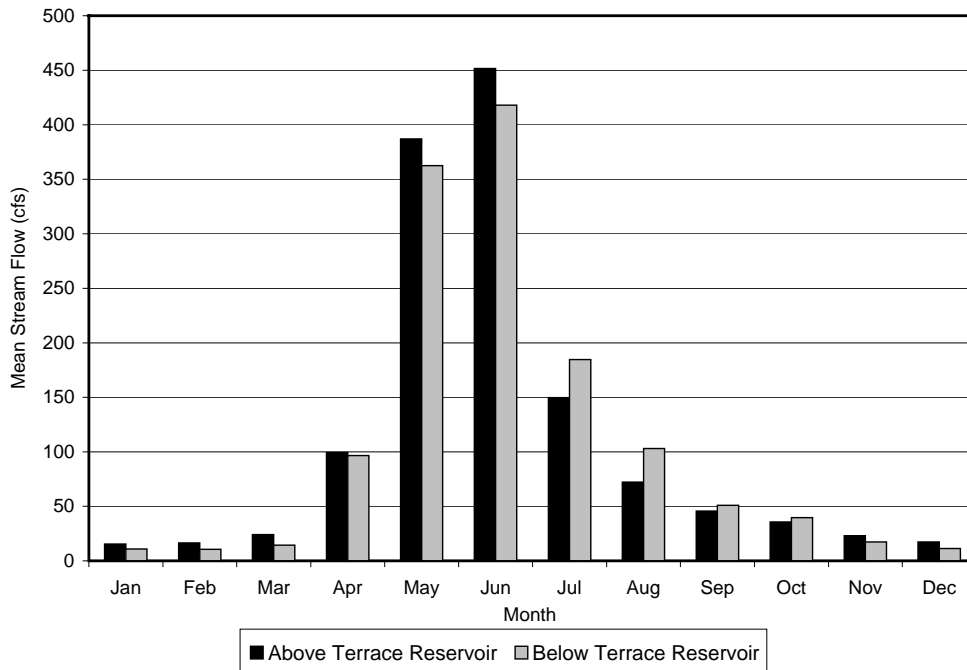
**Figure 2-22. Mean Monthly Flow for Alamosa River near Terrace Reservoir**

Source: USGS Gage Data and CDWR Data (Above Terrace 1914–2002, Below Terrace 1923–2002)

The seasonal variation in streamflow at each gage is depicted in **Figure 2–22**. The maximum flow at each gage typically occurs in June. An average of less than 50 cfs occurs from September through March. Flow is smaller at the “Below Terrace Reservoir” gage than the “Above Terrace Reservoir” gage from November through June due to water storage. Flow is greater at the “Below Terrace Reservoir” gage the rest of the year due to irrigation releases from the reservoir.

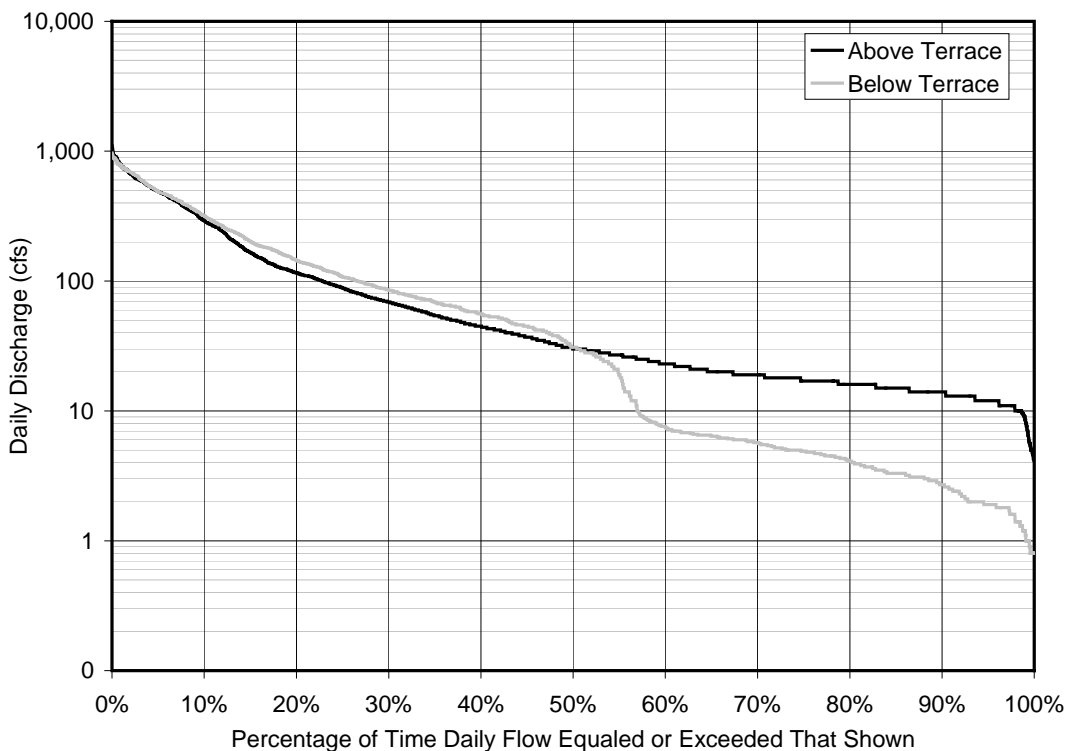
**Figure 2-23. Flow Duration Curve for Alamosa River (October 1981 to September 2002)**

Source: CDWR Gage Data

Figure 2-23 shows the flow duration curves for the Above Terrace Reservoir and Below Terrace Reservoir gages for water years 1982 to 2002. There is a pronounced dip in the discharge at the Below

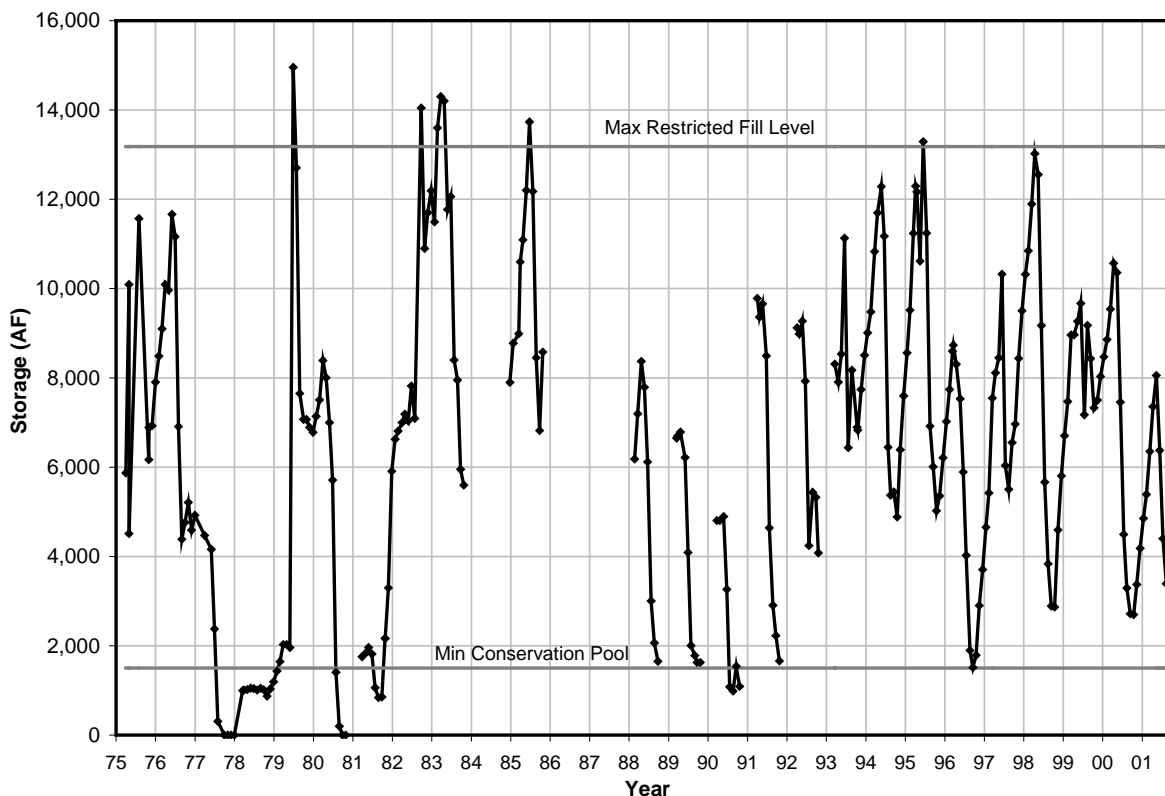
Figure 2–25. Terrace Reservoir Historic Water Storage

Note: The gaps in the chart represent periods where data is not available.

Source: Vandiver, 2002 and Miller 2004

Terrace Reservoir currently has a maximum restricted fill level of 8,564 feet above mean sea level (msl) with a total storage capacity of about 13,000 acre–feet (Miller, 2004). The fill level is restricted due to the limited spillway capacity of 8,928 cfs (see more discussion in Section 2.6). The spillway crest elevation is 8,571 feet (msl), at which the storage volume is about 15,000 acre–feet (Miller, 2004). Figure 2–25 depicts the historic water storage in Terrace Reservoir. Reservoir storage follows an annual cycle, usually reaching a maximum storage level in June and then draining down to a minimum in the fall. Since 1975, Terrace Reservoir has reached the restricted level 6 times and used its spillway three times, in 1979, 1984, and 1985 (McCann, 2004). The fact that the reservoir only fills in well–above average precipitation years is evidence of the over–appropriated nature of the Alamosa River basin.

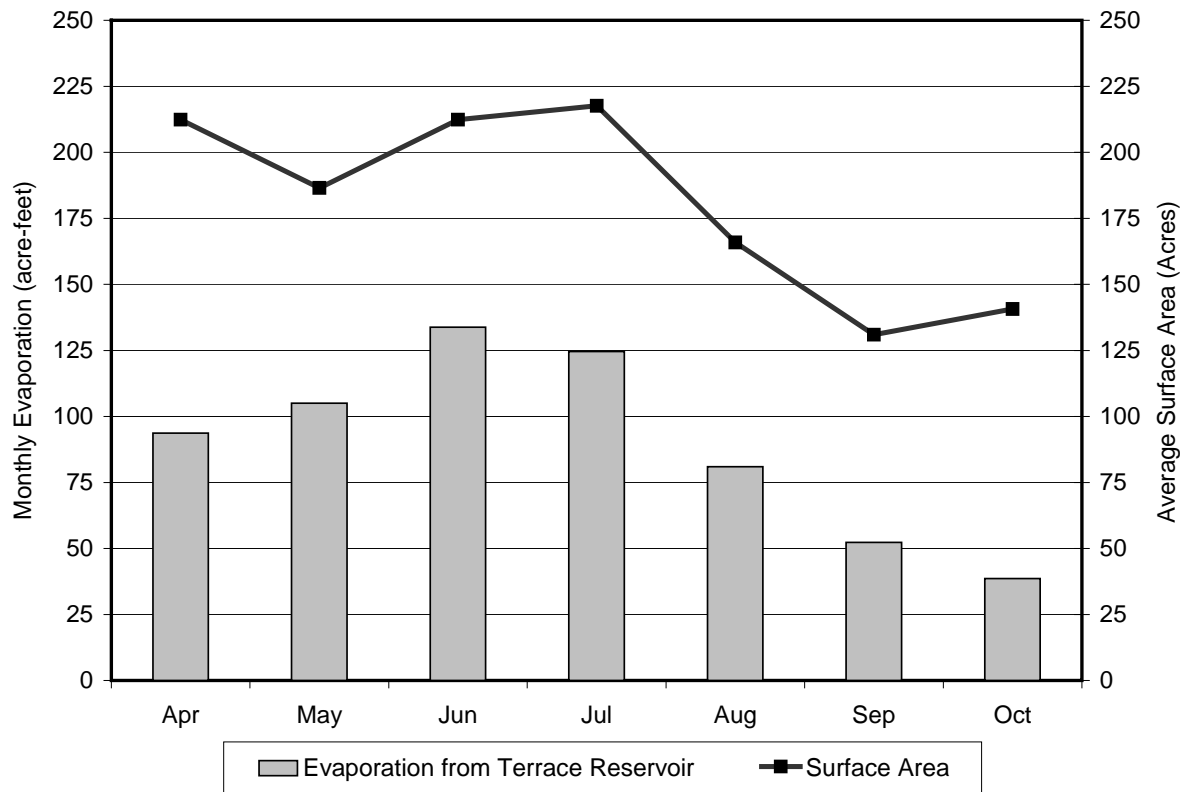
**Figure 2–26. Average Monthly Surface Area and Evaporation from Terrace Reservoir**

Terrace Reservoir loses approximately 600 acre–feet of water each year to evaporation. This estimate is based on the average monthly surface area of the reservoir, and an evaporation rate equal to 75 percent of the monthly pan evaporation rate at the Alamosa weather station. Evaporation is likely overestimated because Terrace Reservoir is at higher elevation and probably experiences less wind than the Alamosa station. The surface area of the reservoir fluctuates based on the depth of the reservoir. The pan evaporation rate varies according to climactic conditions. Evaporation is minimal during the winter when ice covers the reservoir and there are no measurements of pan evaporation available. **Figure 2–26** shows how evaporation and the surface area of Terrace Reservoir vary by month.

Source: WRCC, 2004b

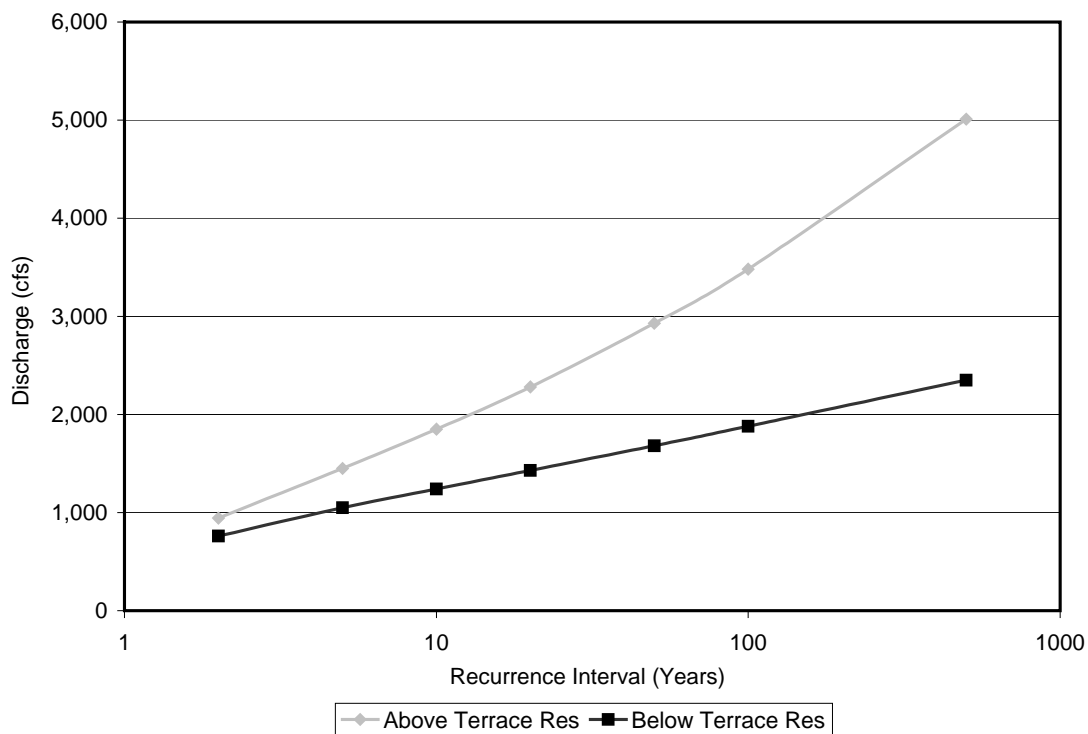
**Figure 2-27. Alamosa River Flood Frequency Curve**

Flood frequency data based on historical annual peak flow data for the Above and Below Terrace Reservoir gages are shown in **Figure 2–27** and **Table 2-7**. The flood frequency analysis consisted of fitting all available peak flow data to a log–Pearson distribution. The largest recorded flow at the Above Terrace Reservoir gage was 5,200 cfs in 1911. The 100–year flood event is 3,480 cfs at the Above Terrace Reservoir gage and 1,880 cfs at the Below Terrace Reservoir gage. The two–year flood event is approximately 940 cfs at the Above Terrace Reservoir gage and 760 cfs at the Below Terrace Reservoir gage. The State Engineer’s Office determined the Probable Maximum Flood inflow to Terrace Reservoir is 26,900 cfs (VSCC, 2003).

Source: Provided by CWCB in 2002

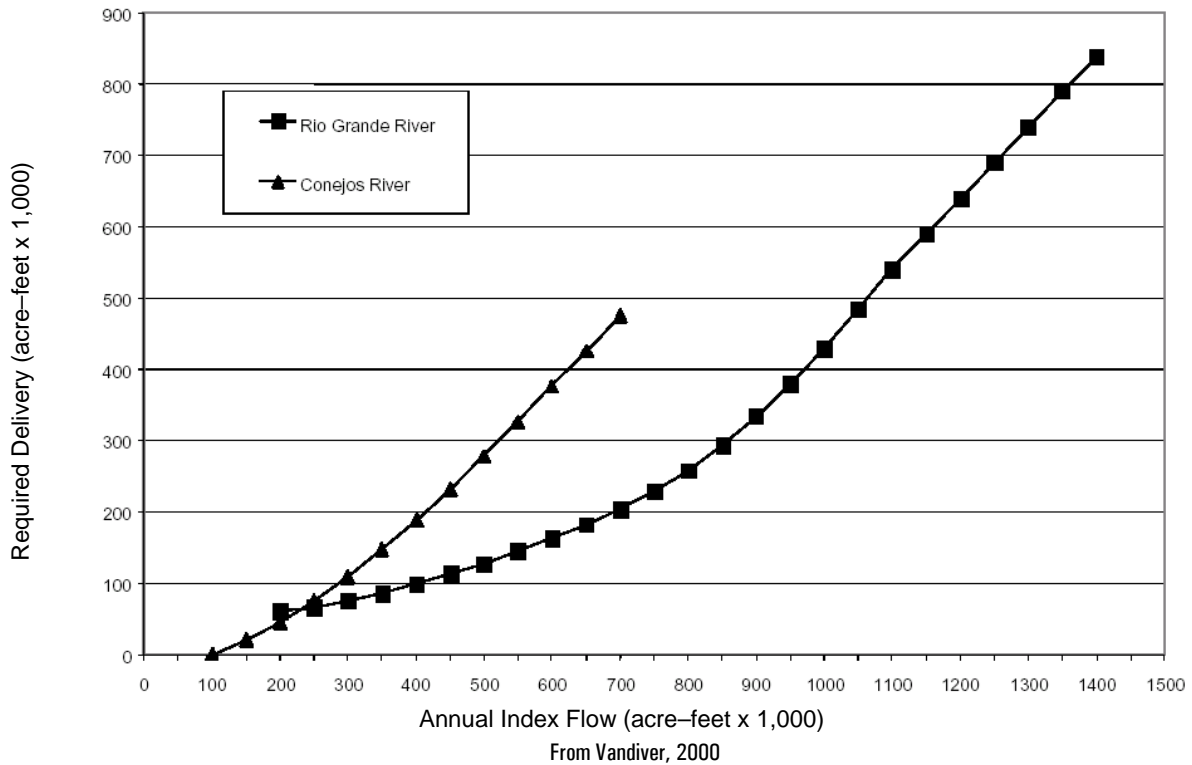
**Figure 2-30. Rio Grande Compact Delivery Requirements Verses Annual Index Flows**

The Division Engineer has administered the Compact under the assumption that normal surface flows in the Alamosa River are not tributary to the Rio Grande (and thus are not subject to Compact limitations), but that groundwater and flood flows could be tributary to the Rio Grande. The Division Engineer defines normal surface flows as those up to that level which is required to satisfy all existing water rights in the Alamosa River basin (Vandiver 2004). At times of high flow, the Rio Grande delivery schedule requires an increase in obligation that is higher than the increase in flow coming into the system at Del Norte, and the Division Engineer feels that the framers of the Compact recognized that flood and groundwater flows from non-Compact tributaries would contribute to the flow at Lobatos gage (Vandiver 2002). It has been the policy of the State Engineer that groundwater tributary to and floodwater that accrues to the Rio Grande is not to be diminished.
