Scallop Dredge Comparison Study

**Final Report
For
NMFS, Northeast Fisheries Science Center
NFFM7320-8-26515**

**Ronald Smolowitz and Matthew Weeks
Coonamessett Farm, Inc**

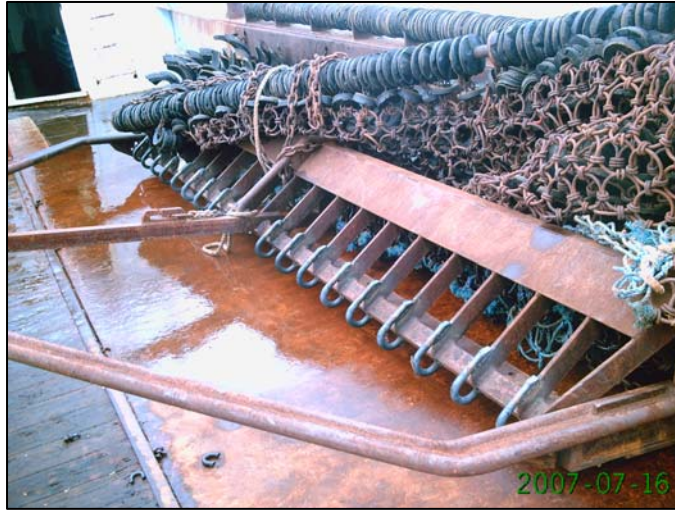
Figure 1. Experimental dredge design 3 with turtle guards on the cutting bar and a doubled outer bale.

Experimental Dredge Frame Design 3, as seen in Figures 1-7, was tested on trips Friendship 2007-4, and Friendship 2007-5. On the remaining trips, the dredge was fished without any turtle guards attached to the cutting bar (Design 5).

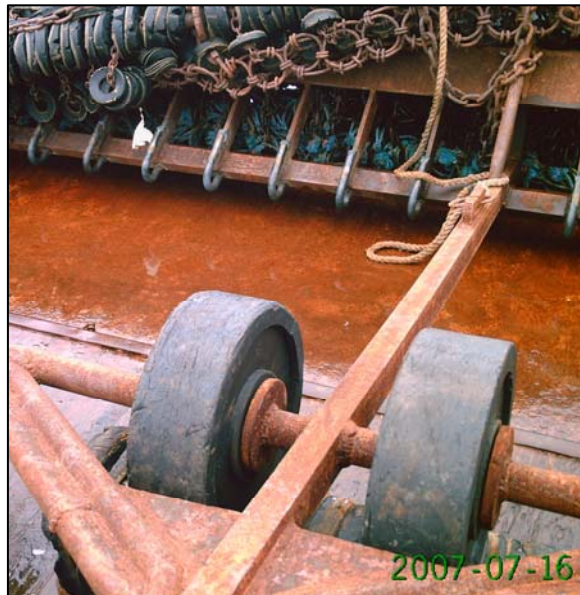
Figure 2. Wheels used on the experimental dredges had two molded 5"x 16" wheels with the axis positions 30" from top of the gooseneck.

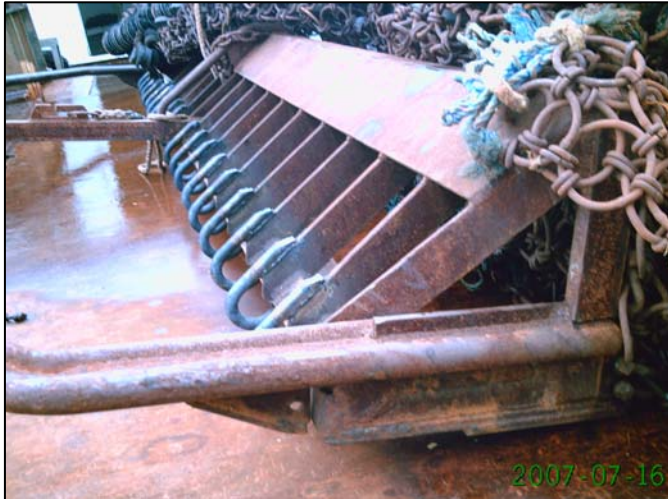
Figure 3. Side view of shoe used; the shoe was $\frac{1}{2}$ " x 3" spring steel cut 17 $\frac{1}{2}$ " long and attached to 1 $\frac{1}{2}$ " x 3 $\frac{1}{2}$ " x 15" long bar stock

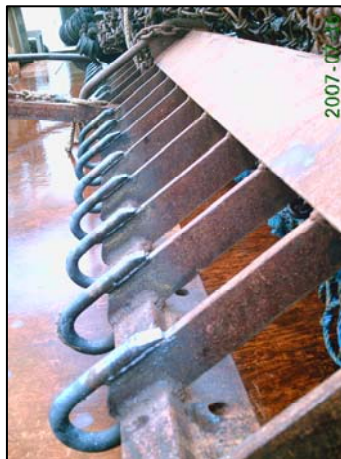
Figure 4. Space between struts measured 8 $\frac{1}{2}$ "; the spacing between the 8" depressor plate and cutting bar measure 10". The turtle guards were made of 1" hardened steel round stock and placed every 9" along struts

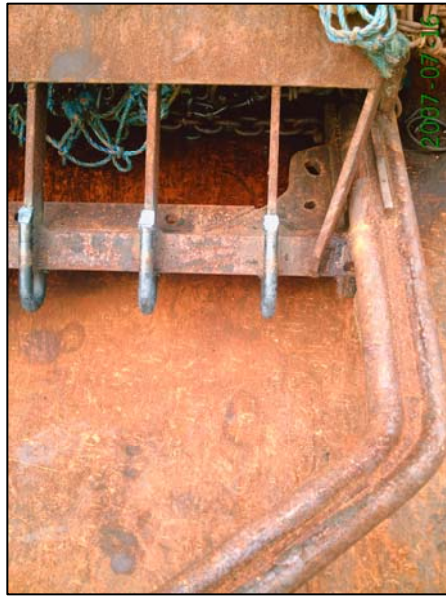
Figure 5. The bale extended forward 9 inches (interior measurement) before tapering to the tow point.

Outer Bale: The bar that runs along the outside of the dredge from the frame to the towing point. Figure 5 shows a double bale bar while figure 6 shows a single bale bar.

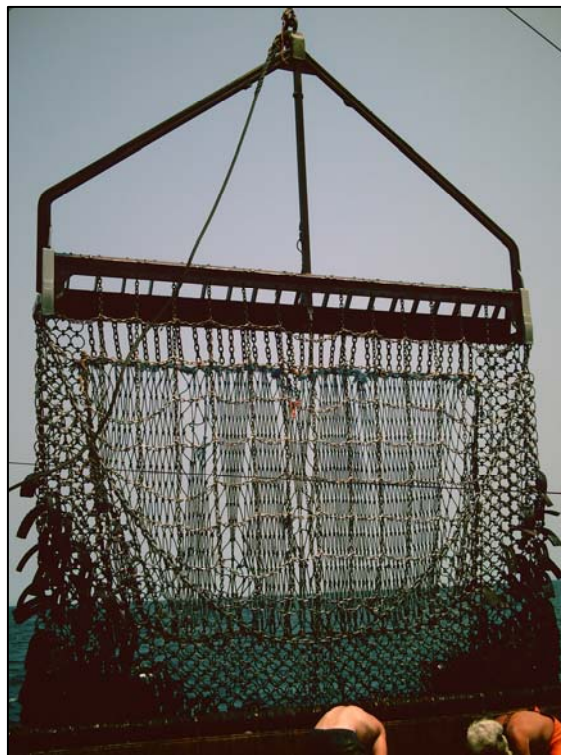
Figure 6. Overall view of dredge
