14 Maintaining the Building

This chapter provides guidance on maintaining the building structure and envelope.

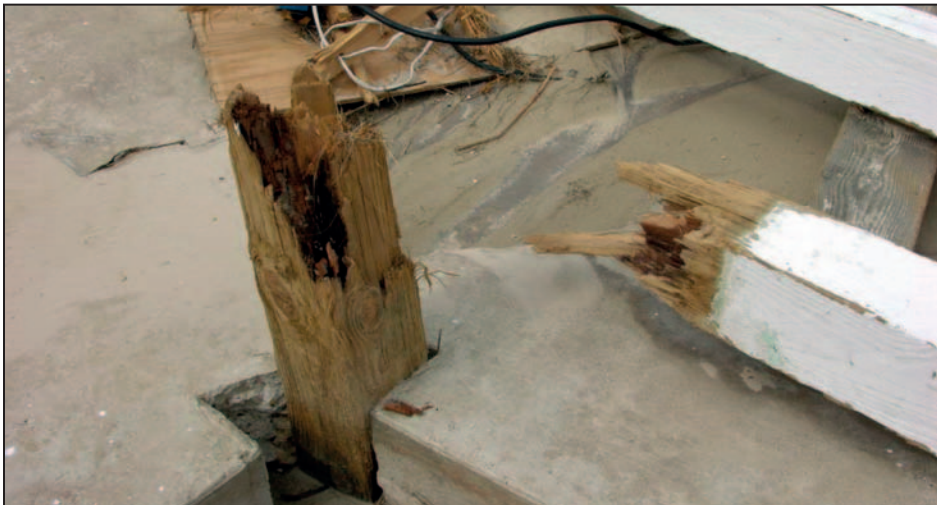
Figure 14-1.
Pile that appears acceptable from the exterior but has interior decay

acceptable condition but is weakened by interior decay, which can be determined only through a detailed inspection. This post failed under the loads imposed by a natural hazard event.

For maximum performance of a building in a coastal area, the building structure and envelope (i.e., exterior doors, windows, skylights, exterior wall coverings, soffits, roof systems, and attic vents) must not be allowed to deteriorate. Significant degradation by corrosion, wood decay, termite attack, or weathering increases the building's vulnerability to damage from natural hazards. Figure 14-1 shows a post that appears on the exterior to be in

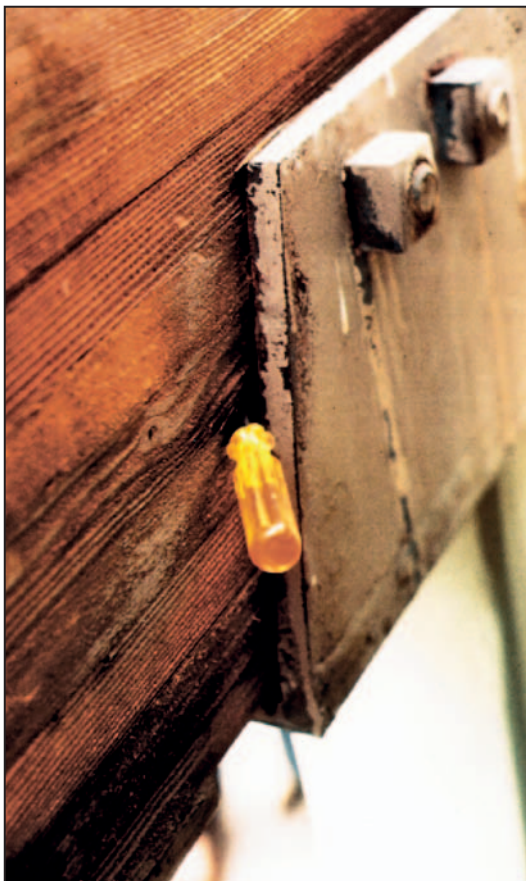
Figure 14-2.
Wood decay behind a
metal beam connector

There are many sources of exterior moisture from outside the home in the coastal environment. Whenever an object absorbs and retains moisture, the object may decay, mildew, or deteriorate in other ways. Figure 14-2 shows decay behind the connection plate on a beam.

Connectors should be designed to shed water to prevent water from accumulating between the connector and the material the connector is attached to. Trapped moisture increases the moisture content of the material and potentially leads to decay. Moisture is most likely to enter at intersections of materials where there is a hole in the building envelope (e.g., window, door) or where two surfaces are joined (e.g., roof to wall intersection). If properly installed, the flashings for the openings and intersections should not require maintenance for many years. However, flashings are frequently not properly installed or installed at all, creating an ongoing moisture intrusion problem.

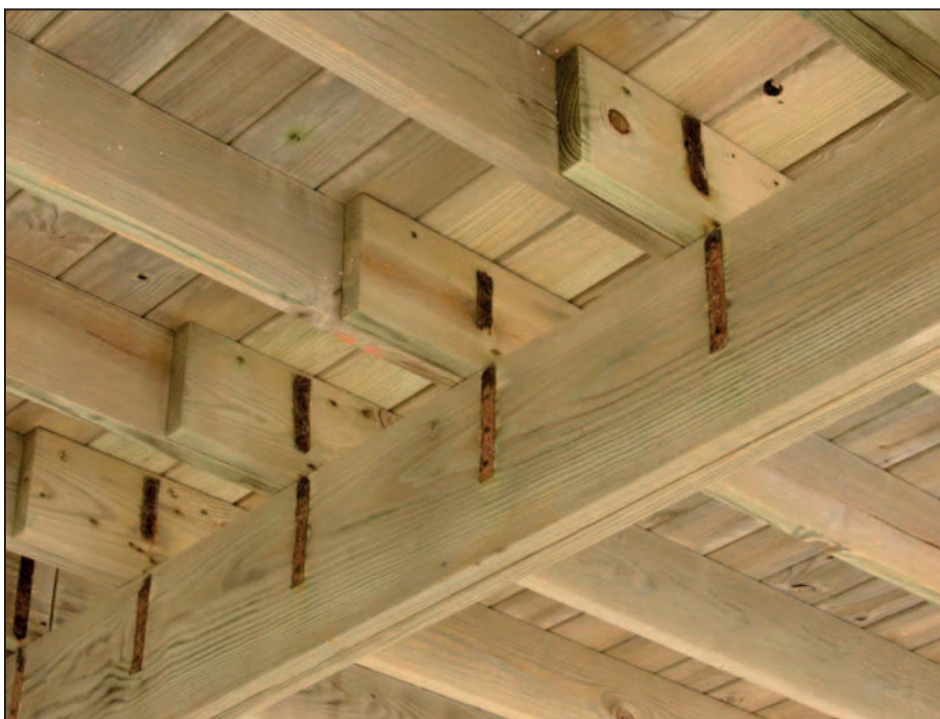
Figure 14-3.
Severely corroded deck connectors

been consumed and the corrosion rate of the unprotected steel can be expected to accelerate by up to a factor of 50 times. Figure 14-3 illustrates severe corrosion under an exterior deck.

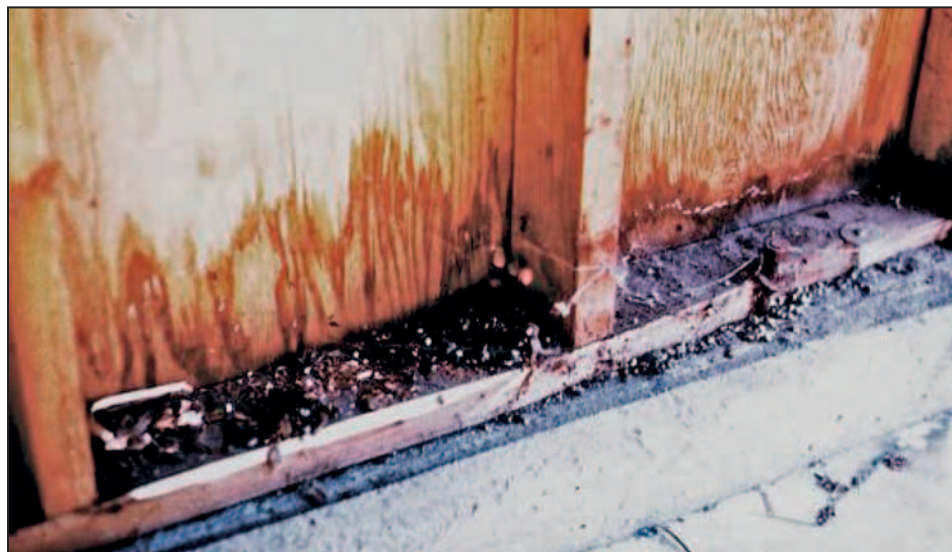
Figure 14-4.
Deteriorated wood sill
plate

Shearwall sill plates bearing directly on continuous footings or concrete slabs-on-grade, if used in coastal construction, are particularly susceptible to decay in moist conditions. Figure 14-4 shows a deteriorated sill plate. Even if the decay of the preservative-treated sill plate is retarded, the attached untreated plywood can easily decay and the shearwall will lose strength. Conditions that promote sill and plywood decay include an outside soil grade above the sill, stucco without a weep screed at the sill plate, and sources of excessive interior water vapor. Correcting these conditions helps maintain the strength of the shearwalls.
