Drainage for Dams and Associated Structures

United States Department of the Interior
Bureau of Reclamation

2004

Technical Service Center
Denver, Colorado
2004

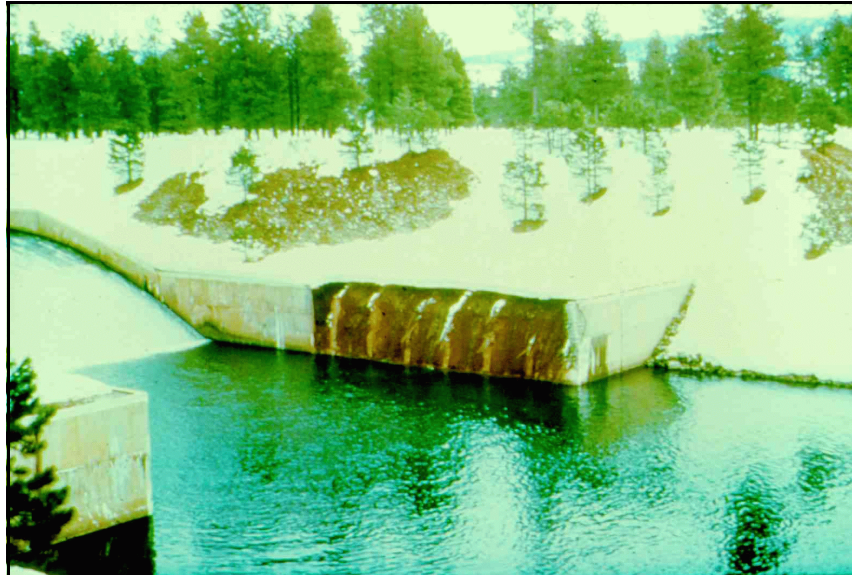
a. Vallecito Dam spillway stilling basin, Colorado.—Failure of the left retaining wall was the result of inadequate drainage provisions, which led to accumulation of water behind the wall, and subsequent large lateral loads, due to ice formation.

c. *Spillways and Outlet Works.*—Drains beneath and/or adjacent to appurtenant structures should be provided to control (mitigate) excessive water pressures which might lead to instability, including failure of appurtenant structures and/or their foundation (see fig. 5 for examples). Appurtenant structures include spillways, outlet works, canals, pipelines, retaining walls, drainage adits, access adits, powerplants, and pumping plants. Historically, it has been the Bureau of Reclamation's (Reclamation) practice to design appurtenant structures to withstand part or all of an anticipated water pressure (i.e., assuming drains do not function or are only partially effective). However, it has been and is considered prudent engineering practice to provide drainage for critical appurtenant structures (An appurtenant structure is considered critical if increased risk to the dam and/or downstream consequences could result from misoperation, inability to operate, and/or failure). It should be noted that the science of drainage and groundwater has progressed to the point where drain designs can incorporate considerations/details that will result in a high level of confidence that drainage effectiveness can be maintained over the service life of the appurtenant structure. Other guidelines/criteria recommend that drainage provisions should be considered for any appurtenant structure where the permanent water table is above the foundation or the temporary water table, due to local ponding or seasonal variation, could exceed the foundation level [3].

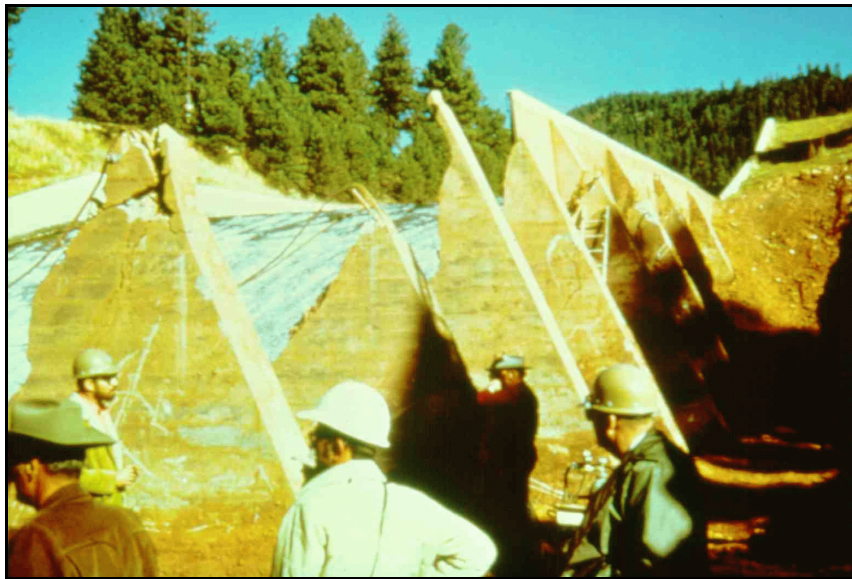
b. Vallecito Dam spillway stilling basin, Colorado.—After backfill was excavated, only portions of the counterforts remained.

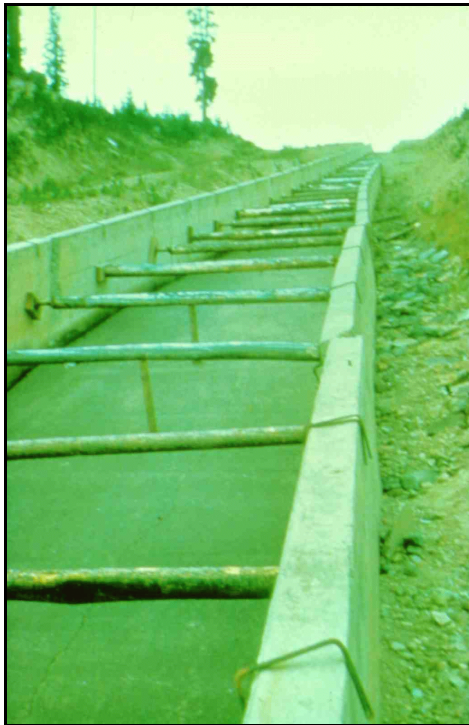
d. Grassy Lake Dam spillway, Wyoming.—Due to excessive frost heave, walls have failed.

| 29 | Grassy Lake Dam Spillway, Wyoming—Chute floor has succumbed to inadequate drainage provisions and frost heave | 52 |

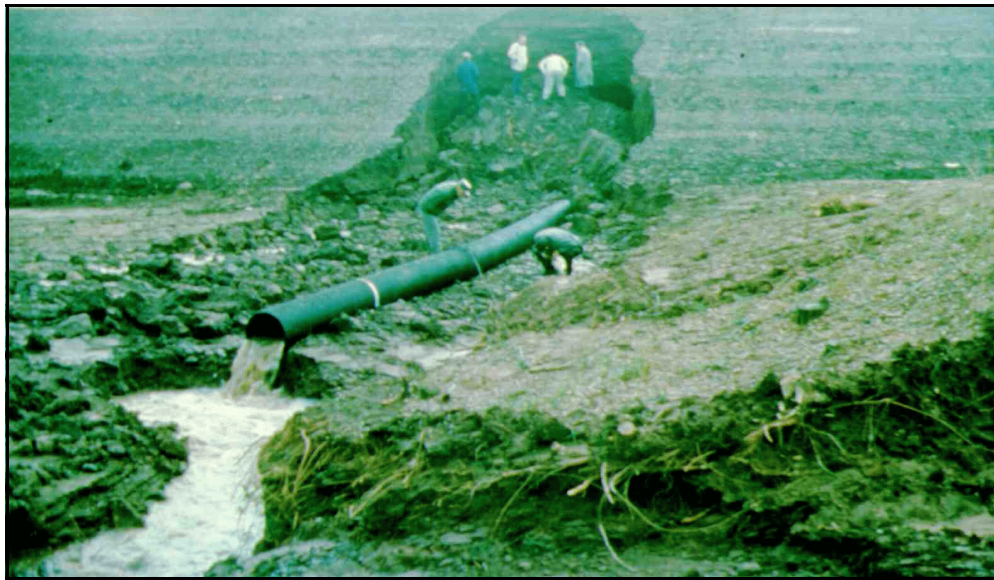
f. Unknown dam.—The worst-case scenario for piping of adjacent embankment material can lead to failure of not only the outlet works, but also the embankment.

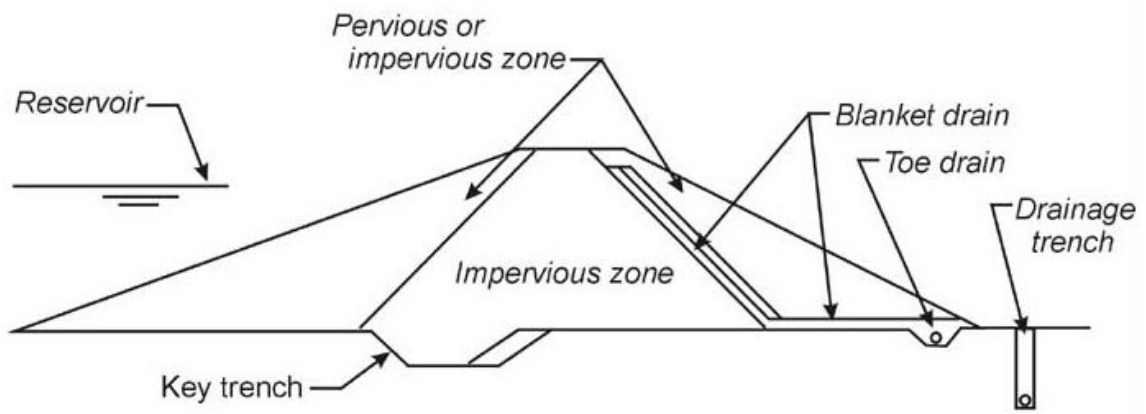
Figure 13.—Embankment dam drains.

a) Blanket Drain, Toe Drain and Drainage Trench

b) Pressure relief well

1. *Blanket Drains.*—A blanket drain is a horizontal or inclined layer of sand and gravel material that carries the seepage water to a pipe or natural exit. These drains are also known as filter/drain layers, chimney drains, inclined filters, and horizontal filters. Drainage blankets are used beneath slope protection, beneath membrane liners, beneath embankments, and on abutments, and can be used as a part of an internal drainage system in embankment dams and dikes. Figure 13 shows the general location of blanket drains in an embankment dam.

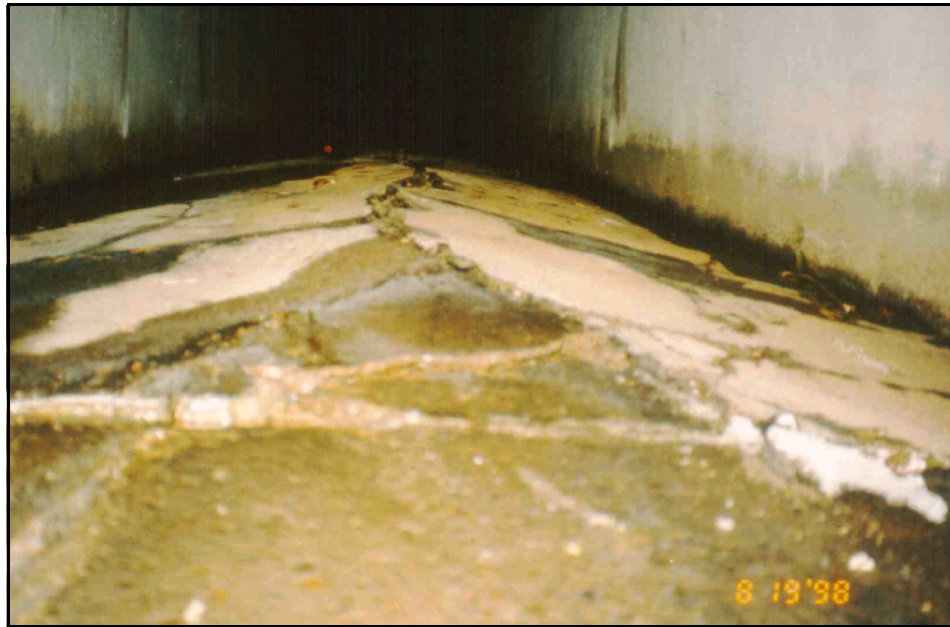
Figure 29.—Grassy Lake Dam Spillway, Wyoming—Chute floor has succumbed to inadequate drainage provisions and frost heave.

5. *Insulation Requirements.*—Considerable damage and even failure can result from freezing foundations and adjacent materials, particularly if the materials are soil (refer to figure 29 for example of frost-heave damage to an appurtenant structure). As described in *Pervious Backfill* above, unheated appurtenant structures’ surfaces in contact with frost-susceptible backfill or foundation and with access to water are subject to frost penetration, ice lensing, and subsequent loading that can be significant. To address this concern for

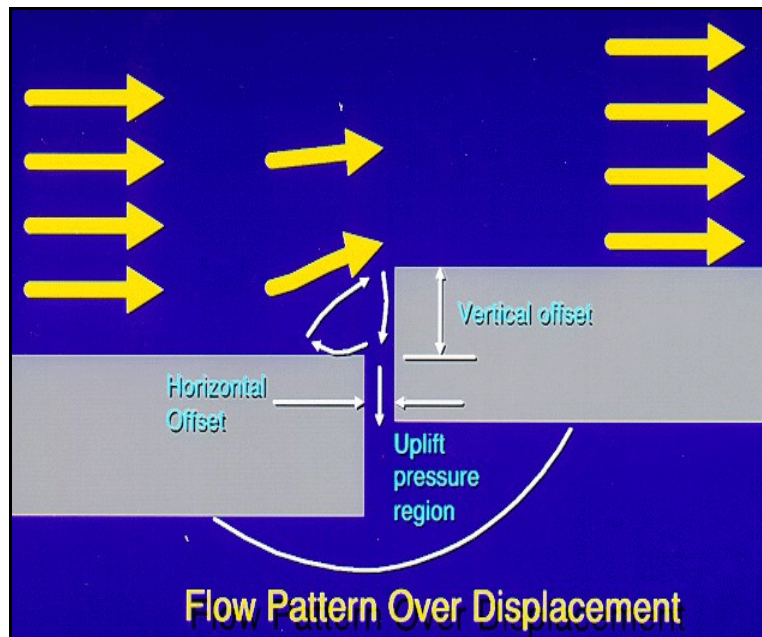
Figure 32.—Illustration of conditions that could result in a stagnation pressure failure. Laboratory modeling has indicated that uplift pressures could be as high as a 0.9 velocity head.

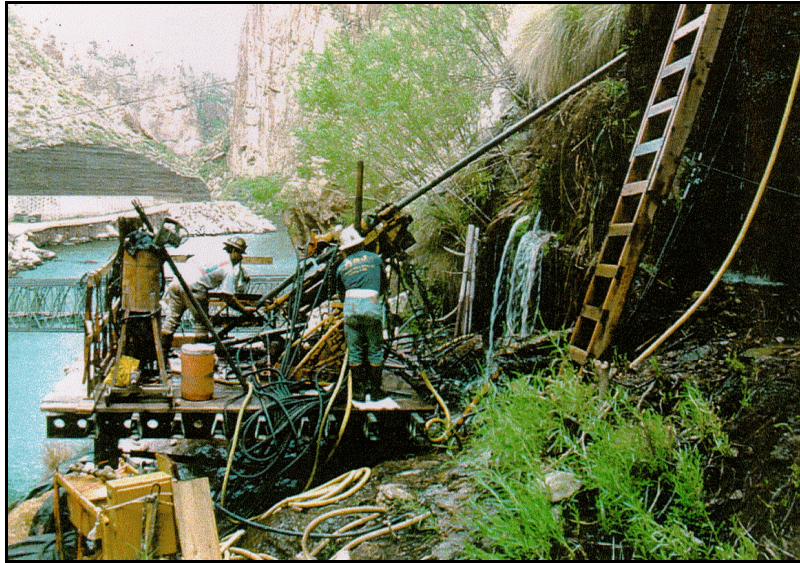
Figure 44.—View of rotary drilling operations to install high-angle drain holes in bedrock from a platform on the downstream right abutment of Horse Mesa Dam, Arizona. The drill rig is a Craelius Diamec 260.

2. *Rotary Methods.*—Rotary drilling methods are any form of drilling which makes a hole by turning the bit at the bottom of the hole. Rotary drilling methods include diamond coring, roller rock bits, plug bits, and can also use either a top hole hammer or a down hole hammer to drill through very firm or tough materials. Rotary methods are usually limited to a maximum size hole of 24 inches. Figures 44 and 45 show rotary drilling equipment installing drains on a dam abutment and within a drainage adit.

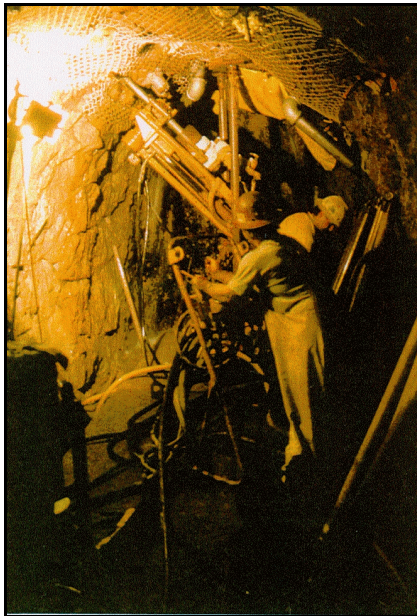
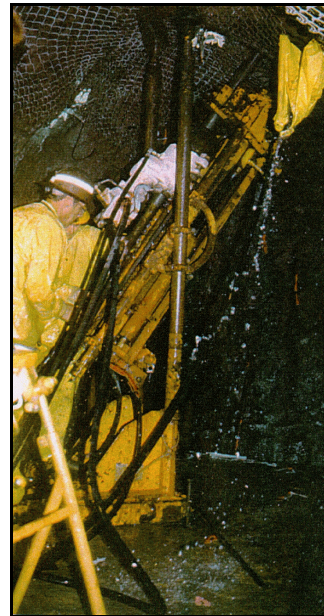
Figure 45.—Views of rotary drilling operations to install high-angle drain holes in bedrock in a drainage adit in the downstream right abutment of Horse Mesa Dam, Arizona. The drill rig is a Craelius Diamec 260. The drill is mounted on a stand when drilling high-angle drain holes.

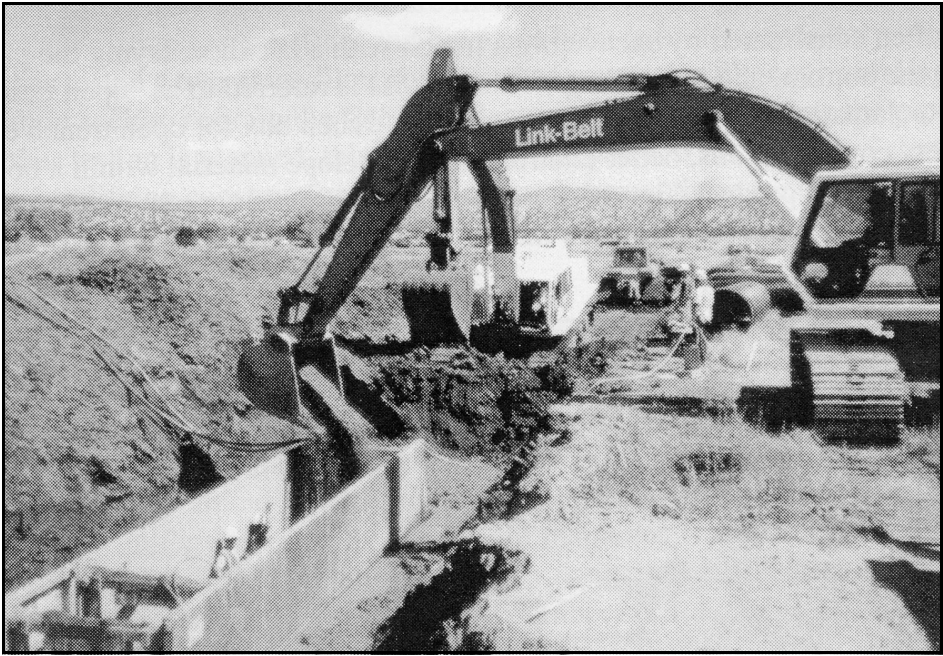
Figure 47.—Open trench excavation with a trench box.

a. *Backhoe.*—With this method, drains are constructed by excavating a trench with a backhoe, placing the pipe and envelope material and backfilling the trench. This method is referred to as “open trench” construction and an example is shown in figure 46. The use of a trench box as shown in figure 47 is highly recommended for open trench construction. It provides for a safer installation and better control of the envelope material. Care must be

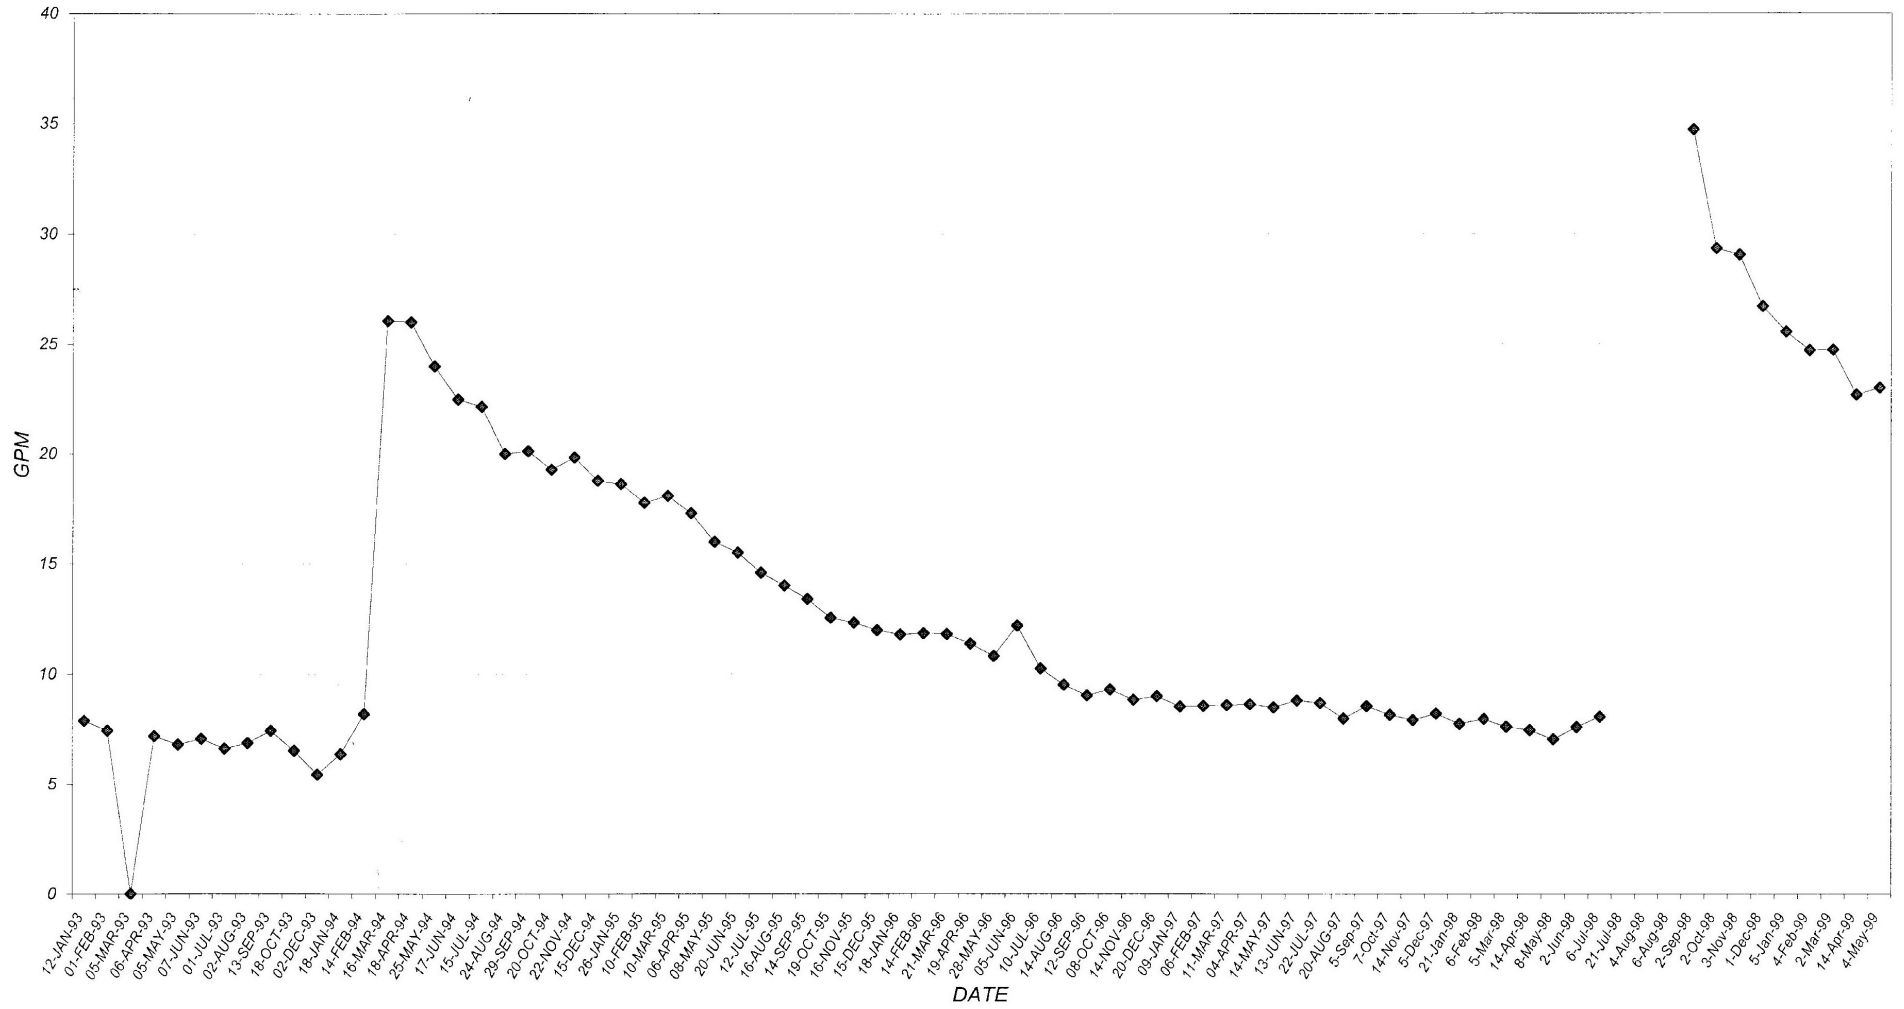
DW-033
TOTALIZER GALLONS

Figure 65.—Discharge from drain well No. 33, showing a large increase in production after cleaning.

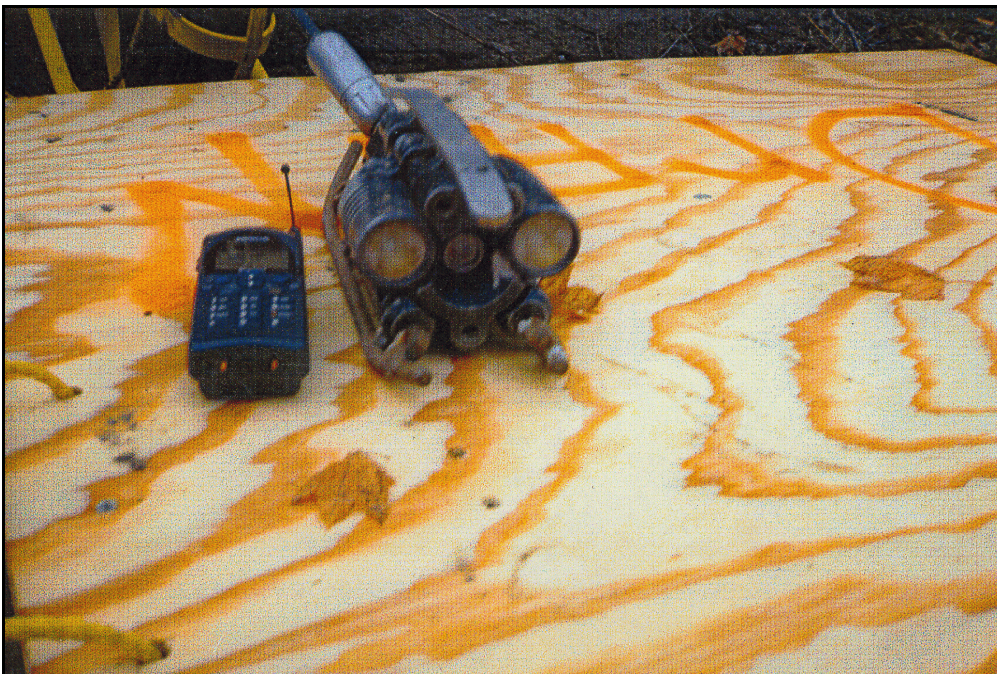
Figure 67.—Sled-mounted camera (the cell phone provides scale).

a. *Ochoco Dam Video Inspections.*—The original east and west drains at Ochoco Dam were constructed of concrete bell and spigot pipe. In 1998, video examinations were performed on all existing east and west drains. The video camera was supplied and operated by a subcontractor that specialized in inspections of sewer lines. The camera, which had the capability to view left, right, up, and down, was mounted on a motorized, tracked vehicle. Typical inspection cameras are shown in figures 66 and 67.

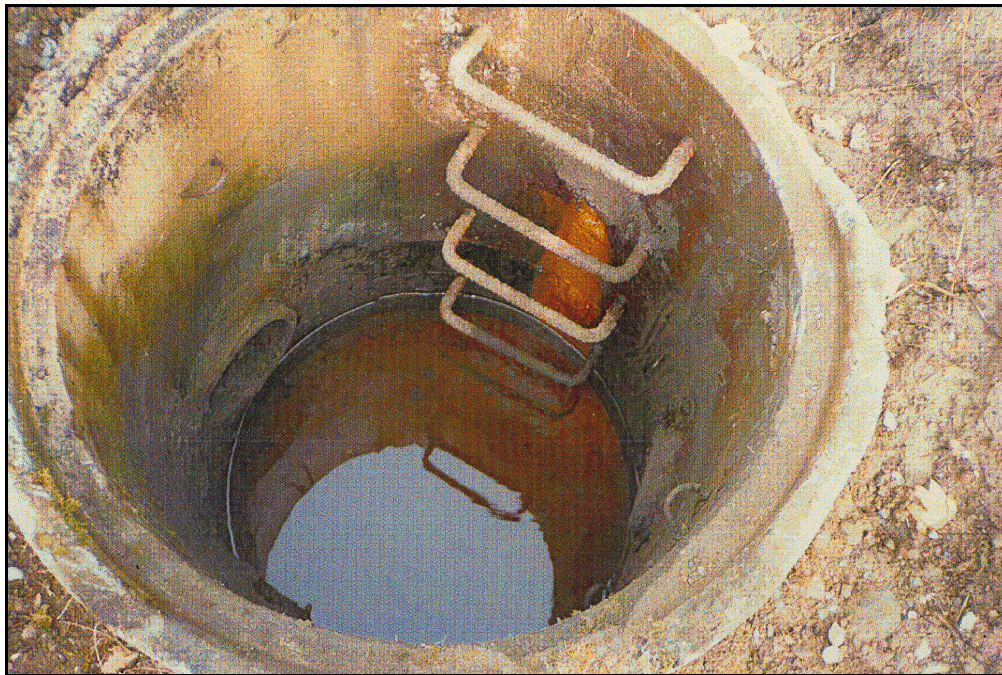
Figure 70.—Typical inspection well used to gain access to outfall pipes.

Inspection wells, which were installed at the junction of drains and/or outfalls, were constructed of 8-foot diameter concrete pipe. The inspection wells are especially useful in gaining access to bends in the east drain. A typical inspection well is shown in figure 70.

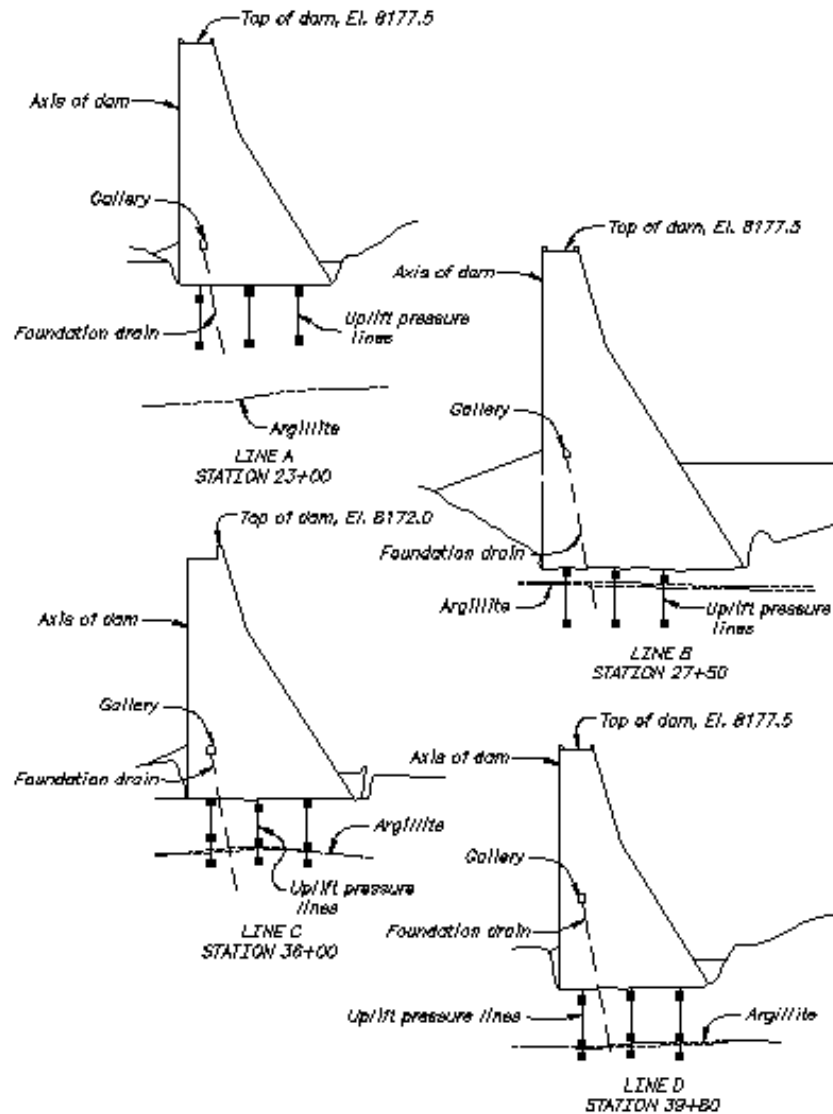
Figure 80.—Uplift pressure lines.

Four lines of piezometers are provided within the dam foundation to provide upstream/downstream profiles of foundation uplift pressures. The four lines are located at stations 23+00 (line A), 27+50 (line B), 32+00 (line C) and 38+70 (line D). Figure 80 provides cross sections at each of the uplift pressure lines.

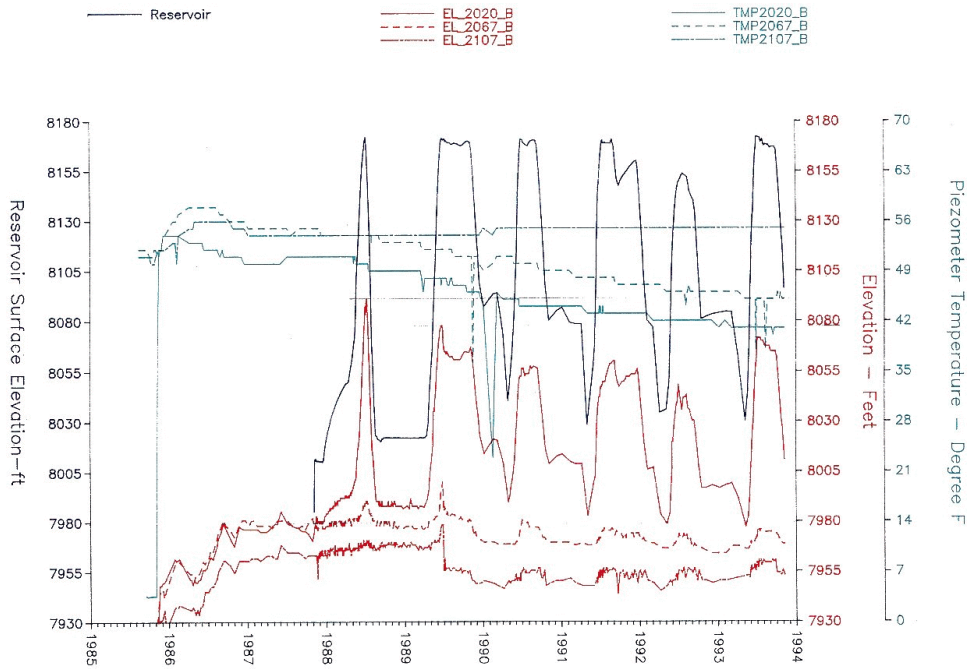
Figure 81.—Plot of piezometer data along line B at Upper Stillwater Dam.

Some of the piezometers in the dam foundation indicated increases in foundation uplift pressures after the grouting. Most of the increased pressures were upstream of the drainage curtain, with only one increase occurring downstream of the drainage curtain. Some of the piezometers indicate pressures that exceed Reclamation criteria, and all of these are upstream of the drainage curtain. The pressures that exceed Reclamation criteria act over relatively small areas and do not present a significant concern [37]. See figure 81 for the plot of piezometer data along line B.

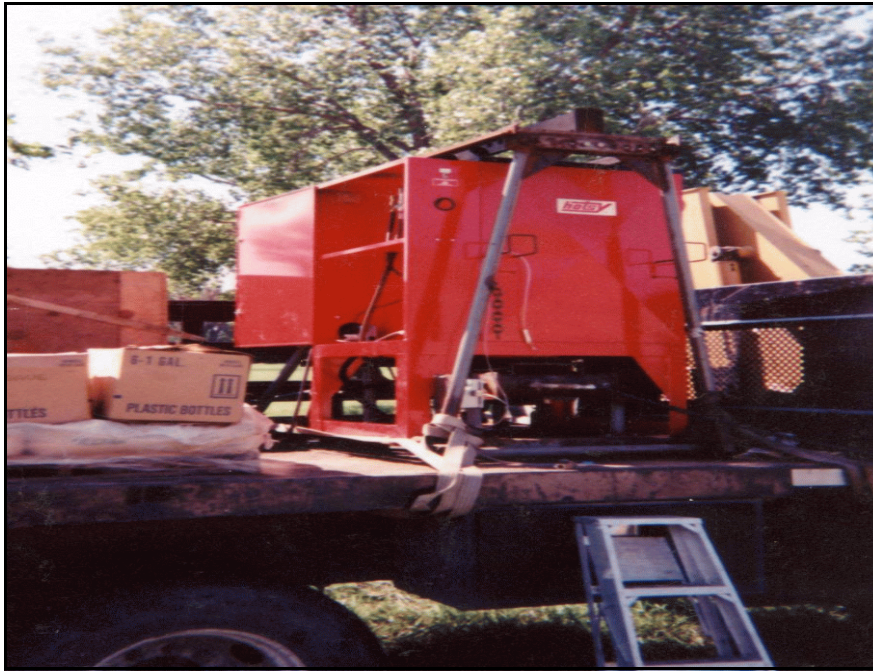
Figure 87.— Hotsy unit used in the BCHT process.

Figure 87 is a photograph showing the “Hotsy” unit that the USACE uses to heat and control the boiling water to be injected into the relief wells. The unit is basically a steam cleaner with a high capacity boiler for heating the water.

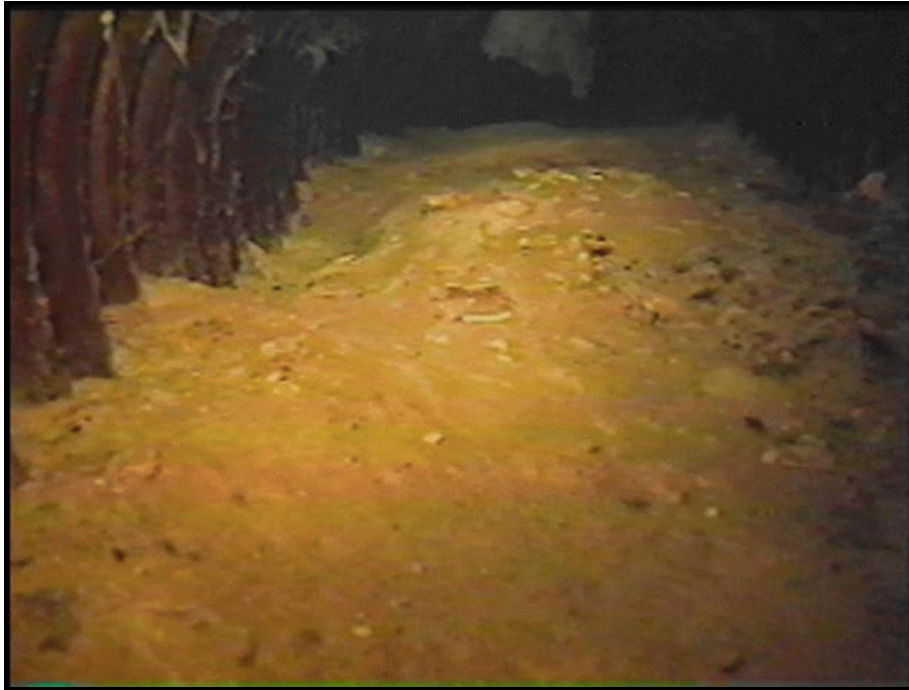
Figure 89.—The typical amount of sediment deposition observed in toe drain pipes in a November 2000 inspection.

b. *Inspections and Cleanings.*—In November of 2000, Reclamation performed a video inspection of the toe drains at Davis Creek Dam as part of routine drain maintenance. Observations from the video inspection showed areas of pipe failures, other potentially damaged areas of pipe, and sediment deposition. The photo in figure 89, taken during the inspection at an unknown location, shows the typical amount of sediment deposition that was seen in the toe drain pipe.

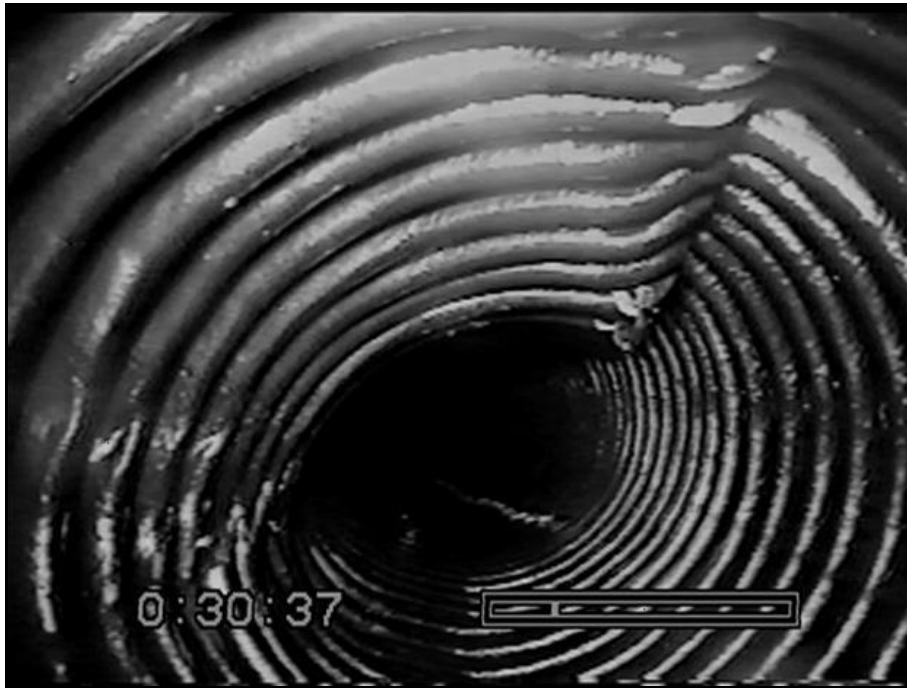
Figure 90.—A damaged left toe drain pipe at approximately sta. 23+25 stopped the camera-crawler. A cleaning removed fine materials from the pipe invert.

On February 12, 2002, Reclamation inspected the cleaned reaches, including the short reach of the Davis Creek toe drain outfall replacement pipe and stations 98+95 to 99+12 of the Jack Canyon drain. The video inspection consisted of viewing the interior surfaces of drain pipe using Reclamation’s inline MicroTrac camera-crawler. The inspection of the left toe drain at Davis Creek was within the 12-inch diameter pipe. The camera-crawler was inserted into the manhole at station 23+00, and then it proceeded downstream to station 19+46.91. The camera-crawler was then backed out and turned around in order to proceed upstream. The camera-crawler proceeded upstream to approximately station 23+25. The reaches of the left toe drain pipe that were inspected are outlined in figure 88. Originally, it was intended to inspect the entire cleaned reach to station 26+00, but the camera-crawler was unable to proceed when it came across damaged pipe that was previously reported during the 2000 inspection. Figure 90 shows the results of toe drain cleaning and the pipe damage

that halted the camera-crawler. This photograph was taken in the Davis Creek toe drain at approximately station 23+25. From the photograph, it can be seen that the fine materials previously seen on the pipe invert have been removed.

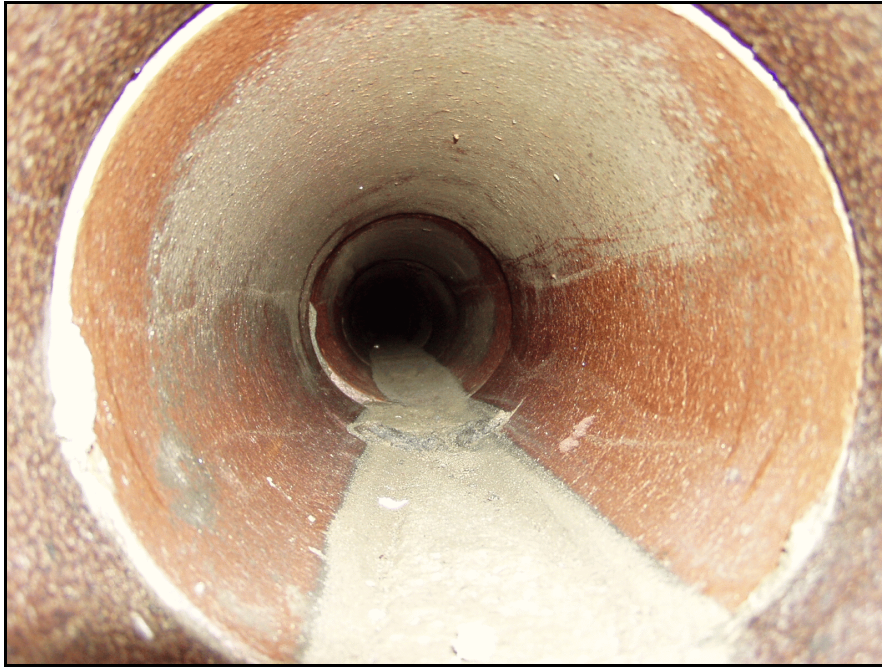
Figure 92.—Clay tile outfall pipe with fines in the invert.

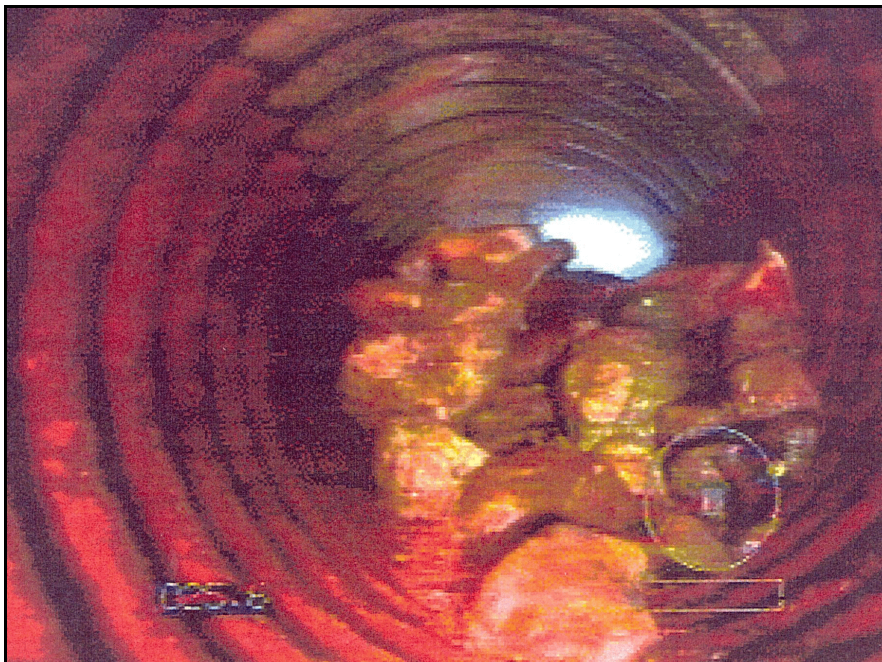
Figure 93.—CMP outfall pipe with coarse grained material.

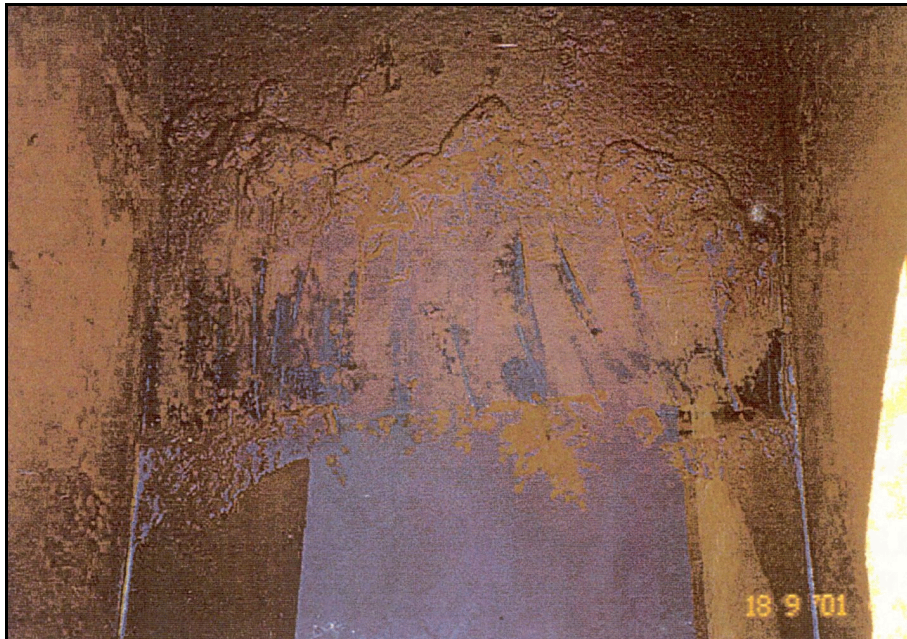
Figure 94.—Sediment sump for SM-D11 and -D12 showing fines that accumulated in one season.

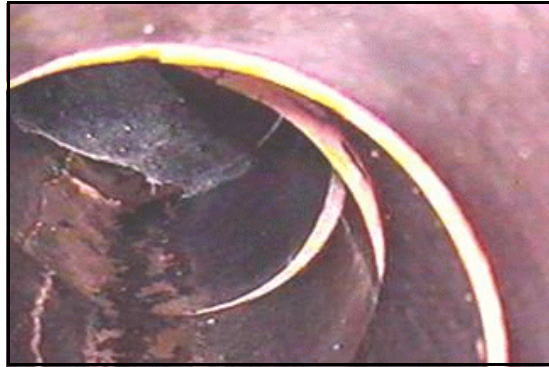
Figure 97.— Extensive joint offsetting within a clay tile pipe.

Joint offsets and separations were observed in 67 percent of all clay tile pipes. Joint offsets and separations ranged from minor to extensive. Figure 97 shows a clay tile pipe that has experienced extensive joint offsetting.

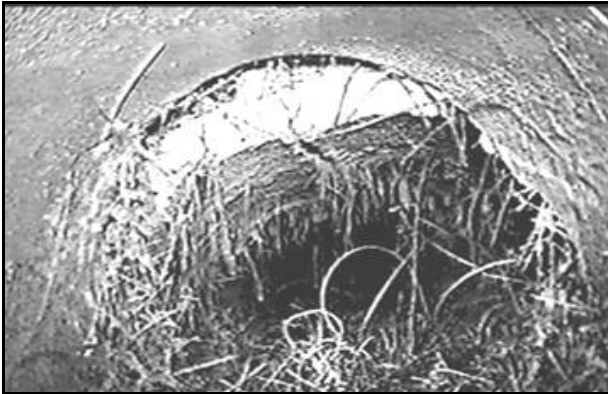
Figure 98.— Clay tile pipe experiencing inward collapse of the crown.

Shape deformation and failure was observed in 24 percent of all clay tile pipes. Shape deformation ranged from minor to extensive. Figure 98 shows a clay tile pipe experiencing a failure of the crown.

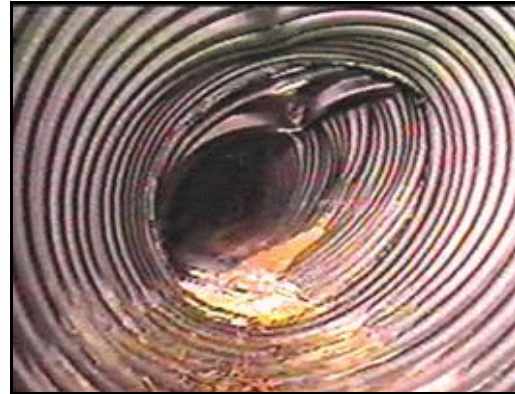
Figure 99.— HDPE pipe experiencing extensive shape deformation.

2. *HDPE.*—Shape deformation and failure was observed in 56 percent of all HDPE pipes. Shape deformation ranged from minor to extensive. Figure 99 shows an HDPE pipe experiencing extensive shape deformation. Figure 100 shows an HDPE pipe that has failed.

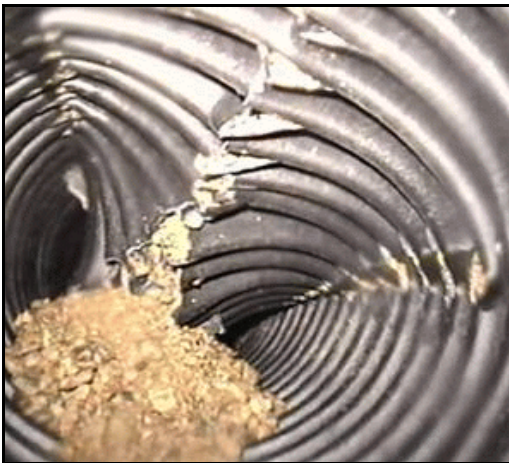
Figure 100.—HDPE pipe experiencing failure at the crown. Materials surrounding the pipe have entered through the failure.

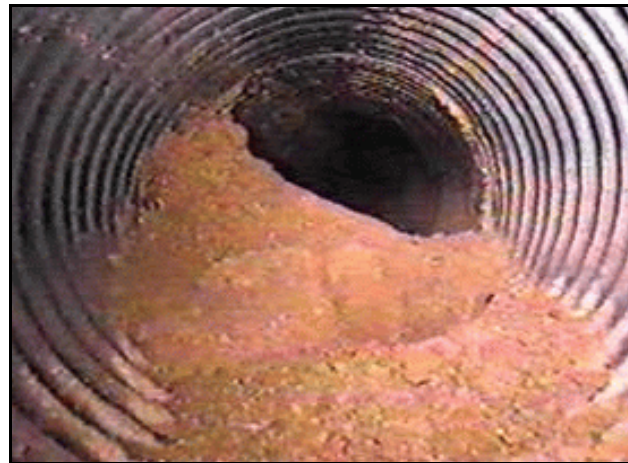
Figure 101.—An HDPE pipe joint has experienced extensive separation. Materials surrounding the pipe have entered through the separated joint.

Joint offsets and separations were observed in 11 percent of all HDPE pipes. Joint offsets and separations ranged from minor to extensive. Figure 101 shows an HDPE pipe joint that

has experienced an extensive separation and has allowed materials surrounding the pipe to enter through the separated joint.

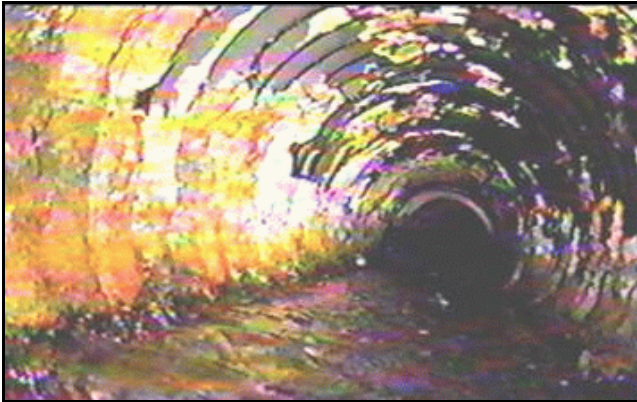
Figure 102.— Extensive deterioration existing within a CMP pipe.

3. *CMP.*—Deterioration was observed in 75 percent of all CMP pipes. Deterioration ranged from minor to extensive. Figure 102 shows a CMP pipe that has experienced extensive deterioration.

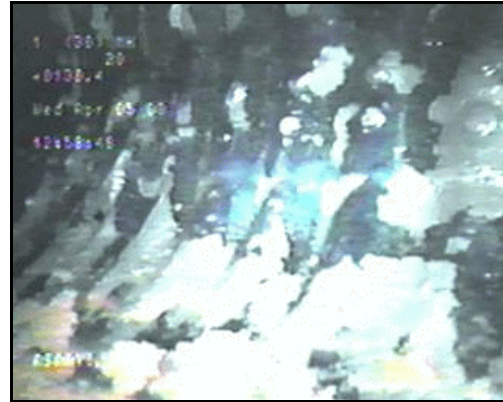
Figure 103.—CMP pipe experiencing extensive loss of surface coating due to delamination.

Some CMP pipes have the interior surfaces coated with asbestos bonded or bituminous coatings. Instances of loss of surface coating due to delamination was observed in about 69 percent of all surface-coated CMP pipes. Loss of surface coating ranged from minor to extensive. Figure 103 shows a CMP pipe that has experienced extensive loss of surface coating due to delamination.

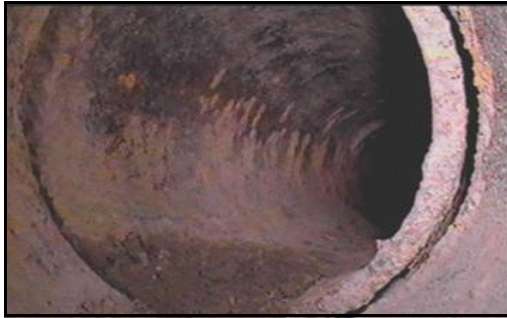
Figure 104.—Concrete pipe experiencing extensive joint offset and separation at a bend in the pipe.

4. *Concrete.*—Joint offsets and separations were observed in 58 percent of all concrete pipes. Joint offsets and separations ranged from minor to extensive. Figure 104 shows a concrete pipe that has experienced extensive joint offset and separation at a bend in the pipe.

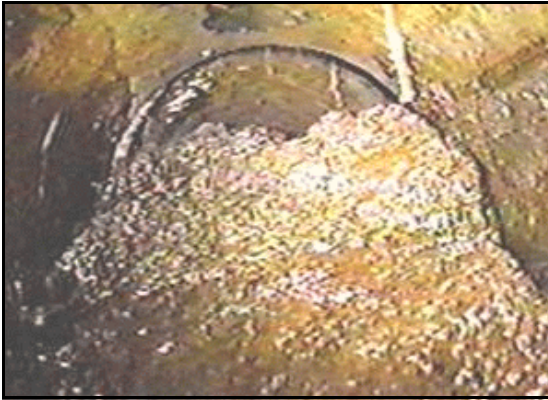
Figure 107.—Accumulation of sediments has resulted in plugging of the pipe.

Figures 107 through 110 show examples of toe drain pipes which have experienced plugging due to sediments, biofouling, mineral incrustation, and roots, respectively.

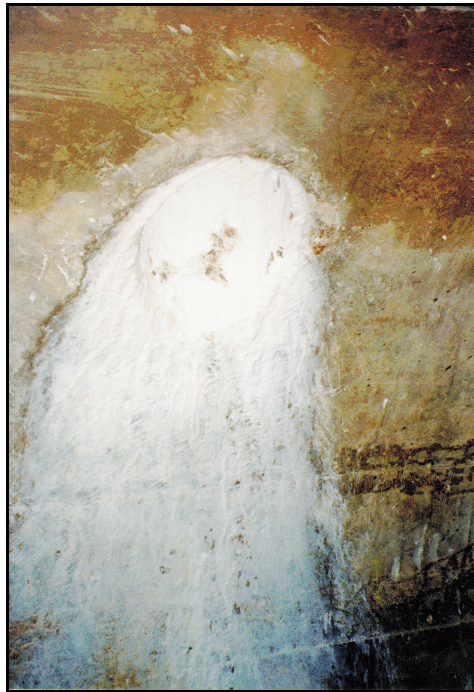
Figure 111.—Calcium carbonate deposit.

a. *Calcium Carbonate Precipitation.*—Solid deposits are often found at the seepage drain emergence points and at other locations where drainage water evaporates. These deposits often contain calcium carbonate (CaCO_3), which commonly precipitates out of solution as the mineral calcite. Figure 111 shows an example of a calcium carbonate deposit at the

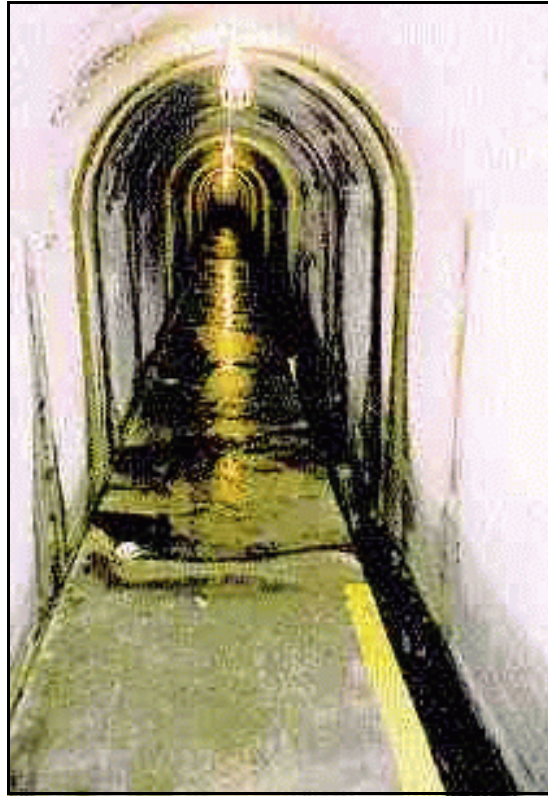
Figure 112.—Iron sulphide deposits in foundation gallery.

Figure 112 shows iron sulphide deposits from drain flows in a concrete dam foundation gallery. Shock chlorination is an effective method for preventing iron bacteria growth. The Grand Coulee Dam case history (in ch. 4) provides an example of the use of this technique. Using hot water or steam to kill the bacteria has also shown promise as a preventive measure.

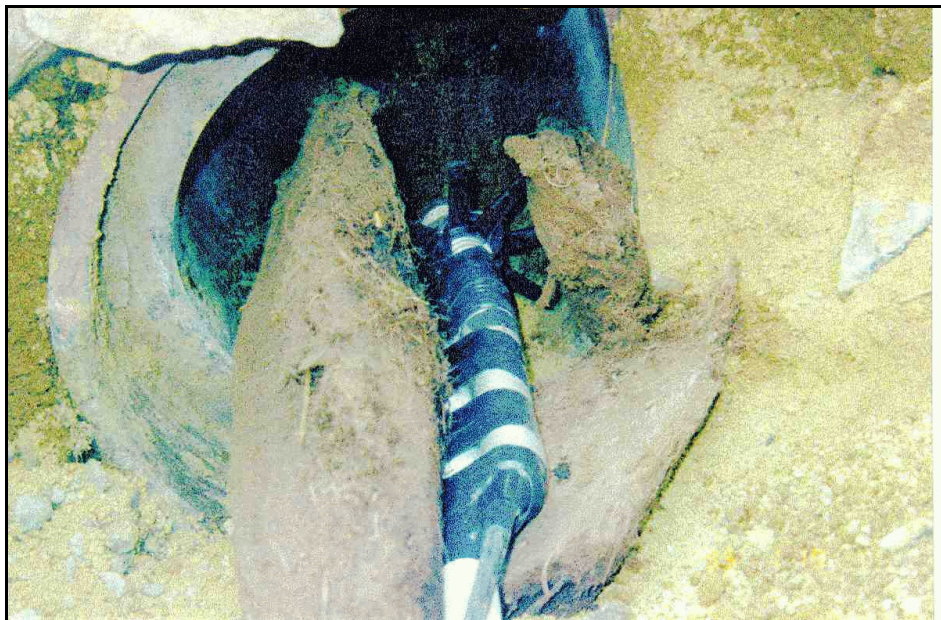
Figure 113.—Plug of organic material in toe drain (also shown is camera used to inspect drain).

d. *Other*.—Other mechanisms for plugging drains include roots from trees or bushes that penetrate the drains and cause obstructions; the accumulation of inorganic fibers (fig. 113); collapse of drain hole in either rock or soil; plugging from animals or humans (vandalism); debris plugs (from back flooding); and deterioration of the drain pipe material (i.e., corrosion of metal pipes) which may lead to a collapse of the pipe. In some installations, drain pipes are damaged during installation, and the damage is not detected, because a video inspection of the pipe is not performed immediately after backfilling and installation of the drain is completed. On Brantley Dam, for instance, a video inspection of a drain in 1991 showed that a lath had been driven through the plastic pipe to hold it in place and never removed. Recent video inspections of the HDPE toe drains installed at San Justo and Davis Creek Dams have revealed collapsed portions of the drains. The damage likely occurred during the installation of these drains.

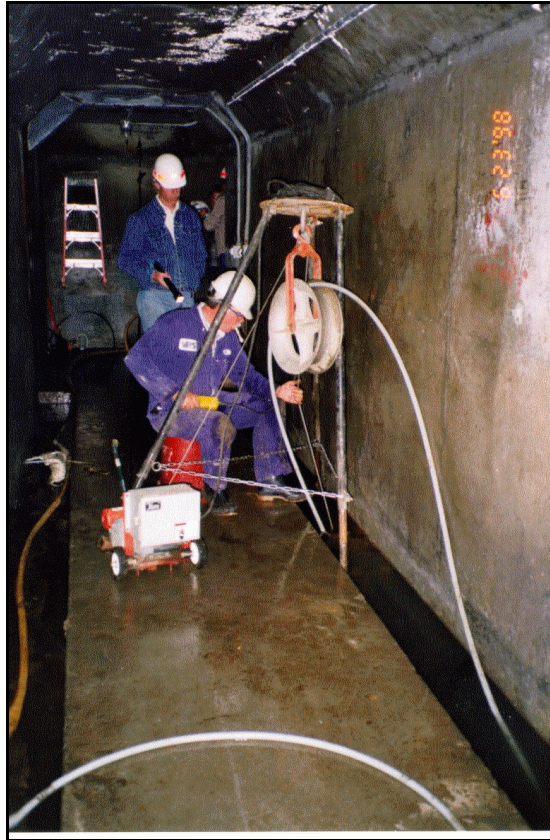
Figure 114.—High pressure water jet nozzle and hose being lowered into foundation drain.

f. *High Pressure Water Jet System.*—This method delivers a flow of 10 to 20 gal/min at a pressure typically between 6,000 and 10,000 lb/in². Other than the pressure and flow rates, the equipment and methods for these systems are similar to the ultrahigh pressure water jet systems. Figures 114 and 115 show equipment used for high pressure water jet cleaning. Extreme care should be exercised when using this method for drains in embankment dams and in areas of soft foundation rocks or in other areas where surrounding materials could be fractured or washed away. Under these conditions, a good knowledge of the foundation/drain conditions is required, along with the experience and expertise to adjust the equipment for the site conditions. Both the ultrahigh pressure water jet system and the high pressure water jet system are very effective, cost-efficient methods when used by trained personnel. These methods are very effective for drains installed in concrete or rock.

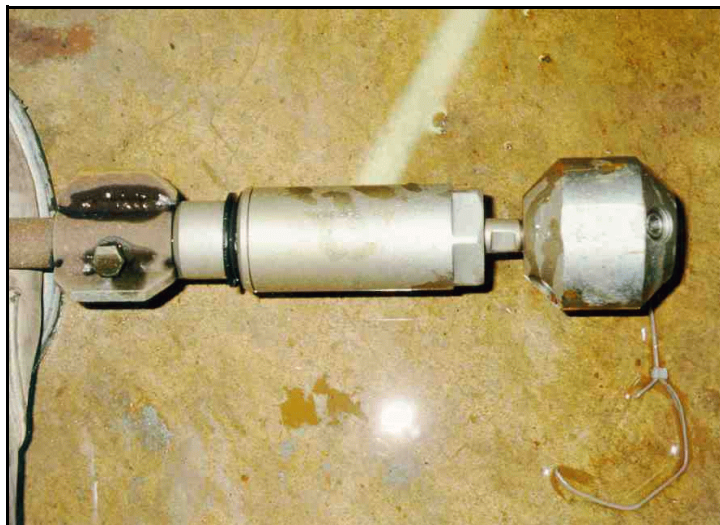
Figure 115.—High pressure water jet nozzle.
