Drainage for Dams and Associated Structures

United States Department of the Interior
Bureau of Reclamation

2004

Technical Service Center
Denver, Colorado
2004

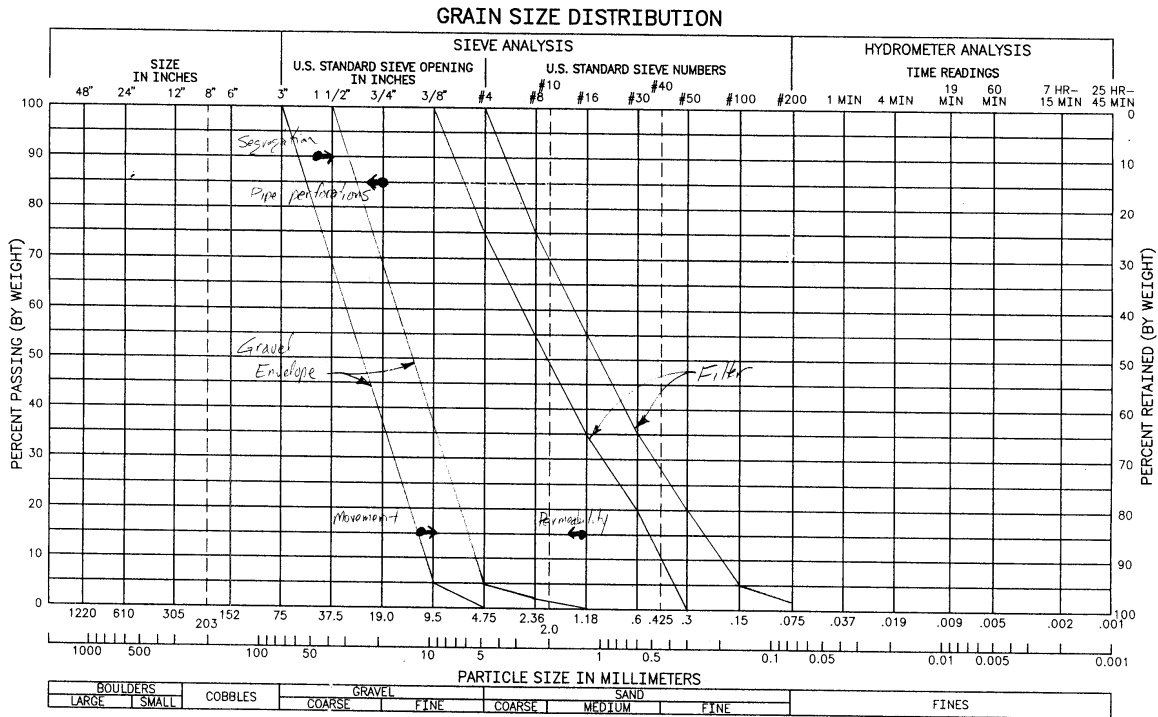
Figure 12.—Gradation of gravel envelope.

The gradation limits of the gravel envelope are shown on figure 12. Note that all criteria could not be completely satisfied. However, the critical cases are the “movement potential” and “perforation size” for a gravel envelope. In this example, only the segregation criteria, which can be easily monitored and controlled, is not fully satisfied on the course end. (However the “average” gradation would meet the requirement.)

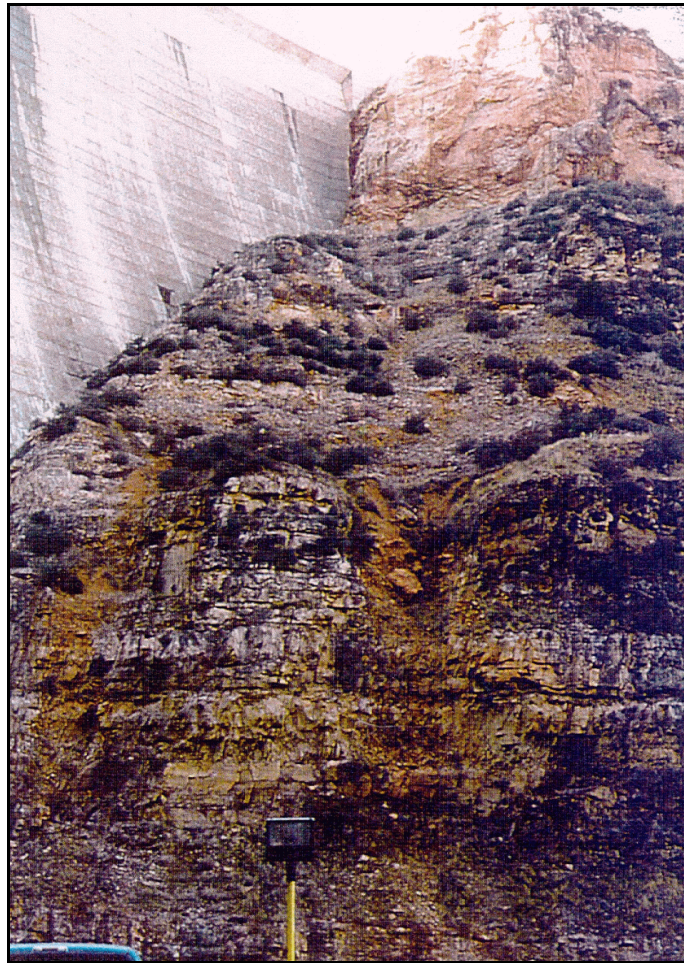
Figure 2.—Madison Limestone outcrop in the left abutment downstream from the dam. Note the weathering in fractured zones. The rock in this abutment is not as sound as in the other abutment.

c. *Foundation Geology.*—Bedrock in the foundation of Yellowtail Dam and powerplant is Mississippian age Madison Limestone (figs. 2 and 3). The formation is near-horizontally bedded, and mostly consists of hard limestones with interbedded siltstone layers—especially near the top of the unit. Jointing is well developed, but proved to be relatively tight during construction grouting. Several slip planes degrade the rock of the left abutment, and additional grouting was necessary in that area.

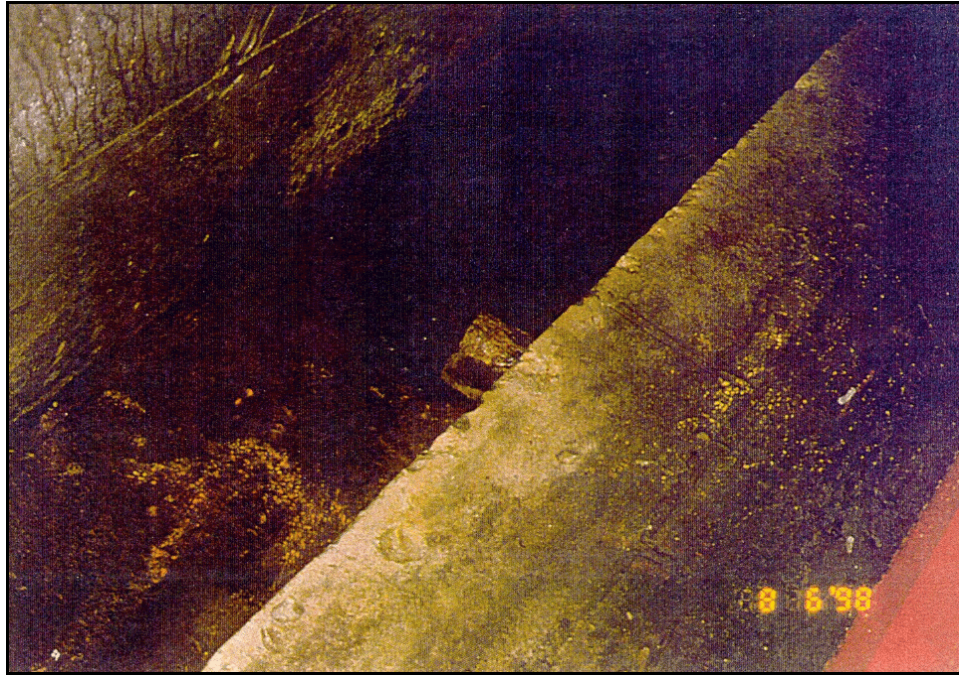
Figure 4.—Gutter along the upstream side of the foundation gallery. The outlet of a lateral discharge pipe is shown near the center of the photograph. It connects to a nearby drain. Most of these pipes were at least partially plugged prior to the drain cleaning operation.

e. *Individual Drain Construction.*—The floor of the access tunnel or powerplant is flat, or sloping in the inclined sections. A nearby gutter in the concrete floor (fig. 4) provides a means of passing the drain flows to a centralized sump and discharge pumps in the base of the dam. This gutter is located along the upstream side of the access tunnel in the foundation. Three-inch diameter drain holes are drilled in a fan pattern around the perimeter of the dam foundation at a slight angle downstream. Holes in the dam foundation

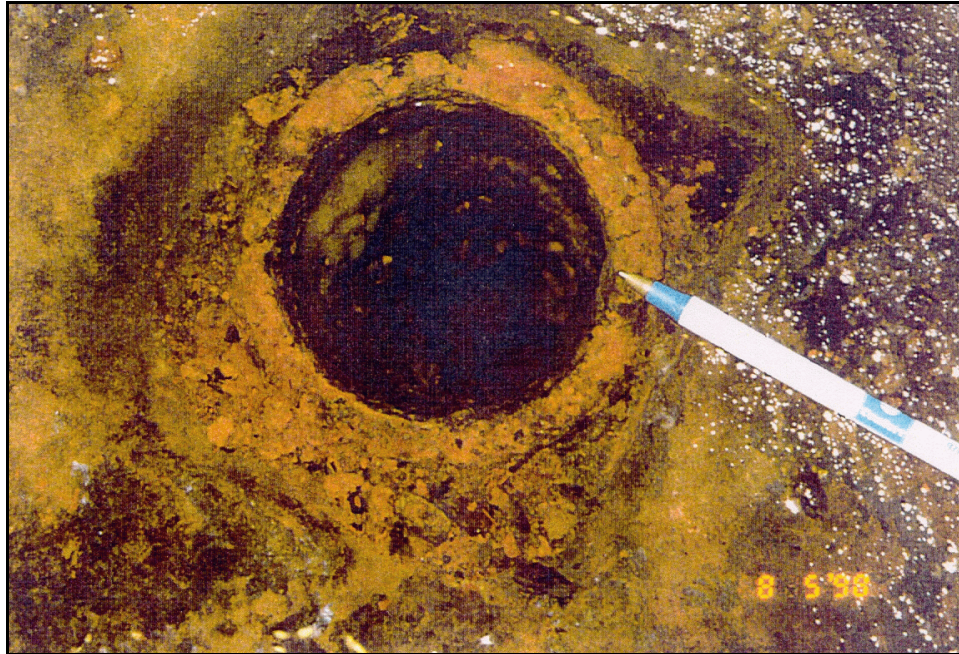
Figure 5.—Top of a drain showing the rusted out threads in the 3-inch steel pipe and the deposit of iron bacteria in the upper part of the hole.

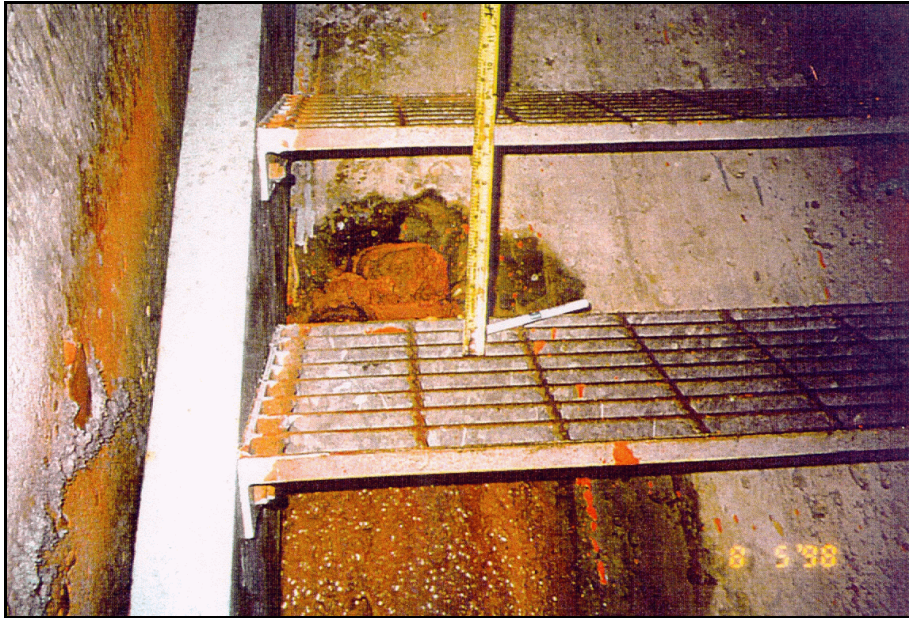
Figure 7.—Red clay oozing from a drain under a sloping staircase. The plumber's packer that had capped the hole was pushed out by the pressurized mud.

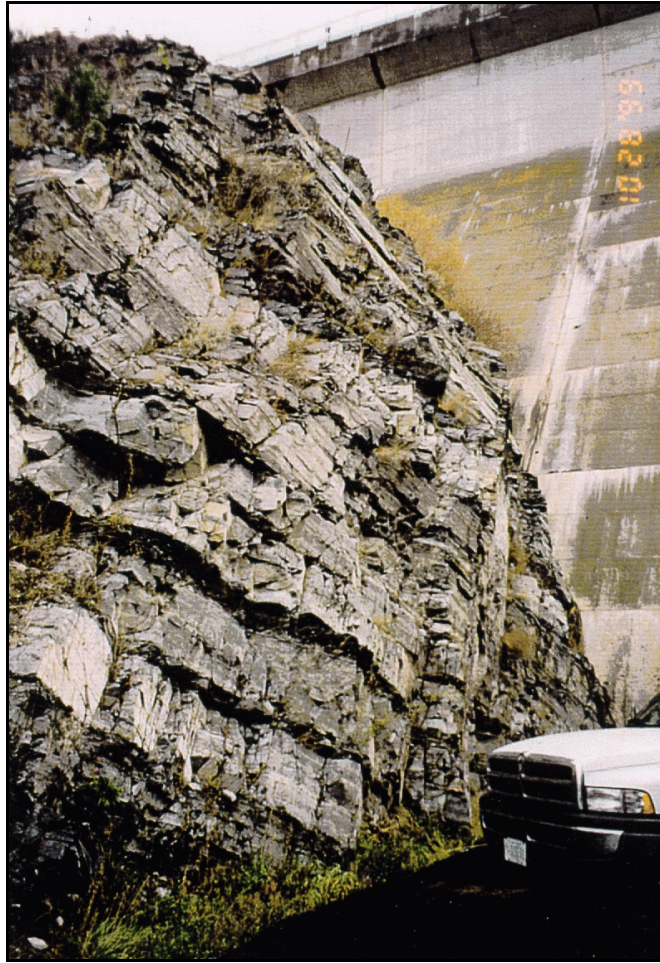
Figure 10.—Empire Shale, classified as hornfels, right abutment downstream from the dam.

c. *Foundation Geology.*—Bedrock in the foundation of Canyon Ferry Dam consists of Empire Shale in the Precambrian sedimentary unit known as the Belt Series (fig. 10). The shale is a massive, exceedingly fine-grained, dense, hard, and brittle rock which has been classified as hornfels. Because of the brittle nature of the rock, structural deformations have caused it to have a very complex, closely spaced system of joints. Superimposed on these joints are faults and shears with crushed zones, clay-gouge seams, and shattered zones. Two faults crossing the foundation in the areas of blocks 8 and 15 have associated with them

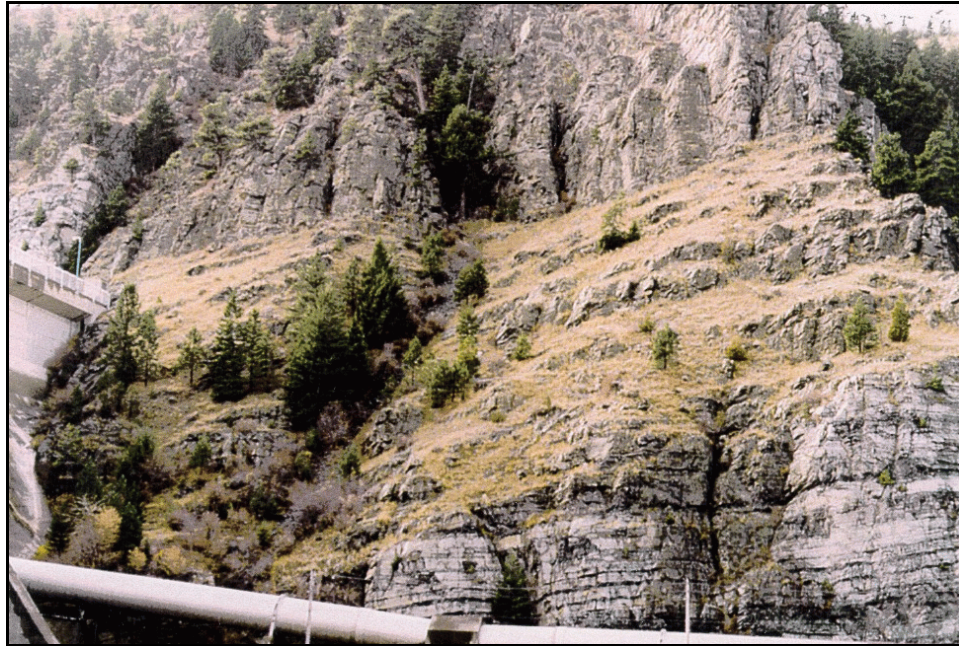
Figure 11.—Empire Shale in the left abutment downstream from the dam.

crushed and brecciated zones. Figure 11 shows the bedrock in the left abutment, and Reclamation drawings 296-613-619 and 296-613-620 show the geologic section along the foundation gallery.

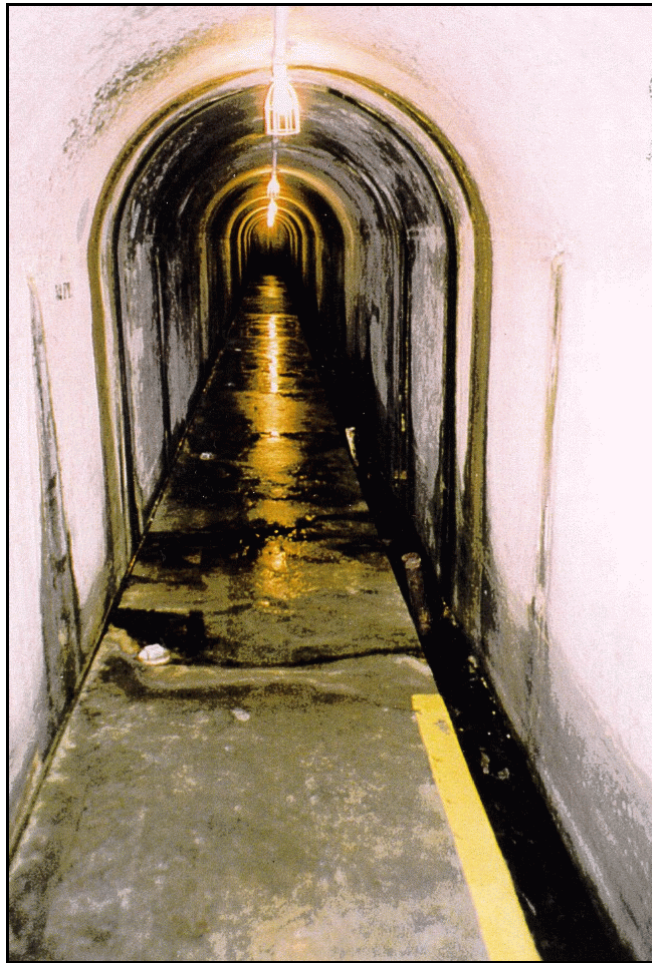
Figure 12.—Drainage ditch located along the upstream side of the access tunnel or gallery. Water is passed from the drain holes into the drainage ditch through a 2-inch steel pipe embedded in the concrete floor. This view looks along the right abutment foundation drainage tunnel.

ditch (fig. 12) is located along the upstream side of the access tunnel in the foundation. Water is transferred from the drain hole into the drainage ditch through a 2-inch diameter steel lateral discharge pipe or cross pipe embedded in the concrete floor. All drain holes are capped with 4-inch threaded caps (fig. 13). Table 1 lists individual hole numbers and original or probed depths.

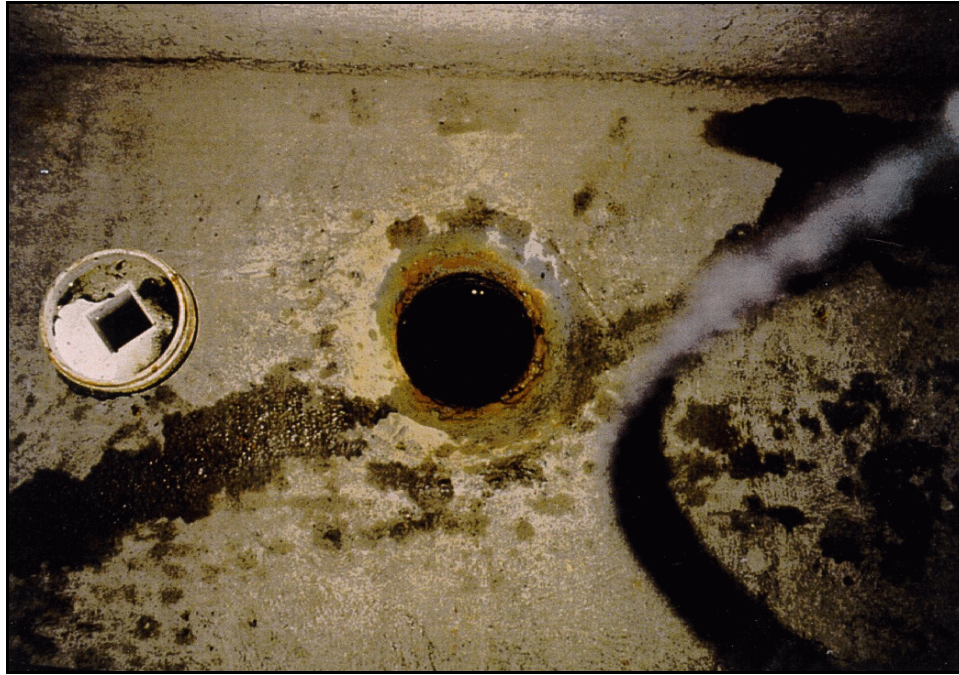
Figure 13.—Top of a drain hole with a 4-inch threaded cap. The pipe is 4 inches in diameter, and the hole becomes 3 inches upon entering bedrock.

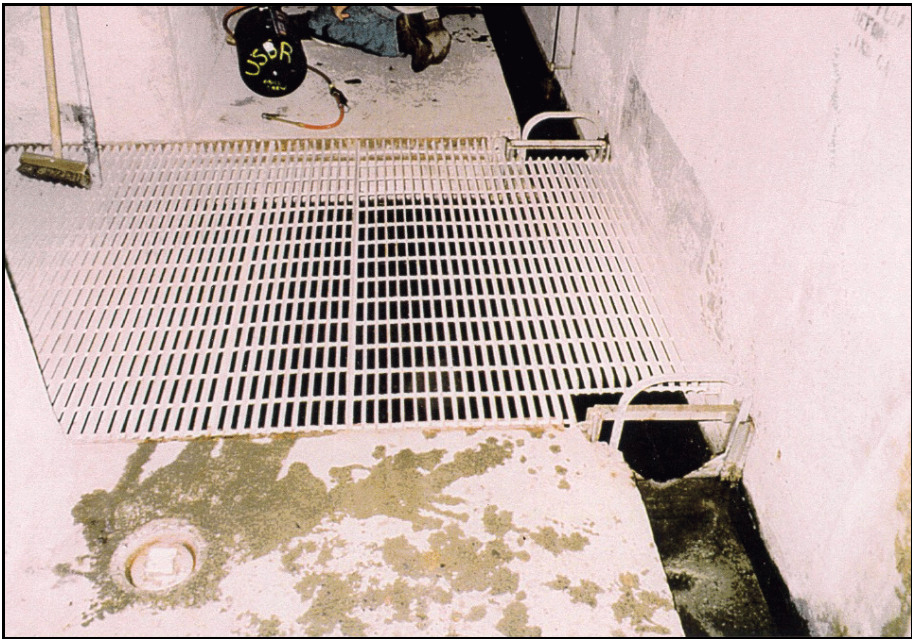
Figure 15.—Weir readings are recorded before and after cleaning.

Individual flow measurements were recorded before cleaning and after cleaning. Table 1 indicates these flow measurements. Weir readings are measured and recorded monthly by the powerplant personnel. Two weirs are located in the foundation gallery drainage gutter on either side of a collection and pumping sump in block 12 (fig. 15). One of these weirs measures total drain flow from blocks 5 to 12, and the other measures total drain flow from blocks 12 to 22. Table 2 indicates weir readings from January 1997 through January 2000.

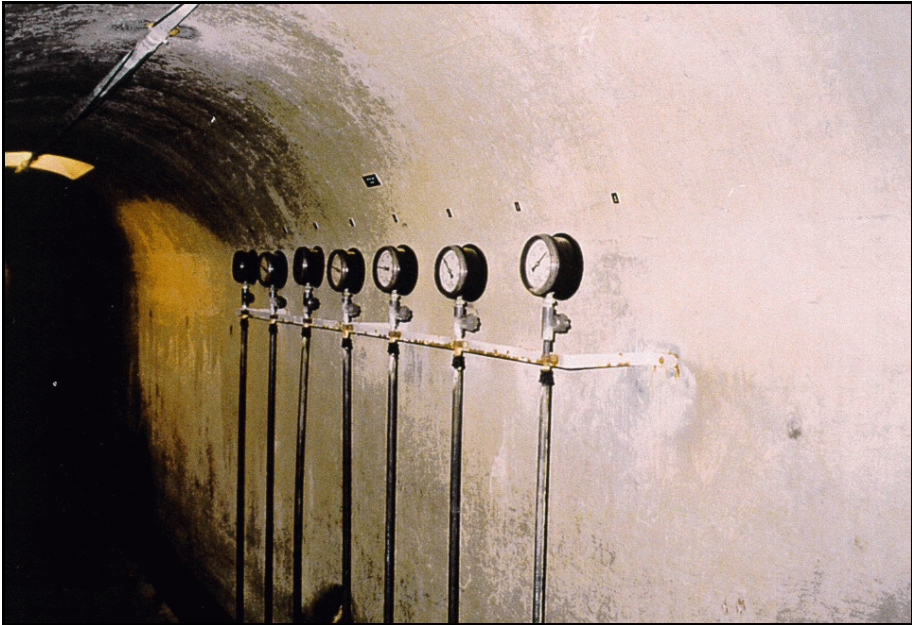
Figure 16.—Uplift pressure gauge readings are recorded before and after cleaning.

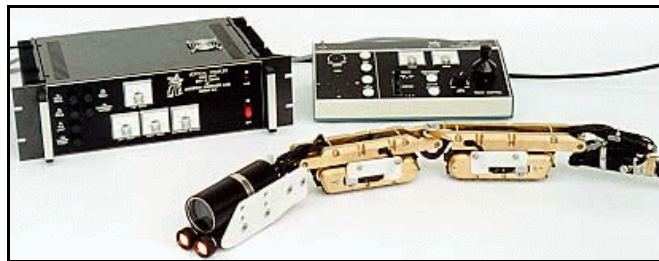
Figure 2.—RCVI instrumentation and control equipment.

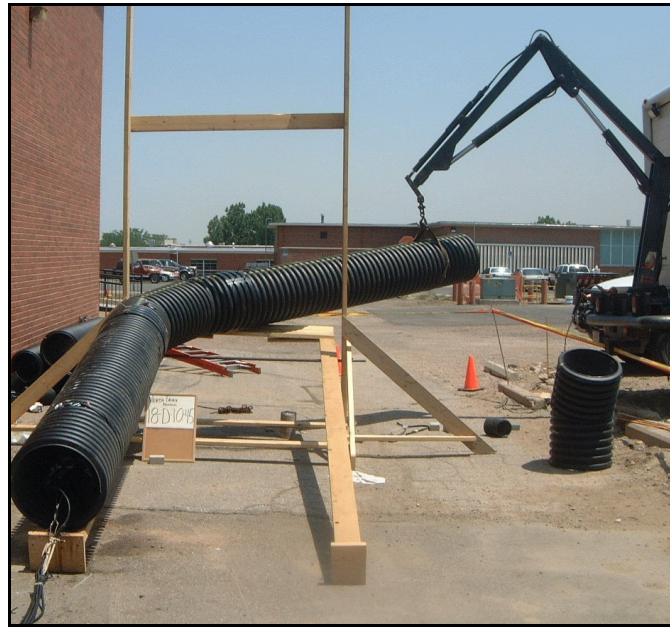
Figure 3.—Apparatus used for performance testing of remotely controlled video inspection equipment within HDPE pipe.

1. *Testing Apparatus.*—In June 2002, the TSC’s laboratory construction shop constructed a testing apparatus. The apparatus was designed to be multifunctional, so it could be configured to accommodate a variety of pipe diameters, bends, invert slope inclinations, and invert conditions. Some of the tests required supplemental support assistance supplied by a small, 1,500-lb capacity boom crane mounted on a truck. Figure 3 shows the testing apparatus.

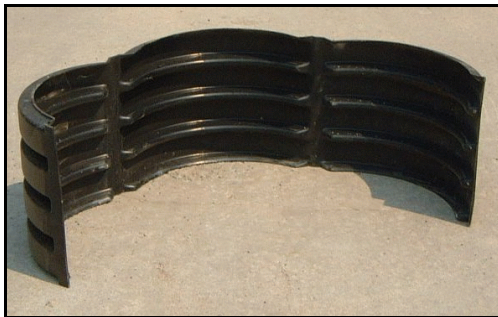
Figure 6.—Manufacturer supplied coupler.

All pipe bends were connected using the manufacturers' supplied couplers and secured together using plastic cable ties (figs. 6 and 7).

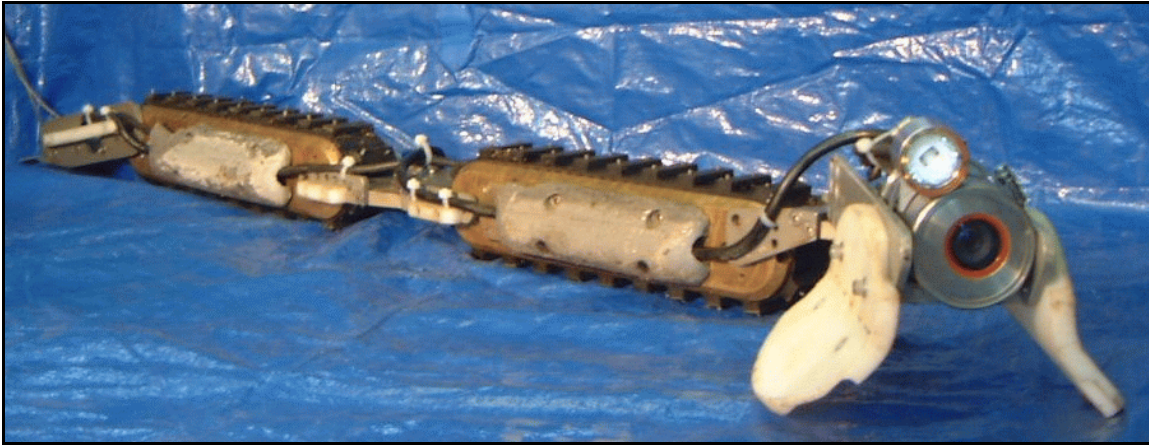
Figure 8.—The MiniTrac remotely controlled inspection system.

The MiniTrac system (fig. 8) uses a transport vehicle with two motorized brass track units in an inline configuration.

Individual control units, plugged into a standard 120VAC 60-Hz power source, power the track units, lights, and cameras. The camera-crawler is connected to the track unit control by use of the cable tether. The cable tether consists of two 500-foot-long polyurethane jacketed coaxial cables joined together by a connector assembly. The cable tether feeds the power and control signals to the transport vehicle, camera, and lights and also returns data from the sensors to the controllers. The control units for the lights and cameras are connected directly to the track control unit. Table 1 summarizes the camera-crawler specifications.

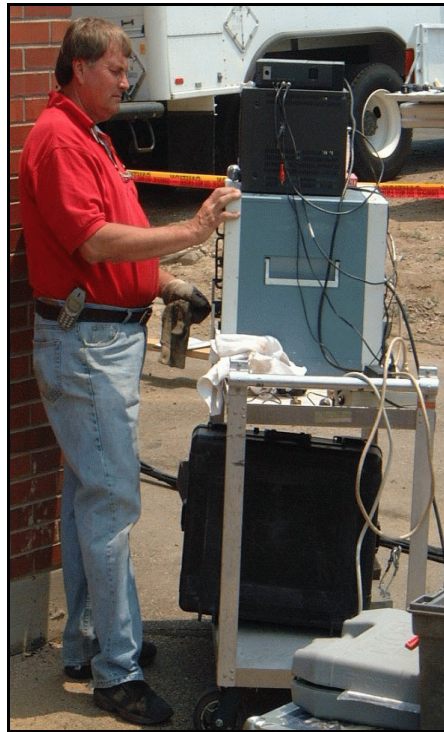
Figure 10.—Operator controlling the remote inspection equipment.

An operator (fig. 10) controls the movement of the camera-crawler's track units, lights, and camera.

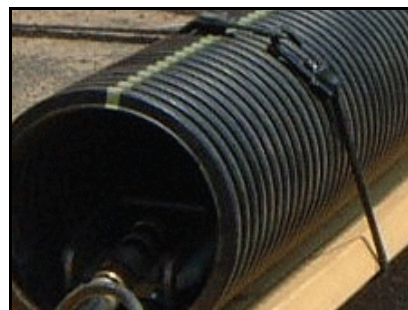
Figure 11.—Bungee cords used to secure the pipe to the testing apparatus.

The HDPE pipe was positioned on the testing apparatus and secured in place using rubber bungee cords (fig. 11).

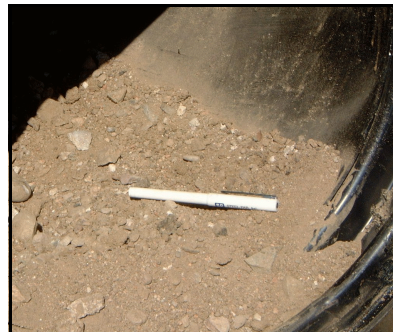
Figure 13.—Random mixture of fine and coarse aggregates used to simulate sediment deposition on the pipe invert.

A random mixture of fine and coarse aggregates (fig. 13) was used to simulate deposits that occasionally collect on the inverts of toe drain pipes.

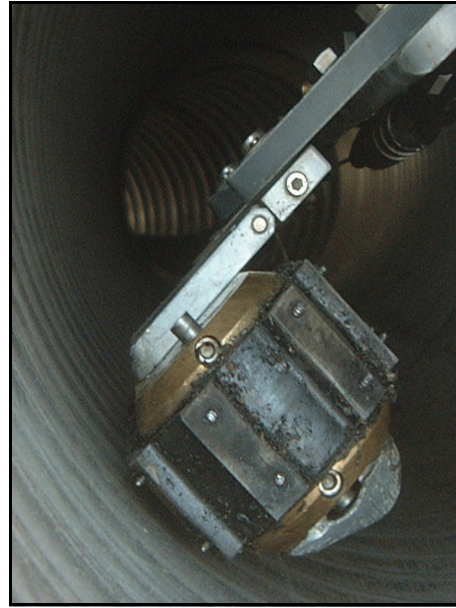
Figure 14.—Cleated track belt on the VersaTrax 150 system.

improve traction, cleats (fig. 14) were installed into the track belts. These cleats consisted of two No. 6 stainless steel screws ($\frac{3}{4}$ in. long) drilled through each lug on the track belt. The pointed tip of each screw was cut off using a bolt cutter.

Conclusion: The cleated track belts provided significant added traction over the noncleated track belts. The added traction using cleated track belts improved cable tether pulling capacity by as much as four times that of the noncleated track belts. Due to the improved traction, all subsequent performance tests were conducted using cleated track belts.

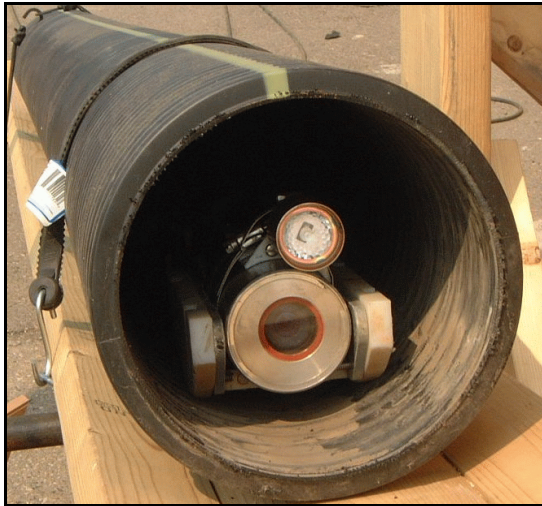
Figure 15.—The MiniTrac system inside an 8-in. diameter pipe.

Performance tests were conducted using the MiniTrac and VersaTrax 150 systems. A variety of pipe diameters were tested to see what entrance limitations are encountered with the camera-crawlers. Successful entry into pipes can be limited by the positioning of the lights and camera on the transport vehicle. Improper positioning of the lights and camera can result in elimination of the required crown clearance within the pipe. Although camera-crawlers are available for pipes smaller than 8 inches, they are very limited in cable tether pulling capacity and generally do not have sufficient traction for use in toe drain inspection. The MiniTrac system could easily enter all pipes 8 inches or larger (fig. 15). The VersaTrax system could enter all pipes 15 inches or larger (fig. 16). One caveat to note:

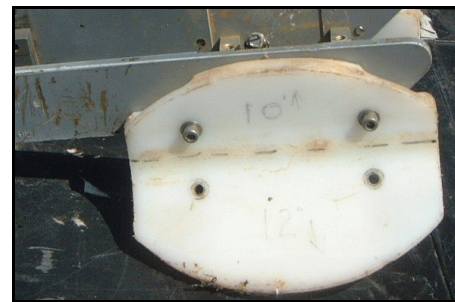
Figure 18.—Stabilization wings used on the MiniTrac system.

- *Clearance.*—Stabilization wings (fig. 18) are used on camera-crawlers to provide stability as it travels through the pipe. These wings are not required in pipes with diameters of 8 inches. However, in pipes with diameters larger than 8 inches, the stabilization wings are normally used to prevent the camera-crawler from trying to run up the side of the pipe and turning over onto its side. Pipe bends present navigation problems for camera-crawlers since the lights and stabilization wings reduce required clearance and interfere with advancement through the bend.

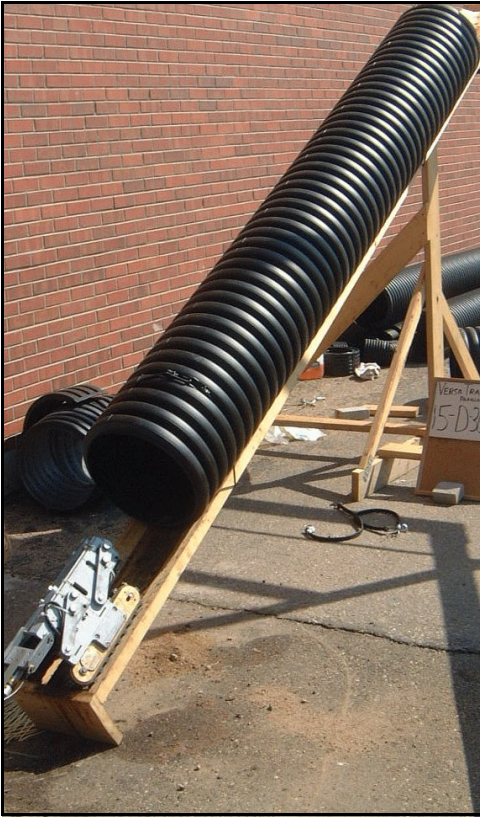
Figure 20.—VersaTrax 150 system traveling up a 30-degree dry invert slope.

Graphs 2 through 10 show the effects of flat and 10-degree invert slope inclination for 8-, 12-, 15-, and 18-inch diameter pipes. In general, invert slope inclination reduces the amount of cable tether a transport vehicle can pull by 10 to 70 percent depending upon the pipe diameter, degree of pipe bend, and the invert condition. Only the VersaTrax 150 system was able to travel up an invert slope inclination of 30 degrees. However, due to a significant loss of traction, only a very short length of cable tether could be successfully pulled up the slope. Also, for the 30-degree inclined slope, the VersaTrax 150 system could only travel up a dry invert (fig. 20) and could not navigate any pipe bends.

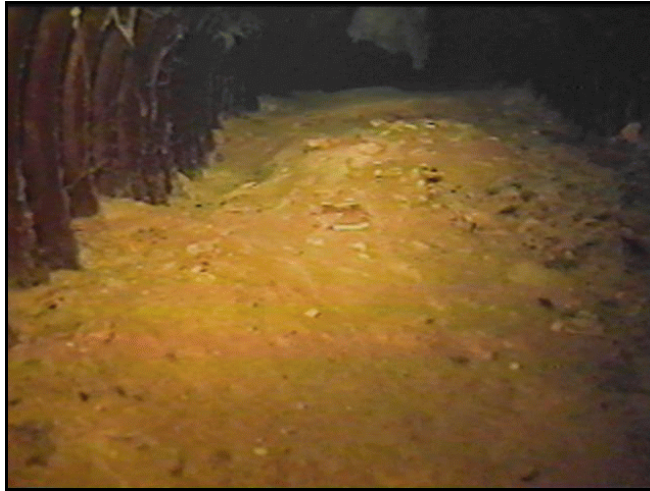
Figure 21.—Example of sediment deposition encountered during a video inspection of a toe drain.

Figures 21, 22, and 23 show examples of invert conditions that have been encountered during recent remotely controlled video inspections of toe drains by the Technical Service Center.

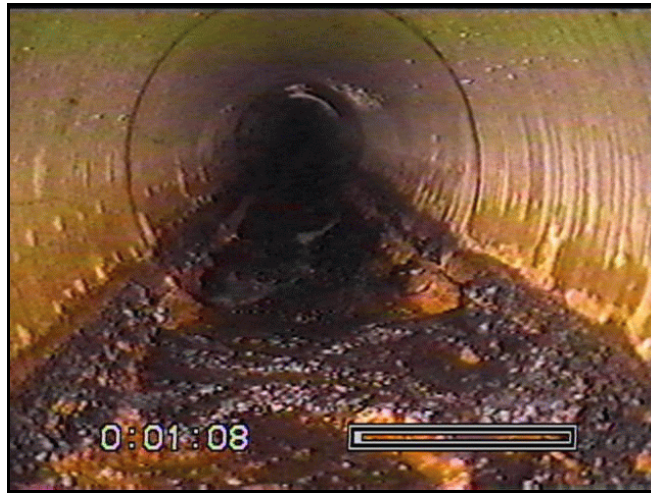
Figure 23.—Example of bacterial growth encountered during a video inspection of a toe drain.

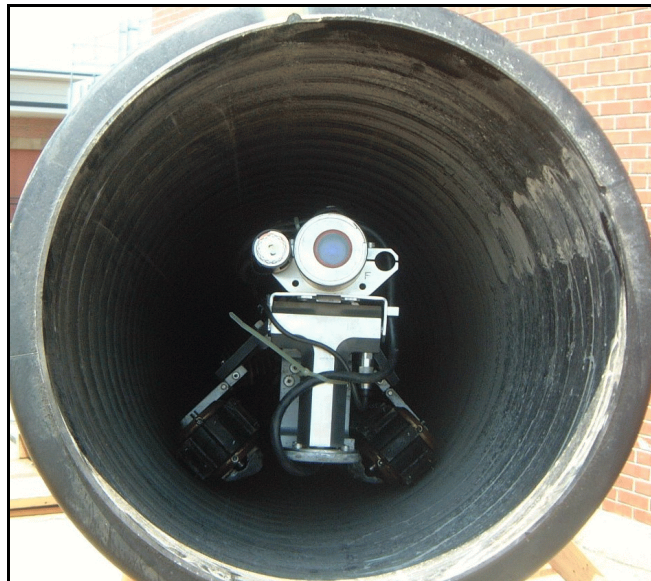
Figure 24.—Example of the dry invert condition.

invert slope inclinations of flat and 10 degrees. In general, invert conditions reduced the amount of cable tether a transport vehicle can pull by 10 to 60 percent depending upon the pipe diameter, degree of pipe bend, and the invert slope inclination. Figures 24, 25, and 26 show dry, slippery, and gravel invert conditions, respectively.

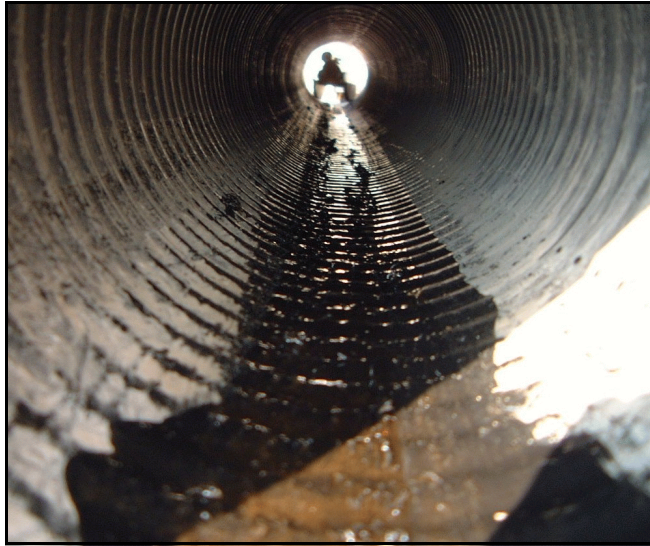
Figure 25.—Example of the slippery invert condition.

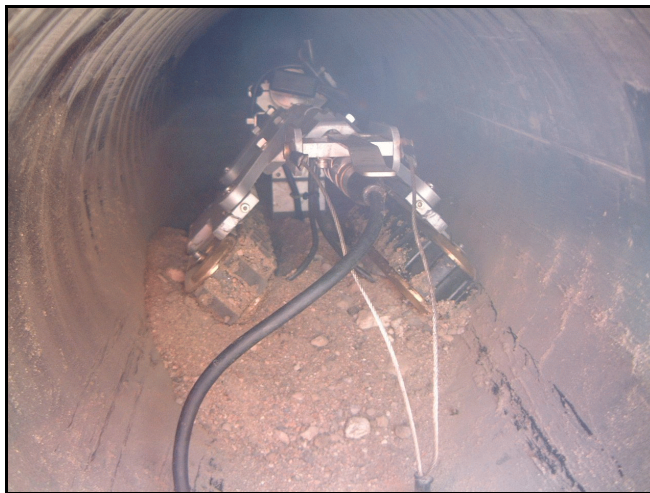
Figure 26.—Example of the gravel invert condition.

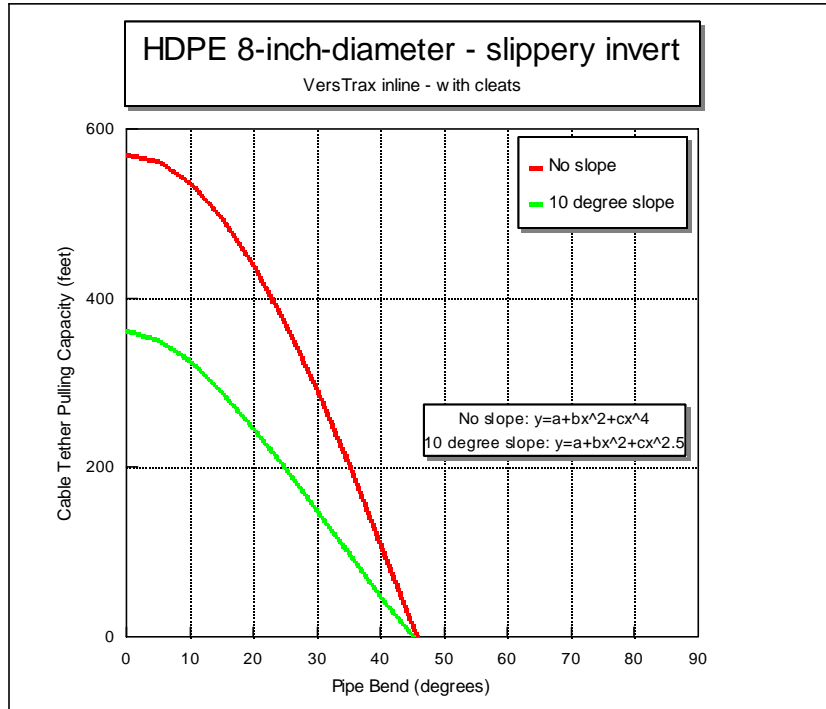
Graph 4

10° slope:

$$\begin{aligned} a &= 361.07671000000 \\ b &= -0.49988957000 \\ c &= 0.04799311700 \end{aligned}$$

Graphs 2, 3, and 4 summarize the results of tests using an 8-inch diameter pipe. The MiniTrac system could be navigated through 0- and 22.5-degree pipe bends, but cable tether was significantly reduced by about 15 to 40 percent depending upon the invert slope inclination and the invert condition. The camera-crawler could not be navigated through a 45-degree pipe bend (fig. 17), since the camera did not clear the pipe crown as it traveled through the bend. The use of stabilization wings (fig. 18) affects travel through bends

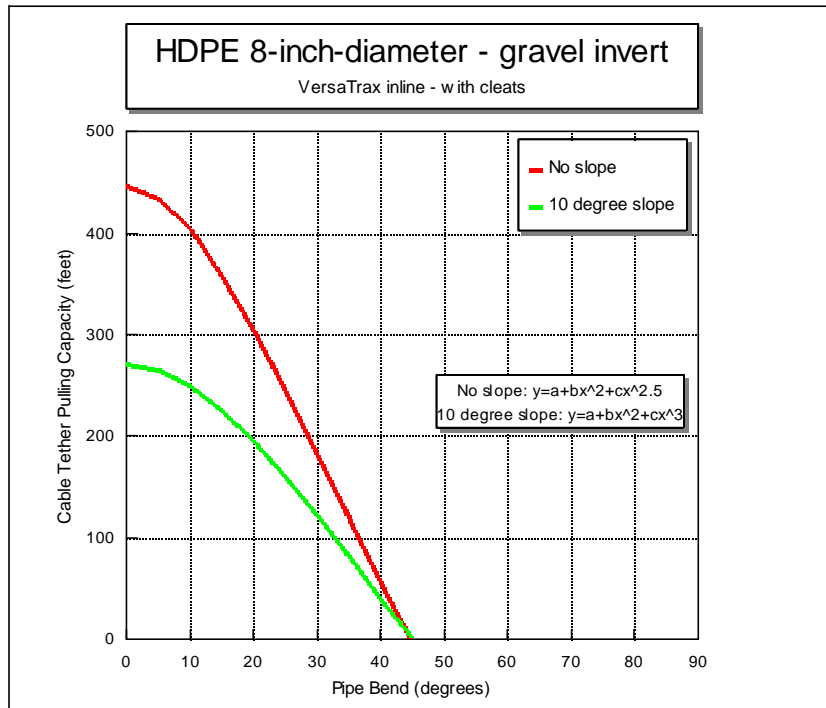
Graph 5

10° slope:

$$\begin{aligned} a &= 271.17391000000 \\ b &= -0.23367840000 \\ c &= 0.00222436930 \end{aligned}$$

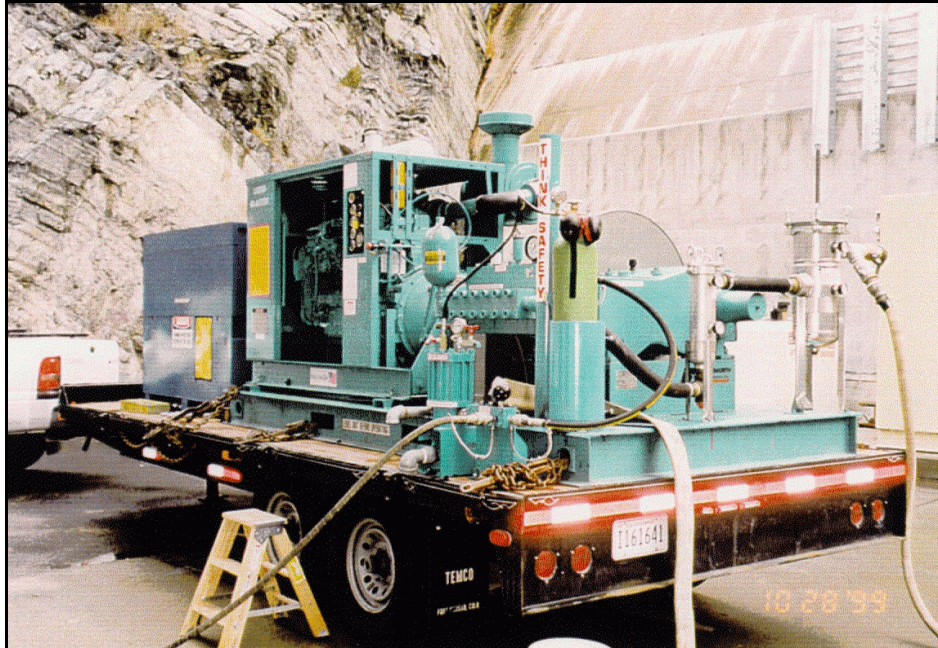
Figure 27.—High pressure water jetting unit used to clean drains. Pump powered by a 215-hp diesel engine.

C-3—High Pressure Water Jetting Equipment.—The Great Plains Regional Office of the Bureau of Reclamation purchased a complete high pressure water jetting system in 1998. The system provides the capability of adjusting cleaning pressures and nozzle configurations to best suit the site conditions. The major pieces of equipment (diesel engine and pump) can be located remotely from the drains being cleaned. The pump is powered by a 215-hp diesel engine (figs. 27 and 28) and rated to deliver 15,000 lb/in² at 22 gal/min at the pump discharge. Fifteen hundred feet of ½-inch I.D. high pressure hoses in 100- and 50-foot lengths transfer water from the pressure regulator on the pump unit (fig. 29) to the control apparatus in the drainage tunnels (fig. 30), which regulates flows going into the drains. A flexible ½-inch I.D. lance hose (fig. 31) is connected to a variety of both rotating or nonrotating cleaning heads (figs. 32 through 34) in the drains.

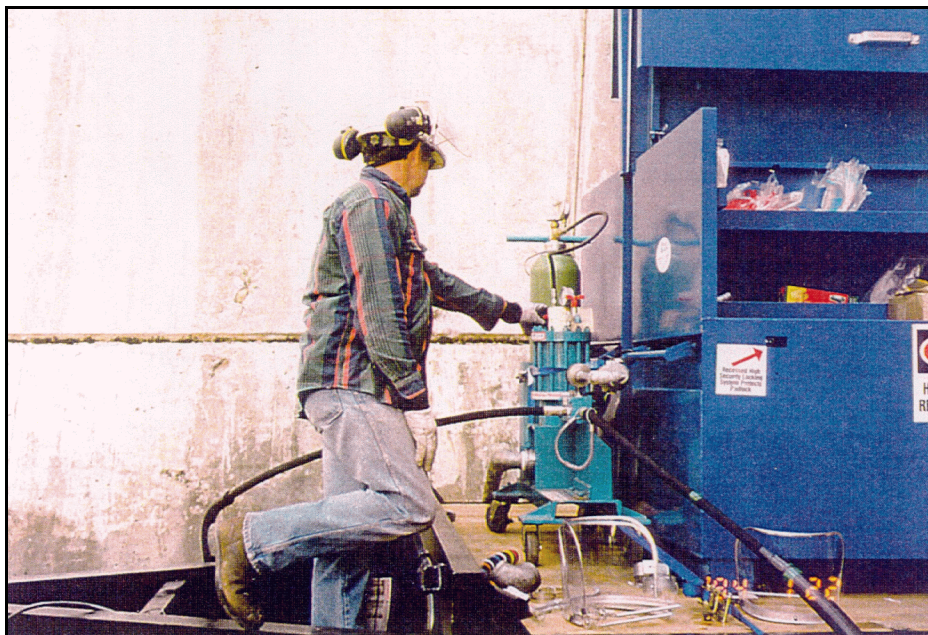
Figure 29.—Driller adjusting the pressure regulator between the high pressure pump and the delivery lines supplying water to the control.

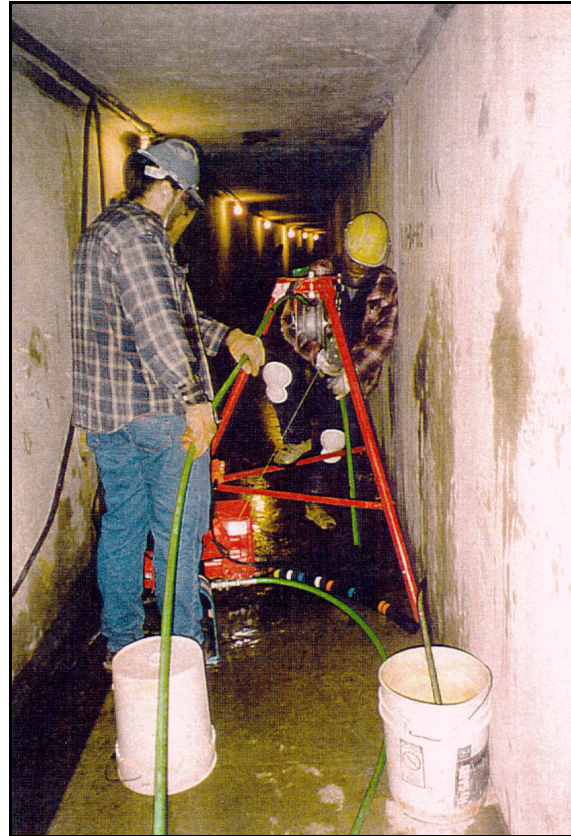
Figure 31.—Green flexible lance hose being lowered into a drain using the tripod with electric winch that is being used to help retract the cleaning unit from deep, near vertical holes.

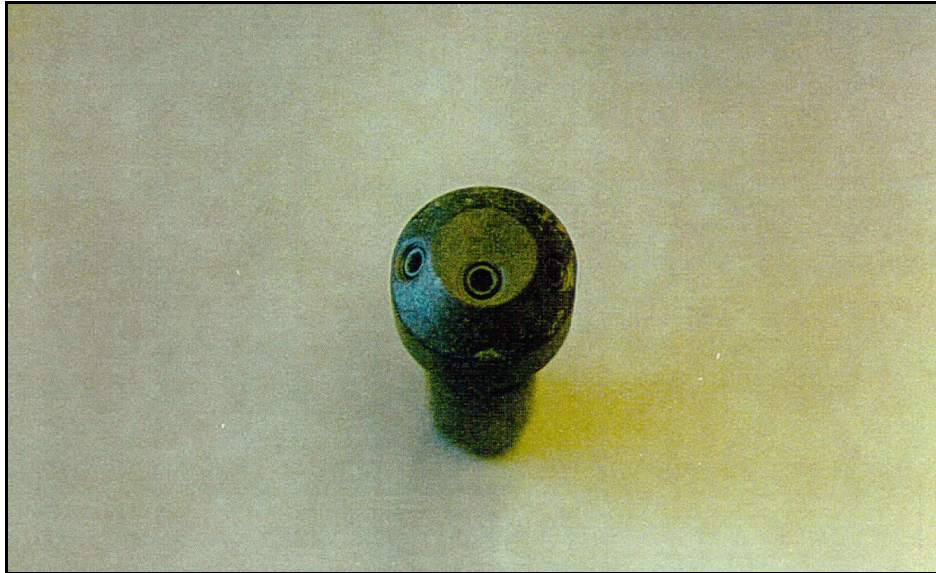
Figure 33.—Front view of the rotating cleaning head, showing the opposing side jets pointing forward at 45° and the offset front jet pointing forward at 10°.

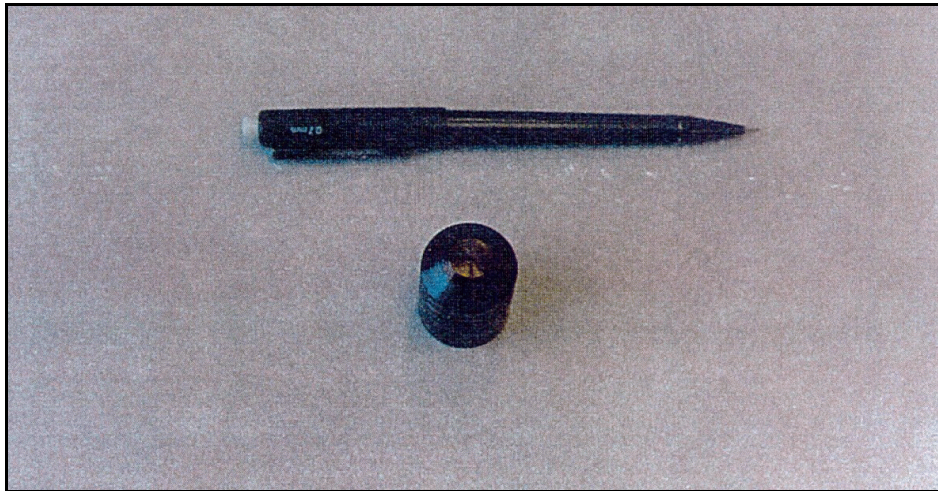
Figure 34.—Front view of nonrotating sewer cleaning nozzle. One predrilled hole points straight forward from the center. Three other predrilled evenly spaced holes point straight forward from the beveled portion. This cleaning head is used for flushing with pressures of less than 2,000 lb/in².

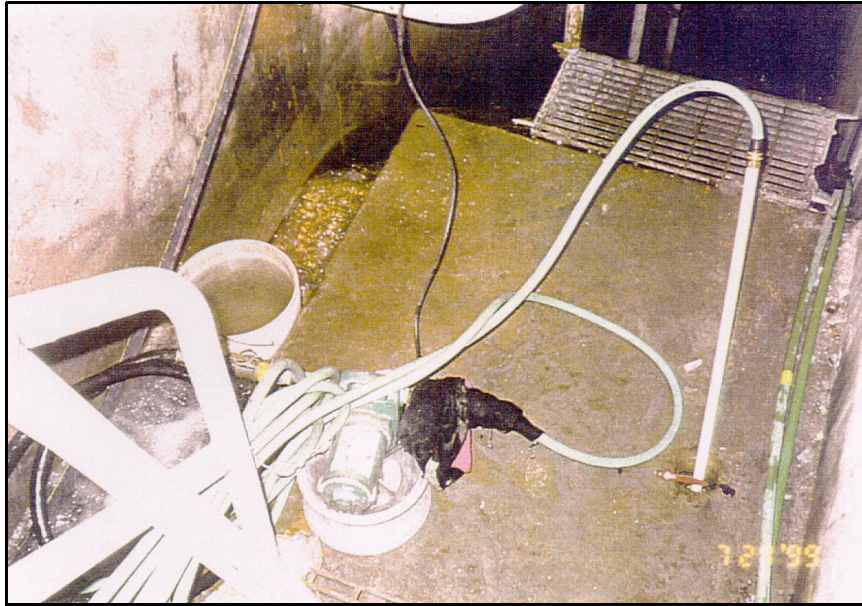
Figure 38.—Electric pump, garden hose, and flush-jointed PVC used to flush drains before making an initial down-hole video examination. Water was obtained by placing a temporary dam in the nearby drainage gutter.

A submersible pump, rated at 50 gal/min and 100 lb/in², supplies water to the water jetting unit and is double filtered before entering the jetting system (fig. 35). A bypass device (fig. 36) diverts excess flows from the delivery pump when they are not needed. A portable electric car wash unit (fig. 37) was also purchased for cleaning the lateral discharge pipes from concrete dam foundation drains as well as for performing general cleaning of gallery walls and floors. Figure 38 shows equipment for flushing drains before and after cleaning. Individual drains are usually isolated and measurements taken before and after drain cleaning

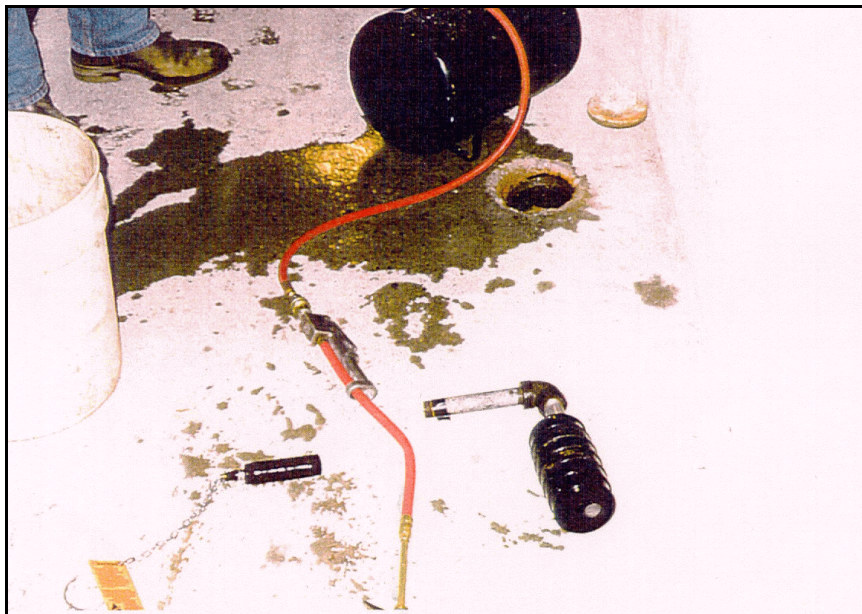
Figure 39.—Portable air tank and pneumatic packers to take before and after cleanout drain flow measurements. The small packer closes the end of the lateral discharge pipe, and the larger packer with the elbow pipe extension goes in at the top of the drain.

(figs. 39 and 40). Videotaping of drain holes before and after cleaning is also important for evaluating the effectiveness of drain cleaning (fig. 41). The cleaning system is mounted on a flatbed trailer along with two large tool boxes of sufficient capacity to contain all of the hoses and other cleaning paraphernalia.

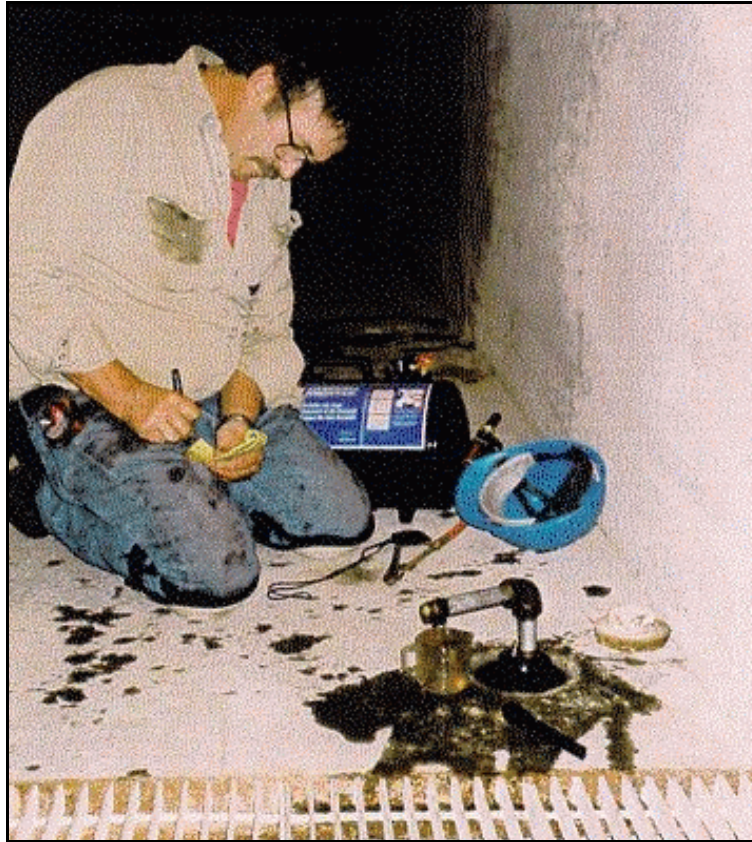
Figure 40.—Individual drain flow measurement being recorded.

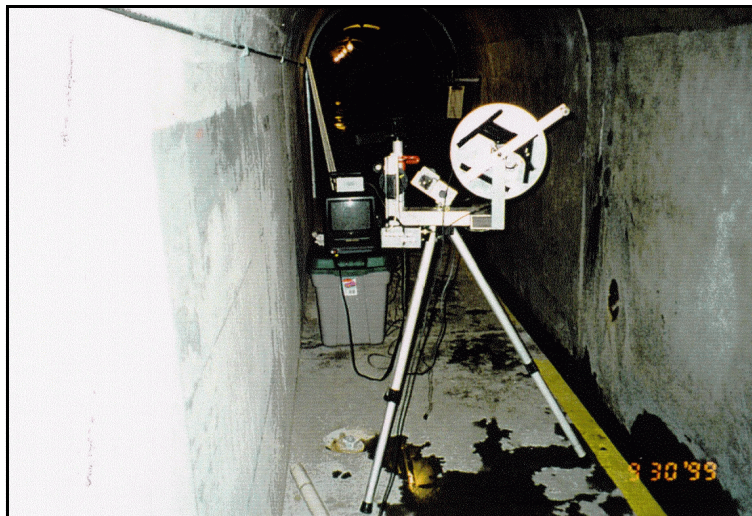
Figure 41.—Down-hole video equipment used to determine the condition of the drains before and after cleaning.

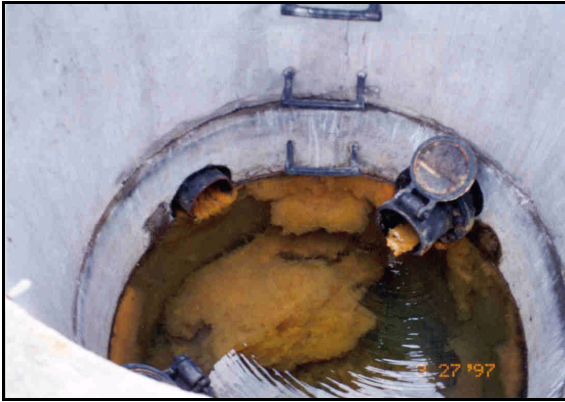
Figure 42.—The manhole shows an example of biofouling

If deposited materials are present, they will be revealed during inspections or monitoring of the drain. The sampling will typically be scheduled for a later date or routine O&M activities. Instructions to O&M personnel should be clear and concise. Figures 42 to 53 contain photographs that show examples of biofouling, biofilms, bacterial growths, mineralization, sediments, and vegetation found in drains during inspections.

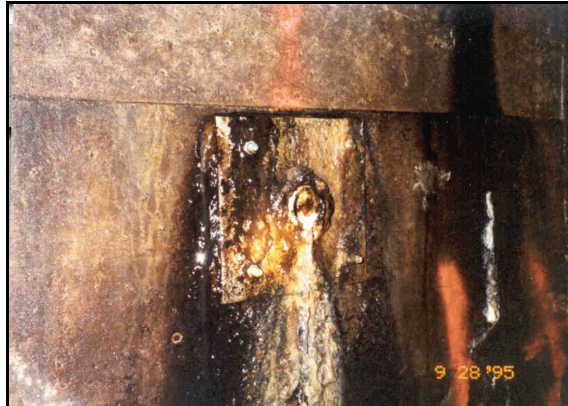
Figure 45.—The weep hole shows an example of sulfur (yellow) and phosphorous (white) related biofilm.

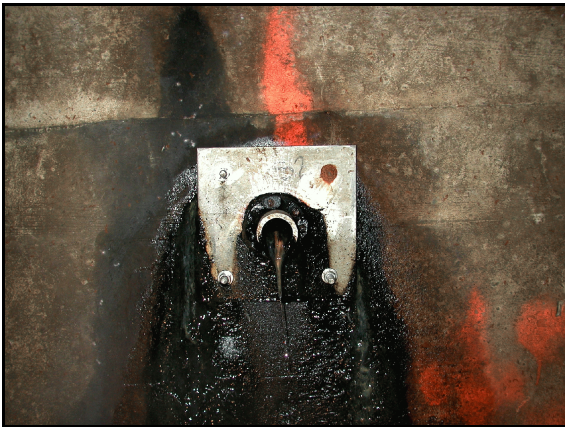
Figure 43.—The weep shows an example of a sulfate (black) related biofilm
