Drainage for Dams and Associated Structures

United States Department of the Interior
Bureau of Reclamation

2004

Technical Service Center
Denver, Colorado
2004

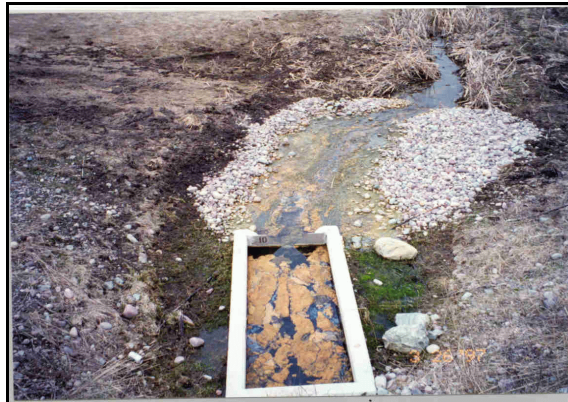
Figure 46.—The weir shows an example of biofouling.

If deposited materials are present, they will be revealed during inspections or monitoring of the drain. The sampling will typically be scheduled for a later date or routine O&M activities. Instructions to O&M personnel should be clear and concise. Figures 42 to 53 contain photographs that show examples of biofouling, biofilms, bacterial growths, mineralization, sediments, and vegetation found in drains during inspections.

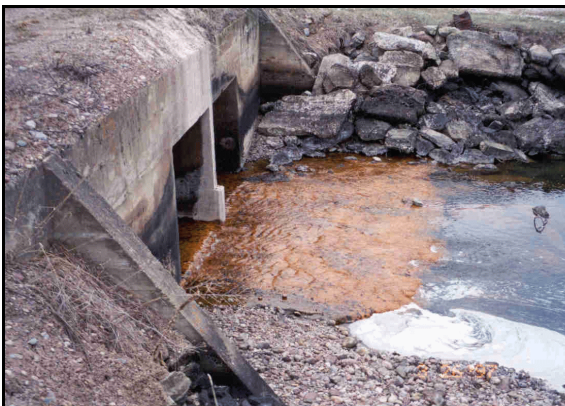
Figure 44.—The outlet shows an example of biofouling.

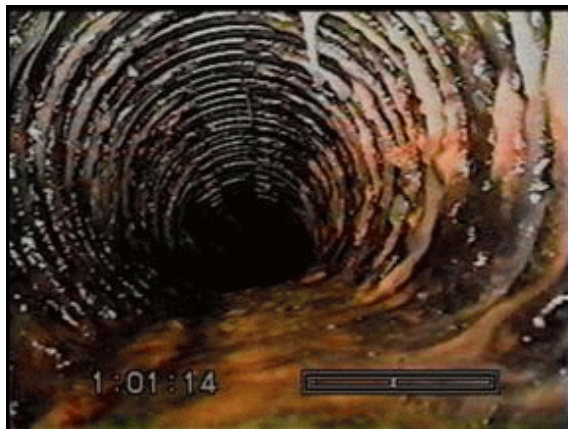
Figure 47.—The bacterial growth is partially covering the inside of 8-inch diameter HDPE pipe.

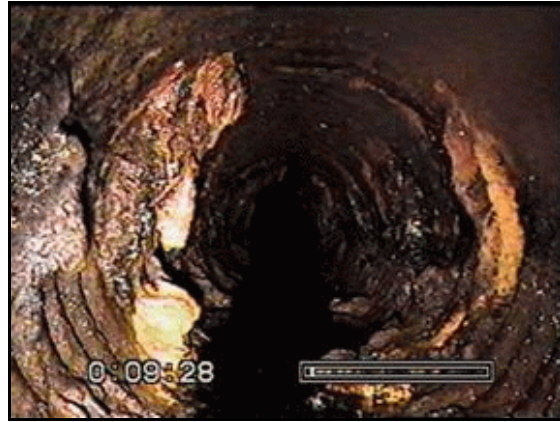
Figure 51.—Calcium carbonate precipitate was observed covering the 18-inch pipe interior about 60 ft upstream of the outfall exit portal of a toe drain.

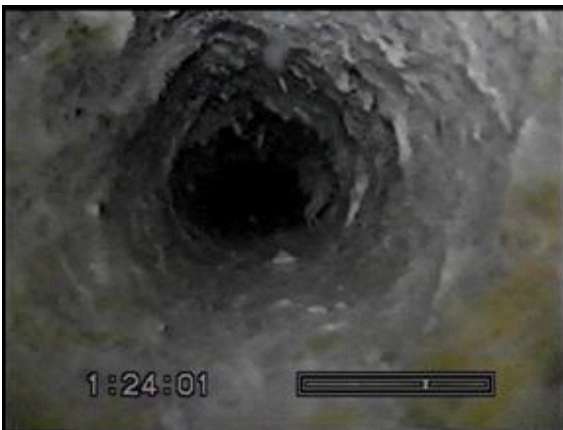
Figure 49.— Bacterial growth is shown completely covering the 8-inch diameter HDPE pipe.

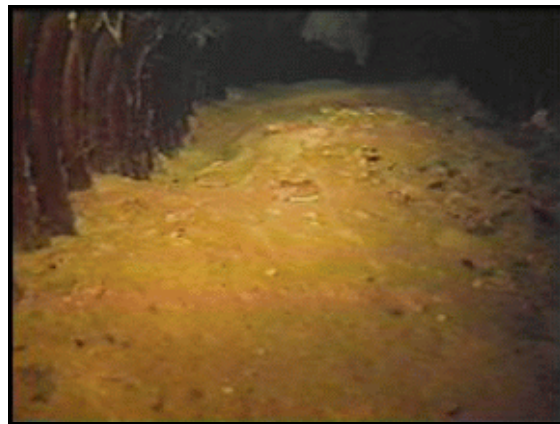
Figure 52.—Sediments were observed fouling the invert portion of a 12-inch diameter HDPE pipe.

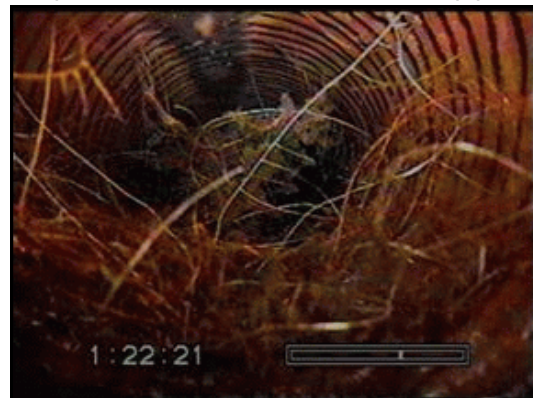
Figure 53.—Vegetative growth shown fouling 8-inch-diameter HDPE pipe.
