A Summary of a NIOSH fire fighter fatality investigation

Volunteer Fire Fighter Dies After Nine-Foot Fall From Ladder -Pennsylvania

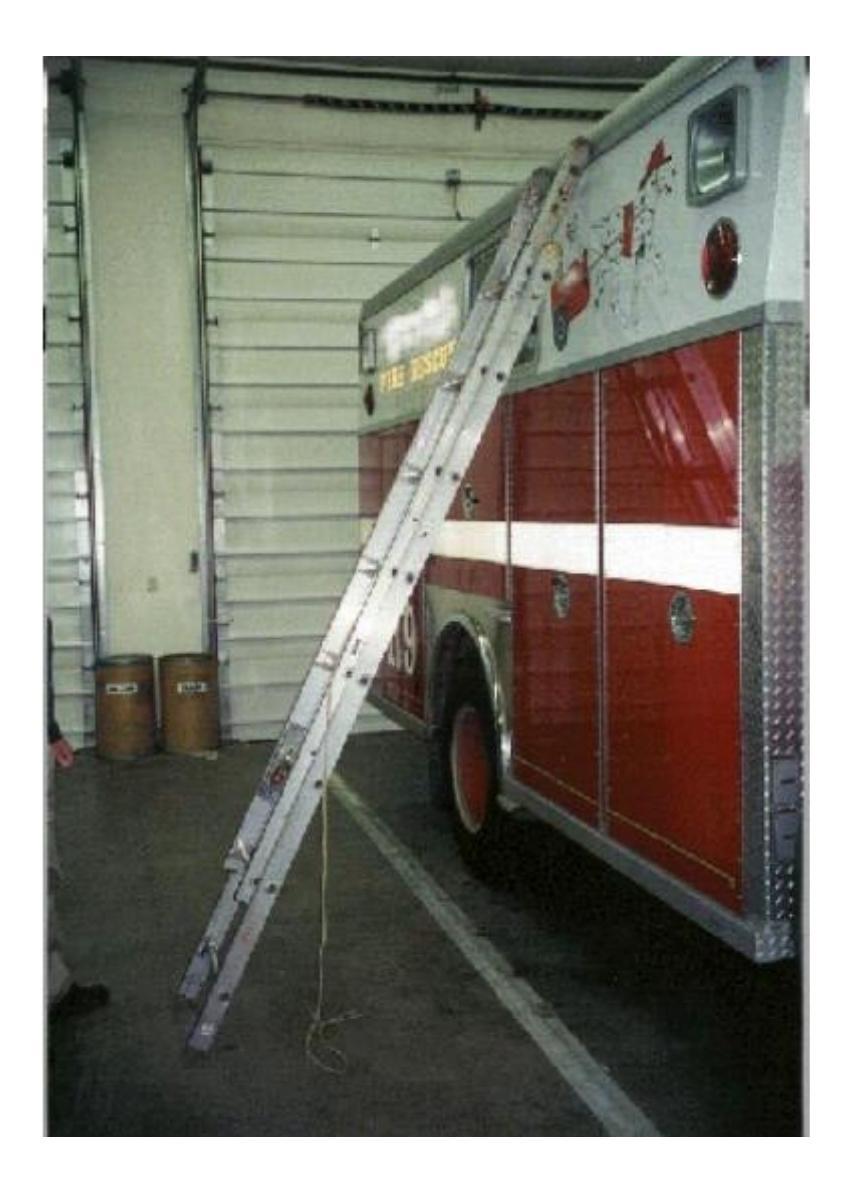
Figure 1. Fire Rescue Truck With Ladder

On January 16, 2000, two volunteer fire fighters and a civilian were replacing a garage door opener with a new door opener that would more reliably handle the weight of the 16-foot garage door. The civilian was assembling the new door opener on the ground while the two fire fighters were to remove the old door opener. The door opener was located on the ceiling in the middle bay of the five bay fire station. A 14-foot heavy-duty aluminum fireground extension ladder was leaned against the side of the fire rescue truck to gain access to its roof, which they used as a work platform. The truck was 9 feet, 4 inches high, but the ladder appeared to be extended to only 9 feet, 2 inches. The two fire fighters climbed the ladder to the roof of the fire truck and removed the old garage door opener. Instead of waiting for the new door opener to be handed up, they both decided to go down the ladder to see if they could help the civilian assemble it. At 1432 hours the victim was in the process of descending the ladder when it kicked out

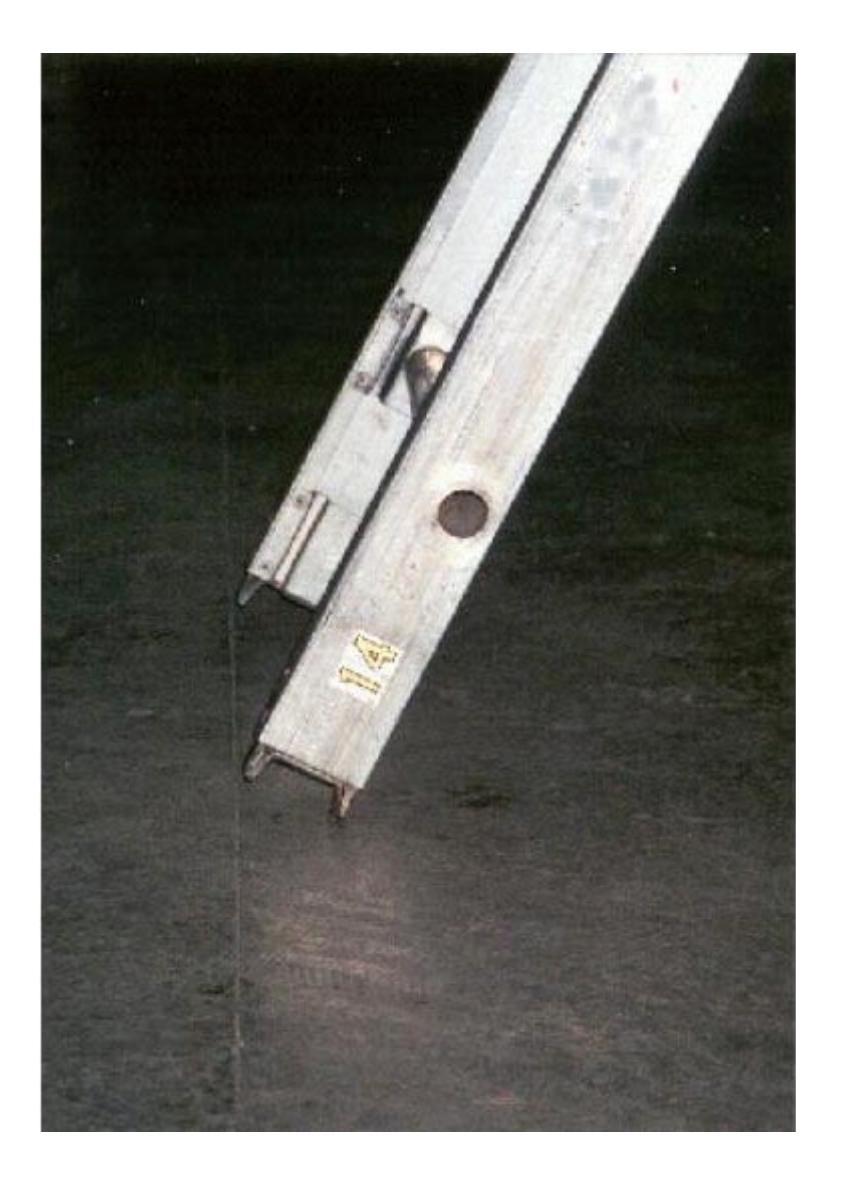
Figure 2. Fireground Aluminum Extension Ladder

Discussion: Occupational Safety and Health Administration (OSHA) standards require that the base, or feet, of portable metal ladders be placed on a substantial base; that they extend 3 feet above the working surface; and that ladders in use be tied, blocked, or otherwise secured to prevent displacement. Training should be provided and include safe work practices for employees to avoid the risk of being injured or killed while working from ladders. The victim was a volunteer fire fighter and was not covered by OSHA regulation. However, fire departments could use OSHA safety standard 29 CFR 1926.1053 as a source of information and provide training to fire fighters who face the risk of a fall from a ladder. Since this incident happened as part of a maintenance activity inside of a fire station, a conventional extension ladder with safety feet would

have been a more appropriate choice than a **REFERENCES** fireground ladder with butt spurs (see Figure 2).
