# **SHOULDER RUMBLE STRIP EFFECTIVENESS:**

# DRIFT-OFF-ROAD ACCIDENT REDUCTIONS ON THE PENNSYLVANIA TURNPIKE

#### January 1997

From a paper presented at the 76th Annual Meeting of the <u>Transportation Research Board</u>. Published in *Transportation Research Record 1573*, TRB, National Research Council, Washington, D.C., 1997, pp. 105-109.

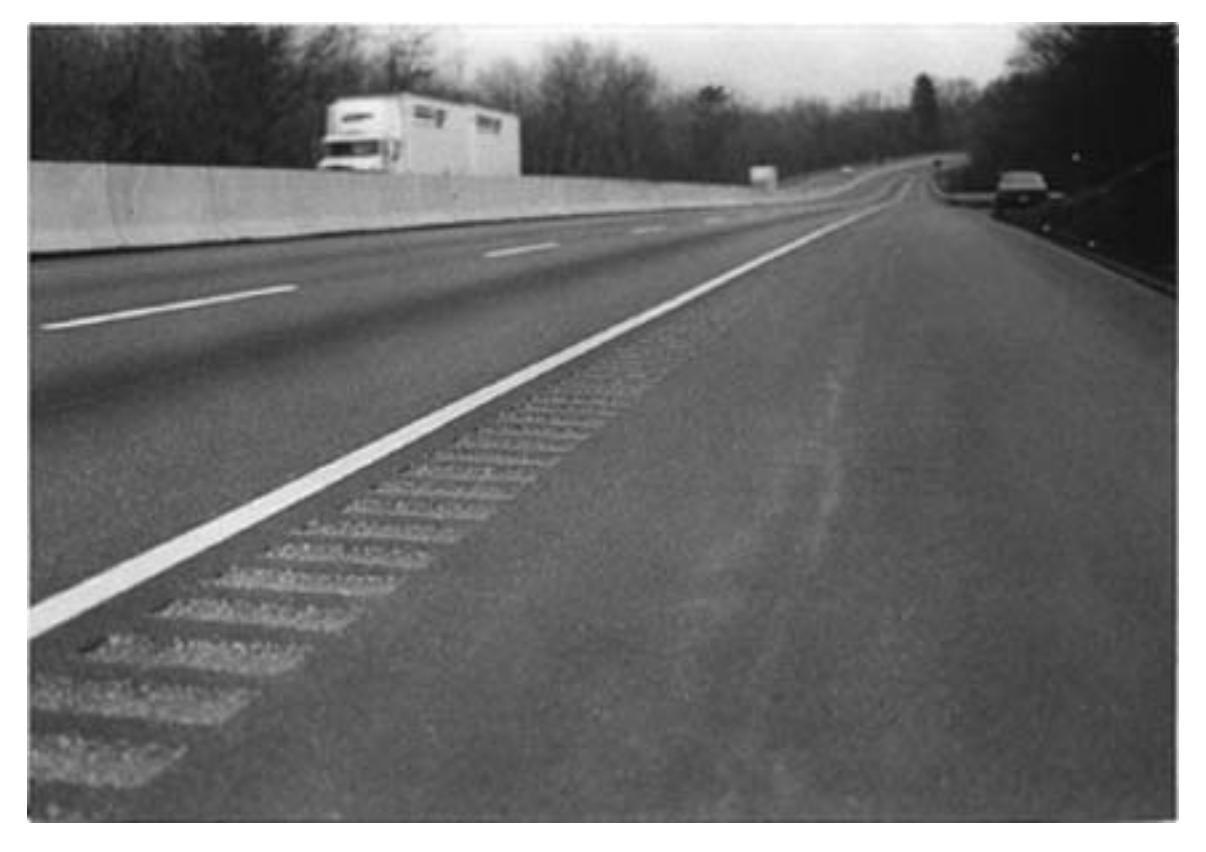
#### FIGURE 1: Sonic Nap Alert Pattern (SNAP) along shoulder of Pennsylvania Turnpike.

All but a few miles of initial SNAP installation projects are now 7x16 in. (17.78 x 40.64cm) indentations, 1 groove per foot (.305m), milled 0.50 in. (1.27cm) deep starting 4 in. (10.16cm) outside the roadway edgeline along the shoulder as shown in Figures 1 and 2. At highway speeds, a high enough acoustic pitch of 95 cps at 65 mph (105 kph) and tactile vibration is produced by vehicle tire drop to alert even truck drivers guite effectively. Turnpike maintenance vehicles can use the rest of the shoulder for routine work and can plow down to bare pavement without "shoes" on the snowplows. SNAP's shallow shape and proximity to passing traffic keeps them cleaned out. When milled in, they have not been wearing or smoothing out after use because material was physically removed in the milling process. Rolled-in or impressed patterns show some smoothing out since material was pushed out of shape for installation and flexible asphalt pavement can recover shape under traffic (4). SNAP has also been successfully "bull floated" into wet concrete but is more frequently milled into the completed concrete shoulders. Specifications now call for milling or grinding the 7 in. (17.78cm) openings. Costs are now less than \$0.30 per foot (.305m) of asphalt shoulder. Installation of SNAP on both shoulders of 1 mile (1.61km) of highway can now be completed in 6 hours for less than \$5000. Completion of the entire 506-mile (815km) system will end up costing the Turnpike between \$2 and \$3 million.

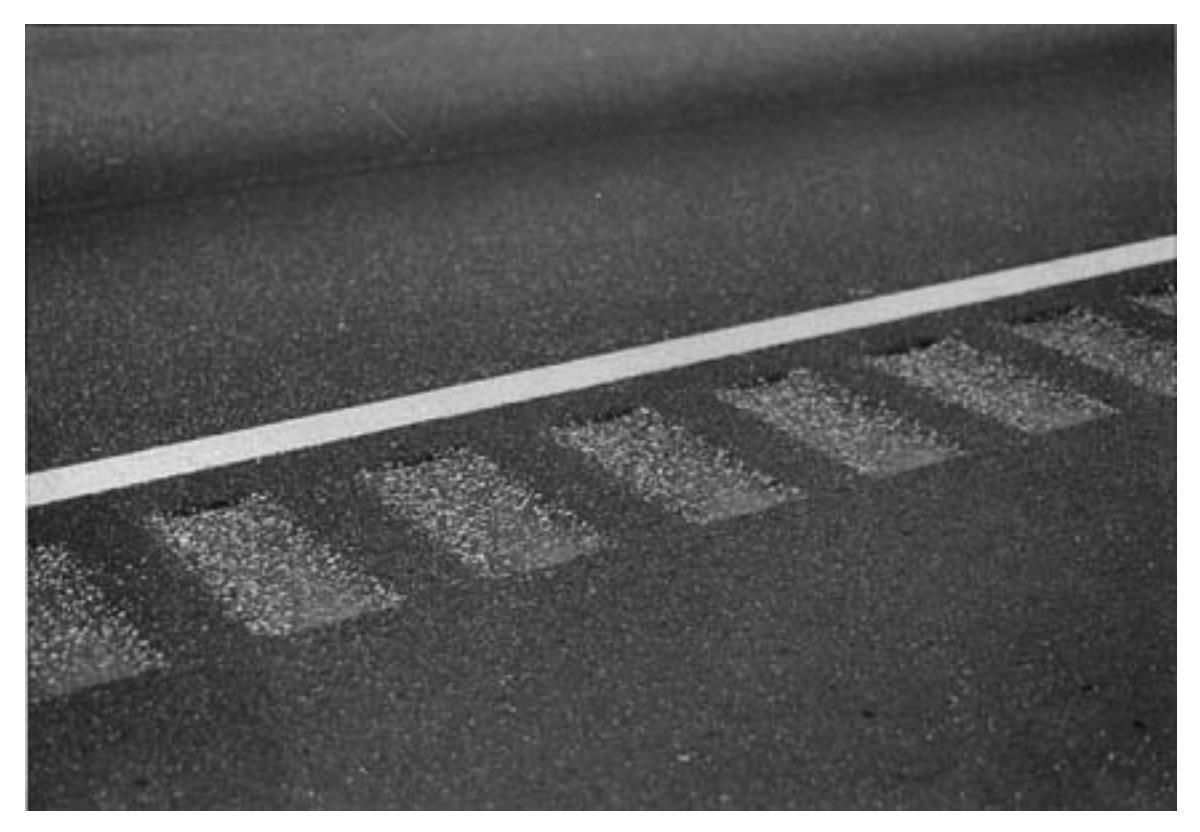
FIGURE 2: Close-up of SNAP.

After the first highway installation, project contractors asked to try milling SNAP in existing shoulders rather than rolling or impressing it in hot asphalt during paving. The milling head was 24 in. (60.96cm) in diameter, which produced a 7 in. (17.78cm) opening while grinding to the specified 0.50 in. (1.27cm) depth. This modified design with 7 in. openings 5 in. (12.7cm) apart was 3 decibels louder (at 89 decibels) than the original rolled-in depressions with 4 in. (10.16cm) openings, which is a perceptible difference.
