GUIDELINES FOR AIRFIELD RUBBLIZATION

By: Mark Buncher, PhD, PE Director of Engineering Asphalt Institute 2696 Research Park Drive Lexington, KY 40511 USA Phone: (859) 288-4972, <u>mbuncher@asphaltinstitute.org</u>

PRESENTED FOR THE 2010 FAA WORLDWIDE AIRPORT TECHNOLOGY TRANSFER CONFERENCE Atlantic City, New Jersey, USA

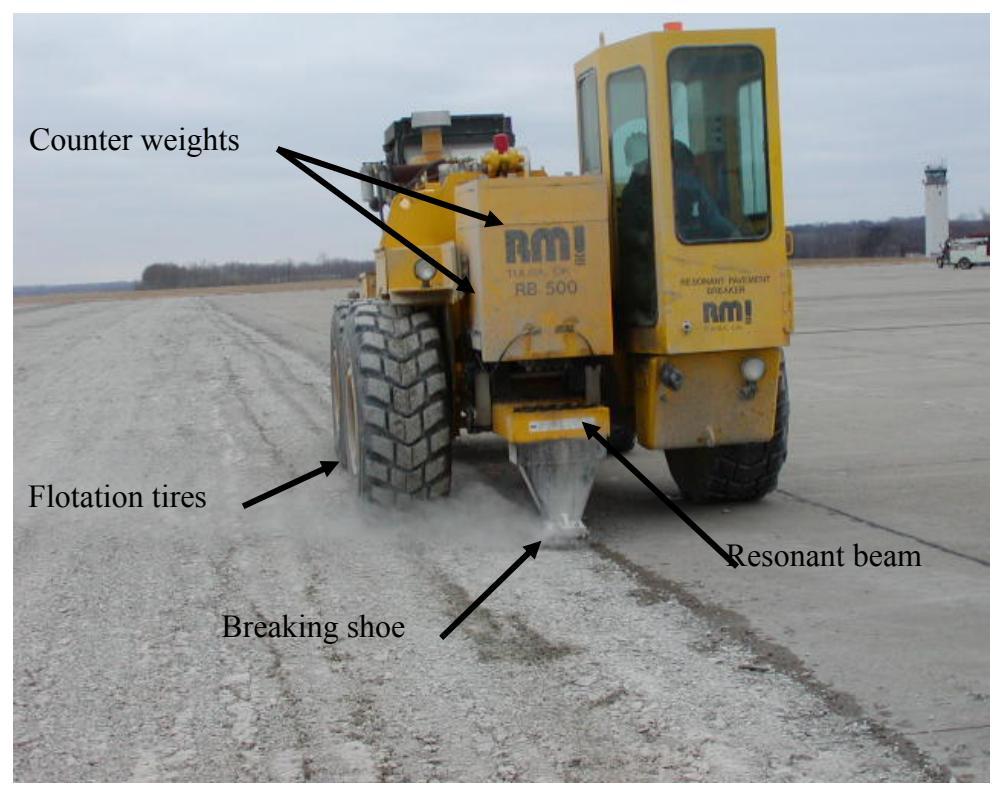
Figure 1. Resonant Pavement Breaker (RPB)

There are two basic types of rubblization equipment; the resonant pavement breaker (RPB) and the multi-head breaker (MHB). Both types can vary in size and weight depending on the model. The RPB is shown in Figure 1 and the MHB in Figure 2. The RPB is a self-propelled breaking unit that produces low amplitude (1/2-1 inch), high frequency (42-46) impacts per second (hertz) through a massive steel beam, often described as a "giant tuning fork." The vibrating foot rubblizes the concrete pavement in narrow strips as the machine moves forward along the unfractured edge of the pavement. The MHB is both a tractor and breaking unit, consisting of numerous pairs of 1,200 lb, 8-inch wide hammers mounted laterally across the breaking unit that produces continuous breakage from side to side. Each hammer pair operates independently and develops between 1,000 and 8,000 foot-pounds of energy (depending upon the drop height selected) and cycles at a rate of 30 to 35 impacts per minute. The MHB travels on unbroken slabs as it moves forward. Production rates for both the RPB and the MHB are generally from 6,000 to 8,000 yd² per unit per work shift, with thick airfield pavements being on the low end of this range.

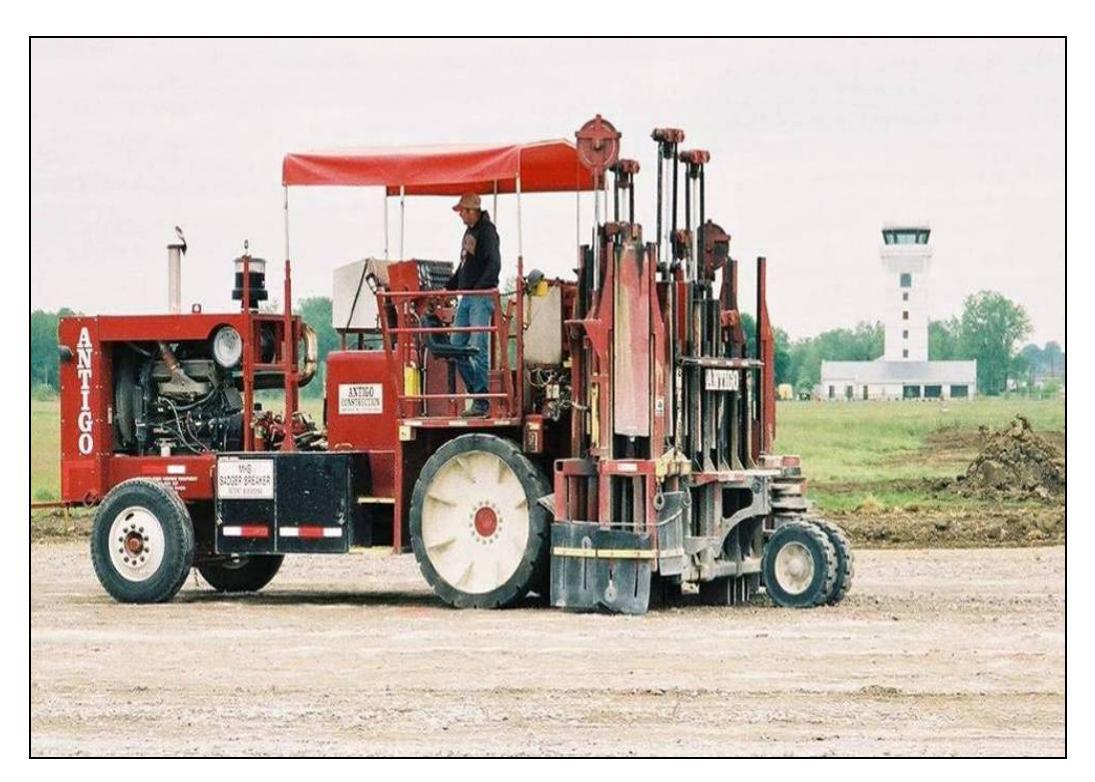
Figure 2. Multiple Head Breaker (MHB)

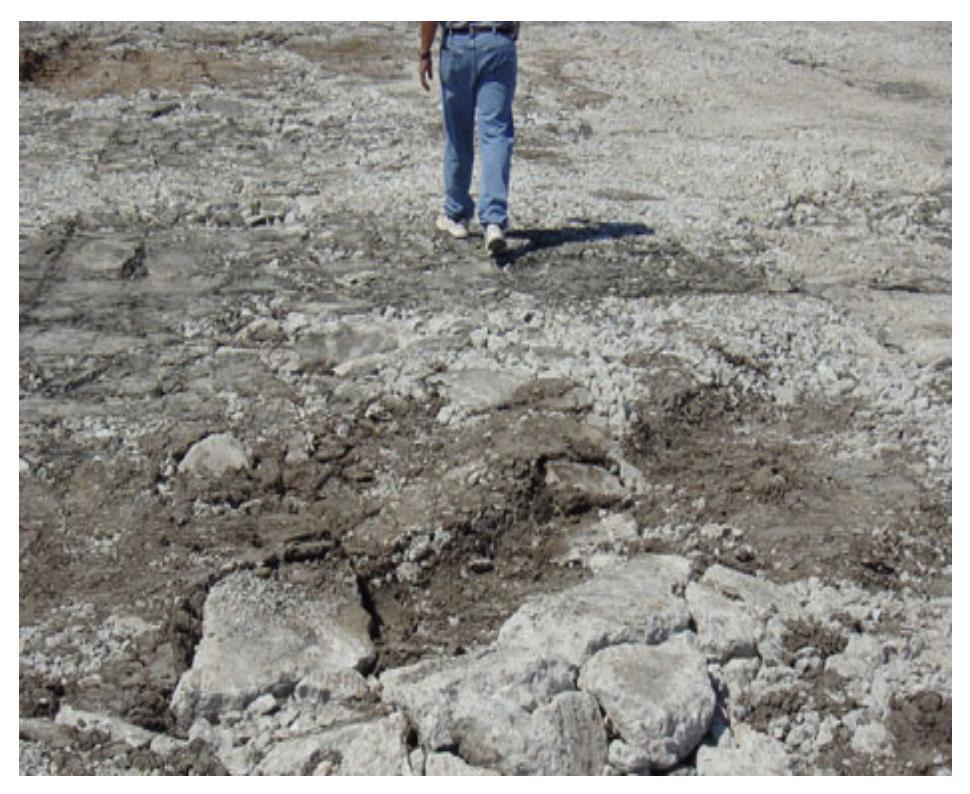
Figure 3, Ineffective Rubblization (Large PCC Pieces) at Pratt Due to Weak Support

The combination of thin slabs (less than 9-inches) <u>and</u> weak underlying support (little to no subbase and soft subgrade that is often saturated) can produce marginal stability and difficulty in effectively rubblizing the PCC to specified criteria. World War II era airfields built in the U.S. and later converted into GA airfields often fit this category. Of the 30 airfield rubblization projects found with this study, 13 had slabs between 6-8 inches thick. On three of these, significant stability problems were reported while the other 10 apparently went well. The three projects with problems were Pratt Airport Runway in Kansas in 2005, USAF Kegelman Auxillary Field Runway in Oklahoma in 2006, and Tullahoma Regional Airport Runway Feasibility Trial in Tennessee in 2007. All three had PCC thicknesses less than 8 inches, no base and a very weak subgrade. Problems that can occur on these "marginally stable" pavements are large unbroken PCC pieces when either the MHB or RPB is used (Figure 3), rutting and "punch-thrus" by the RPB (Figure 4), and shifting/rotation of large PCC pieces by the HMA haul trucks or paving machines when either the MHB or RPB was used. All these lead to full-depth removal and patching of the damaged rubblized and underlying layers (Figures 5 and 6).

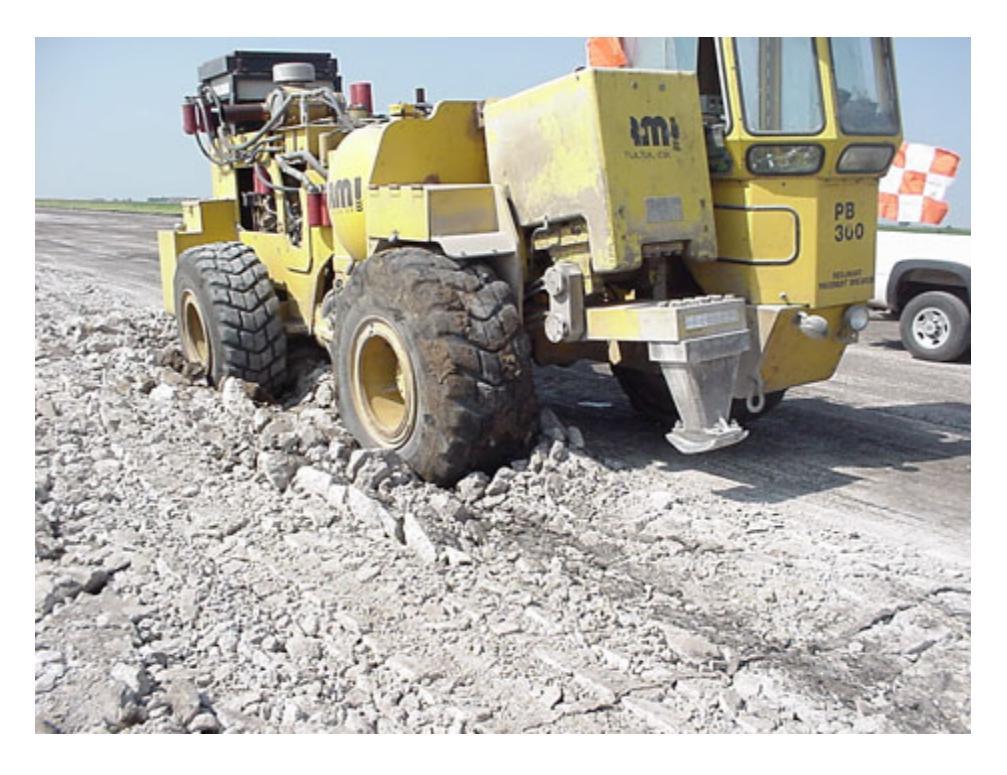
Figure 4, RPB with High Flotation Tires Stuck in Unstable Area at Pratt

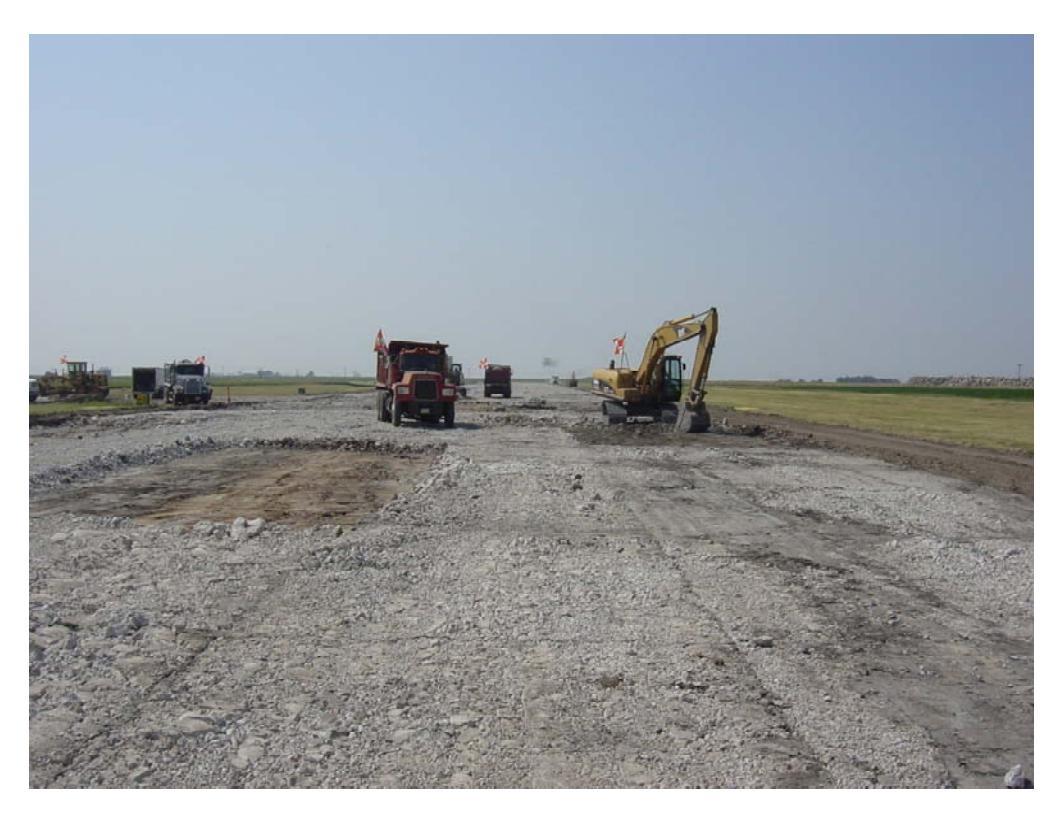
Figure 5, Excavation of Ineffective Rubblized Areas at Pratt for Full-depth Patch

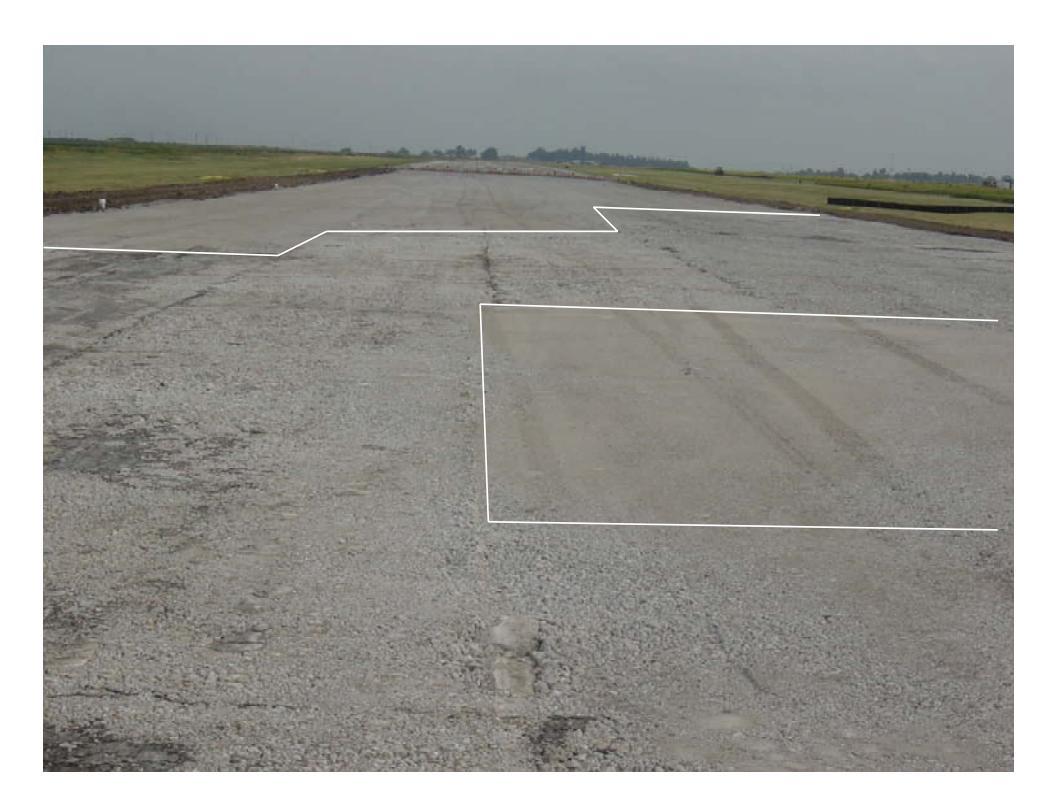
Figure 6, Finished Patched Areas Outlined in White at Pratt using Crushed Aggregate

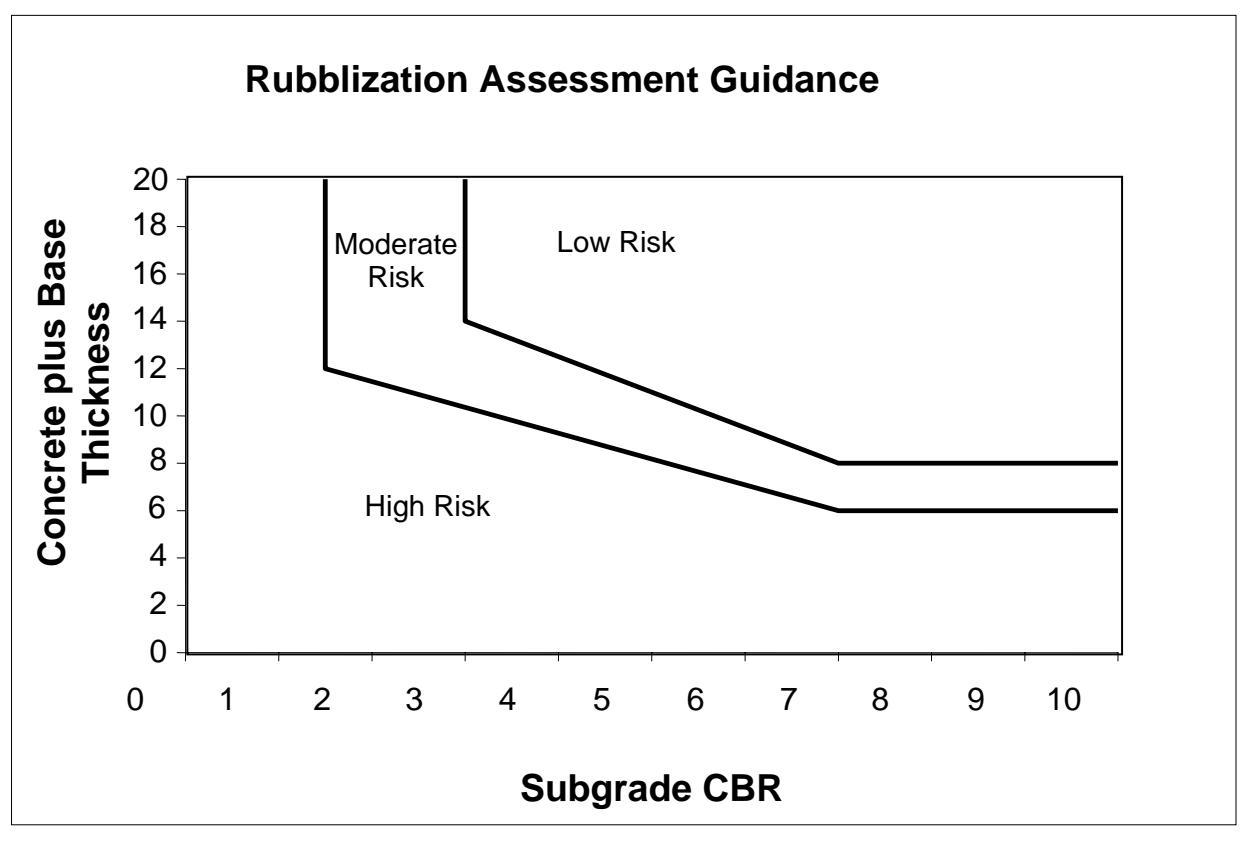
Figure 7, Rubblization Assessment Chart for Airfields

The author and his research team developed an evaluation protocol and risk assessment criteria for potential rubblization projects that contained these marginal support conditions (less than 9" thick PCC, little or no base, <u>and</u> weak and/or saturated subgrade). The evaluation protocol developed was modified from one newly developed by the Texas DOT and the risk assessment criteria were modified from the Illinois DOT.

The protocol collects information on the pavement structure through historical records, a visual condition survey, and in-situ testing that includes ground penetrating radar (GPR), falling weight deflectometer (FWD), and DCP. The GPR survey estimates pavement layer thicknesses, identifies changes in the pavement structure, and detects locations of wet subgrade or saturated voids. The FWD provides data to evaluate the structural condition of the pavement layers and overall pavement strength at one location relative to others. The DCP data serves for validation of base layer thicknesses and base and subgrade strength conditions. Once the evaluation data is collected and analyzed, rubblization can be assessed against the criteria in Figure 7. More details on the analysis are provided in the full report.

This evaluation protocol and chart should be used for evaluating airfield rubblization candidates where PCC slabs are less than 9 inches thick and support conditions are suspect. The high risk zone is indicative of areas likely to be problematic, the moderate risk zone of potentially problematic areas, and low risk zone of areas that should rubblize nicely. Airfield pavements with a substantial granular or stabilized base will fall in the low risk area and are good

rubblization candidates. On the other hand, thin slabs with no base and weak subgrade may fall into the moderate or high risk area. If the PCC plus base thickness is 6-8 inches, and CBRs are 10-14 (off the chart), we believe the appropriate risk level is moderate. The risk levels can be plotted versus station number to assess the relative risk over the entire project. The frequency of FWD and DCP testing, and overall robustness of the evaluation, will depend on a number of factors, including the level of concern based on current knowledge of in-situ conditions. This evaluation procedure allows the design engineer to predict the amount and location of full-depth repairs before the project starts, and once the rubblization process has started to adjust that prediction for the remainder for the project based on actual ability to rubblize under the known conditions. Unfortunately, there is little field data to validate the accuracy and recommended application of this chart. As with any new criteria, these guidelines need to be validated and possibly adjusted based on actual field experience. This can only occur with data collected from an evaluation similar to that prescribed here.

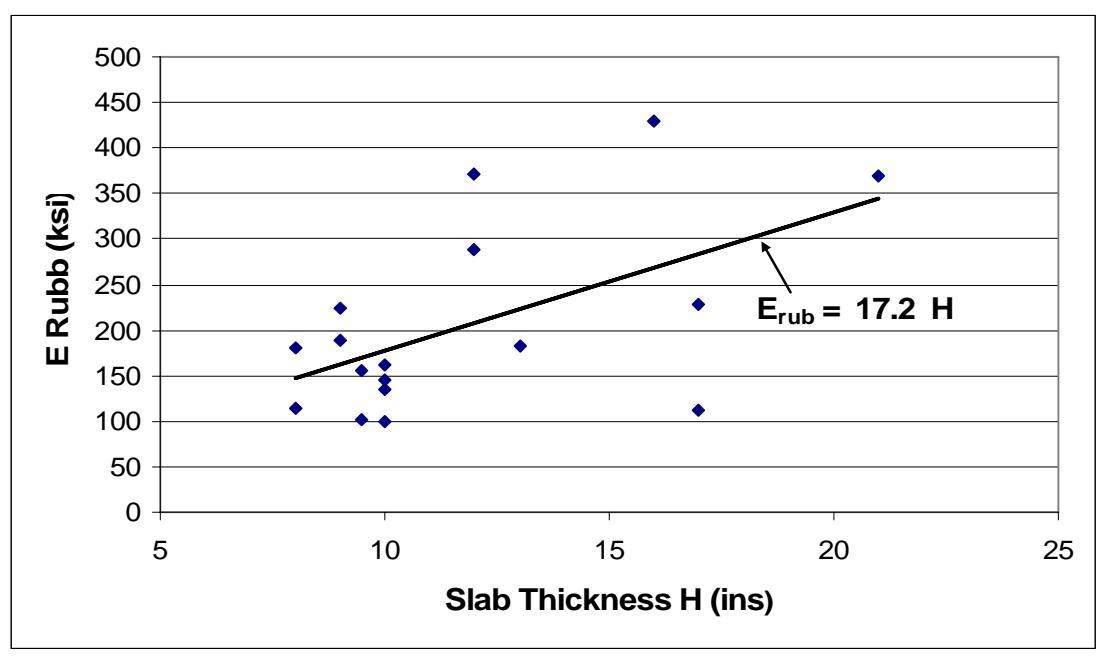
Figure 8. Average Initial Moduli versus Slab Thickness for All Sections Discussed

To determine appropriate design modulus values for a rubblized layer, the literature was reviewed for studies where back-calculated modulus values of rubblized layers (E_{rub}) were determined. In addition, new back-calculations were performed for several projects, providing a total of 17 unique rubblized sections. The 17 data points are plotted in Figure 8 to show the relationship between modulus and slab thickness.

The average in-place E_{rub} value was 205 ksi, with the range being 100-430 ksi. This is significantly stiffer than that of a crushed aggregate base, which is assumed to have a modulus of 50-60 ksi. Rubblized modulus (E_{rub}) appears to be influenced by slab thickness (H), although there was a low R² correlation factor (0.32). Thicker slabs did tend to provide higher E_{rub} values.

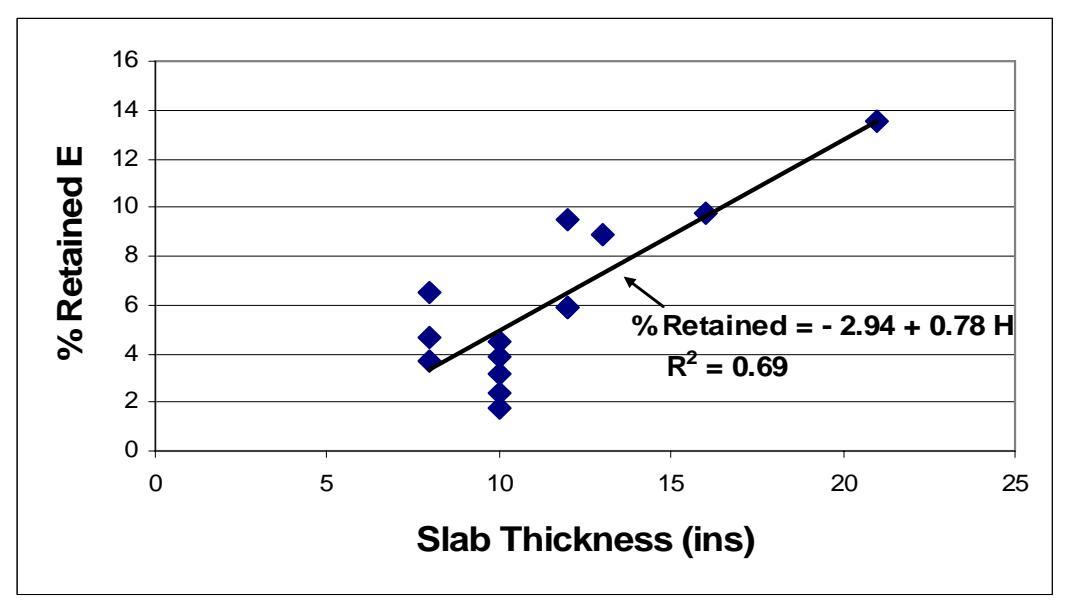
Figure 9. "Retained Modulus" Percent versus Slab Thickness

The concept of "Retained Modulus" was explored. Retained Modulus is defined as the ratio of E_{rub} to pre-fractured PCC modulus (E_{pcc}) or E_{rub} / E_{pcc} . There were 13 sections (of the 17 sections) with sufficient data for determining E_{rub} / E_{pcc} . These are plotted in Figure 9.

Retained Modulus values were in the range of 1.8-13.5%, with an average of 6.0%. The thicker slabs tended to have higher E_{rub} / E_{pcc} values versus thinner slabs. The R² correlation factor between (E_{rub} / E_{pcc}) and (t) was fair (0.69). The concept of Retained Modulus needs to be explored further, but seems to make sense considering that the presence of reinforcing steel, hard aggregates, etc should have the same positive influence on both pre and post-rubblized modulus.
