## tornado outbreak of 2011

## IN ALABAMA, GEORGIA, MISSISSIPPI, TENNESSEE, AND MISSOURI

# **Design and Construction Considerations**

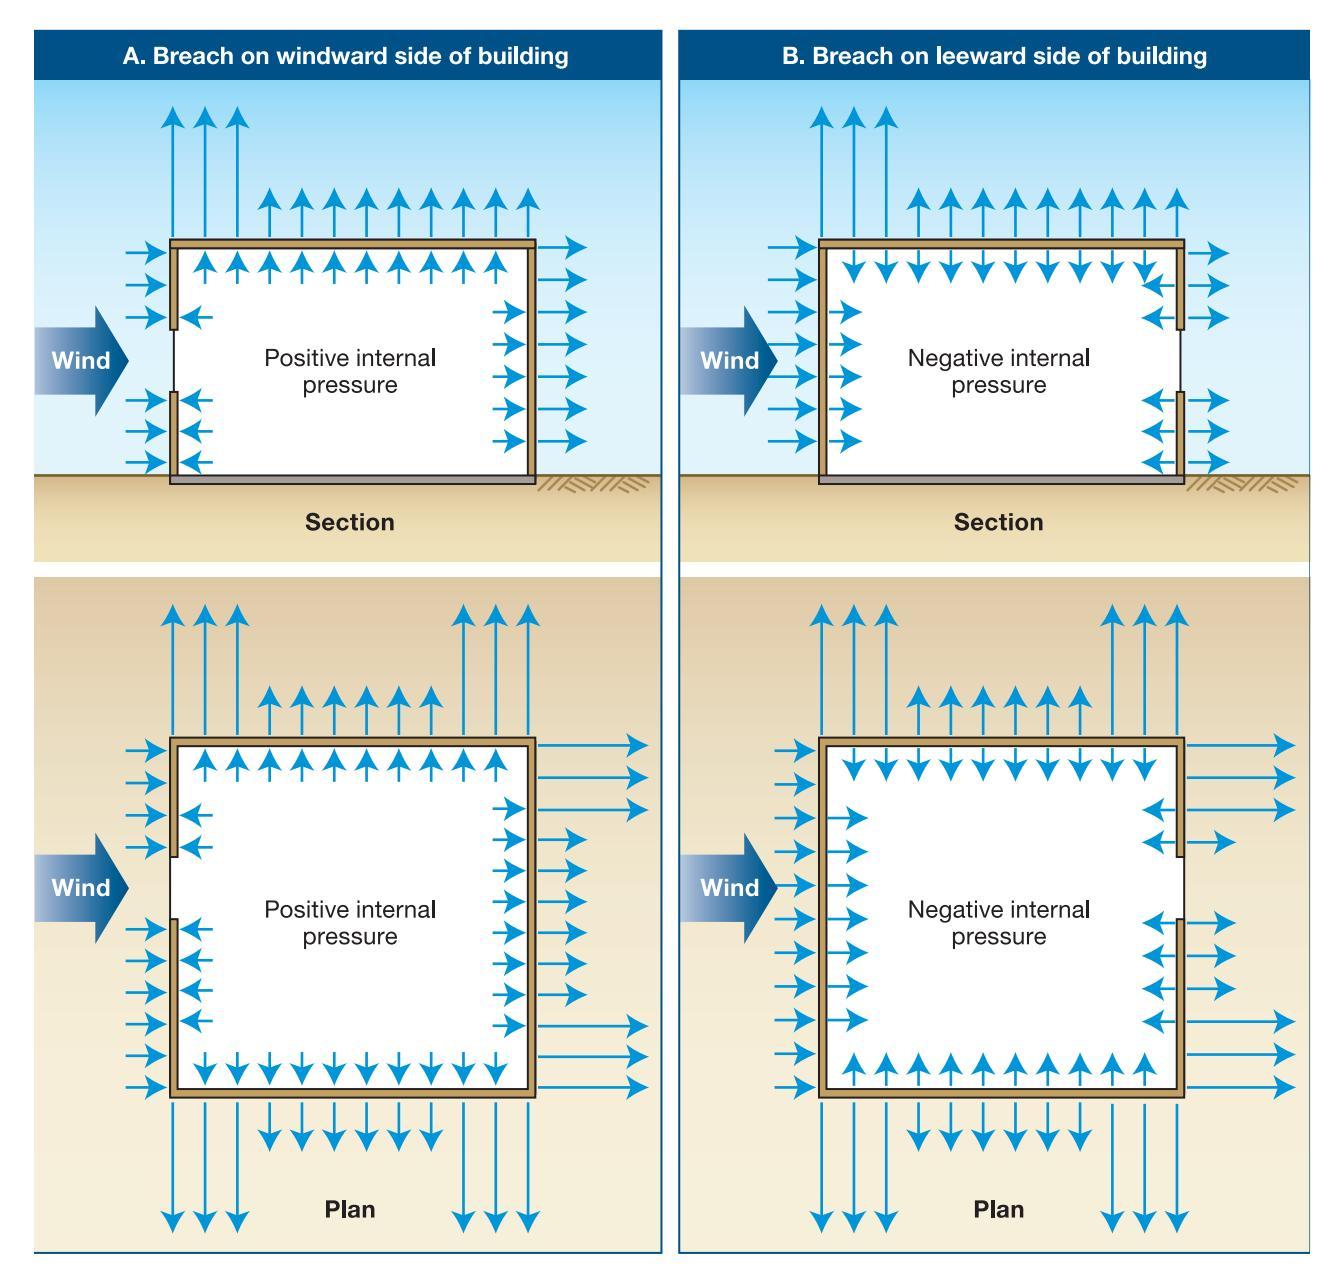
Figure 3-1: Effects of a breach in a building envelope when the breach is on the windward (a) or leeward (b) side of a building, shown in plan and section views SOU RCE: HTTP:// .WBDG.ORG/RESOURCES/ENV\_WIND.PHP Figure 3-2: Load path continuity in CMU wall SOURCE: FEMA 577, FIGURE 4-26

Effects of wind on a building include internal pressurization, increased lateral forces, uplift, and external pressures. Internal pressurization occurs when wind enters a building and lateral forces act either inward, created by the wind blowing directly on the face of a building, or outward, due to suction forces created when low pressure conditions occur inside the building. Most buildings are designed as *enclosed structures* with no large or dominant openings in the envelope that allow wind to enter. However, a breach in this normally enclosed building envelope due to broken windows, failed entry doors, or a failed garage door causes a significant increase in the net effective wind loads acting on the building under strong wind conditions. In such cases, the increased wind load may initiate a partial failure or cause a total failure of the primary structural system. A schematic diagram illustrating the increased loads due to a breach in the building envelope is shown in Figure 3-1.

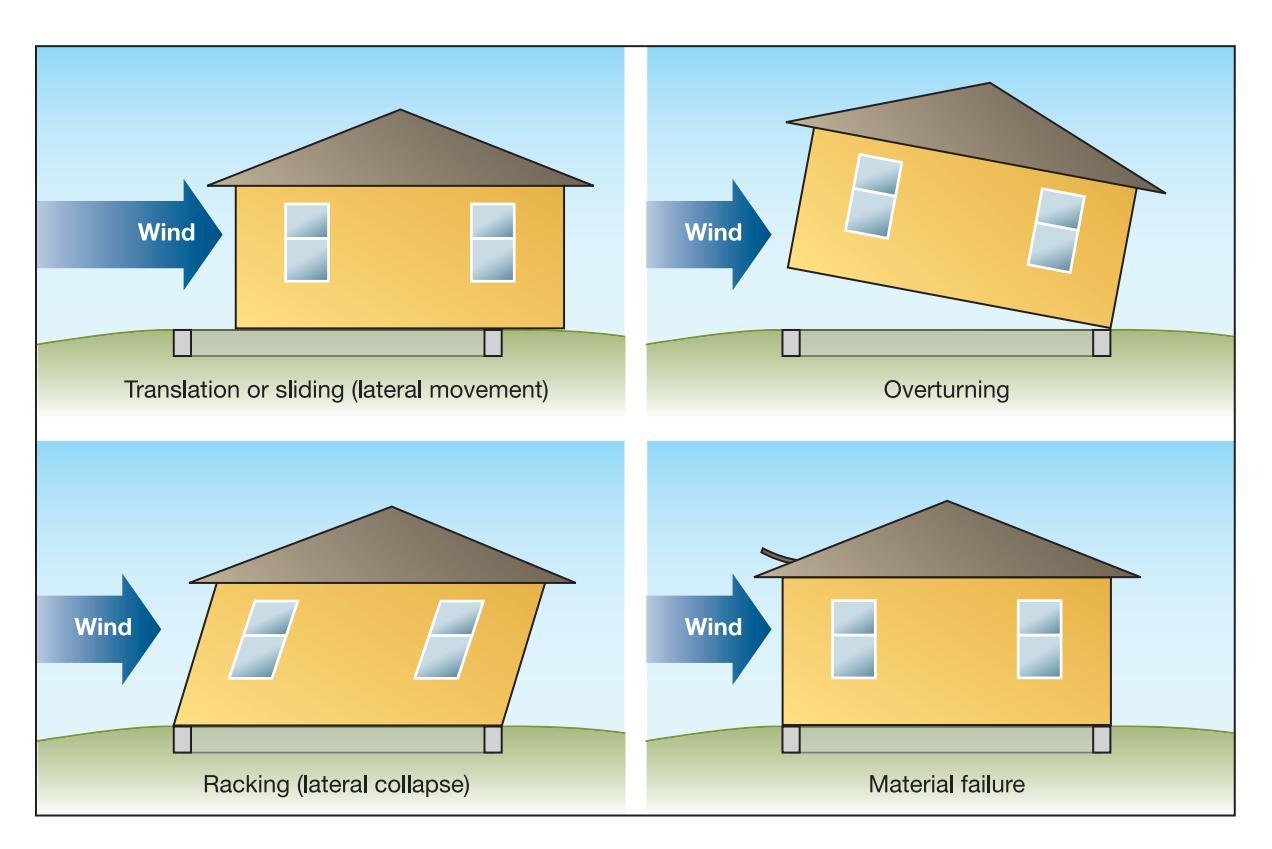
Figure 3-3: Building failure modes in high-wind event SOURCE: FEMA 342, FIGURE 3-3

Winds moving around a structure create vertical and lateral forces that act on the building and cause several different failure modes (Figure 3-3). Uplift is a force caused by the wind accelerating around and over buildings and is affected by the geometric changes in the building shape (Figure 3-4).

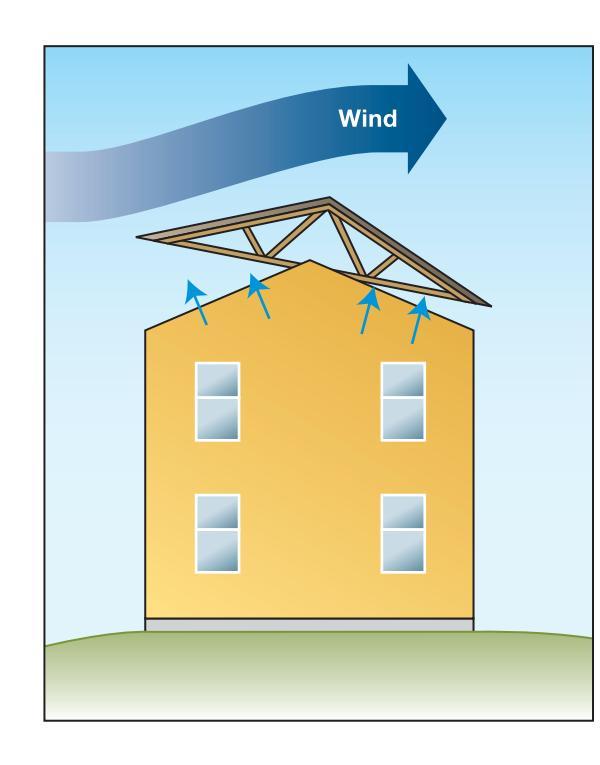
Figure 3-4: Uplift pressures acting on a building

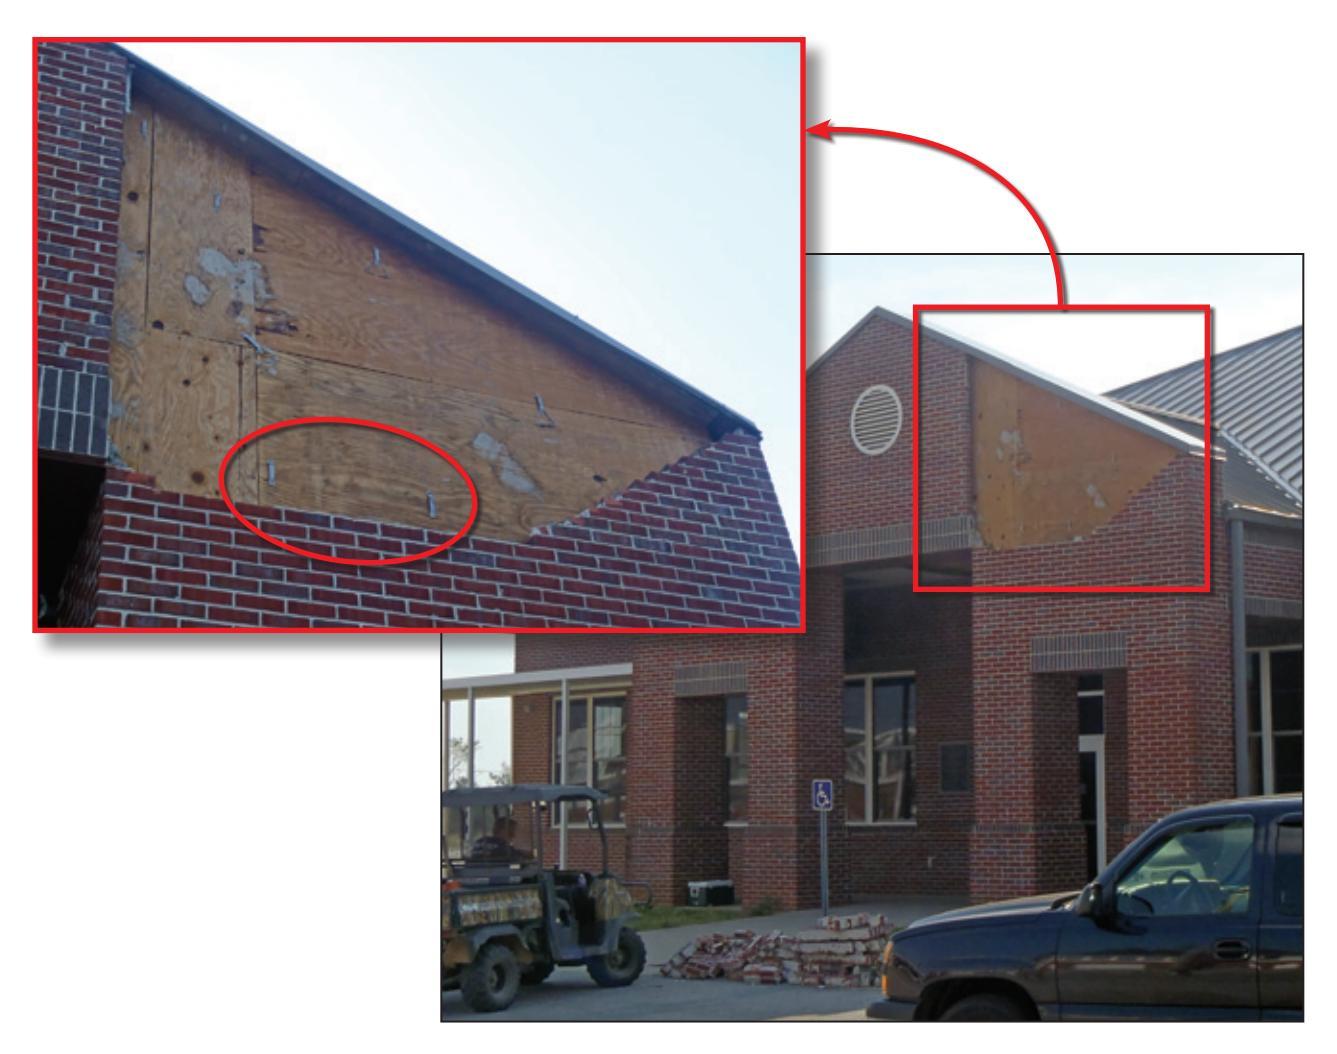
Figure 3-5: Brick veneer blew off this high school cafeteria during the tornado in Phil Campbell, AL. Note that brick ties do not appear to be at the correct spacing, which may have contributed to the failure (shown in red circle in inset).

Some of the damage to buildings noted by the MAT was considered non-structural since only architectural and decorative finishes on the exterior were damaged (Figure 3-5). Engineering

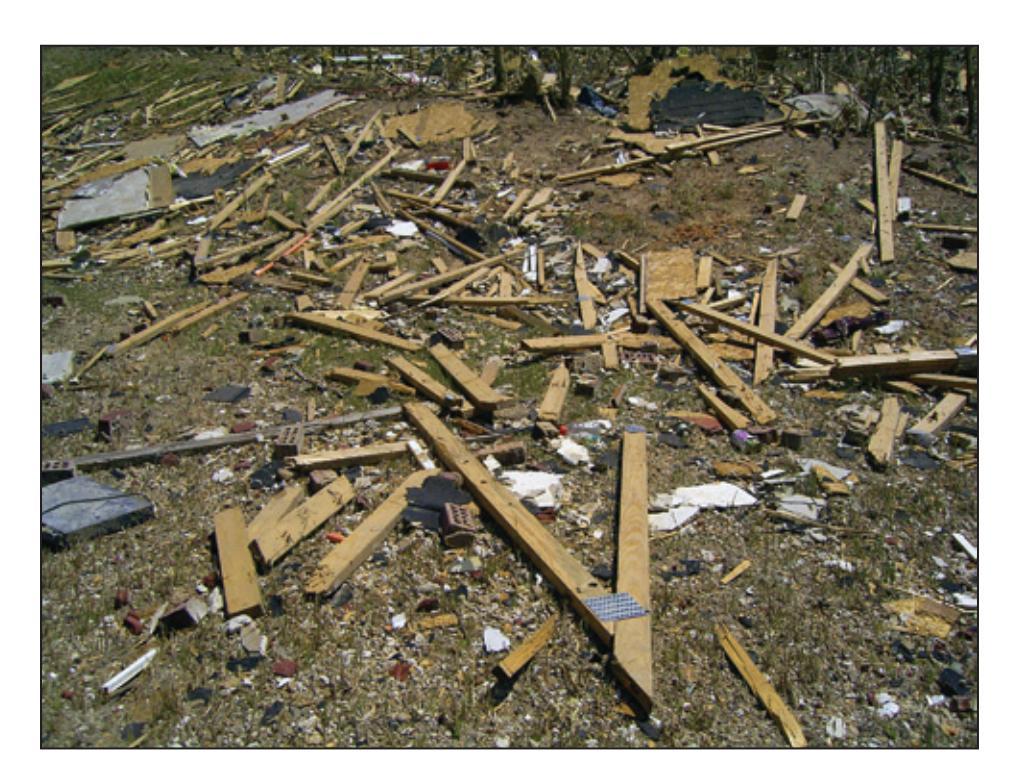
Figure 3-6: Example of small- and medium-sized missiles commonly observed by the MAT (photograph taken near an apartment complex in Tuscaloosa, AL)

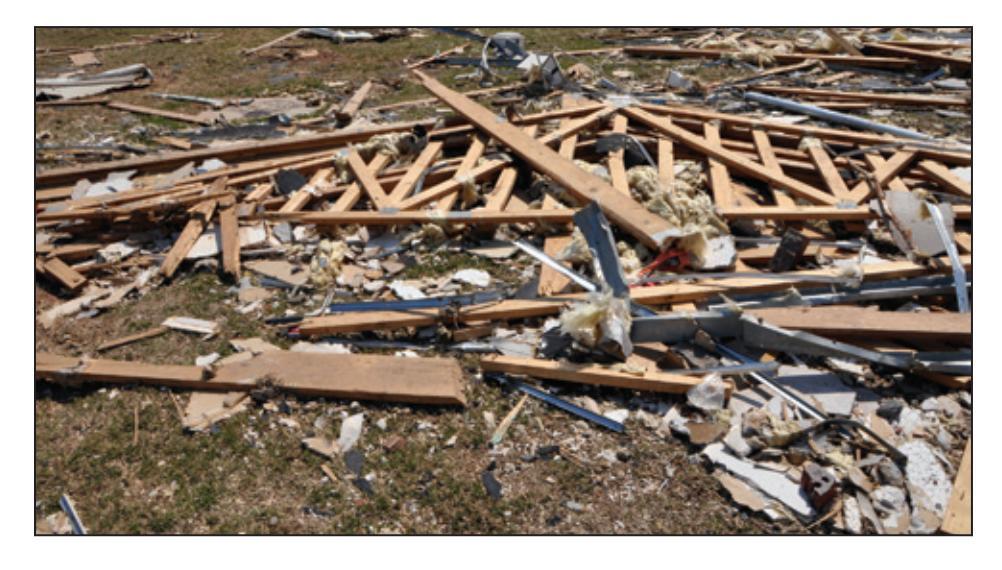
Figure 3-7: Example of medium- to large-sized wind-borne missiles (photograph shows roof trusses displaced from a nearby building in Tuscaloosa, AL)

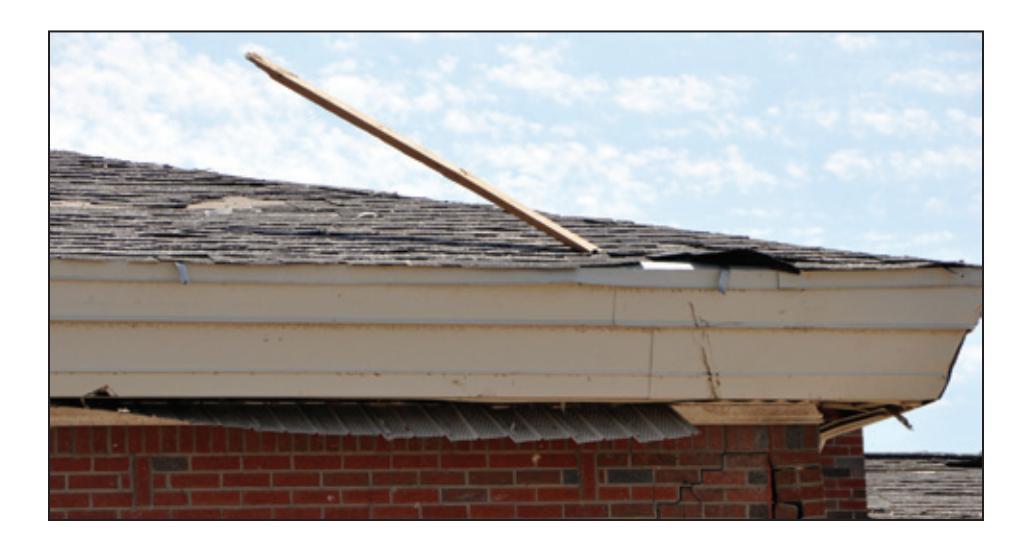
Figure 3-8 shows a 2x4 piece of wood that pierced the roof of Alberta Elementary School in Tuscaloosa, AL. The source of this missile was most likely a dislodged piece of the roof framing system from elsewhere at the school (see also Section 6.1.1).

Figure 3-8: Medium-sized missile that struck the roof of a school building (Tuscaloosa, AL) Figure 3-9 shows a roof truss penetrating a home in Athens, AL, a town just north of Huntsville, AL. The truss most likely originated from the detached garage approximately 100 feet behind this home.

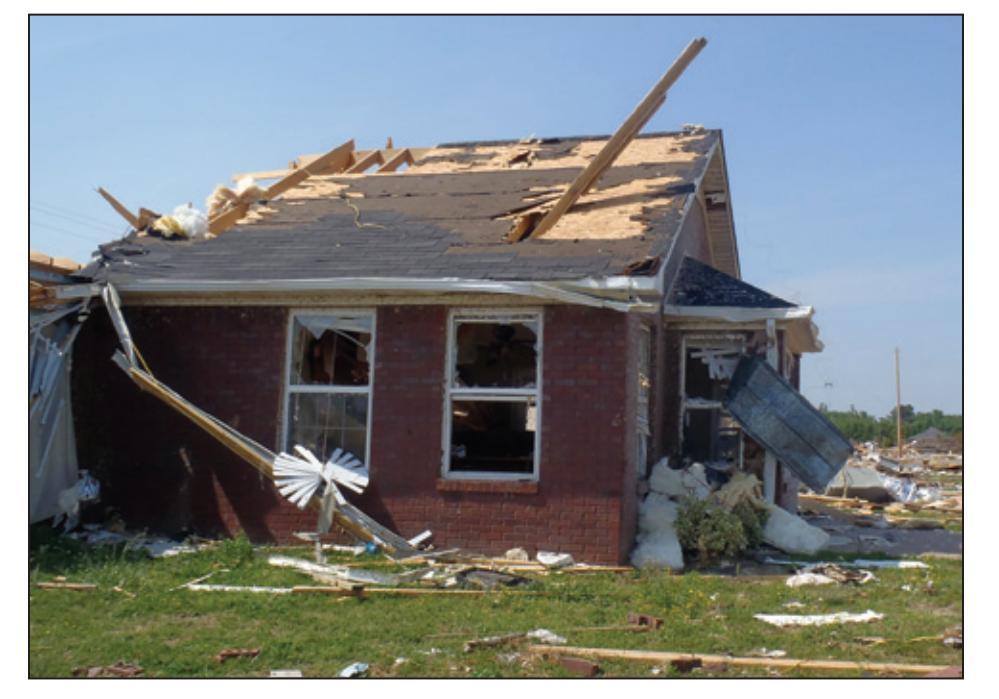
Figure 3-9: Large roof beam penetrated the roof of this home (Athens, AL)

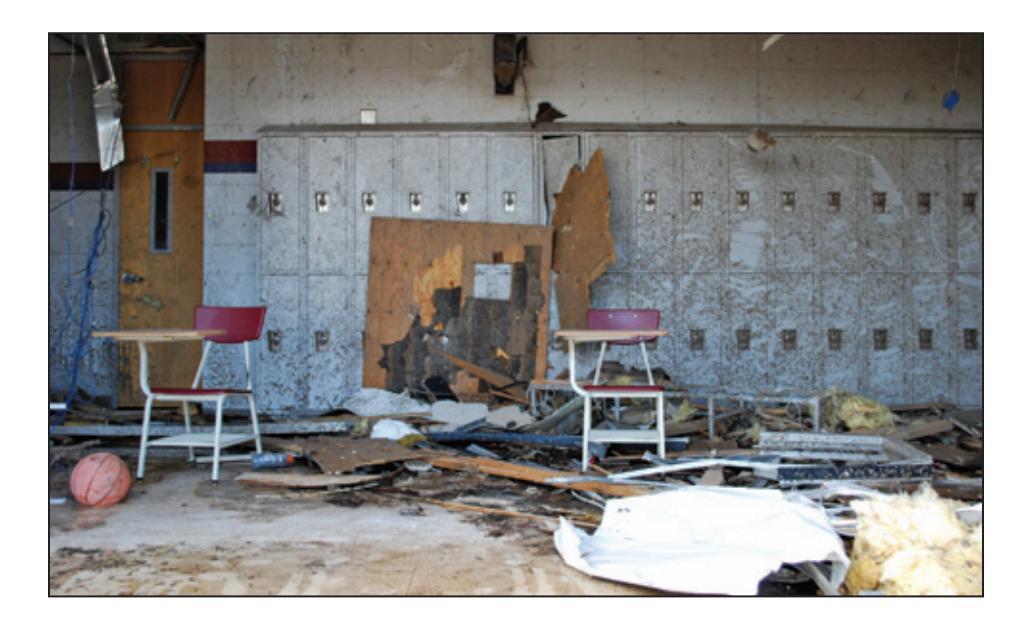
Figures 3-10 and 3-11 show two instances of oriented strand board (OSB) as debris, one striking a school locker (Figure 3-10) and one impacting the roof of a home in a residential neighborhood (Figure 3-11). Poorly fastened trusses, rafters, and OSB have more potential to generate debris than material that is properly fastened.

Figure 3-10: OSB damaged the first floor locker in Joplin High School (Joplin, MO) Figure 3-11: Small pieces of OSB debris penetrated the roof of a home (Harvest, AL)

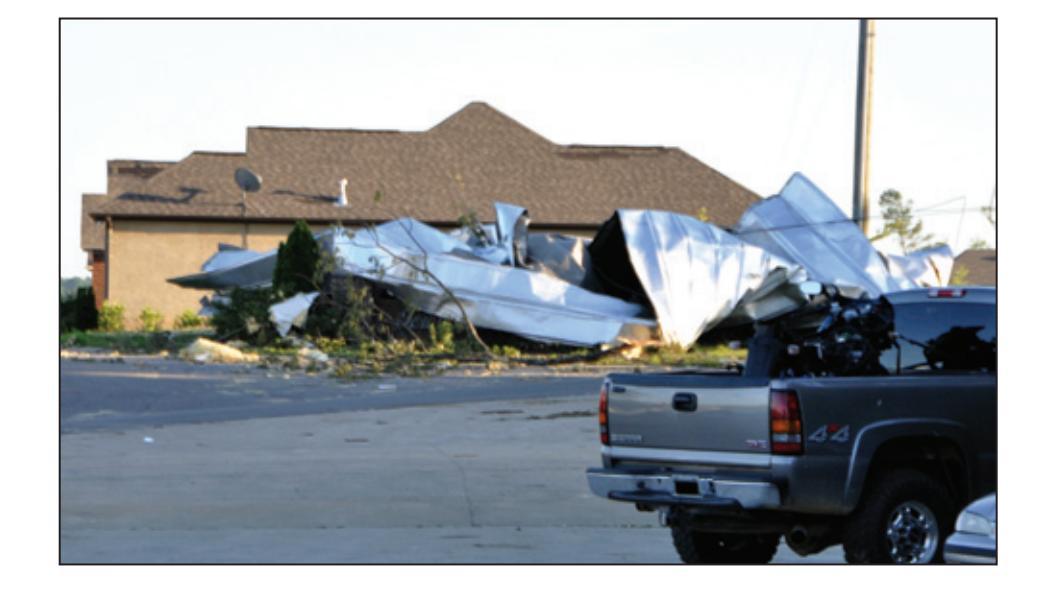
Figure 3-12 shows metal sheathing blown from the roof of the Fultondale Fire Station in Fultondale, AL, and carried nearly 200 feet. Figure 3-13 shows a car in Joplin, MO, with its roof penetrated by a 2x6 framing member. The MAT also observed cars that had become rolling debris during the tornado events, similar to other large debris types.

Figure 3-12: Metal sheathing travelled 200 feet as wind-borne debris and landed next to a building outside of the tornado swath (Fultondale, AL)

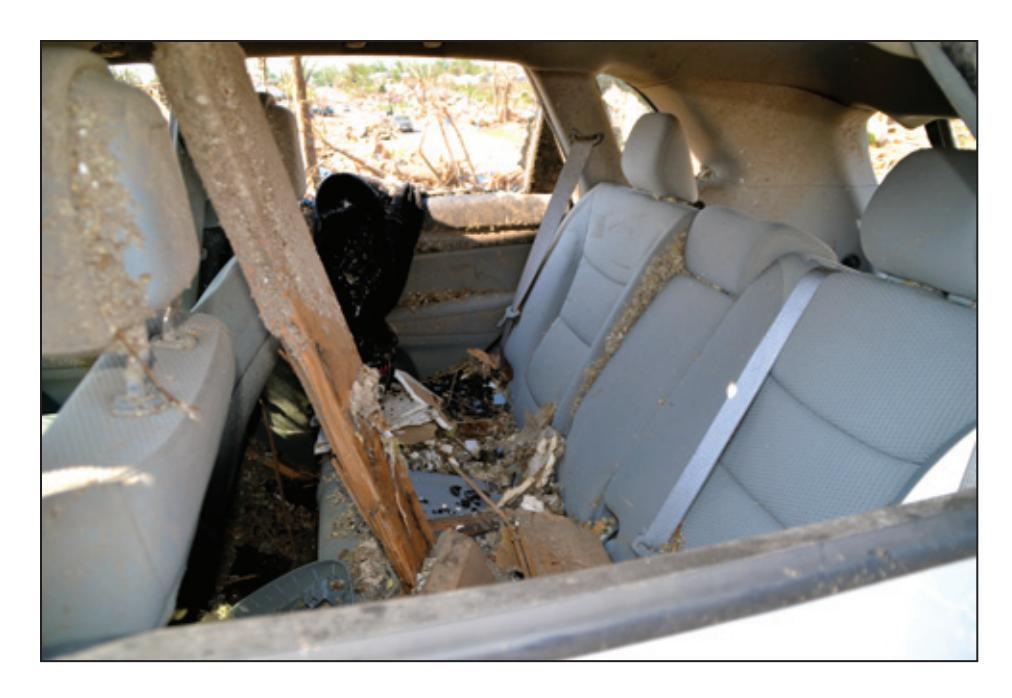
Figure 3-13: A 2x6 missile penetrated the roof and seat of a car in a residential neighborhood just outside the damage track of the violent tornado in Joplin, MO

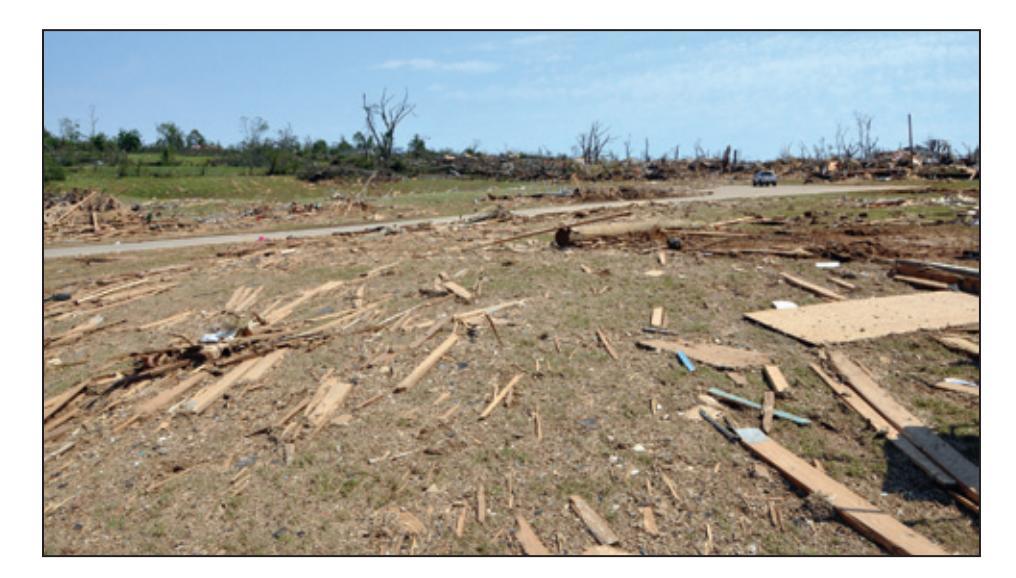
Figure 3-14: Wind-borne debris consisting of wood framing members and plywood sheathing near the Alberta Elementary School, Tuscaloosa, AL

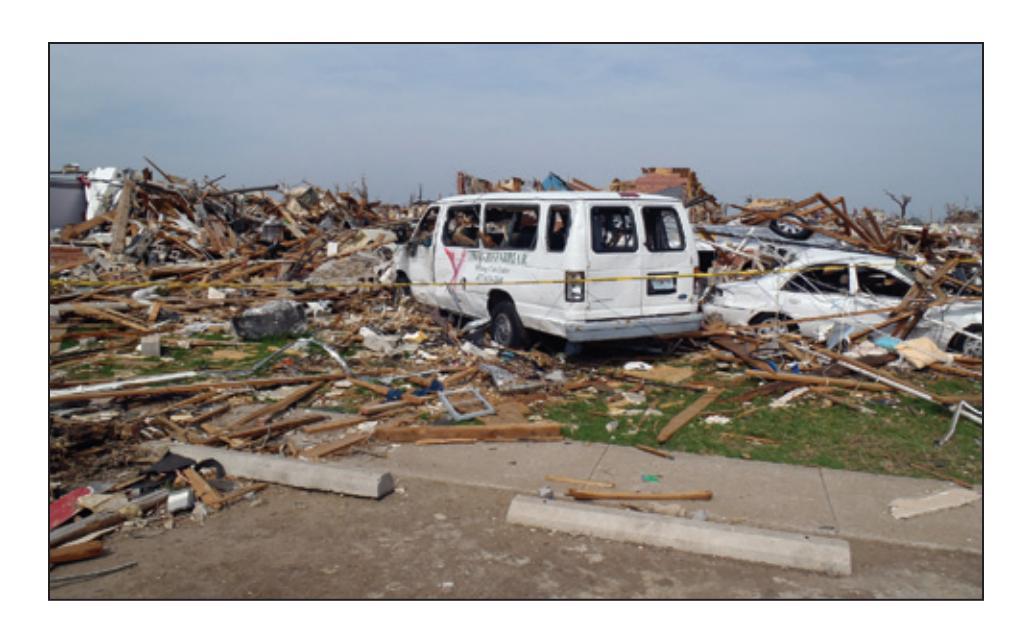
Figure 3-15: Large quantity of windborne debris covering the lawn of a nursing home in Joplin, MO

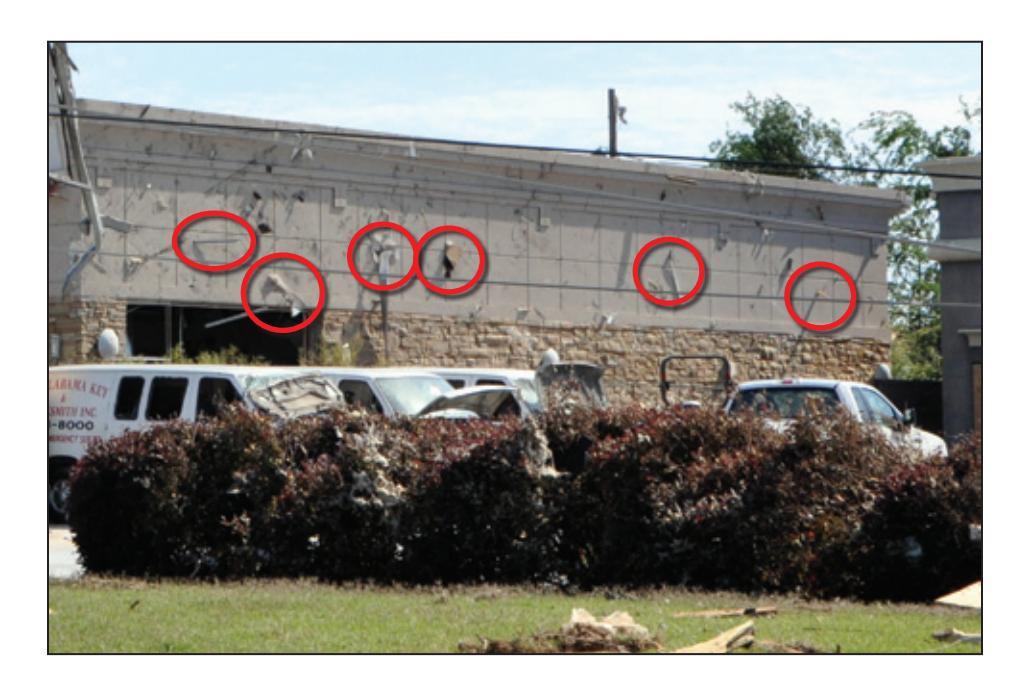
Figure 3-16: Numerous missiles struck the outer wall of this non-residential building, including several that remained embedded (indicated by red circles) (Tuscaloosa, AL)

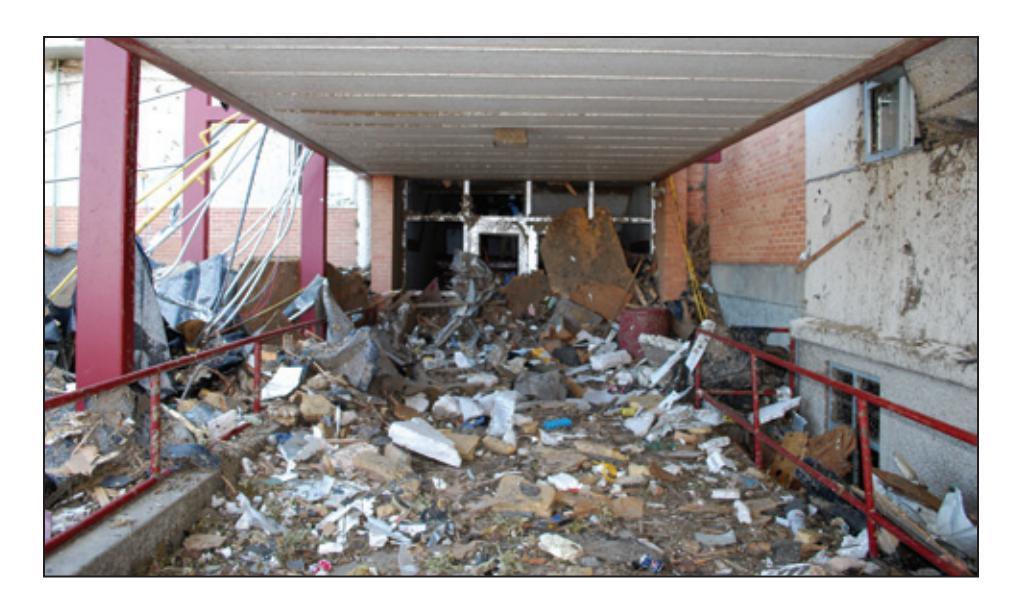
Figure 3-17: Large pile of small- and medium-sized wind-borne debris outside of Joplin High School (Joplin, MO)
