CALLBACK

Number 305

February 2005

Domestic RVSM Reporting

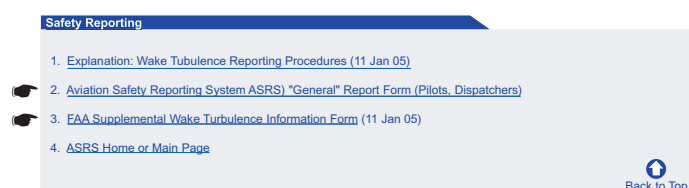
Fig. 2

The "Safety Reporting" section of the FAA's RVSM Documentation Web Page provides links to the NASA ASRS General Report form and the "Supplemental Wake Turbulence Information" form. The links are found at the bottom of the page. (http://www.faa.gov/ats/ato/rvsm_documentation.htm [Fig. 2]).

http://www.faa.gov/ats/ato/rvsm_documentation.htm
