Testing the Energy Performance of Wood Windows in Cold Climates

A Report to
The State of Vermont Division for Historic Preservation
Agency of Commerce and Community Development

August 30, 1996

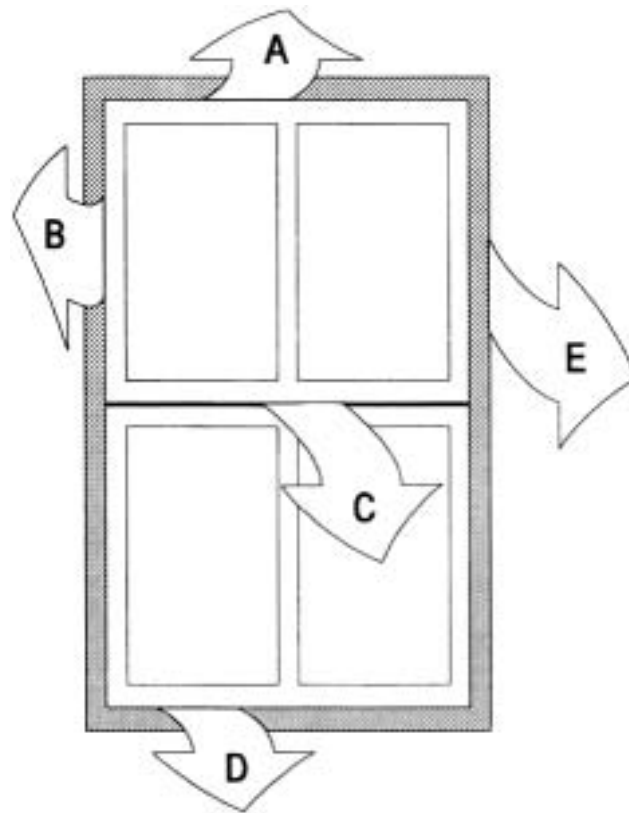
Figure 1: Principle air leakage sites for a typical double-hung window

- A - air infiltration through the head junction
- B - air infiltration through the sash/jamb junction
- C - air infiltration through the meeting rail
- D - air infiltration through the sill junction
- E - air infiltration through and around the jamb from the rough opening

losses were investigated by field and laboratory pressurization testing. Figure 1 is a schematic diagram of a standard double-hung window, showing typical air leakage sites for that style window. Non-infiltrative losses include conduction, convection, and radiation through the materials of the window and were simulated using a computer model.

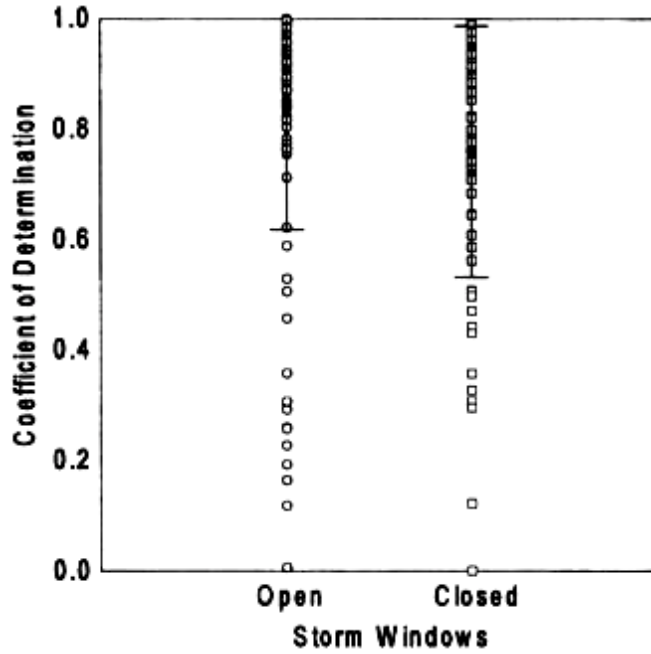
Figure 2: Variability in R^2 values of standard flow model fitted to the field data

A larger variation in R^2 values was observed for those windows allowing little induced air

leakage. For those windows, the effect of even moderate winds on test accuracy increased as both air flow rates and pressure differentials decreased. Table 3 shows wind speeds equivalent to pressure differentials used in the test, with pressures being expressed in both conventional (Inch-Pound) and metric (SI) formats.

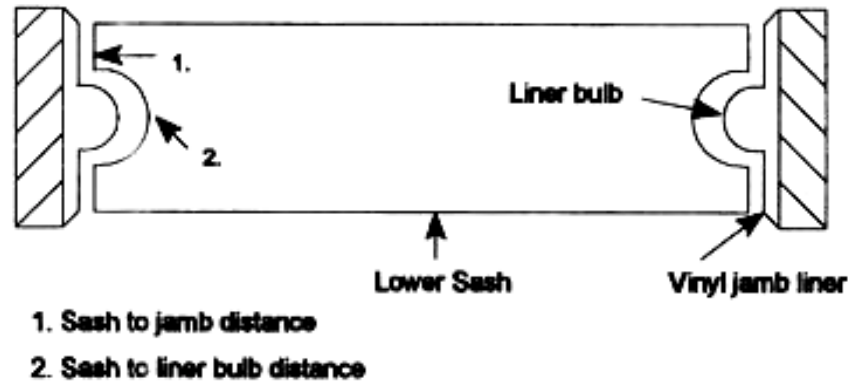
Figure 3: Schematic of lower sash and vinyl jamb liner junction

Separate variance t-tests showed site 12 windows to have significantly larger jamb liner/sash gaps than either site 13 or 7 at a 97% confidence level while having statistically the same $ELA_{s \times 19}$ as site 13. Routing of the sash to accommodate vinyl jamb liners was

done by the same work crew at sites 12 and 13. A different work crew performed the work at site 7. No significant difference in jamb liner/sash gaps was found between sites 7 and 13 at a 98% confidence level while there was a significant difference in $ELA_s \times 19$ between the sites. Based on the limited data, it is inconclusive as to whether differing work crews had a significant effect on installation quality. In an earlier study, few significant differences in leakage rates were observed when differing contractors installed the same type windows in new residential housing in Minnesota (Weidt, 1992). It remained unresolved as to why site 7 window upgrades had better sash leakage characteristics than sites 12 and 13.

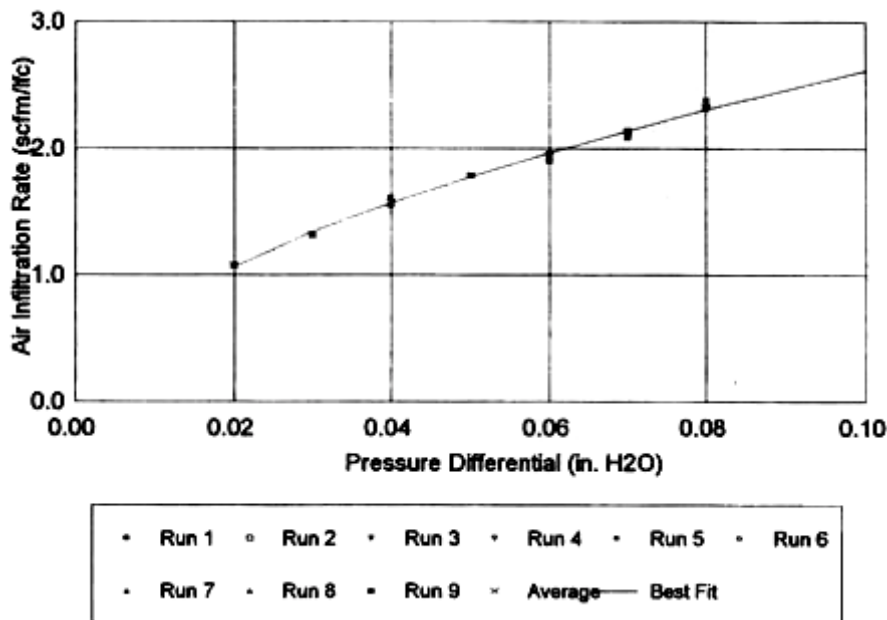
Figure 4: Reproducibility of lab pressurization test results and test device over time

These same sets of data also demonstrate the reproducibility of the test over a period of nine days, resulting in a high degree of confidence in the test procedure and the fan

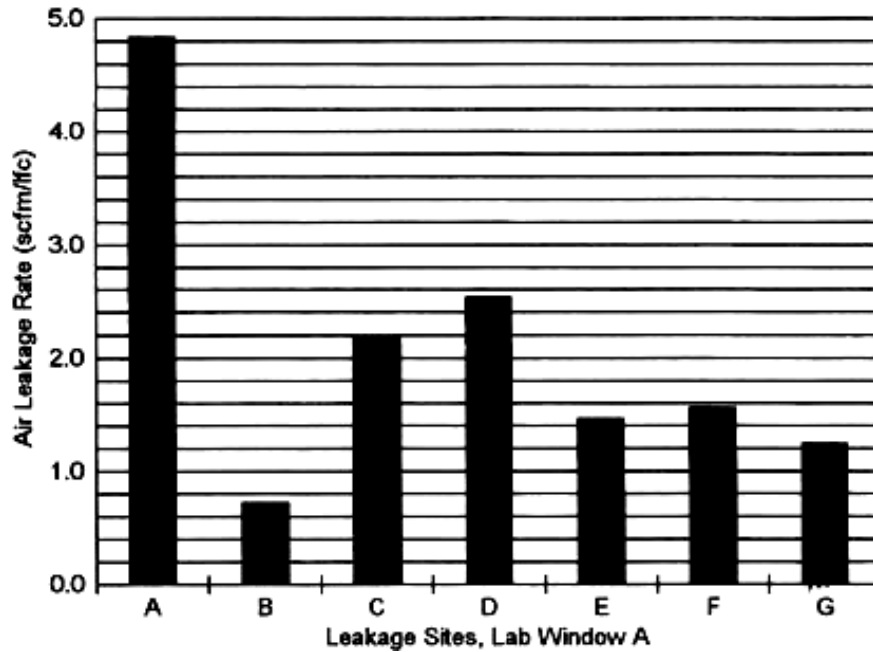
Figure 5: Lab window A leakage rates by site at 0.30 in. H₂O for original condition window

- A - Leakage rate through the total window (extrapolated value)
- B - Leakage rate through the meeting rail
- C - Leakage rate through the upper sash with the meeting rail sealed
- D - Leakage rate through the lower sash with the meeting rail sealed (extrapolated value)
- E - Leakage rate through the sill junction
- F - Leakage rate through the inside edges of the exterior trim
- G - Leakage rate through the outside edges of the exterior trim

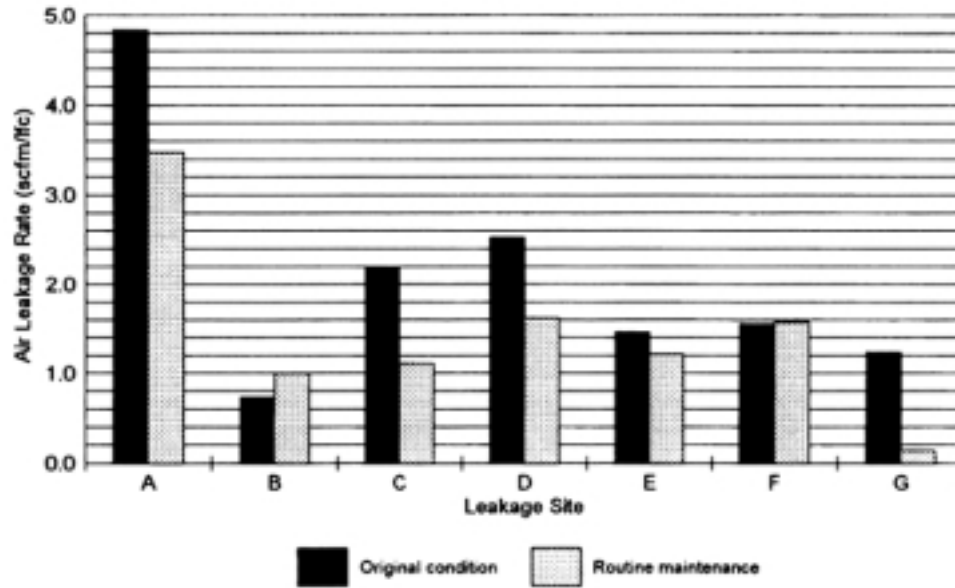
Figure 6: Lab window A sash leakage rates, original condition versus routine maintenance

Leakage rates did not appear additive once again, as noted in the previous section. Effective leakage areas (ELA's) were calculated for leakage sites in both the original condition window and after routine maintenance. Leakage site ELA's are shown in Figure 7. Effective leakage areas appear more additive than leakage rates, overestimating the whole window value by an average of 30%, as opposed to a 65% overestimation when using leakage rates. An anomaly serving to increase overestimation based on ELA's was noted at the meeting rail (site B). Air leakage increased by 25% after routine maintenance, but was expected to remain relatively constant, as leakage rates did at sites E and F. That

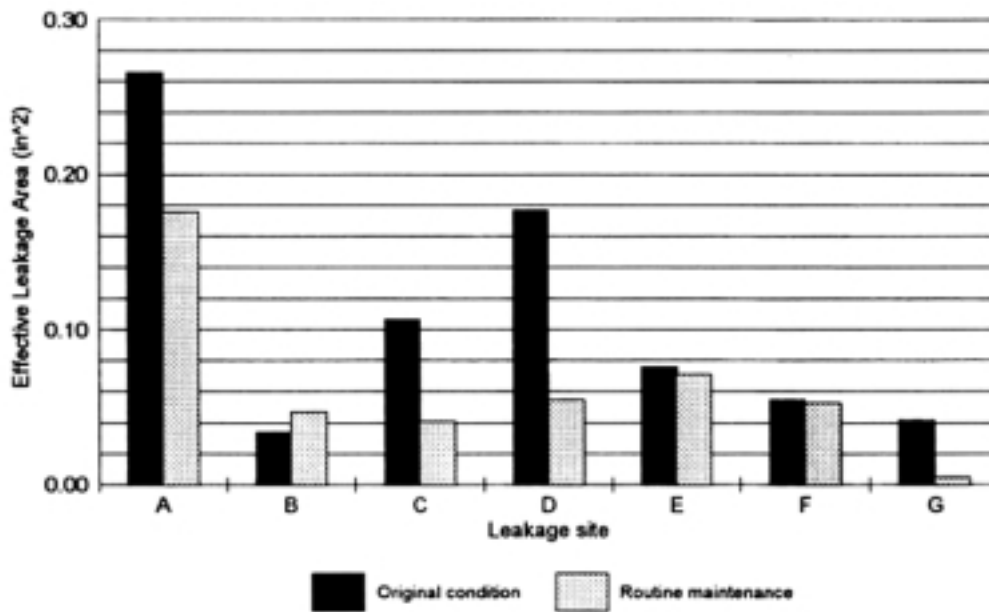
Figure 7: Leakage site ELA's for lab window A, original condition versus routine maintenance

increase was not investigated further as the purpose was to check the approximate additive nature of ELA's.

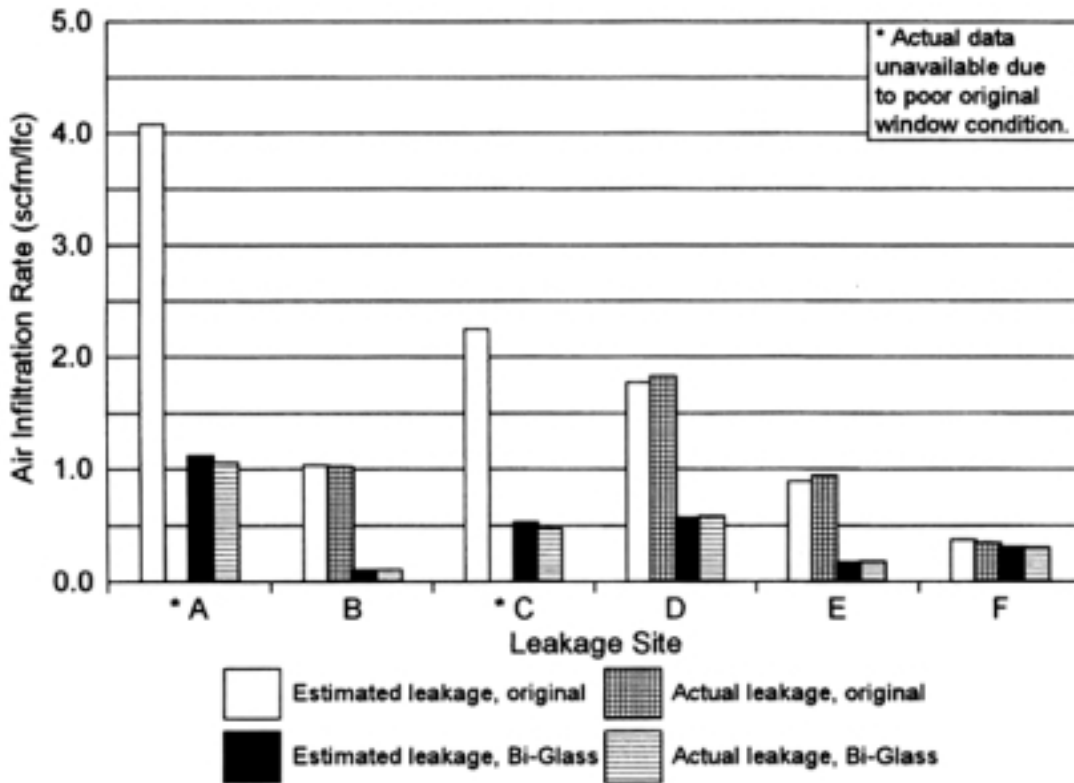
Figure 8: Lab window B, relative air leakage reductions at 0.30 in. H₂O due to Bi-Glass Systems upgrade

Extrapolated leakage rates for lab window B were over 4.0 scfm/lfc, based on regression coefficients for sash leakage at 0.30 inches of water pressure. The Bi-Glass System

- A - Leakage rate through the total window
- B - Leakage rate through the meeting rail
- C - Leakage rate through the upper sash with the meeting rail sealed
- D - Leakage rate through the lower sash with the meeting rail sealed
- E - Leakage rate through the sill junction
- F - Leakage rate through the outside edges of the exterior trim

upgrade decreased the sash leakage rate to 1.1 scfm/lfc, a 360% reduction. While the improvement was significant, the air leakage rate was well above the industry standard for new windows (0.37 scfm/lfc at 0.30 inches of water pressure).

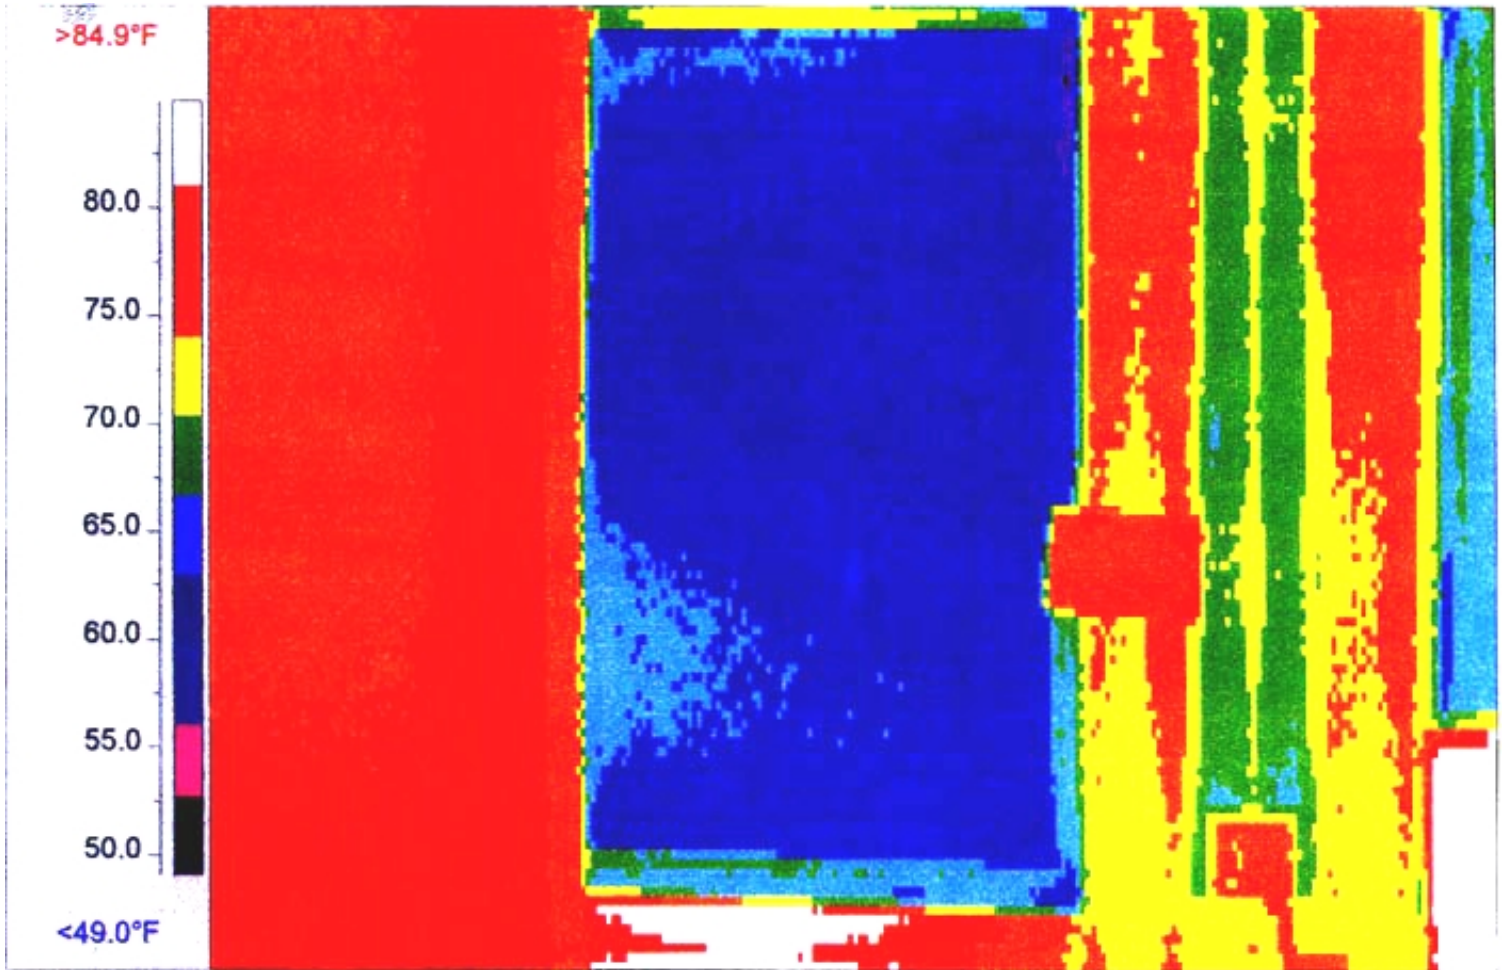
Figure 11: Thermograph of Robinson Hall window with no effective storm attached

Any conclusions based on the Robinson Hall thermographs must consider the effect of unequal space heating. As in most old buildings, hot water radiators were situated beneath the windows. The temperature regimes of the radiators varied considerably from window to window with the coolest radiator being below the coolest window and the hottest radiator being directly beneath the Bi-Glass System upgrade. The radiators likely had a significant effect on the glass surface temperatures, but it is unlikely either of the other two windows would have achieved as high a center of glass temperature as the Bi-Glass window.
