**RESULTS OF THE SECOND
U.S. MANNED
SUBORBITAL SPACE FLIGHT
JULY 21, 1961**

**MANNED SPACECRAFT CENTER
NATIONAL AERONAUTICS
AND SPACE ADMINISTRATION**

This document presents the results of the second United States manned suborbital space flight. The data and flight description presented form a continuation of the information provided at an open conference held under the auspices of the National Aeronautics and Space Administration, in cooperation with the National Institutes of Health and the National Academy of Sciences, at the U.S. Department of State Auditorium on June 6, 1961. The papers presented herein generally parallel the presentations of the first report and were prepared by the personnel of the NASA Manned Spacecraft Center in collaboration with personnel from other government agencies, participating industry, and universities.

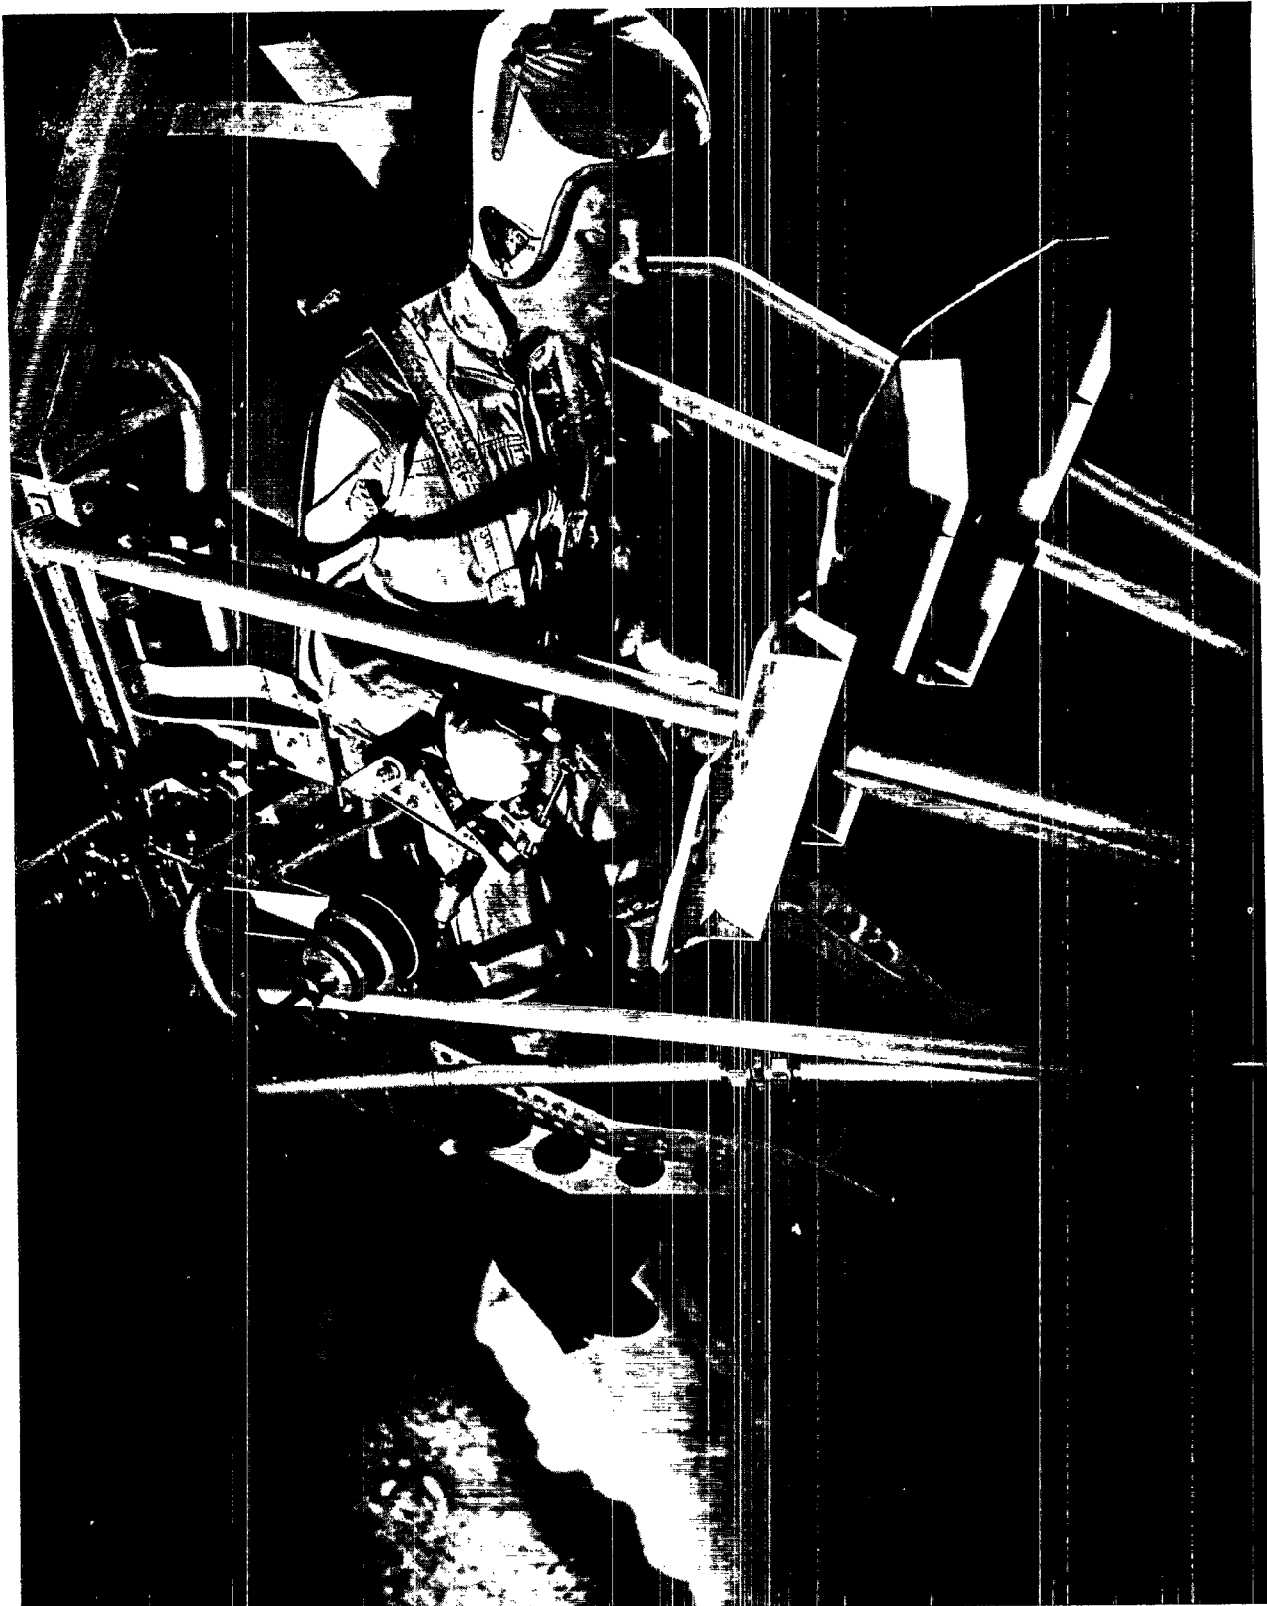
FIGURE 7-3. ALFA trainer.

The second trainer that was of great value and one that I wish had been more readily available prior to launch was the air-lubricated free-attitude (ALFA) trainer at the NASA-Langley Air Force Base, Va. (fig. 7-3). This trainer provided the only training in visual control of the spacecraft. I had intended to use the earth-sky horizon as my primary means of attitude control and had spent a number of hours on the ALFA trainer practicing retrofire using the horizon as a reference. Because of the rush of events at Cape Canaveral during the 2 weeks prior to launch, I was unable to use this trainer. I felt this probably had some bearing on my instinctive switch to instruments for retrofire during the flight, instead of using the horizon as a reference.

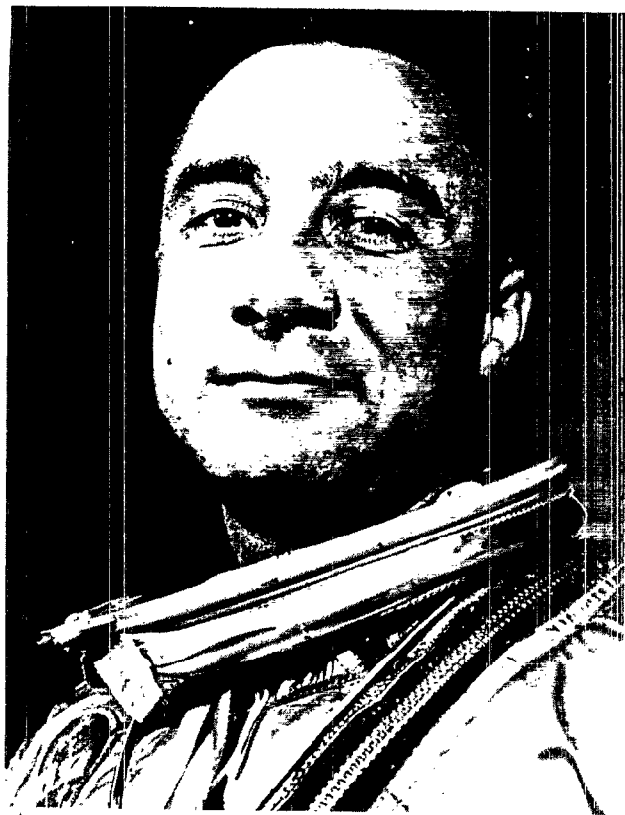
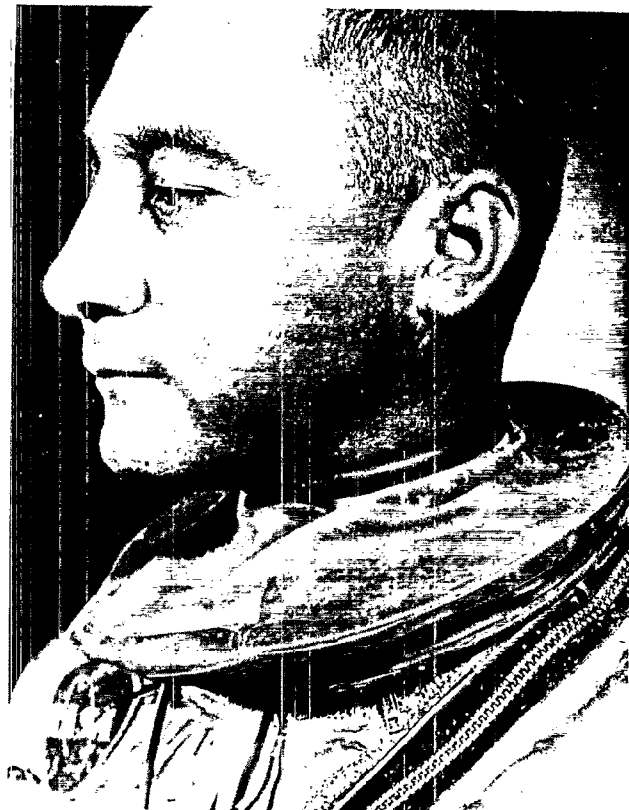
FIGURE 7-6. Neck dam.

(a) Normal stored position.

(b) Unrolled position.

strap, release the lap belt and shoulder harness, release the knee straps, disconnect the biomedical sensors, and roll up the neck dam. The neck dam is a rubber diaphragm that is fastened on the exterior of the suit, below the helmet attaching ring. After the helmet is disconnected, the neck dam is rolled around the ring and up around the neck, similar to a turtle-neck sweater. (See fig. 7-6.) This left me connected to the spacecraft at two points, the oxygen inlet hose which I needed for cooling and the helmet communications lead.

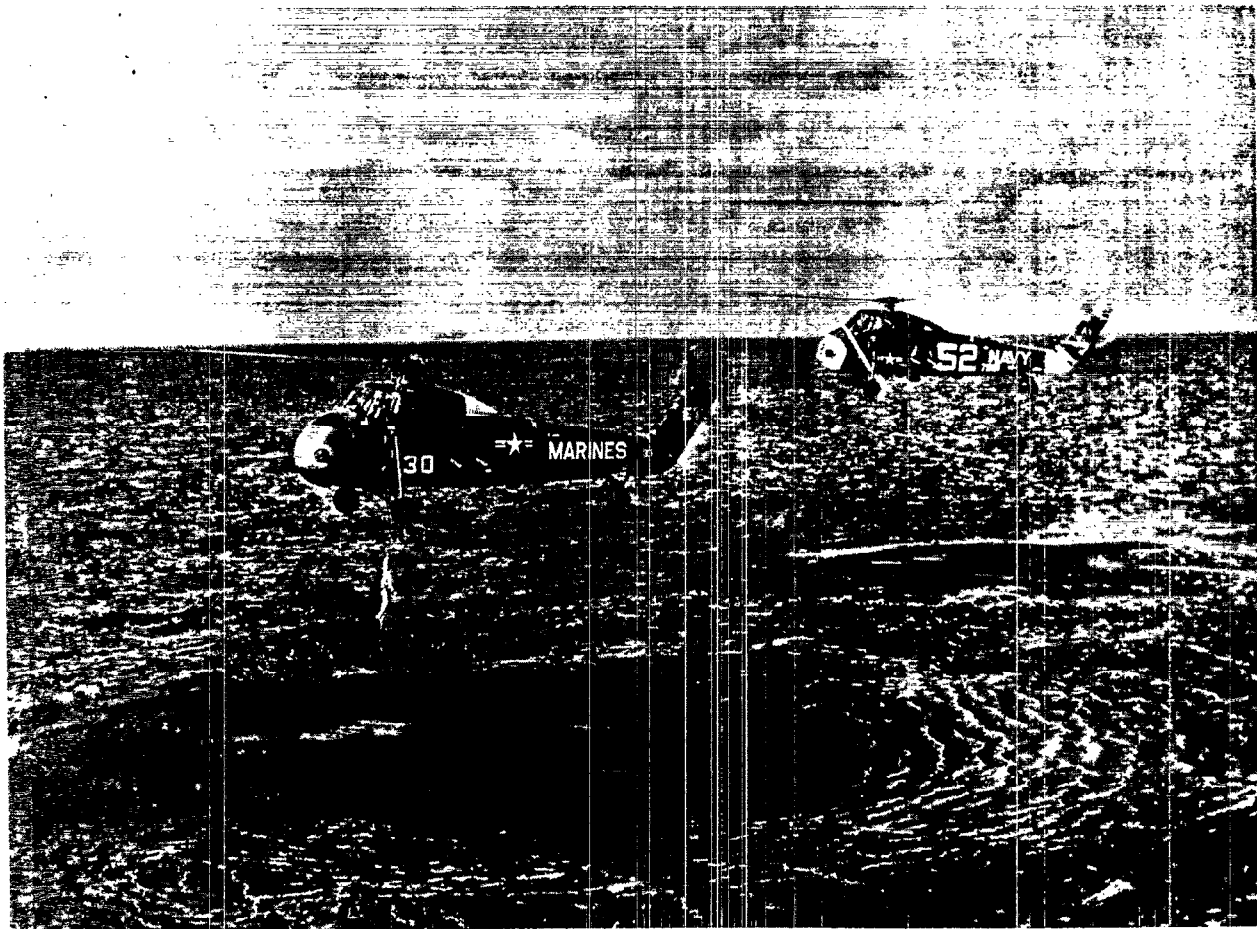
FIGURE 7-8. Helicopter recovering pilot (horsecollar on backwards).

down; then the sling was pulled back into the helicopter and it started to move away from me. At this time, I knew that a second helicopter had been assigned to pick me up, so I started to swim away from the primary helicopter. I apparently got caught in the rotorwash between the two helicopters because I could not get close to the second helicopter, even though I could see the copilot in the door with a horsecollar swinging in the water. I finally reached the horsecollar and by this time, I was getting quite exhausted. When I first got into the water, I was floating quite high up; I would say my armpits were just about at the water level. But the neck dam was not up tight and I had forgotten to lock the oxygen inlet port; so the air was gradually seeping out of my suit. Probably the most air was going out around the neck dam, but I could see that I was gradually sinking lower and lower in the water and was having a difficult time staying afloat. Before the copilot finally got the horsecollar to me, I was going under water quite often. The mild swells we were having were breaking over my head and I was swallowing some salt water. As I reached the horsecollar, I slipped into it and I knew that I had it on backwards (fig. 7-8); but I gave the "up" signal and held on because I knew that I wasn't likely to slip out of the sling. As soon as I got into the helicopter, my first thought was to get on a life preserver so that if anything happened to the helicopter, I wouldn't have another ordeal in the water. Shortly after this time, the copilot informed me that the spacecraft had been dropped as a result of an engine malfunction in the primary helicopter.
