# Restoration Research and Monitoring in Bayland Wetlands of the San Francisco Bay Estuary: The Tolay Creek Project

2002 Progress Report

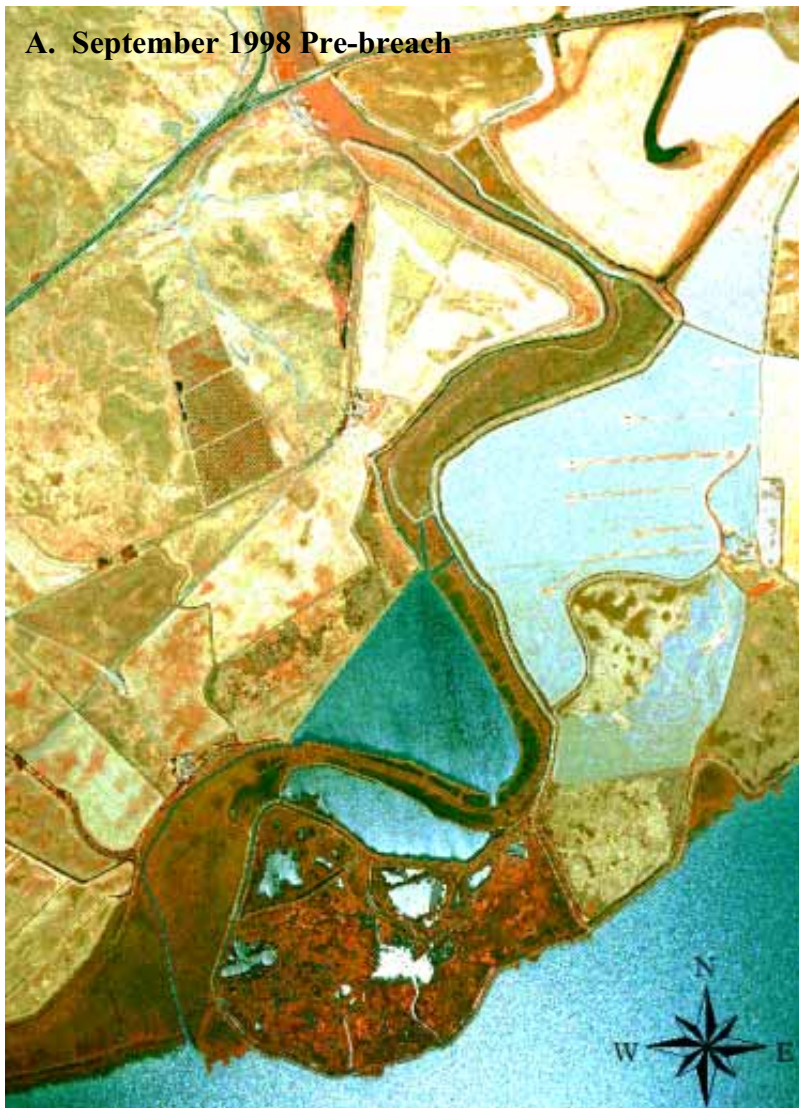
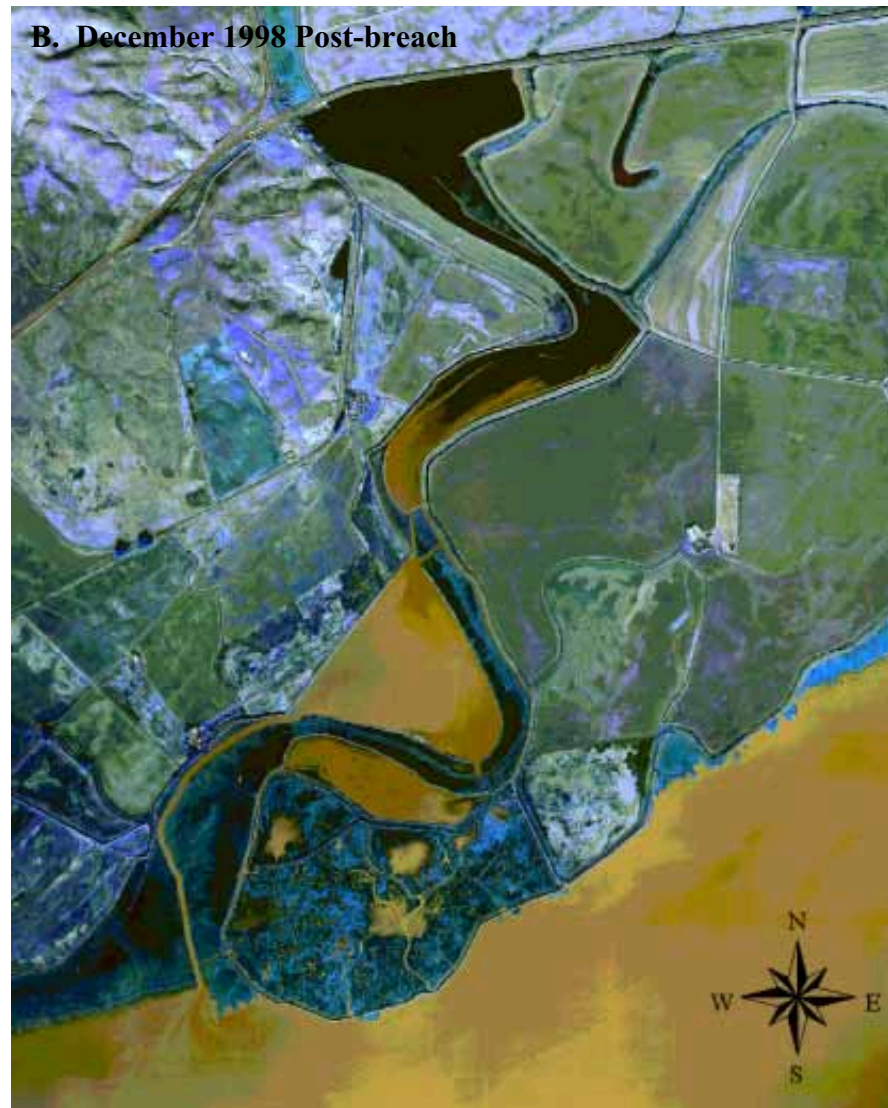
Figure 2. The 176 ha Tolay Creek Restoration Project, Pre-breach (A), and Post-breach (B). The project extends 5.3 km (3.2 mi) from San Pablo Bay at the bottom left, to Highway 37 in the upper middle of the aerial photographs.

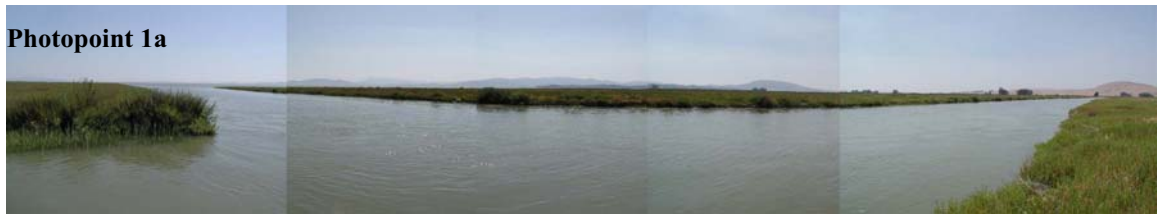
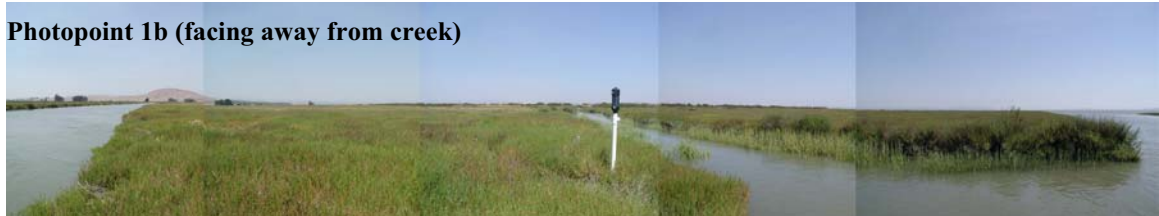
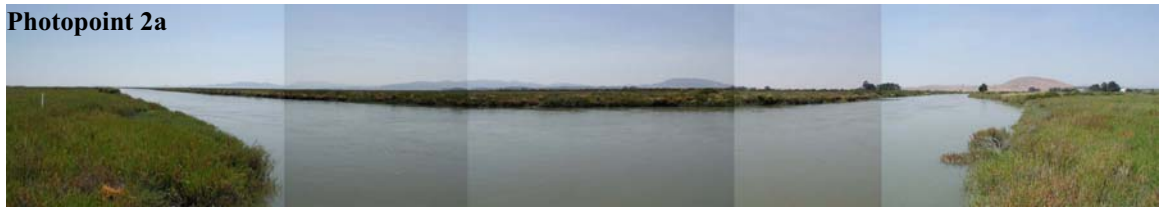
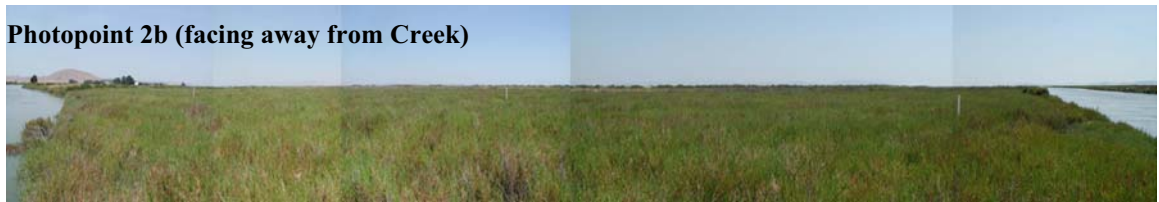
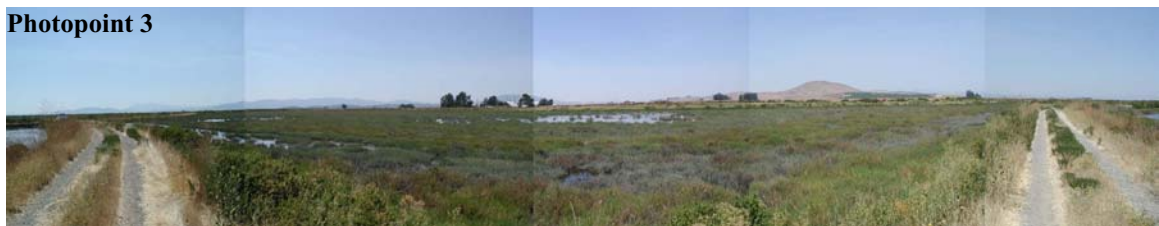
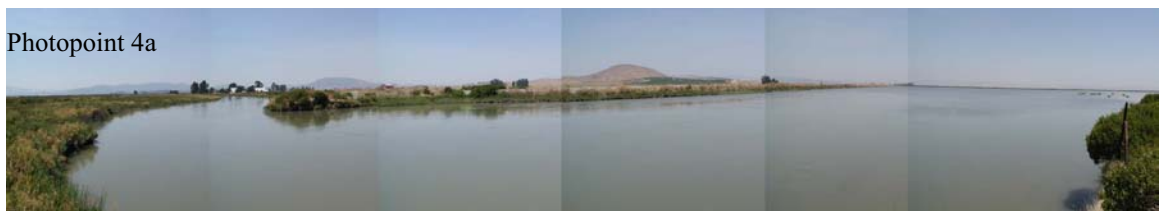
Figure 11. Panoramic views at photo points throughout the Tolay Creek project, August 2002 (See Figure 2 for locations).

Digital ground photographs were taken of the entire site from 14 photo points (Fig. 3) located with GPS at strategic locations, beginning in 2000. At each photo point, a panorama was taken encompassing the site with the frame including 50% of the sky. Aerial photographs were taken of Tolay Creek to assess pre- and post- breach differences (Fig. 2). Aerials were rectified and mapped as Arcview (ESRI, Inc.) coverages in NAD 27. A topographical as-built survey was conducted in 2000 by Ducks Unlimited to determine elevation of the site. A grid was developed from a series of 1:1,200 aerial photographs, ground-truthed to determine elevation, and rectified into an Arcview coverage (Fig. 4).

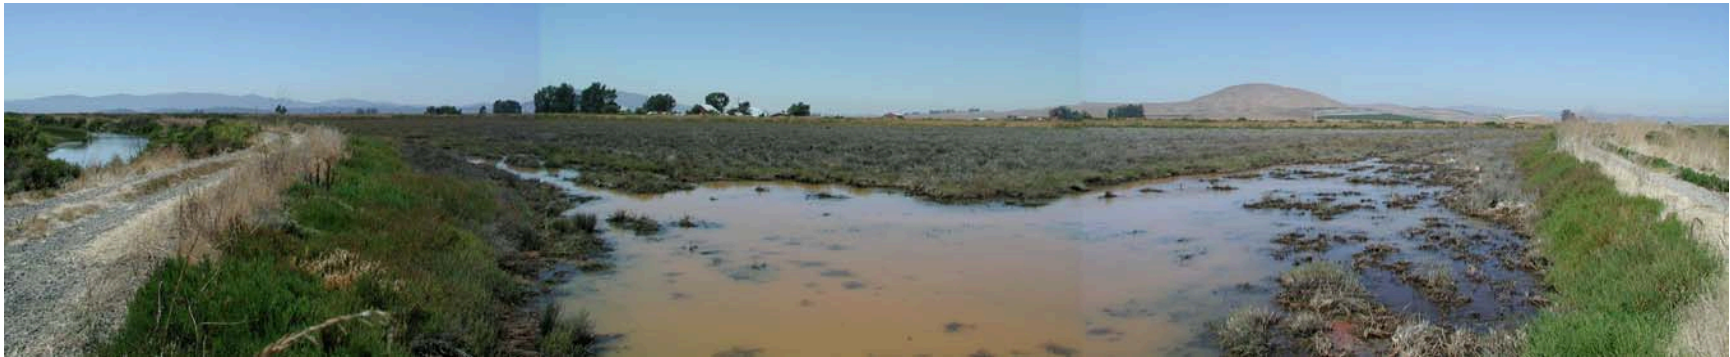
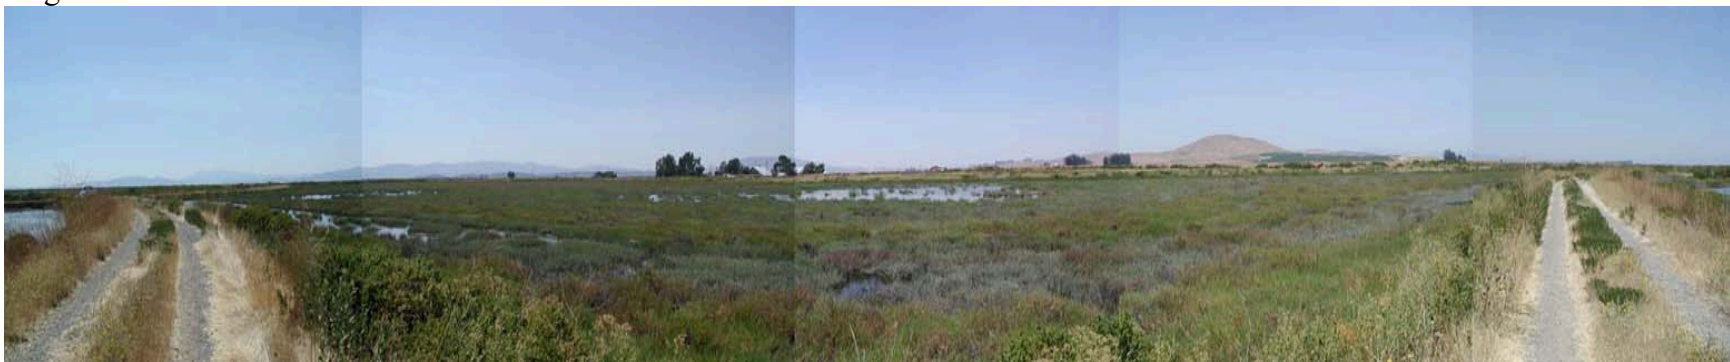
Figure 12. Panoramic view of photo point #3 (See Figure 3 for location) in August 2000 and 2002, providing evidence of qualitative change. Here we document increased pickleweed cover from 2000 to 2002.
