**Further Investigations of Control Surface Seals
for the X-38 Re-Entry Vehicle**

Patrick H. Dunlap, Jr., and Bruce M. Steinetz
NASA Glenn Research Center
Cleveland, OH

**37th AIAA/ASME/SAE/ASEE Joint Propulsion
Conference and Exhibit**

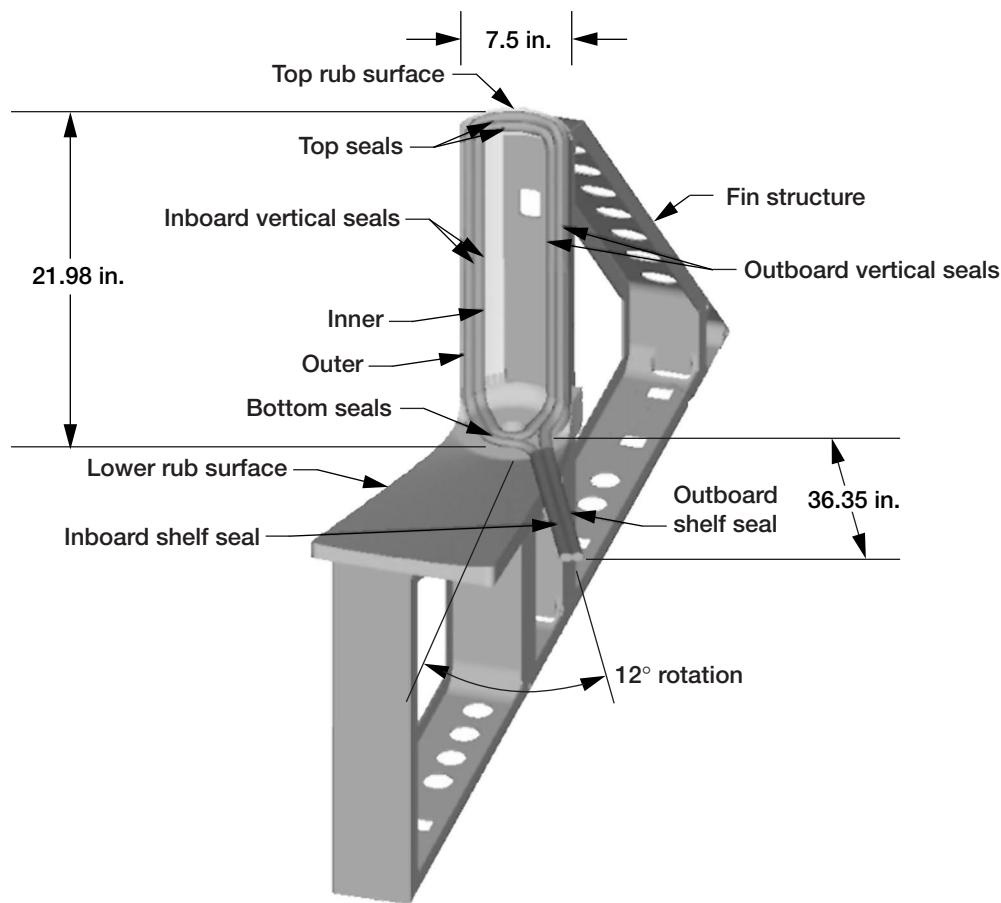
Figure 3.—Computer model depicting rudder/fin seal rotated to full outboard position with seal dimensions.

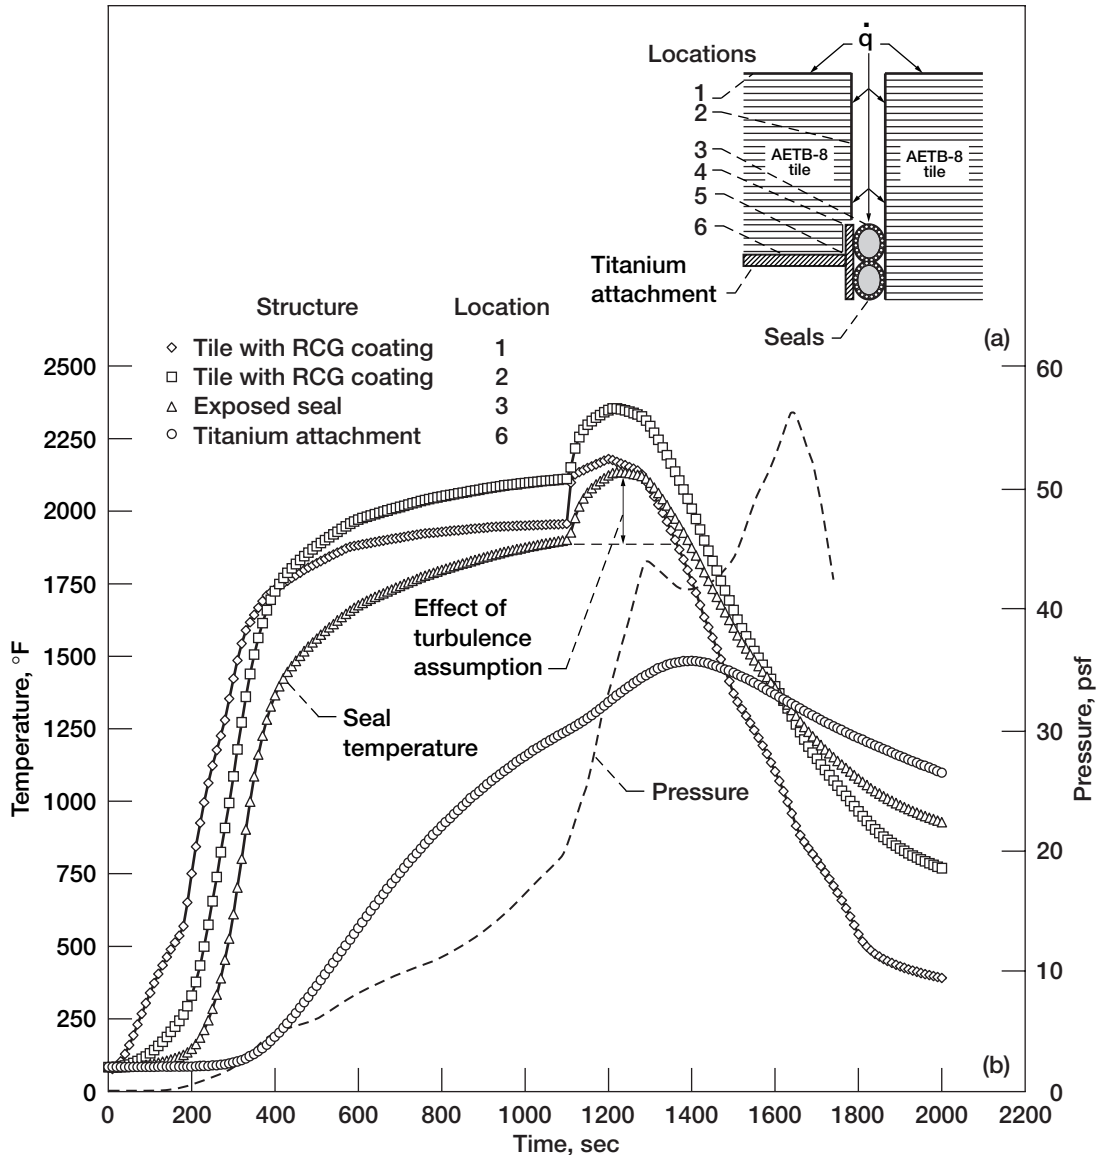
Figure 4.—Thermal analysis of rudder/fin seal. (a) Rudder/fin gap area Thermal Math Model (TMM). (b) Rudder/fin seal temperature and pressure predictions.

seal during maximum heating conditions was 15.6 psf, indicating that flow passed through the seal (Fig. 15). This pressure level is about 44% of the 35 psf pressure predicted at the 1200 sec maximum heating point during X-38 vehicle re-entry (Fig. 4).

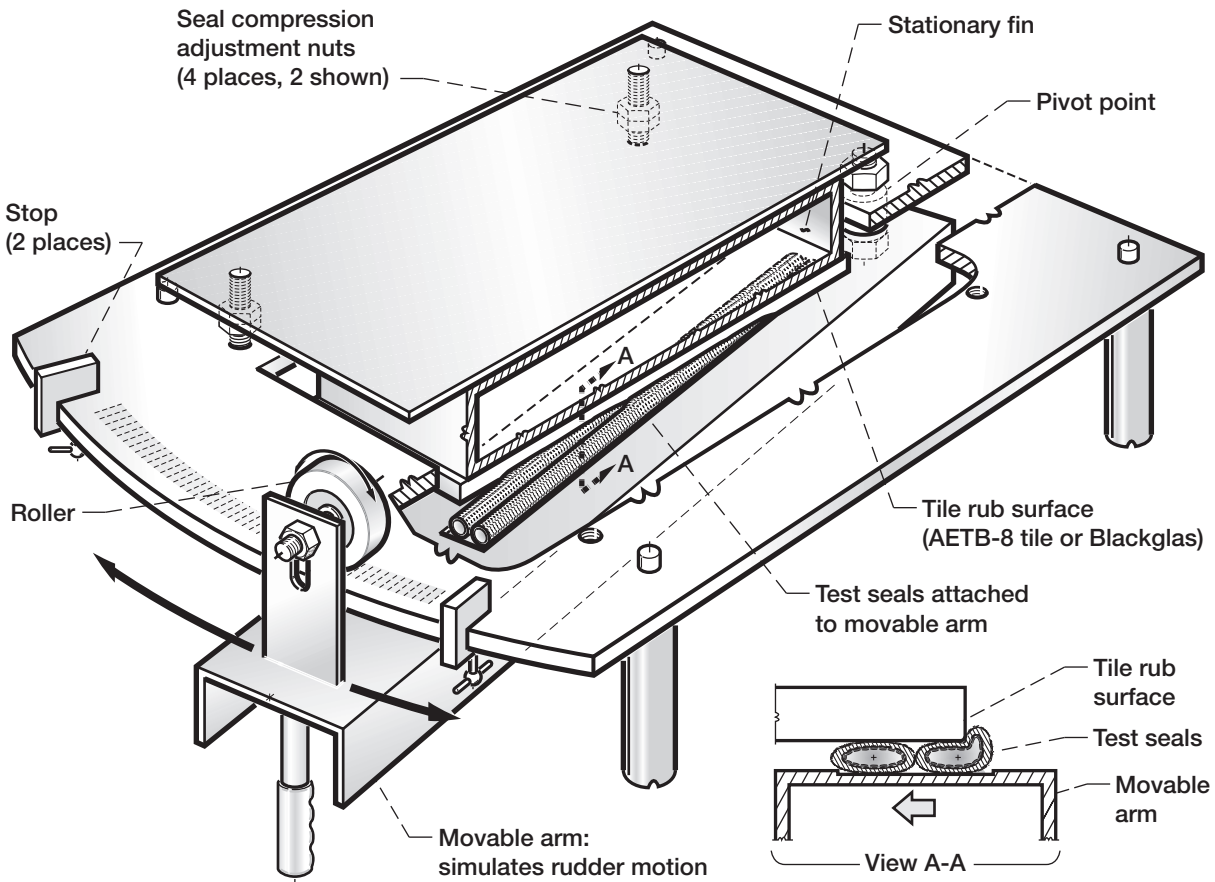
Figure 7.—Isometric of scrub/wear test fixture showing seals re-engaging the tile rub surface.

Test Fixture – The seals were evaluated in a test fixture that simulated the motion of the rudder with respect to a stationary tile sealing surface such as the fin shelf (Fig. 7). Two test seals were attached side-by-side in a groove on the top surface of a movable arm that simulated the rudder in the rudder/fin seal assembly (Figs. 3 and 5). The movable arm was pivoted on one end and mounted on the underside of a table (Fig. 7). At the other end of the arm was a roller that allowed the arm to be suspended below the table and to rotate freely with respect to the pivot. Two stops fixed to the edge of the table limited the amount of rotation of the arm to $\pm 12^\circ$. The seals were scrubbed against a simulated seal rub surface that was suspended through a rectangular hole cut in the center of the table. Four bolts and adjustment nuts were used to compress the rub surfaces against the test seals. The seals were compressed approximately 20% to simulate the design point on the X-38 rudder/fin. Two types of rub surfaces were used for this series of tests. The first was composed of three RCG/TUFI coated AETB-8 tiles. The three tiles were lined up side-by-side opposite the seals along the length of the movable arm. The total length of these tiles was identical to the length of the fin shelf sealing surface on the X-38 rudder/fin. Gap fillers were stuffed into the joints between the tiles. Assembly of the scrub test fixture revealed the need for the gap fillers to be installed flush with the outer surface of the tiles to prevent sneak flows between adjacent tiles above the gap fillers. The second rub surface used for the scrub tests was a ceramic matrix composite (CMC) material called BlackglasTM that was made by Northrup Grumman. Blackglas is a silicon oxycarbide matrix reinforced with Nextel 312 fibers.⁶ This material is being considered for use in control surfaces of future reusable launch vehicles. Advantages that Blackglas has over the coated AETB-8 tiles are that it can be produced in larger sections thereby reducing the number of gap fillers required around the individual tiles, and it is relatively inexpensive. The surface

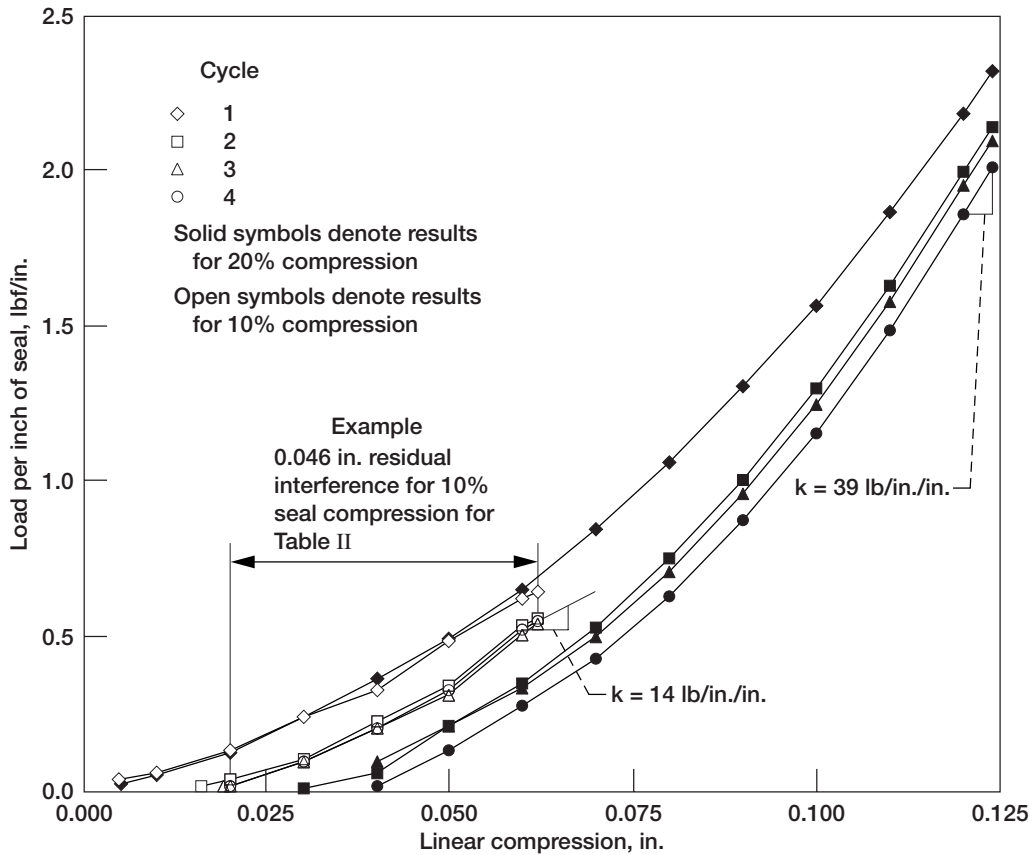
Figure 9.—Load versus linear compression data for four cycles, 6 pcf as-received seal at representative compressions of 0.062 in. (10%) and 0.124 in. (20%).

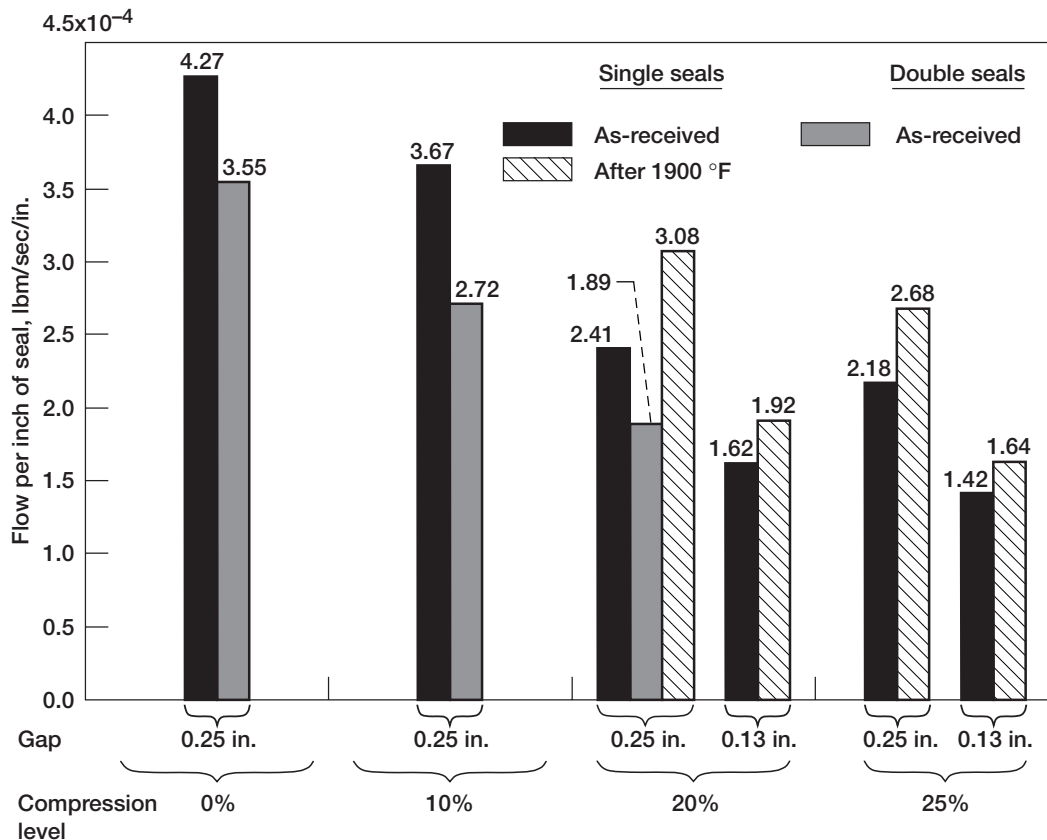
Figure 11.—The effect of number of seals, gap size, compression level, and temperature exposure on seal flow, $\Delta P = 56$ psf.

Flow rates for the 6 pcf seal design in the as-received and after 1900 °F exposure conditions are summarized in Fig. 11. This figure includes both new data recorded for these seals in an as-received state at 0 and 10 % compression and for comparison purposes data recorded previously by Dunlap, et al.³ for as-received and temperature-exposed seals at compression levels of 20 and 25%. The flow rates shown in this figure and in Fig. 12 are presented as the measured flow rate at room temperature at a specific pressure differential (56 lbf/ft² (psf) for the flow rates shown in Fig. 11) divided by the length of seal exposed to flow in the test fixture (10 in.). Figure 12 presents flow versus pressure data for both single and double 6 pcf seals at different compression levels for a pressure range of 0 to 202 psf (144 psf = 1 psi). This figure shows the typical shape of the flow versus pressure curves for these seals.

Effect of Compression Level – As shown by the flow results in both Figs. 11 and 12, flow rates decreased with higher compression levels. As the amount of compression on the seals was increased from 0 to 25% the amount of

Effect of Single vs. Double Seals—Flow rates through a double seal configuration were lower than those for a single seal at 0, 10, and 20% compression (Figs. 11 and 12). Addition of a second seal into the flow path caused a reduction in flow through the seals in the range of 17 to 26% as compared to the flow rates through single seals at the same compression level and gap size. Although the second seal caused a drop in flow rates, it did not cut the flow in half. This type of behavior in multiple seal flow tests was observed previously by Steinetz, et al.⁵ In Fig. 12 it is interesting to note that flow rates for two seals at 0% compression are slightly lower than those for a single seal at 10% compression. Thus, addition of a second seal with basically no preload against it provides a similar amount of flow blocking capability as a single seal under 10% compression. A second seal also provides redundancy should one of the two seals experience damage.

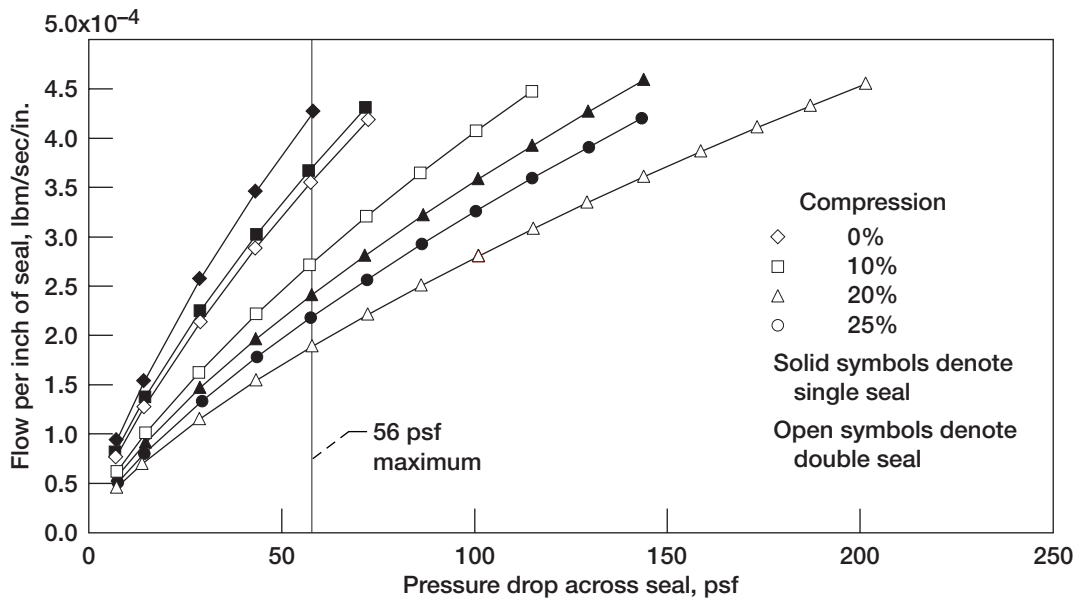
Figure 12.—Flow versus pressure data for both single and double 6 pcf seal configurations at several compression levels with a gap of 0.25 in.

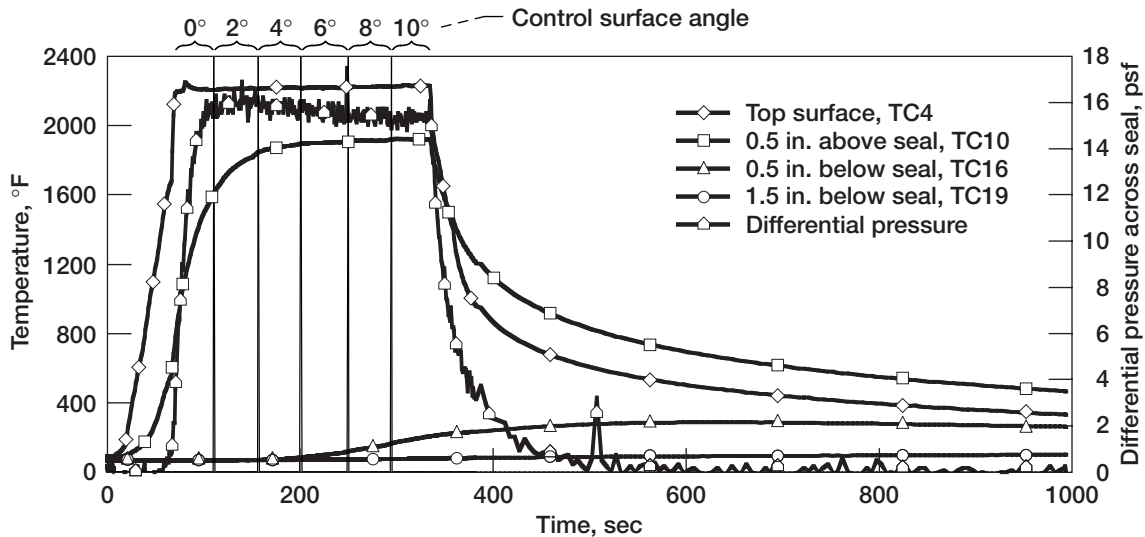
Figure 15.—Temperatures and pressure differential measured for arc jet test with seal installed at 20% compression (test #5), 6 degree table angle, 0, 2, 4, 6, 8, and 10 degree control surface angles, and 0.25 in. nominal gap. (Note that the symbols on the graph are given for identification only; data were recorded every 1 sec.)

Arc Jet Test with Seal Installed – Figure 15 shows the results of an arc jet test (Test #5 in the series of tests) with a seal installed in the gap. The 6 pcf seal was installed at 20% compression in a nominal 0.25 in. gap. As in the open gap test, this test was performed with the overall test fixture (table) rotated up into the arc jet flow at a 6°-angle. The control surface was again fixed at its baseline 0° position when the test began and held there while a steady arc jet flow was established over the fixture until the top surface temperature reached a steady state temperature condition of about 2200 °F. The control surface was held at 0° for 38 sec and then rotated upward in 2° increments approximately every 45 sec until it was angled 10° with respect to the upstream stationary portion of the test fixture. It was held in this final position for an additional 41 sec before the test was ended. Including the 6°-table angle, the final control surface position was rotated upward 16° into the arc jet flow. The total time spent at maximum heating conditions (2200 °F on the top surface) was 263 sec. This time is comparable to the 250 sec of peak heating for the rudder/fin seals predicted between 1100 and 1350 sec of the X-38 re-entry mission (Fig. 4). During the arc jet test the average pressure differential across the

The average temperature on the top surface of the test fixture during maximum heating conditions was 2220 °F. With a seal installed in the gap, the temperature 0.5 in. above the seal did not get as hot as in the open gap test. At this station, the peak temperature reached 1610 °F while the control surface elevation was at its 0° position, 620 °F less than the temperature reached during the open gap test over the same amount of time. As the control surface was rotated upward into the arc jet flow stream in 2° increments, the temperature 0.5 in. above the seal gradually continued to rise until it reached a peak temperature of 1920 °F by the end of the test.
