Monitoring Remediation—Have Mine-Waste and Mill-Tailings Removal and Flood-Plain Restoration Been Successful in the High Ore Creek Valley?

Chapter E2 of

Integrated Investigations of Environmental Effects of Historical Mining in the Basin and Boulder Mining Districts, Boulder River Watershed, Jefferson County, Montana

Professional Paper 1652–E2

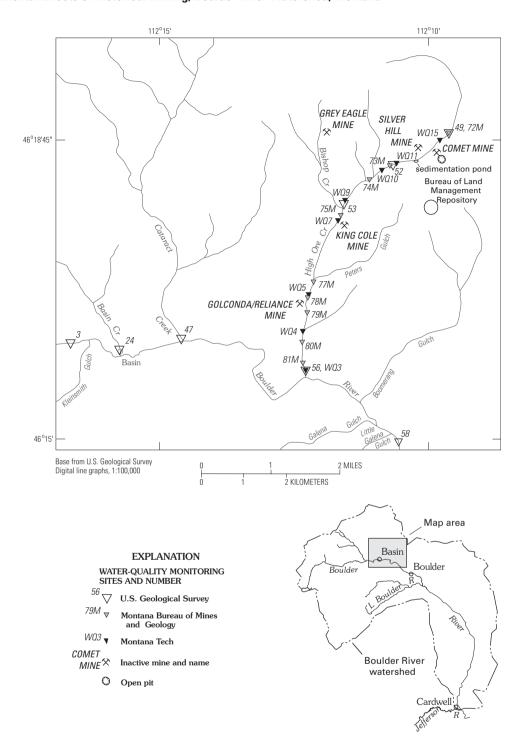
Figure 1. Location of High Ore Creek, Mont., with water-quality monitoring sites and locations of inactive mines.

In addition to the Comet mine, several small mines were located in the High Ore Creek basin (fig. 1; Martin, this volume, Chapter D3, fig. 1). The Grey Eagle mine was the largest of these smaller mines, producing primarily silver (about 2,090 oz) from 1897 to 1941 from about 10,000 ft of underground workings (Elliott and others, 1992; Marvin and others, 1997). The Silver Hill mine adjoined the Comet mine and had underground workings with one shaft (Elliott and

Data for five monitoring sites in the Boulder River watershed (fig. 1, sites 3, 24, 47, 56, and 58) were used to evaluate the preliminary effects of the Comet mine cleanup

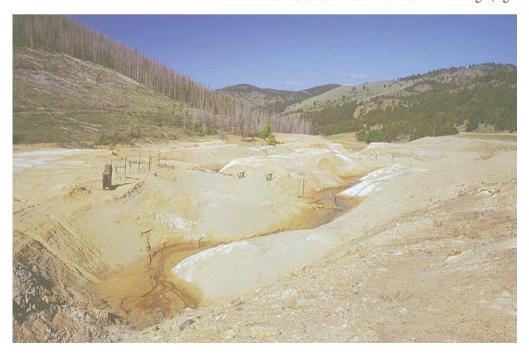
Figure 2. Mill tailings in High Ore Creek valley at Comet mine site before large-scale remediation activities, October 1996. Photograph by D.A. Nimick.

Based on chemical and biological environmental data, the Comet mine wastes and mill tailings (figs. 2, 3) were

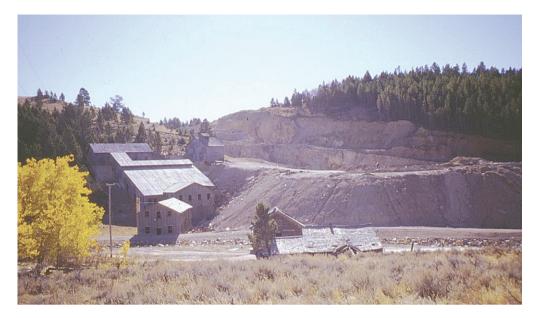
Figure 3. Comet Mill and open-pit mine before large-scale remediation activities, October 1996. Photograph by D.A. Nimick.

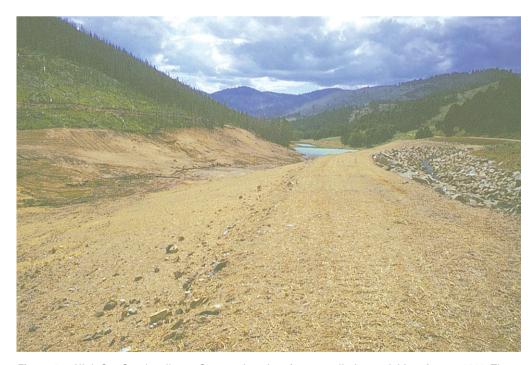
Figure 4. High Ore Creek valley at Comet mine site after remediation activities, August 1998. The creek has been redirected and the area regraded. Photograph by D.A. Nimick.

September to December 1997, waste rock and mill tailings filling the original channel and adjacent valley bottom of High Ore Creek and 1 ft of the underlying native soil near the mine were excavated and moved to the existing open pit, which was used as an unlined repository (figs. 4, 5). From May through July 1998, other waste-rock materials were amended onsite with lime. During the second phase, planned to start in 2001, about 1,700 ft of High Ore Creek will be reconstructed to restore the channel to its approximate premining position and

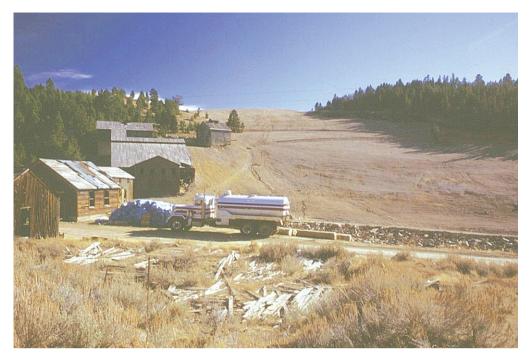
Figure 5. Comet Mill and mine site after remediation activities, August 1998. Waste rock and tailings have been removed, and the open pit has been used as a repository. Photograph by D.A. Nimick.

condition through the Comet mine site. Upon completion of this project, approximately 430,500 yd³ of waste will have been removed (Pioneer Technical Services, Inc., 1997).

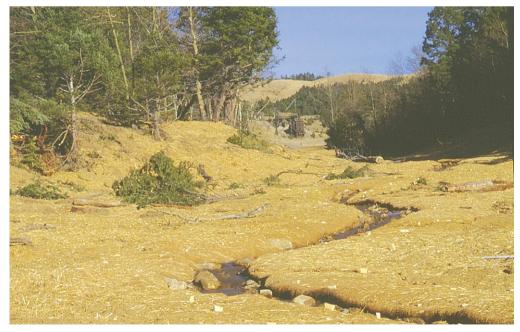
Figure 6. Reconstructed reach of High Ore Creek downstream from Comet mine site, December 1999. Photograph by J.H. Lambing.

by removing about 5,800 yd³ of waste rock and about 28,000 yd³ of mill tailings from the valley bottom (Pioneer Technical Services, Inc., 1999). Upstream from Bishop Creek, floodplain and streambed-sediment deposits were removed, the High Ore Creek channel was reconstructed, and clean material was imported to backfill the excavated areas (fig. 6). Downstream from Bishop Creek, waste rock and flood-plain deposits were either removed or amended in place with lime, but the

stream channel was not disturbed. All excavated wastes were placed in an unlined repository (fig. 1) with a multi-layered cap, south of the Comet mine (Pioneer Technical Services, Inc., 1999).

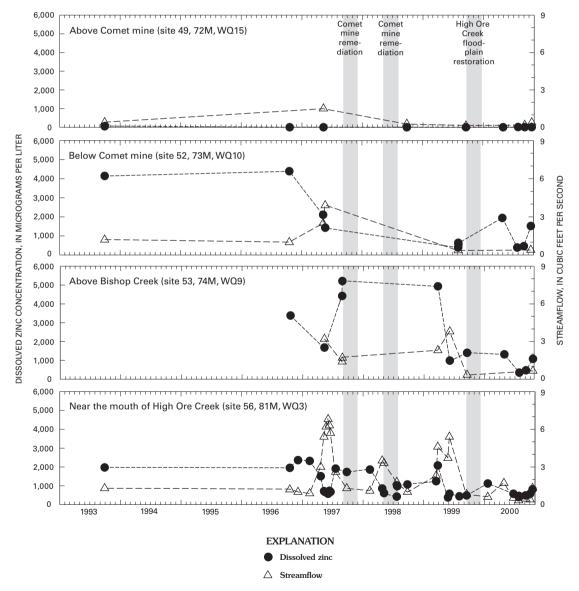
Figure 7. Dissolved zinc concentrations and streamflow in four reaches of High Ore Creek, 1993–2000. Data from Marvin and others (1997), Nimick and Cleasby (2000), Tupling (2001), and Rich and others (this volume). Zinc concentrations reported as less than the minimum reporting level of 1 μ g/L are plotted as 1 μ g/L.

Water-quality samples were collected at or near four USGS sites (fig. 7) on High Ore Creek from September 1993 through October 2000 (Marvin and others, 1997; Nimick and Cleasby, 2000; Tupling, 2001; Rich and others, this volume). Data for these samples show the initial effect of the MDEQ and BLM remediation projects. Dissolved and total-recoverable copper and lead concentrations commonly were less than aquatic-life standards both before and after remediation and are not discussed here in further detail. Dissolved and total-recoverable cadmium, manganese, and zinc concentrations had

similar patterns of temporal variation. Dissolved zinc concentrations, discussed here, illustrate the effects of remediation.

Dissolved zinc concentrations upstream from the Comet mine site (site 49) did not change from 1997 through 2000 and were consistently low (less than 55 µg/L). However, dissolved zinc concentrations at two sites (sites 52 and 53) between the Comet mine and Bishop Creek generally decreased after the beginning of large-scale cleanup in 1997 (fig. 7). Dissolved zinc concentrations near the mouth of High Ore Creek (site 56) also appear to have decreased after the beginning of large-scale cleanup. Samples collected on March 25, 1999, at sites 53 and 56 reflect early spring snowmelt runoff, which had anomalously high concentrations of dissolved zinc as well as other trace elements and suspended sediment (not shown in fig. 7). Sampling was not conducted during similar snowmelt runoff conditions prior to large-scale remediation activities. Therefore, the effect of remediation activities on zinc concentrations during early snowmelt runoff cannot be evaluated.

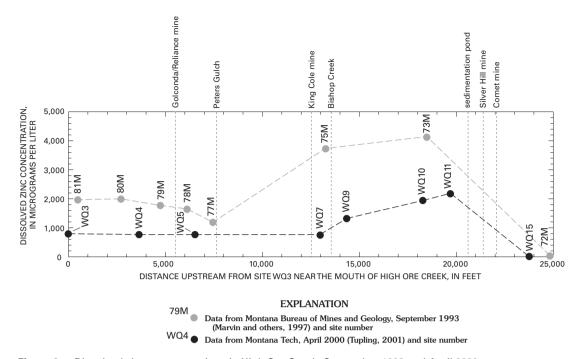
Figure 8. Dissolved zinc concentrations in High Ore Creek, September 1993 and April 2000.

An objective way to look at the effects of the Comet mine remediation is to compare pre- and post-remediation traceelement concentrations along High Ore Creek during similar flow conditions. Data collected by MBMG in September 1993 (Marvin and others, 1997) and Montana Tech in April 2000 (table 1; Tupling, 2001) as part of a post-reclamation study funded by the BLM clearly show the effects of cleanup (fig. 8). Based on limited data, streamflow in April 2000 (1.7 ft³/s at site WQ3, fig. 1) probably was similar to the flow in September 1993 (1.3 ft³/ s at site 81M, fig. 1). Again, dissolved zinc is discussed here to illustrate a pattern that was similar for dissolved cadmium and manganese. Figure 8 shows that dissolved zinc concentrations represented by two sample sets collected during similar hydrologic conditions decreased at essentially all sampling sites between 1993 and 2000. The largest decreases between 1993 and 2000 occurred at sites in the reach between the Comet and King Cole mines. However, the increase in dissolved zinc concentrations downstream from the Comet mine site in 2000 relative to site WQ15 above the mine indicates that the mine site is still a source of dissolved zinc to High Ore Creek. From Bishop Creek to the mouth of High Ore Creek, concentrations in 2000 remained essentially uniform, unlike in 1993 when concentration increases occurred downstream from Peters Gulch and the Golconda/ Reliance mine sites.

Concentrations of dissolved zinc exhibit diel cycles in High Ore Creek, with concentrations fluctuating by as much as a factor of 3 between early morning and late afternoon (Lambing and others, this volume, Chapter D7). These cycles potentially could have a large effect on comparisons of concentration data, such as those in figure 8, collected on different sampling dates. Sites downstream from Peters Gulch (fig. 8) were sampled at about the same time of day during the

September 1993 and April 2000 sampling episodes. Although the same sites were not sampled each year, the sampling time for each site sampled in 2000 was within 60 minutes of the sampling time for nearest site sampled in 1993. Temporal concentration variations attributable to diel cycles during a 60-minute period are only a fraction of the total diel variation and, therefore, would not be large enough to eliminate or reverse the apparent decrease in concentration shown by the post-remediation data in figure 8. Sites between Peters Gulch and the Comet mine were not sampled at similar times during the two sampling episodes. Sites were sampled in mid- to late morning in September 1993, when concentrations would be near their maximum diel values, whereas sites were sampled in mid- to late afternoon in April 2000, when concentrations would be near the diel minimum values. Therefore, the apparent decrease in concentration shown in figure 8 may be much less than shown. These data demonstrate the importance of understanding diel cycles when trends in trace-element concentrations are being assessed.

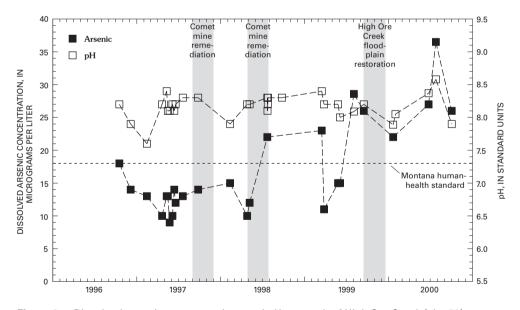
Figure 9. Dissolved arsenic concentrations and pH at mouth of High Ore Creek (site 56), 1996–2000.

In contrast to dissolved zinc, dissolved arsenic concentrations apparently increased since large-scale remediation began in 1997. In particular, concentrations at the mouth of High Ore Creek (site 56) not only have increased from pre-remediation levels, but values that typically were less than the State of Montana human-health standard of 18 µg/L have increased to post-remediation values that typically are higher than this standard (fig. 9). One explanation for this phenomenon is that sorption onto particulates, which is an important control on arsenic mobilization, has decreased. Sorption is dependent on pH, and arsenic desorption increases as pH increases (Pierce and Moore, 1982). However, the pH of High Ore Creek does not appear to have increased after remediation began (fig. 9), so the arsenic probably is not derived from desorption of arsenic from streambed sediment. A more likely explanation of these increases in dissolved arsenic in the stream is that the lime used to amend waste rock at the mine site and flood-plain deposits downstream from Bishop Creek resulted in an increase in pH in these materials. The higher pH likely mobilized arsenic, which then leached into High Ore Creek.

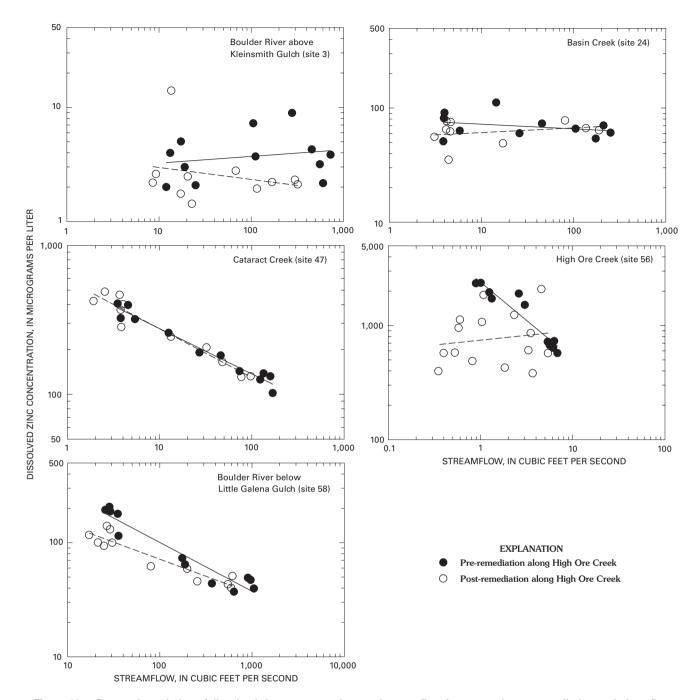
Figure 10. Regression relation of dissolved zinc concentrations and streamflow for pre- and post-remediation periods at five long-term monitoring sites in Boulder River watershed, 1996–2000.

Figure 10 shows ordinary least squares regression relations between streamflow and dissolved zinc concentrations for both pre- and post-remediation at the five Boulder River watershed sites. Basin Creek and Cataract Creek showed very little change in the relation between the two time periods. The upper site on the Boulder River (site 3) displayed some variation, but maintained consistently low concentrations. The most downstream site on the Boulder River (site 58) displayed a clear post-remediation downward shift in zinc concentrations at low streamflows (less than 100 ft³/s), but tended to converge with the pre-remediation relation at higher flows (greater than 100 ft³/s). One notable feature is that High Ore Creek post-remediation data are highly scattered, indicating that dissolved zinc concentrations have not stabilized since remediation activity ended. With time, a stronger relation between streamflow and concentration might be expected to develop as remediated areas physically stabilize and hydrologic and geochemical equilibrium is established. Continued monitoring, especially at High Ore Creek and the Boulder River below Little Galena Gulch, would provide the necessary data to better demonstrate and quantify the overall change in trace-element concentrations and, ultimately, to determine the degree to which remediation was successful in improving the health of aquatic biota.
