## **Surviving a Tsunami—Lessons from Chile, Hawaii, and Japan**

Circular 1187

Actions that saved lives, and actions that cost lives, as recounted by eyewitnesses to the tsunami from the largest earthquake ever measured—the magnitude 9.5 earthquake in Chile on May 22, 1960.

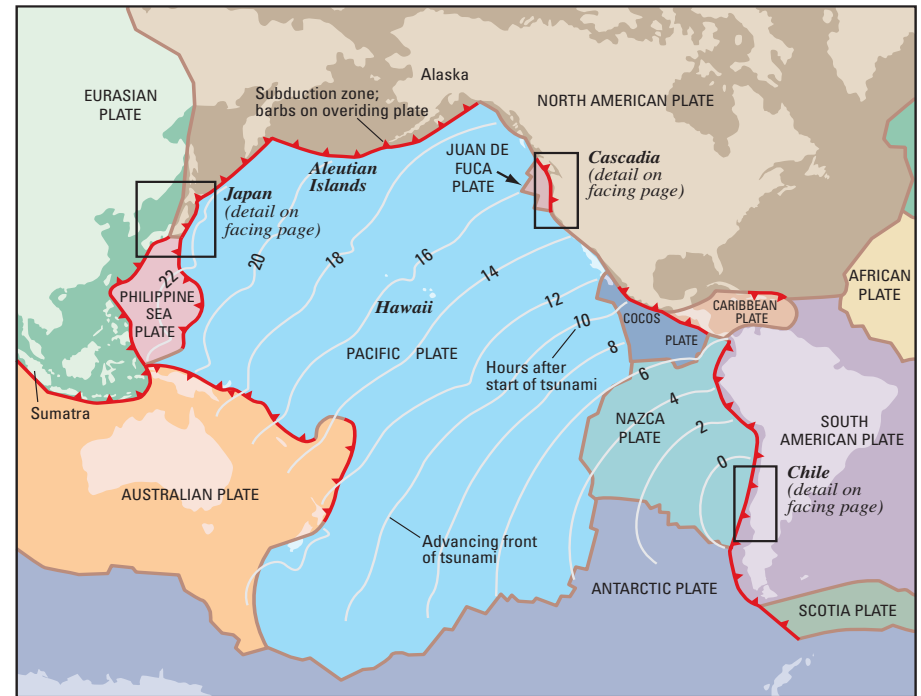
**The 1960 Chilean tsunami radiated outward from a subduction zone along the coast of Chile. Its waves reached Hawaii in 15 hours and Japan in 22 hours.**

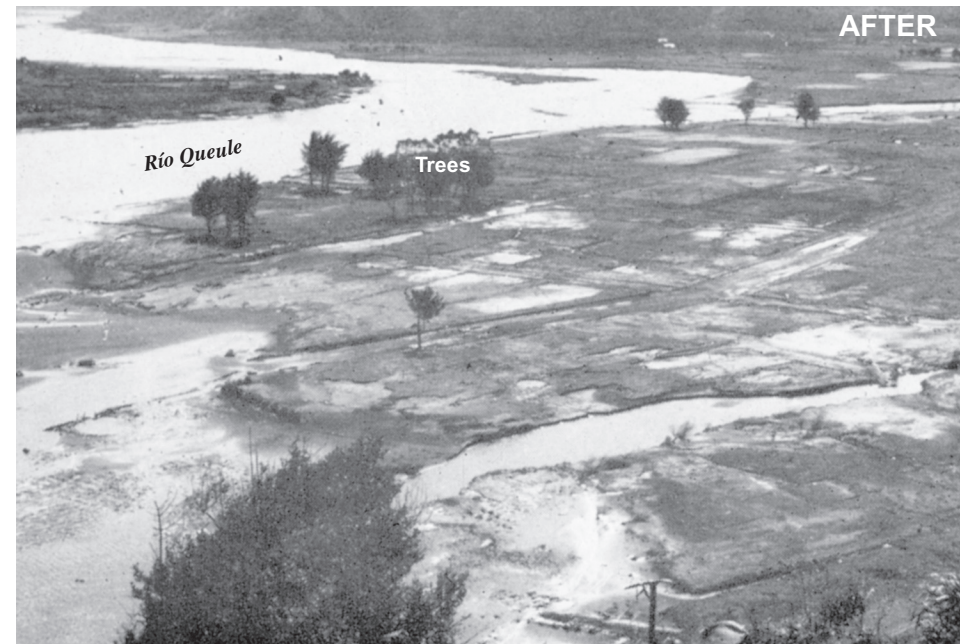
Though a mile from the sea, most of Queule, Chile, was overrun and washed away by the tsunami that followed the 1960 Chile earthquake. Many residents of Queule fled to the safety of high ground soon after the earthquake, but Jovita Riquelme lost her daughter and husband to the tsunami because the family remained at their house on low ground near

the Río Queule. From the height of debris tangled in the branches of trees that remained standing after the 1960 tsunami, Wolfgang Weischet, then a geographer at the Universidad Austral de Chile in nearby Valdivia, estimated that water from the tsunami was as much as 13 feet deep in Queule. Mr. Weischet took these before and after photos.

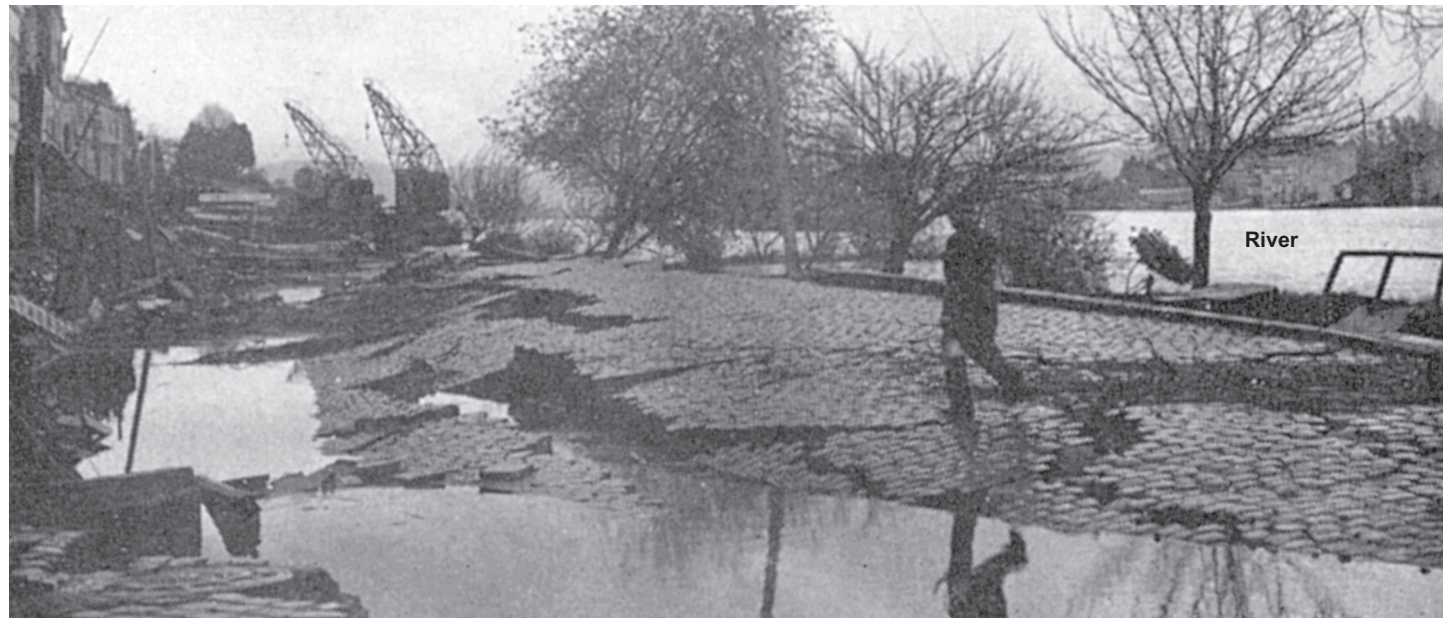
High-water level during the 1960 tsunami

To reach this site, the tsunami flowed inland for more than a mile

The 1960 Chile earthquake cracked a road near Maullín, Chile, used minutes later by René Maldonado. This road was soon cut by the waves of the tsunami that followed the quake. At left, Mr. Maldonado poses on horseback in 1989 beside his 1960 home. Below, a photo from 1960 shows a main street in Valdivia, Chile, that was damaged when shaking from the earthquake caused land to spread toward the adjacent river.

Minutes after the 1960 Chile earthquake, René Maldonado rode his horse on the road from Maullín, Chile (see locations on photo, p. 14). During the ride, Mr. Maldonado's horse had to jump newly formed cracks in the road. The weakened road was soon severed by the waves of the tsunami that followed the earthquake, leaving channels too wide even for a horse to jump.
