TOLERABLE MOVEMENT CRITERIA FOR HIGHWAY BRIDGES

Report No.
FHWA/RD-85/107

Final Report
October 1985

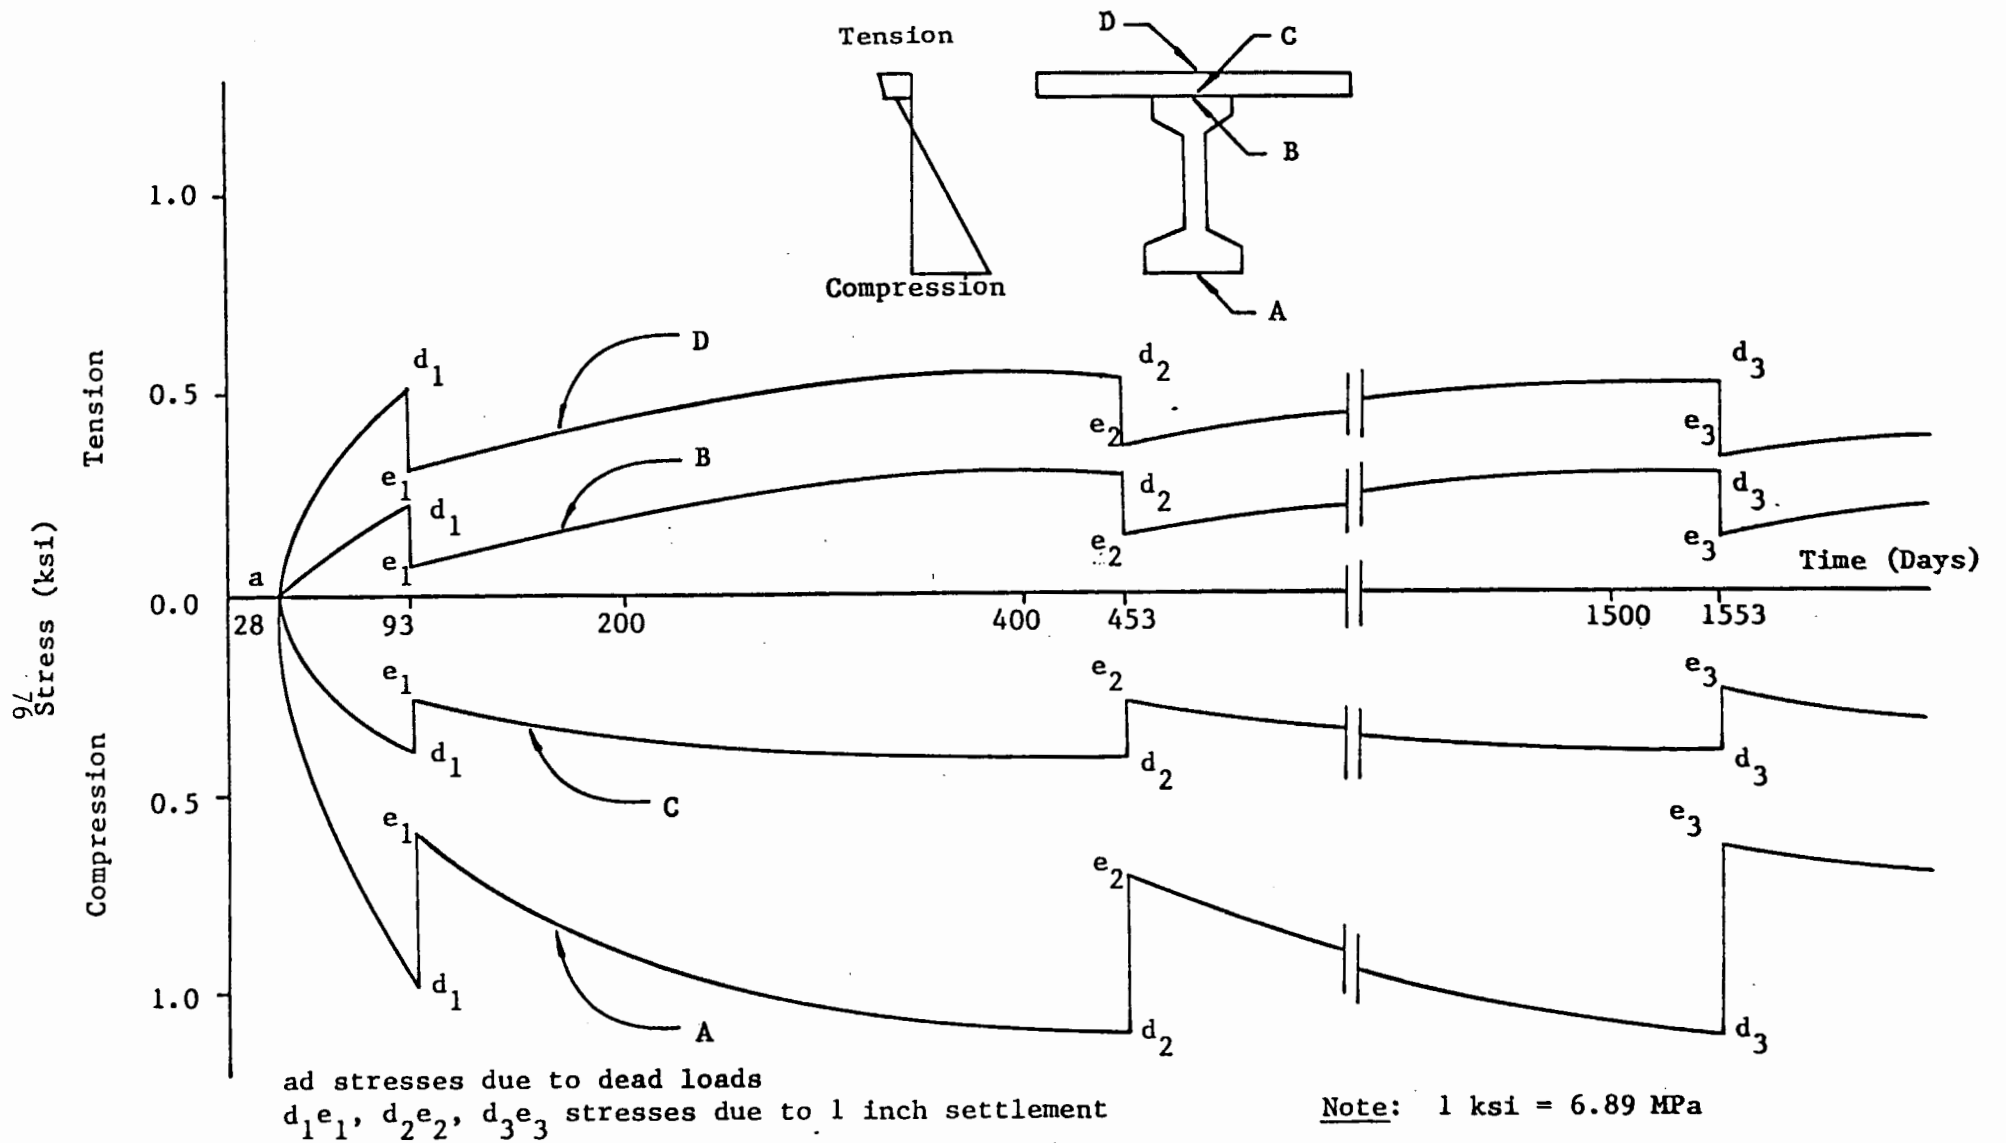
Figure 34. Time-dependent variation of stresses at center support for continuous concrete bridge with 100 foot spans - gradual settlement of center support.
