## Rates of Landsliding and Cliff Retreat Along the Big Sur Coast, California—Measuring a Crucial Baseline

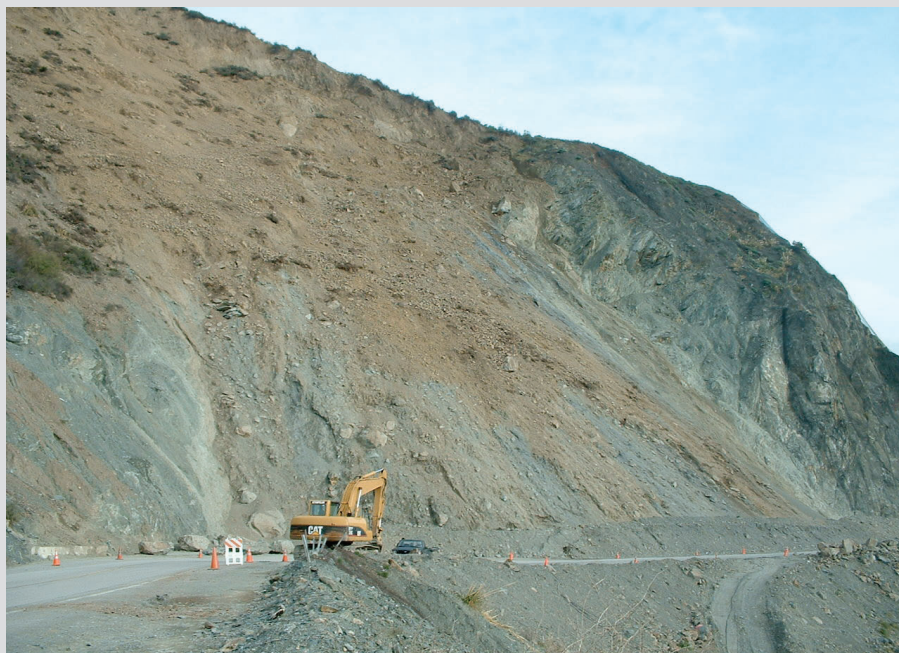
California Department of Transportation (Caltrans) crews work to reopen Highway 1 at Pitkins Curve during winter 2004. When this photograph was taken, one lane of the highway was still closed (note boulders at lower left behind the traffic barricade). This site is currently the most active landslide on the Big Sur coast. (USGS photograph by Cheryl J. Hapke.)

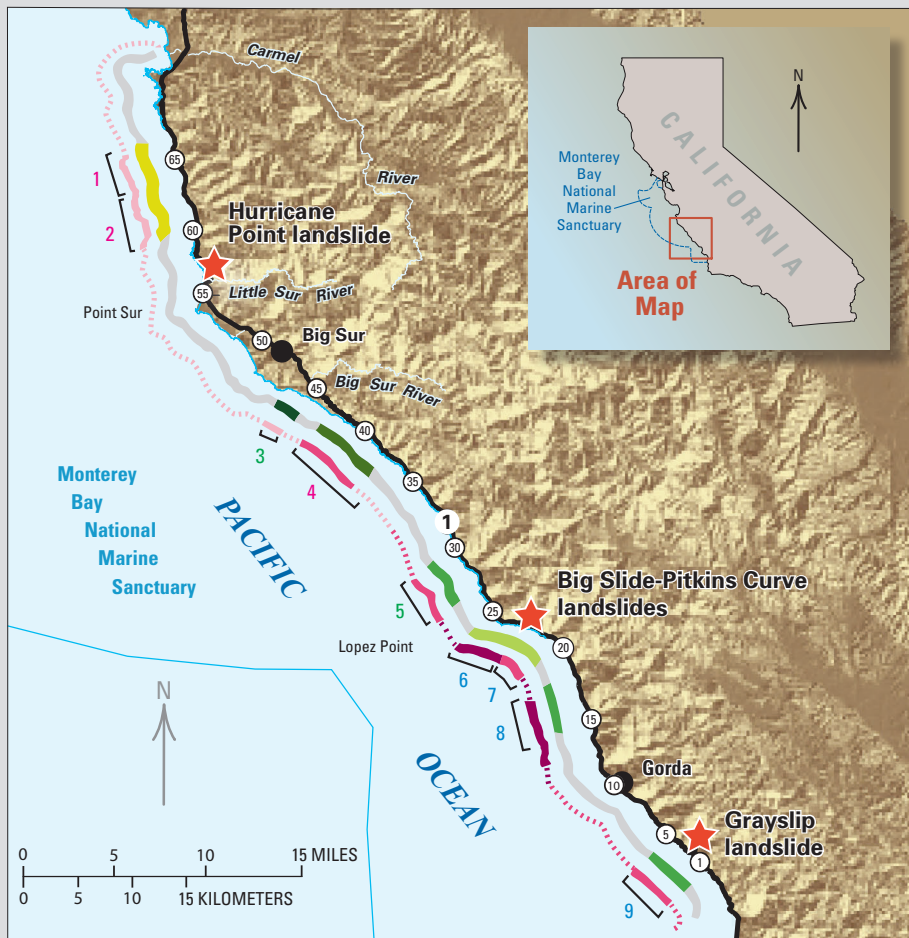
## EROSION RATES AND ROCK TYPES ALONG THE BIG SUR COAST

California's Big Sur coast is characterized by several rock types, which greatly influence rates of coastal erosion. Important rock types include granitic rocks, sedimentary rocks, and melange (a jumbled mixture of tectonically broken and crushed rocks). This map shows the results of U.S. Geological Survey studies of rates of sediment-yield (outer color band) and cliff-retreat (inner color band) at nine sites along the Big Sur coast. The highest rates were found along the southern part of the coast, where the weakest rocks occur. In addition, three large landslides (red stars) were studied in much greater detail.

Sections	Rock type
1, 2, 4	Granitic
3, 5	Sedimentary
6, 7, 8, 9	Melange

Both sediment-yield and cliff-retreat rates vary significantly along the Big Sur coast, partly because of its complex geology. Lower rates generally occur within granitic rocks, which are less faulted and fractured, whereas higher rates occur where weaker, sheared and fractured sedimentary and metamorphic rocks of the “Franciscan Complex” are dominant. In addition to rock strength and type, other factors also influence coastal-cliff erosion and movement on deep-seated landslides, including the previous history of slope disturbance (natural or human), the distribution and density of faults and fractures, variation in rainfall, and protection (or lack thereof) at the slope base by beaches or debris fans.

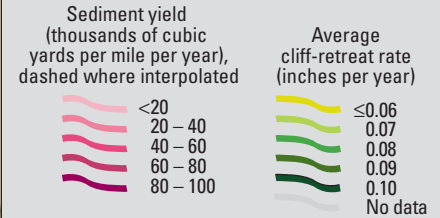
### EXPLANATION

### Study sections, color-coded by rock type

- Location of site-specific analyses
- California Highway 1
- Postmile

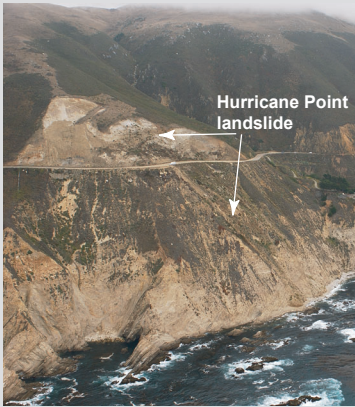
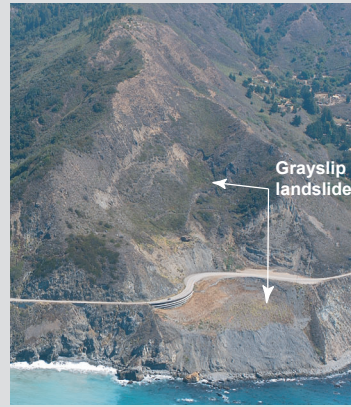
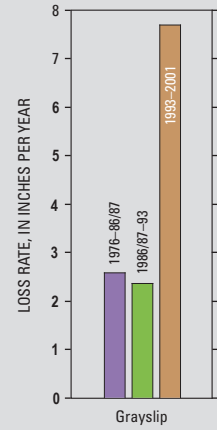
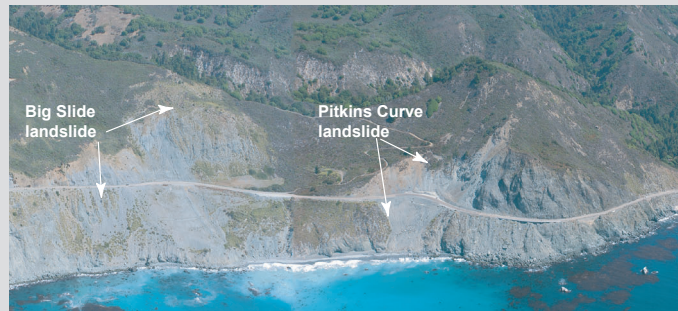
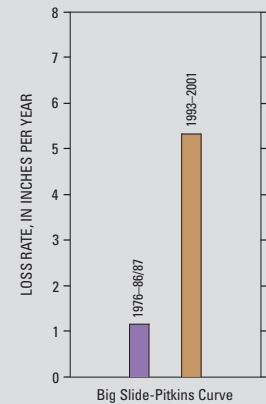
## SITE-SPECIFIC ANALYSES OF CHRONIC LANDSLIDES

To better understand landslide processes along the Big Sur coast, U.S. Geological Survey scientists studied three chronic landslide areas—Hurricane Point, Big Slide-Pitkins Curve, and Grayslip. Using computer analysis of aerial photographs taken over three short time intervals (1976–86/87, 1986/87–93, and 1993–2001), the scientists calculated vertical changes in topography, or “material-loss rate,” over time (for example, see Calculating Material-Loss Rates at right). The results indicate that net loss rates vary substantially along the coast. The bar graphs show that loss rates are lowest at Hurricane Point, which is within less fractured and faulted rocks. The graphs also show that in the interval containing the 1997–98 El Niño, loss rates at all three sites increased by an average of 5 inches per year from the preceding interval. (Photographs copyright by Kenneth Adelman, California Coastal Records Project, <http://www.californiacoastline.org/>.)

For this study, three-dimensional topographic models were created from aerial photographs over three time intervals (1976–86/87, 1986/87–93, and 1993–2001) spanning a total of 25 years. Computer analysis of these models using a geographic information system (GIS) showed that net short-term rates of material loss vary substantially along the coast, apparently in relation to both local rock types and climatic triggers. For example, the loss rates at Hurricane Point, which is within

less fractured and faulted rocks, are the lowest of those at the three sites, whereas the loss rates within weak rocks at the central and southern sites (Big Slides-Pitkins Curve and Grayslip landslides, respectively) are the highest.

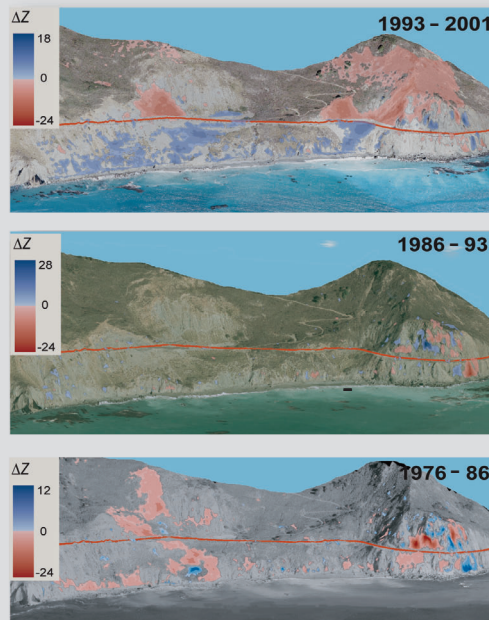
### Calculating Material-Loss Rates

This series of images of the Big Slide-Pitkins Curve landslide area shows where material has been eroded (red) or deposited (blue) owing to landslide movement during three time intervals from 1976 to 2001. Material-loss rates are derived by dividing the change in elevation in yards ( $\Delta Z$ ) by the number of years in the interval.
