U.S. Coast Guard Research and Development Center

Report No. CG-D-05-03

Cape Henry Lighthouse Fuel Cell Evaluation

FINAL REPORT
March 2003

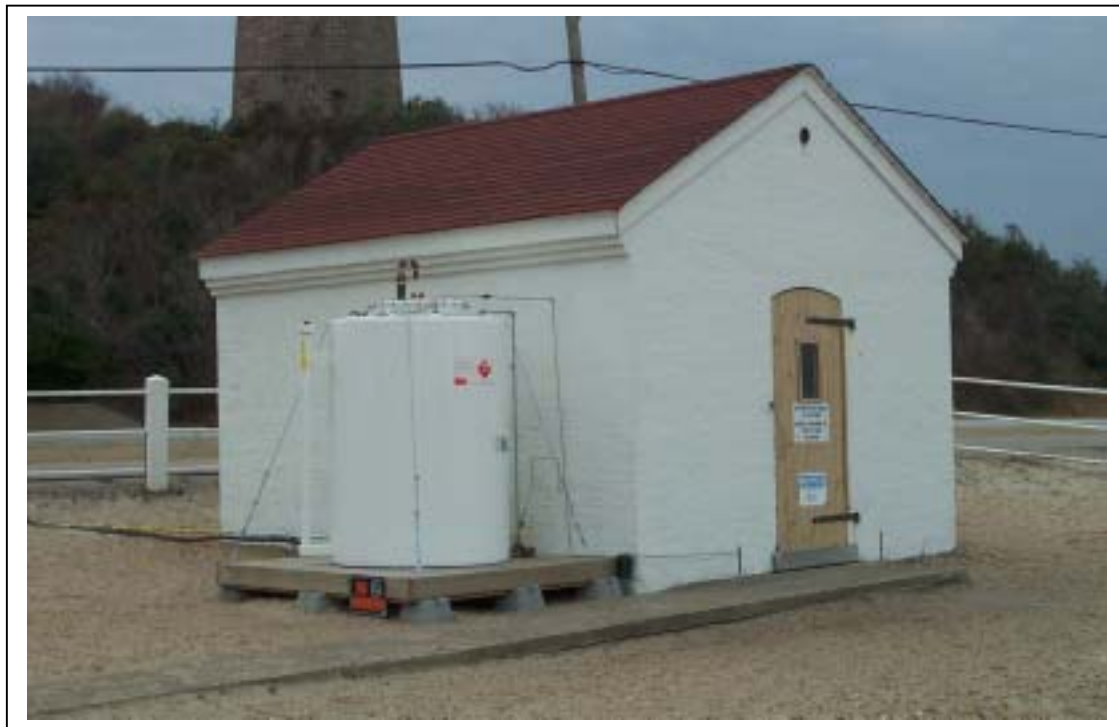
Figure 2. Cape Henry test site with fuel tank.

To prepare the site for the installation, a telephone line was installed to the building. This line would provide the electronic access to the site for monitoring by the USCG R&D Center and Fuel Cell Energy personnel. A deck was constructed to hold the 500-gallon fuel tank, and because it is a historical site the front door was replaced with a new door where holes were cut for ventilation and for a window. Once the installation of the fuel tank was completed, a fence was built around the deck with two doors for access and refueling. Figure 2 shows the fuel building housing the fuel cell with the fuel tank and deck as installed.

USCG personnel prepared the Cape Henry site by running a telephone line into the building, and a deck was built outside the building to support the 500-gallon fuel tank. The tank was delivered and pressure tested to check the double wall containment. It should be noted that the building is considered a historic site so no permanent changes could be made to the structure.

The fuel tank is a double wall tank with a UL rating of 142, which is required for this application. This fuel tank is compliant with NFPA 30. The tank has a built-in visual leak detection system. The tank interior is coated with Ultra liner coating SP-6, and was painted white to reduce heating of the fuel.

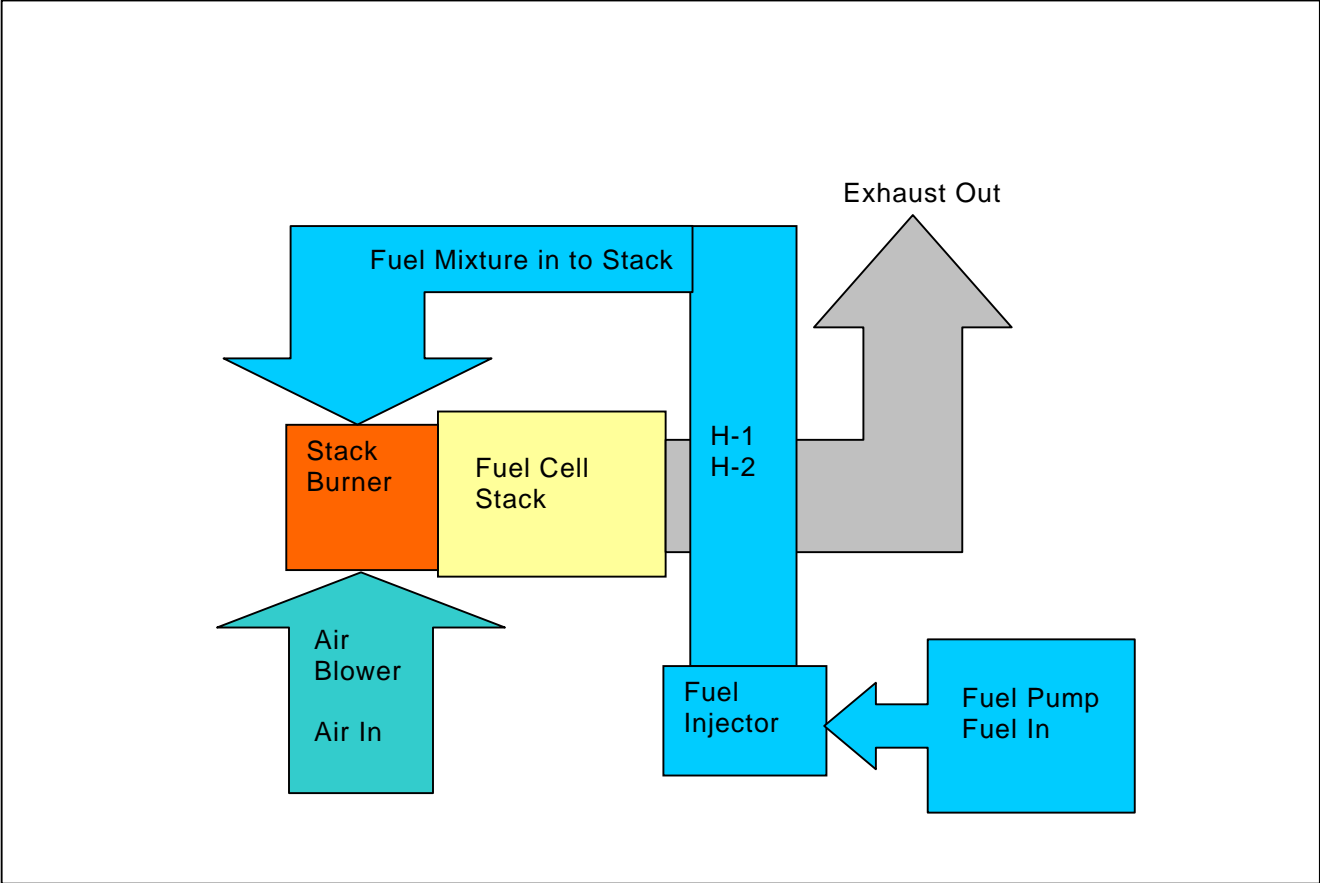
Figure 4. Block diagram of fuel cell.

Figure 4 is a Block diagram of the fuel cell. This system includes three moving parts, the air blower, the fuel pump and the fuel injector. The air blower furnishes oxygen to the system, the fuel pump supplies fuel to the fuel cell stack; H-1 and H-2 are heat exchangers. An aqueous mixture of methanol is pumped to the stack anodes through internal heat exchangers. Residual fuel from the stack anodes reacts with excess air over a catalytic oxidizer and flows through the cathodes of the stack. The stack exhaust gas exits the unit through several heat exchangers used to preheat the incoming reactant streams.

A manual air control valve is provided for bypassing the air heat exchanger during start-up. A fuel pump and an air blower, both powered by 115 VAC supplied by the inverter, deliver the reactants to the unit. An automotive type fuel injector is utilized to modulate the fuel rate in accordance with load and ambient temperature. In the run mode, the operation is completely automatic. The fuel cell stack generates approximately 36 volts DC. The DC power is supplied to a four kW inverter, which supplies AC power to the pumps, blowers, and to the computer and control equipment. Any interruption of this AC power stops all operation of the fuel cell and shuts down the system. Figure 5 shows a picture of the internal stack without any control electronics hooked up. Figure 6 shows a picture of the fuel cell within its enclosure and 1000 Watt lamp in the building.

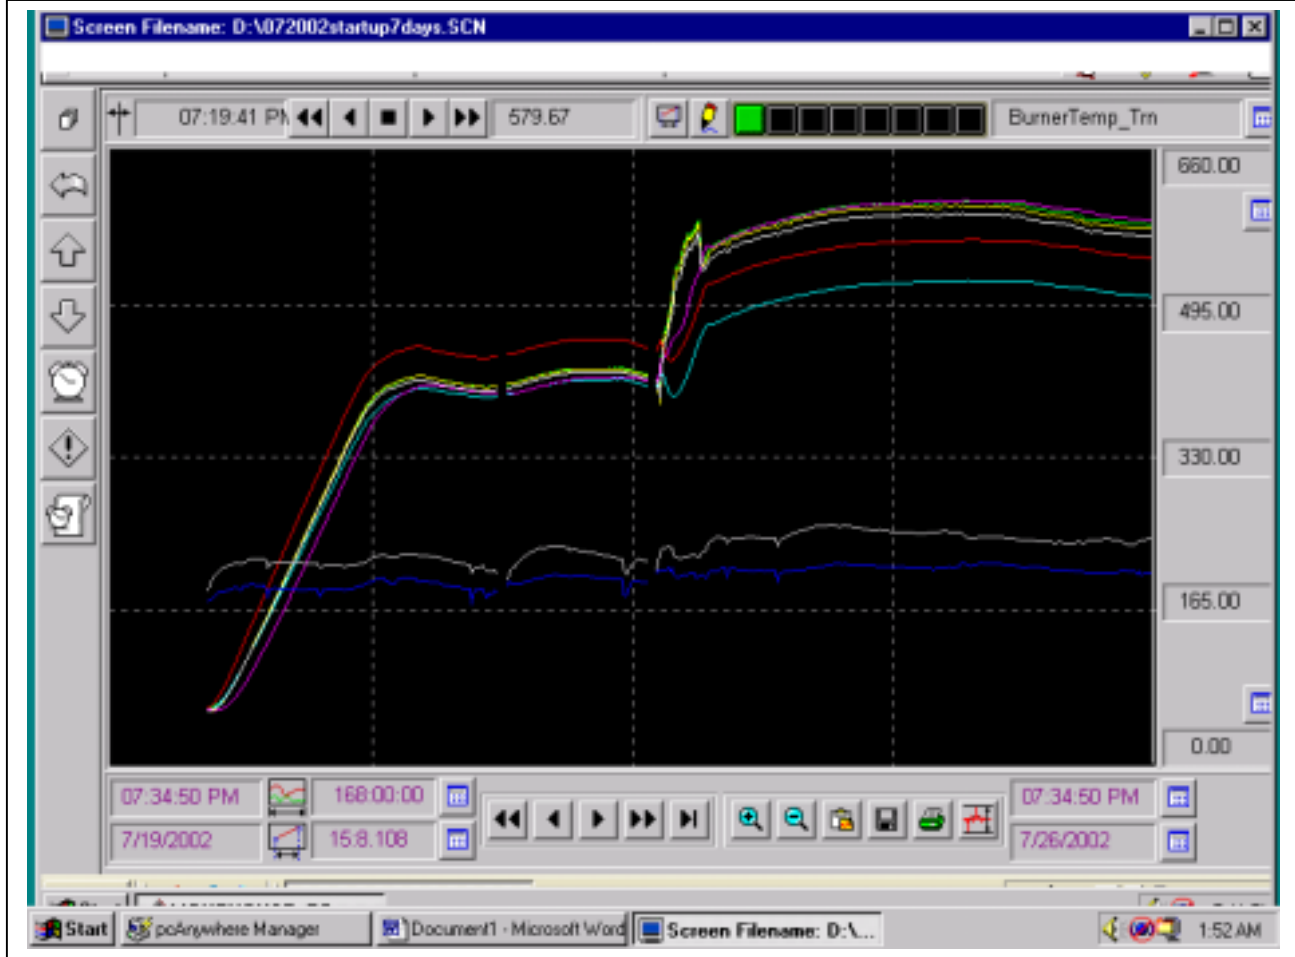
Figure 7. Fuel cell temperatures during startup.

During the five-day on-site test, various temperatures were monitored using an automated data acquisition system (DAS). The main temperature monitored during normal operation is the burner temperature, shown in green on figure 7. Control of the fuel cell, once automatic operation has begun, centers on a burner temperature of 610 °C. The automatic control system keeps the burner temperature at or about 610 °C by adjusting fuel flow through the fuel injector. Figure 7 shows the format of the computer 'Cell Trends' screen available on site and remotely. The screen is a plot of time vs temperature.

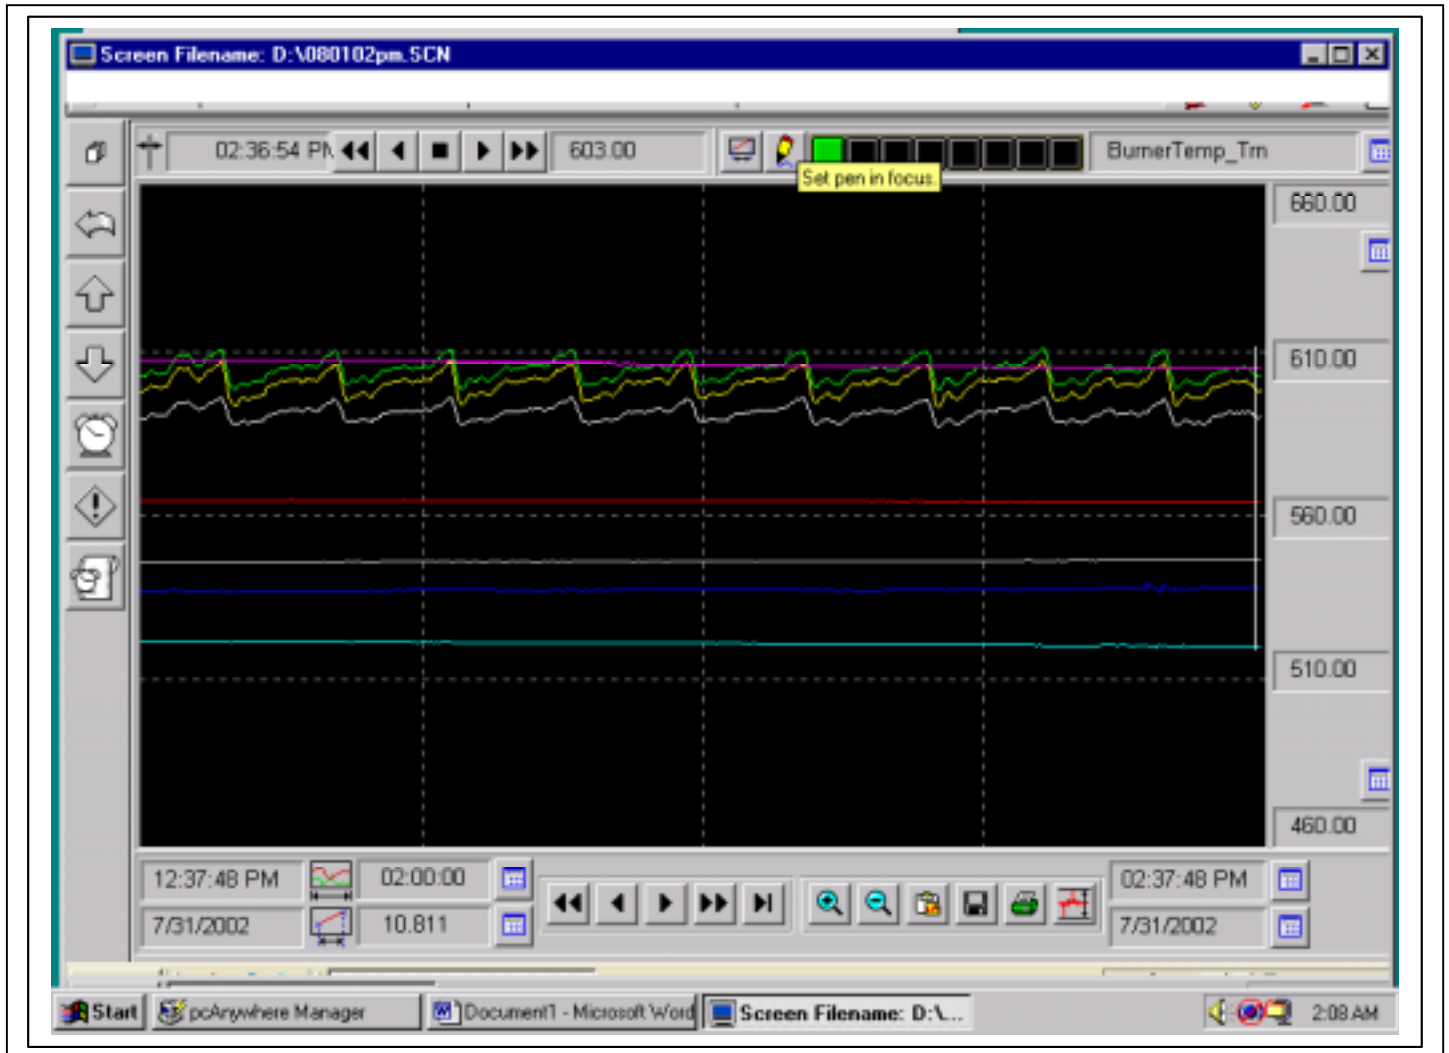
Figure 8. Cell trends during normal operation.

The lower left corner shows the date for the plot. This plot starts at 07:34:50 PM on 7/19/2002 and is for 168 hours, concluding at 07:34:50 PM on 7/26/2002. The computer site was password protected and could be assessed only by authorized personnel. The only control function that could be changed is the open time of the fuel injector mechanism, supplying either more fuel by increasing it or less fuel by decreasing it. Figure 7 shows a typical trace of the burner temperature (shown in green), and other temperatures inside the fuel cell stack, as the system is brought up to operating temperature. Figure 8 shows the same temperatures during a period of normal operation around 610 °C. Two additional computer screens were available for diagnostics and viewing. Figure 9 is a sample of the STATUS screen, and displays cell stack (groups of five cells) voltages and the total current in DC Amps drawn from the fuel cell before the inverter, as well as selected temperatures at the moment. This figure shows the fuel injector pulse rate, which isn't available on the cell temperature screen. Figure 10 is a sample of the MAIN MENU screen, which is a block diagram of the fuel cell system with temperatures appended at the appropriate locations. This figure also shows the fuel injector rate in pulses per second.

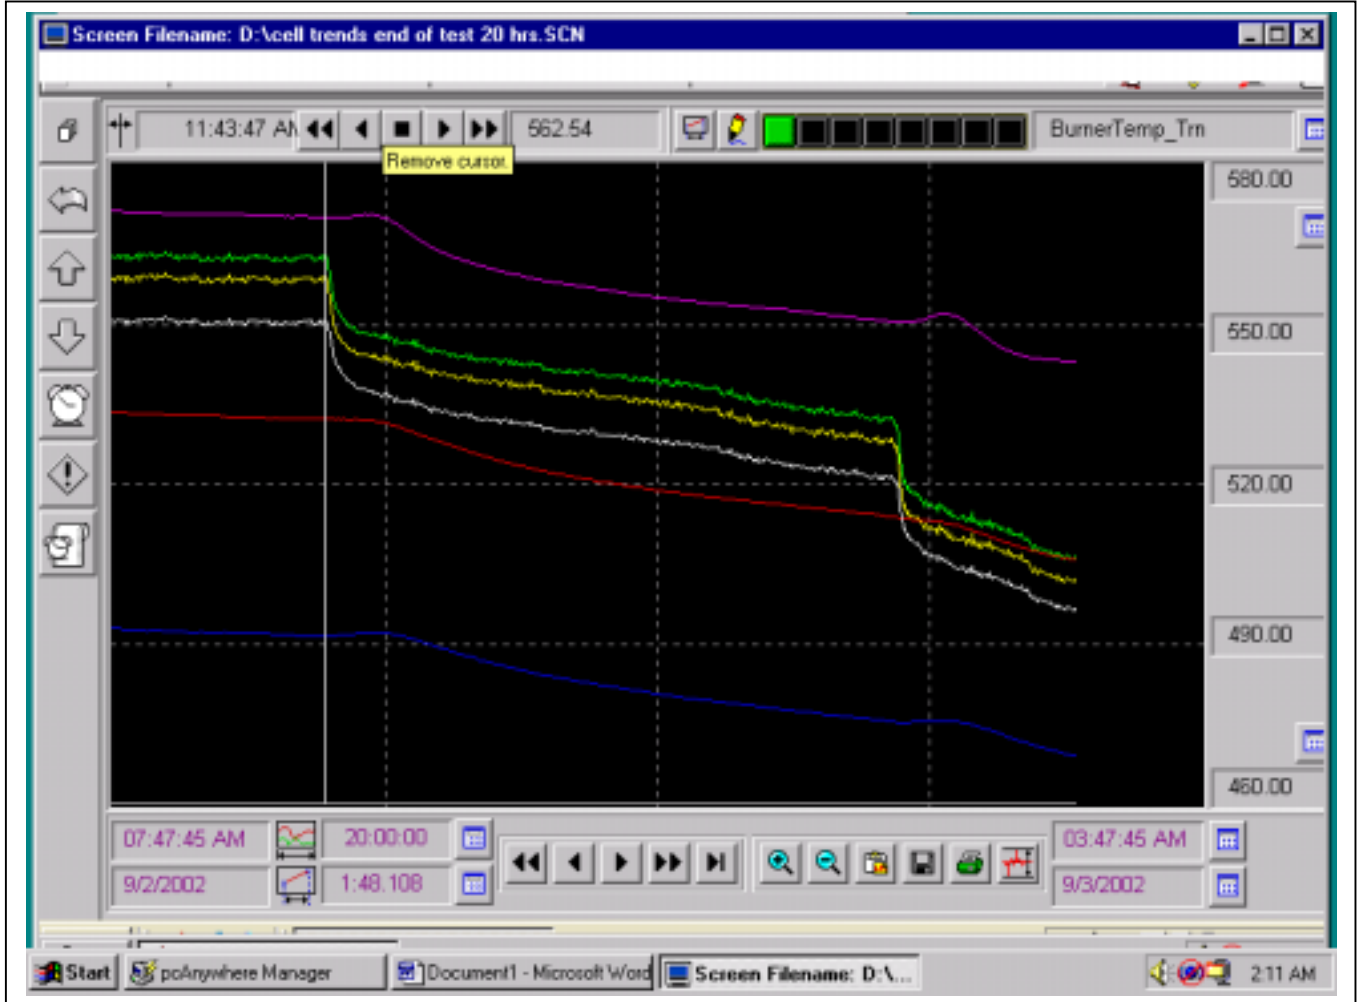
Figure 11. Low temperature shutdown plot.

During the six-month operation of this test system, many outages were experienced. Initially there were multiple problems with the fuel mixture and bubbles within the fuel lines created by the daily heating and cooling of the fuel lines from the storage tank to the fuel cell. In one case, the UPS overheated and shut down due to heat buildup in the building. One of the Programmable Logic Controllers overheated and caused a shut down of the system. One failure was caused by a fuel injector failure in the system. There were two instances of operator errors. All of these failures were overcome and corrected; many were growing pains of a prototype system of new technology. A complete description of these failures can be found in Appendix E. Figure 11 is a screen print showing a low temperature system failure, like that of the fuel injector failure. In all cases, the remote DAS enabled both FCE and the USCG to diagnose problems and expedite corrective action.
