# NOAA Abandoned Vessel Program Removal Case Study: *F/V Done Deal*

Contributing Agency: Florida Keys National Marine Sanctuary

# Removal Case Study: *F/V Done Deal*

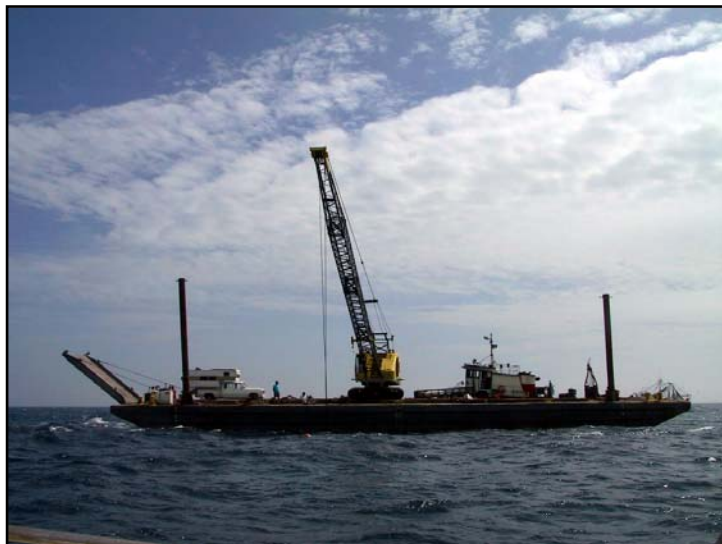
*The salvage barge and crane*

Finally, a salvor was chosen and the removal operation was executed. In this case no other salvors were considered. This was because the NPS had already chosen Maritime Tug and Barge for another operation in the area and the response team was able to piggyback the removal of the Done Deal onto that trip with a cost savings so significant that other providers could not compete. Mobilization and demobilization costs were split between the two operations. The salvors brought in a tug, barge, 60-ton crane and a team of hardhat divers. To minimize environmental impacts, NOAA divers spotted a location to place the barge's anchor and the commercial divers rigged debris with straps and nets to be hoisted onboard the vessel. This minimized anchor damage and avoided damage common to less precise removal techniques like using a clamshell grab.

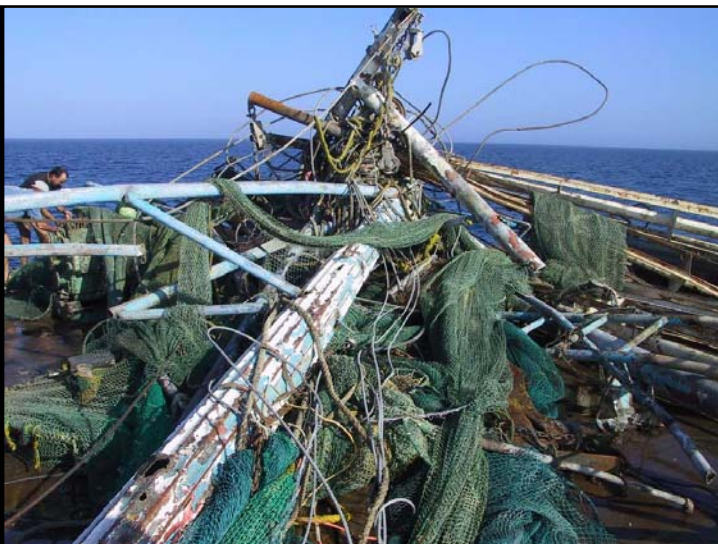
*Debris from Done Deal*

45 cu. yards of debris, 13 cu. feet of fuel soaked nets and 285 gallons of contaminated fuel were barged back to Stuart, FL, the home port for Maritime Tug and Barge. The clean debris was added to their normal outgoing boatyard waste and went to a landfill. The nets and fuel were incorporated into their onsite hazardous material system and disposed of accordingly.

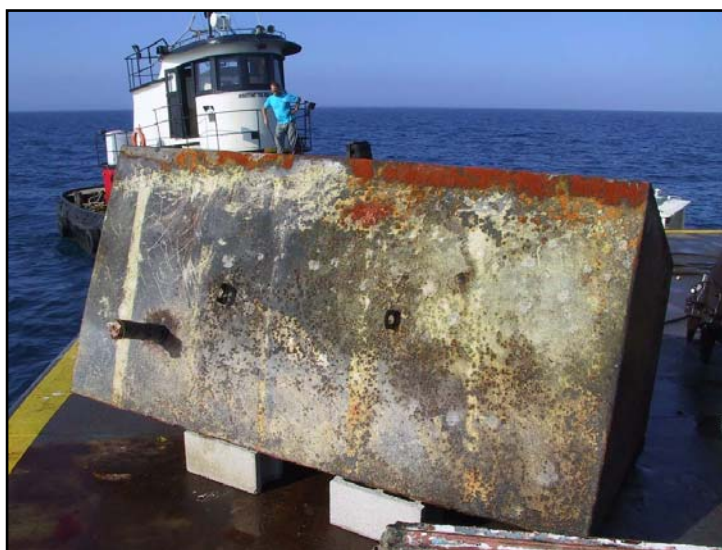
*Recovered fuel tank*

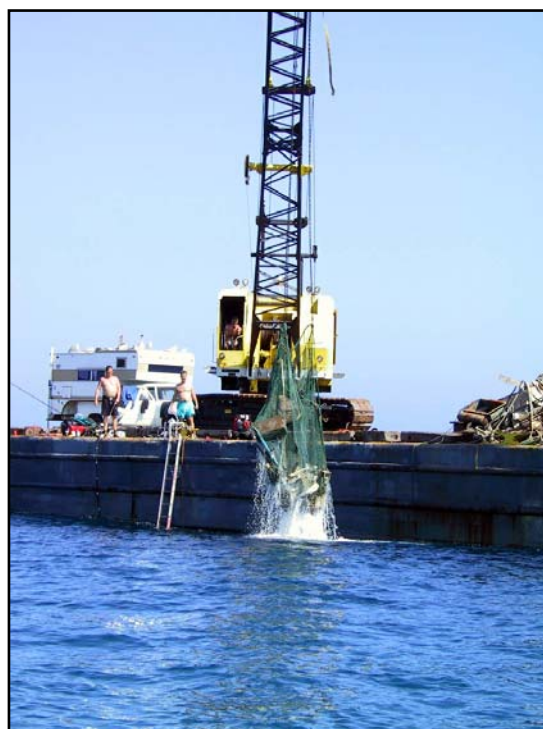
*Salvors recovering load of debris assembled by divers*
