ENVIRONMENTAL ASSESSMENT
CANYON VISITOR CENTER REHABILITATION

February 2001

YELLOWSTONE

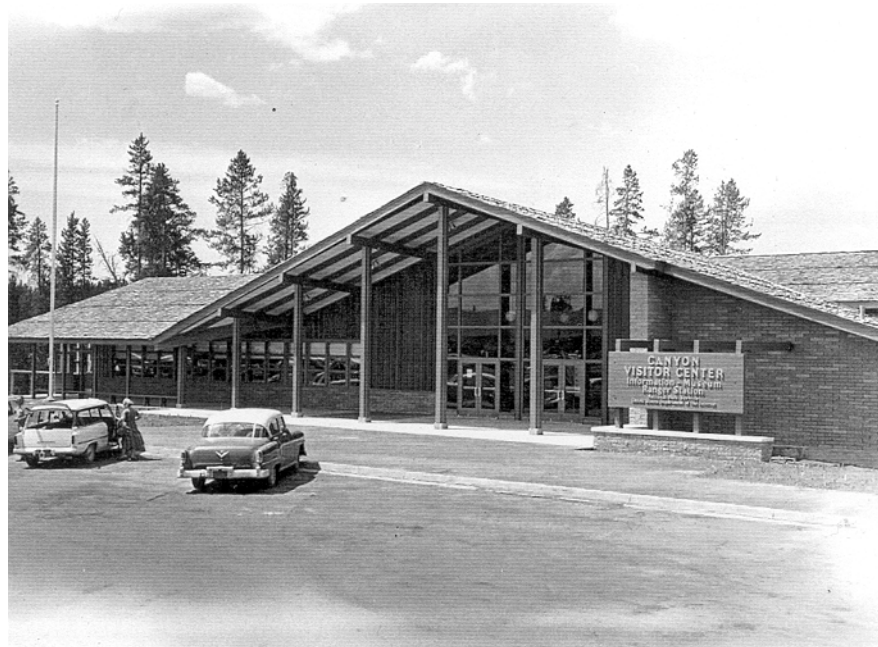
The National Park Service (NPS) is proposing to rehabilitate and upgrade the Canyon Visitor Center in Yellowstone National Park. The present visitor center (shown in the photo below) was constructed in 1958 and has a number of structural and design defects that must be corrected. Additionally, the current visitor center is too small to adequately serve the number of visitors who use it. In order to provide adequate space and services to the public, the size of the rehabilitated building would be doubled (approximately) to 22,820 square feet. This would be done by adding a second story and utilizing the space at the south end of the building now occupied by the U.S. Post Office.

Canyon Visitor Center

The original design of the Canyon Visitor Center proved inadequate from the beginning. Multiple (often-failed) attempts to repair and mitigate various structural and design defects of the building have occurred during the past 30 years. For example, the original roof was poorly designed for the environmental conditions at Canyon where there are long winters with heavy, deep snows. Specifically, the roof pitch is not steep enough to allow snow to slide, thereby creating a severe and dangerous snow-load problem; the original wood shingles exacerbated this problem by inhibiting snow movement. The shake shingles were replaced in the early 1990s with a metal roof with the expectation that the snow would slide, however, snow continues to build up on the roof. Despite two additional attempts to alter the roof pitch, the problem has not been corrected. Added to this, the number of valleys (the trough formed where two roof slopes meet) in the original roof design exacerbates the snow load by trapping snow. A recent architectural assessment of the roof concluded that the pitch and valley problems in the current roof can only be corrected with a totally new roof design.

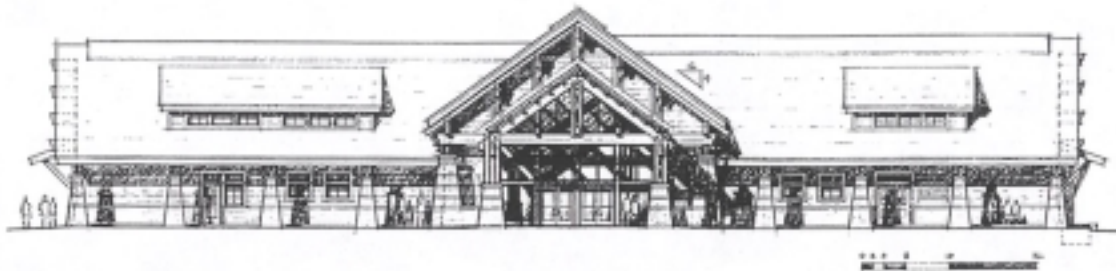
Preliminary design of the building occurred in order to initiate §106 consultation with the Wyoming SHPO. The proposed building (shown below) reflects and melds the Mission 66 architectural philosophy, which embodied a manufactured, “modern” appearance, and the architectural philosophy of the Arts and Crafts period, which was reflected in the Canyon Hotel (this structure burned in 1959). Exposed posts and beams would be sawn and squared, and the siding would be either smooth, sawn cedar shingles or solid wood panels broken with wood cross-trim. The base of the building and pillars would be cut stone. The steeply pitched roof would be covered with sawn cedar shingles. The architect would work with NPS staff to find ways to reduce swallow-nesting opportunities under the overhangs.

Proposed Canyon Visitor Education Center
