# Potential Environmental Impacts of Quarrying Stone in Karst— A Literature Review

U.S. Geological Survey  
Open-File Report OF-01-0484

By William H. Langer

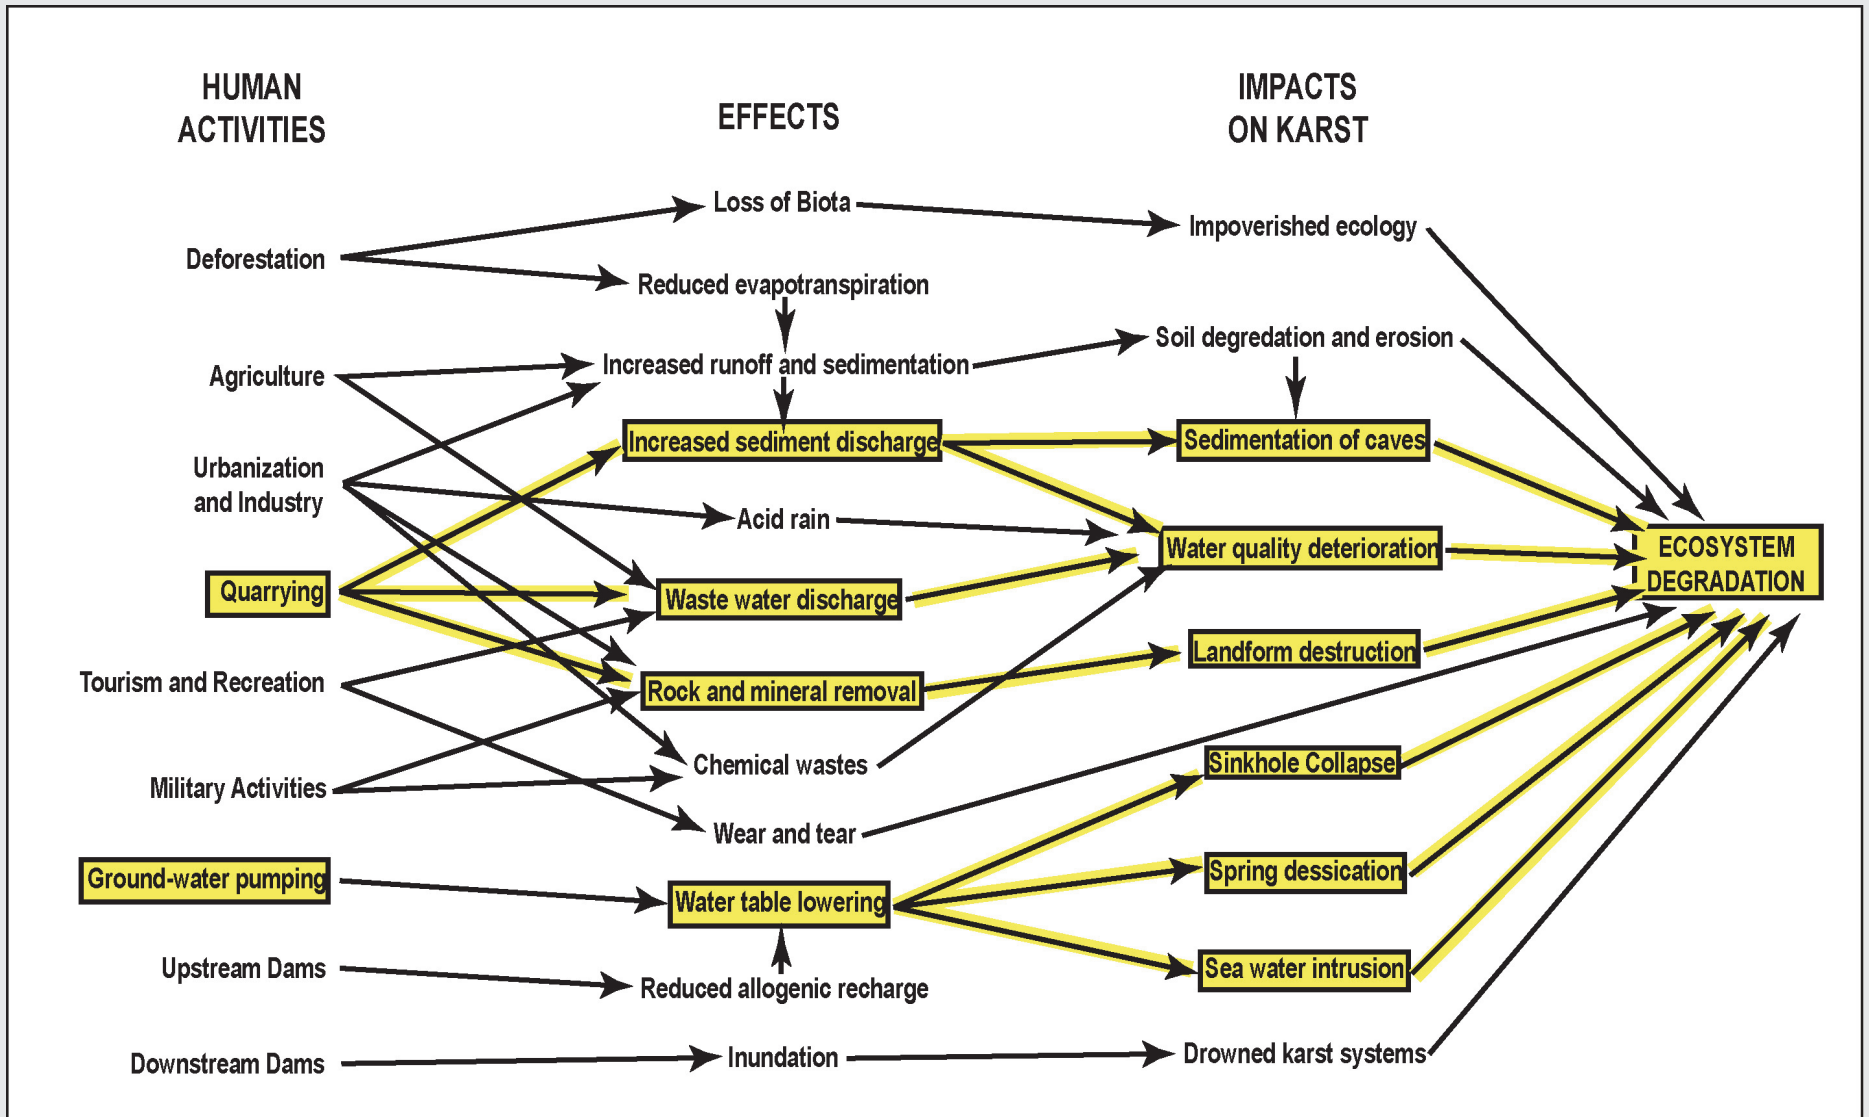
Figure 2. Summary of effects and impacts of various human activities on karst terrains. Effects and impacts from quarrying are highlighted in yellow. (Modified from Williams, 1993a.)

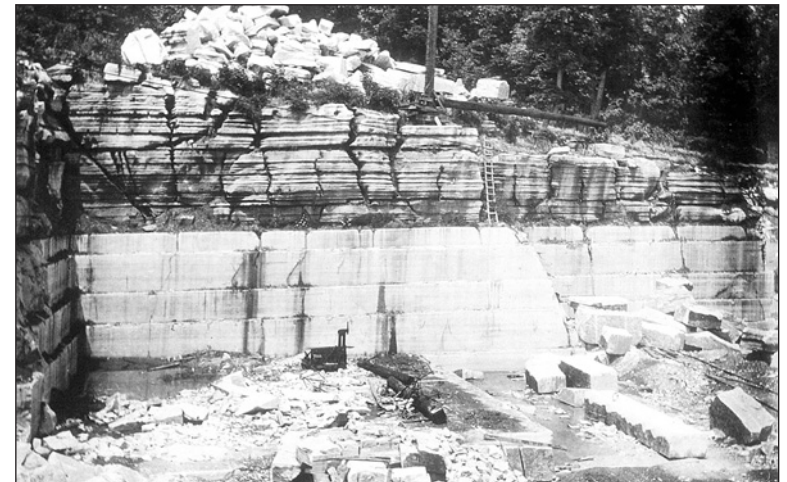
**Figure 4.** Dimension stone quarry showing weathered outcrop (top) and smooth working face of quarry. Vertical solution channels following fractures and joints in the weathered outcrop extend down into the smooth working face. Horizontal solution features occur between beds of the rock. Notice ladder for scale. (USGS photographic library - Loughlin 154.)

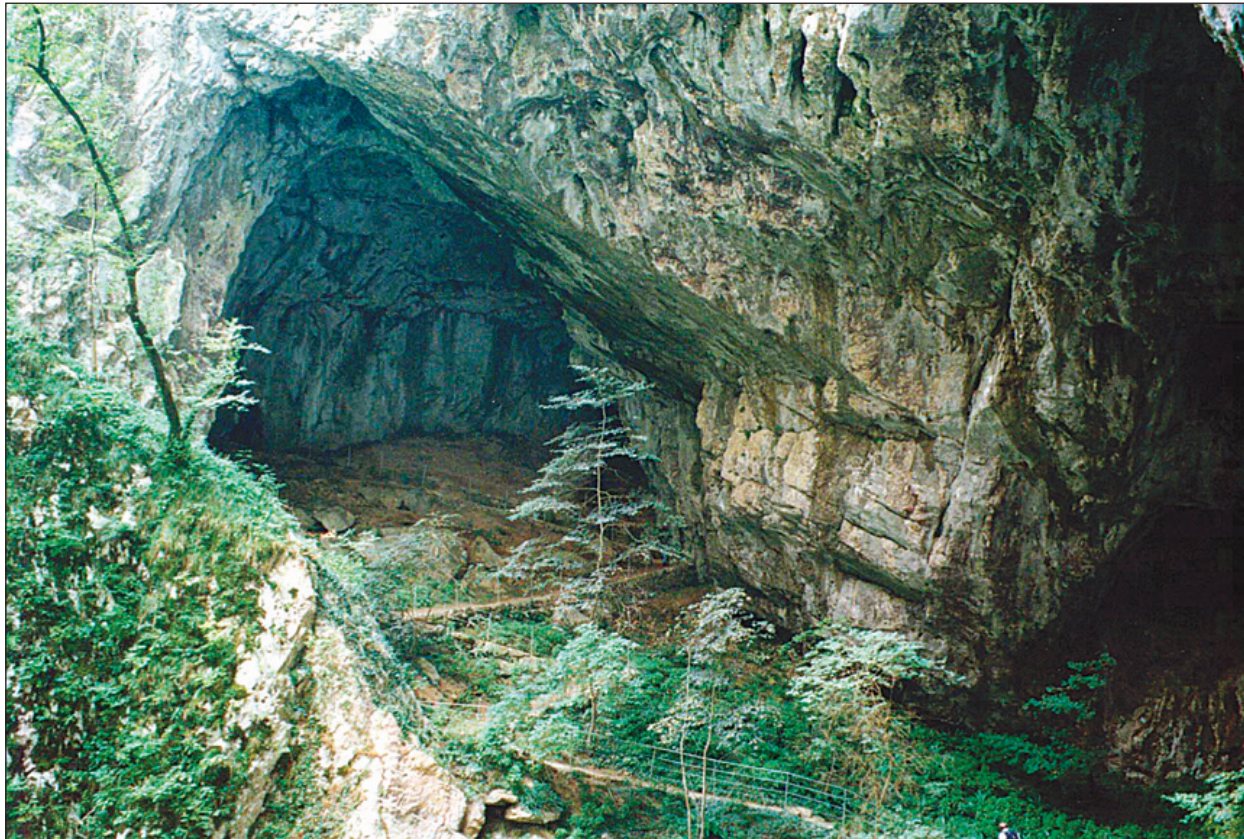
**Figure 5 (above).** Cave opening in karst terrain, Škocjan Cave, Slovenia.

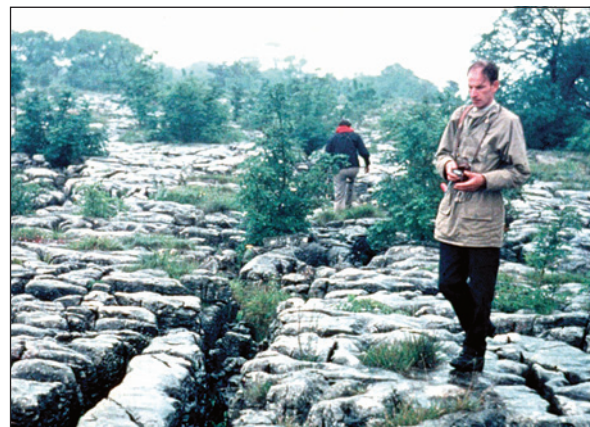
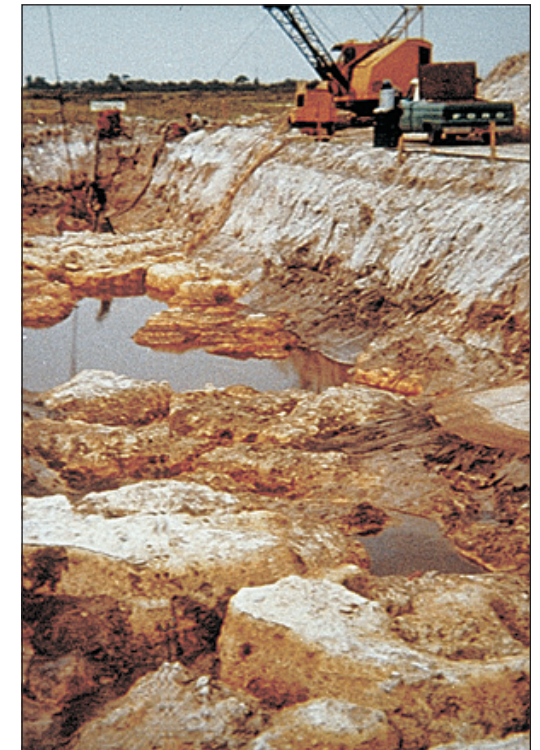
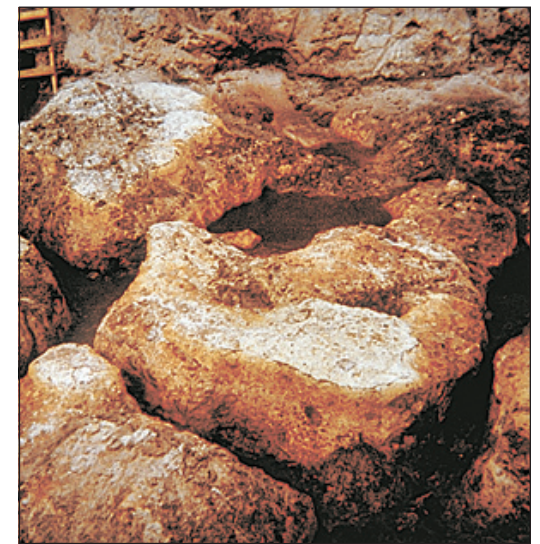
**Figure 6-a (right).** Limestone surface in karst area with no soil cover.

**Figure 6-b (far right, top and bottom).** Removal of overburden has exposed the furrowed and pitted surface of carbonate rock. (Photograph courtesy of Keith Bennett, Williams Earth Sciences, Inc.)

Unusual bedrock surfaces may be created as the carbonate rock is dissolved (fig. 6a and 6b). In temperate climates, some of the surfaces resemble abstract sculptures or contain pointed columns called pinnacles. A residual soil forms over the bedrock because there are minerals within limestone that are not affected by carbonic acid. As the process of dissolution continues, these insoluble minerals collect on top of the bedrock surface as clayey residual material. Some residual material is carried by water into openings in bedrock where they clog the openings. Other material, such as stream alluvium, may overly the clay. Depending on the climate, topography, and type of parent bedrock, soil on the bedrock surface can be non-existent or greater than 50 m thick.

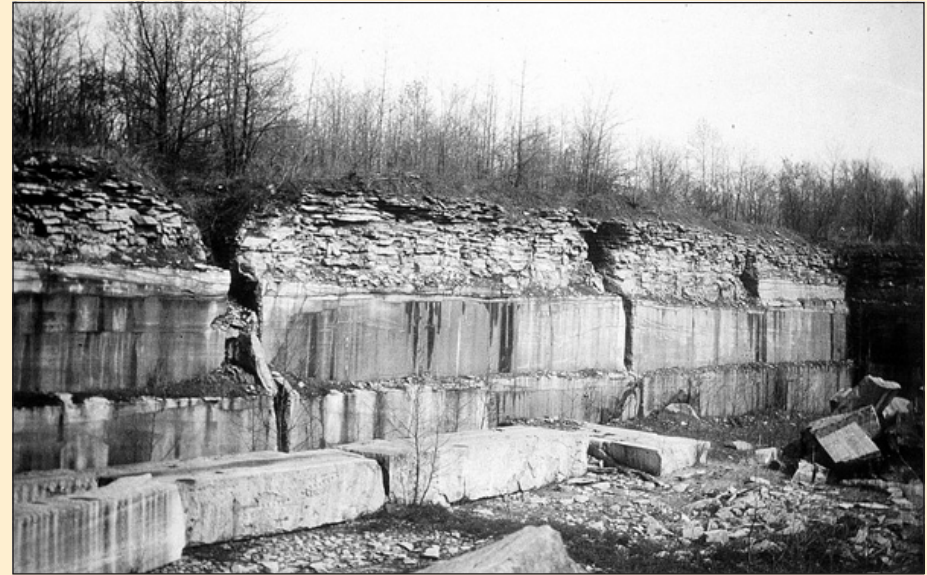
**Figure 7.** Working face of dimension stone limestone quarry in Lawrence County, Indiana, showing smooth surfaces from which large blocks have been removed. (USGS photographic library – Burchard #556.)

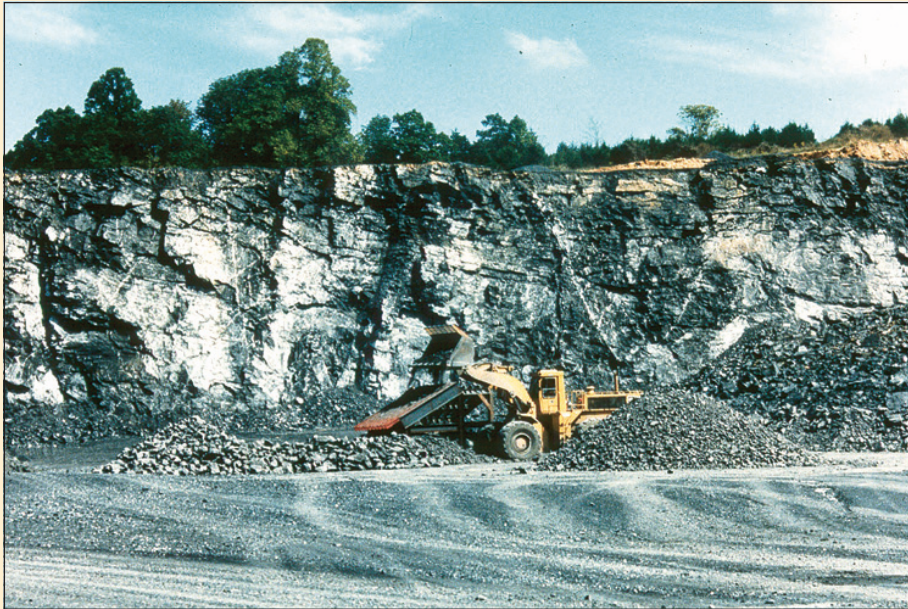
**Figure 8.** Working face of crushed stone operation showing rubble created by blasting.  
(Photograph courtesy Luck Stone.)

The general objective of crushed stone quarrying is to produce relatively small pieces of rock that are suitable for crushing into gravel-sized particles (fig. 8). To produce crushed stone, the rock is first drilled and blasted. Blasting commonly breaks the rock into pieces suitable for crushing. When the blasted material is dry, it can be extracted by using conventional earth-moving equipment, such as bulldozers, front loaders, track hoes, and scraper graders. Rock quarries that do not penetrate the water table, or where discharge from the water table naturally drains from the quarry, is offset by evaporation, or is otherwise insignificant, commonly are mined dry.

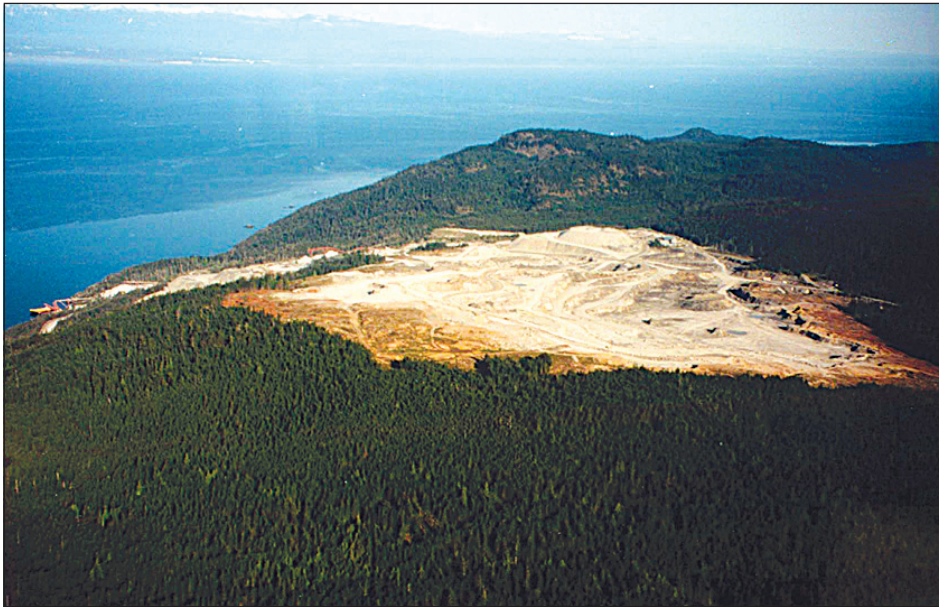
**Figure 11.** Quarries can occupy a significant part of the visual landscape.

The extent of the geomorphic impact is a function of the size of the quarry, the number of quarries, and the location of the quarry, especially with respect to the overall landscape and the local landforms (fig. 11). The influence of quarry size on environmental impact is obvious: all other things being equal, the larger the quarry, the larger the geomorphic impact. The size of quarries has increased over time, and so has their impact.

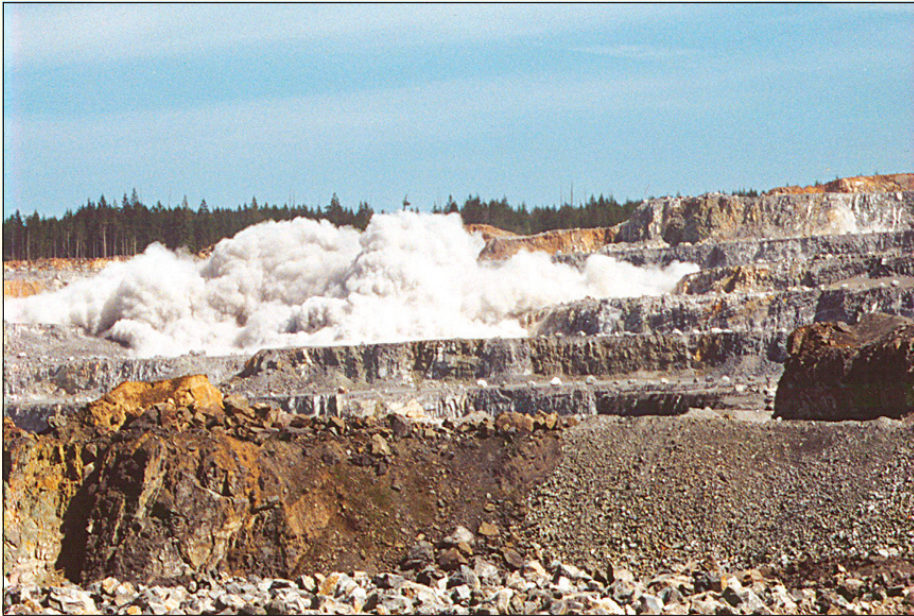
**Figure 12.** Rock is drilled and blasted for use as crushed stone. In some isolated areas where people are not located nearby, larger amounts of explosives may be used.

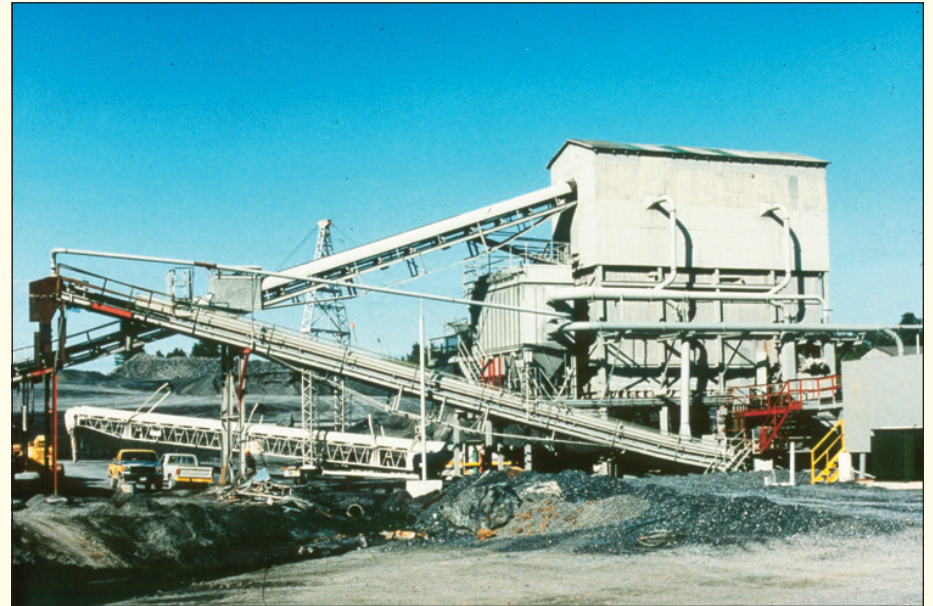
**Figure 13.** Noisy equipment can be located away from populated areas and can be enclosed in sound-deadening structures. (Photograph courtesy Luck Stone.)

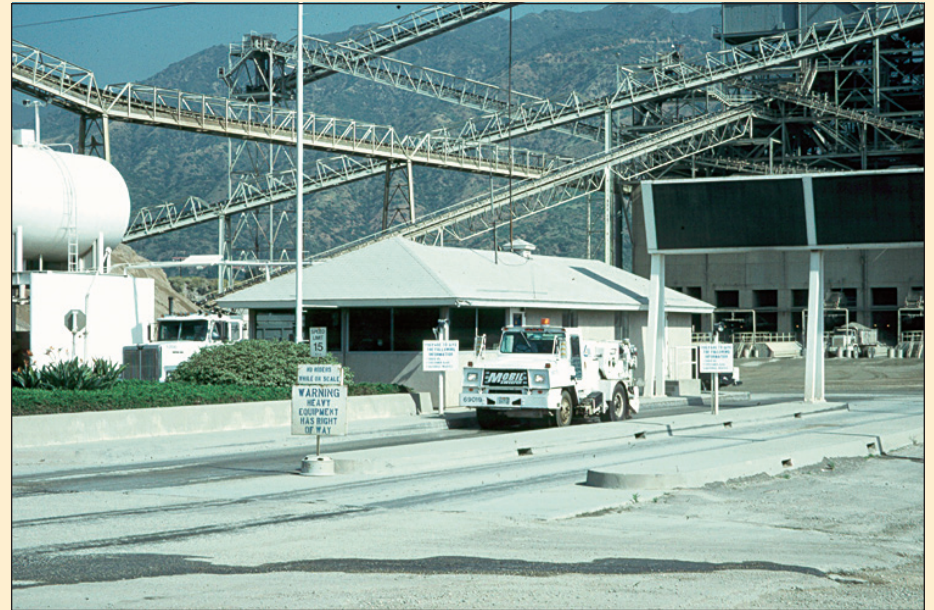
**Figure 14.** Dust control techniques include the use of water trucks and sweepers on haul.

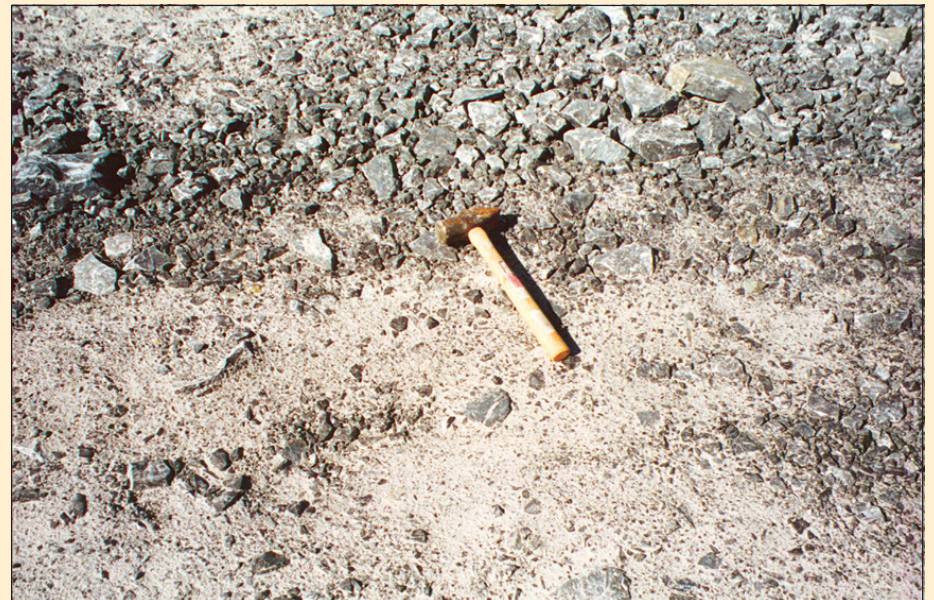
**Figure 15 (right).** Dust on quarry floors can clog pores in the ground, thus altering ground-water recharge.

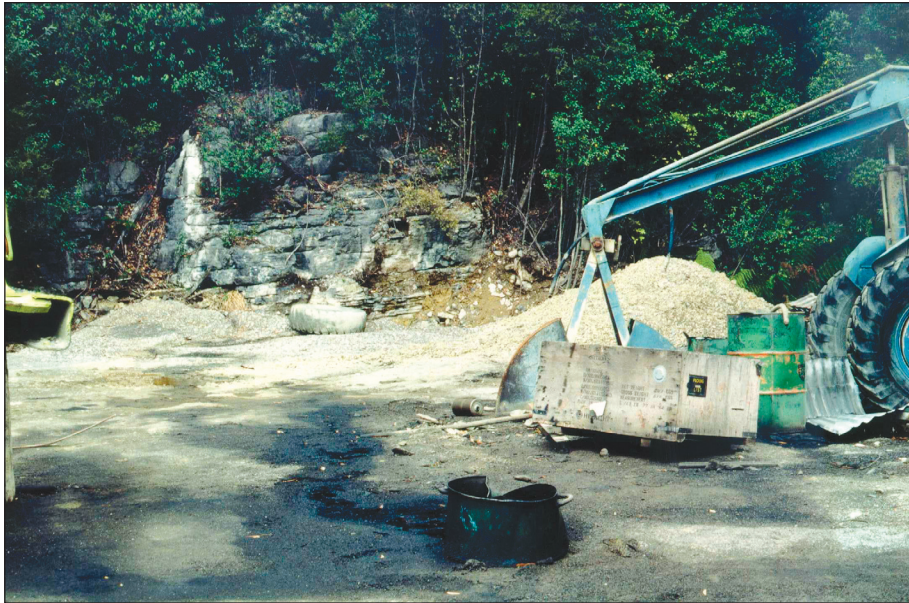
**Figure 17a.** Fuel oil spills can rapidly contaminate karst aquifers. (Photograph courtesy Elery Hamilton-Smith.)

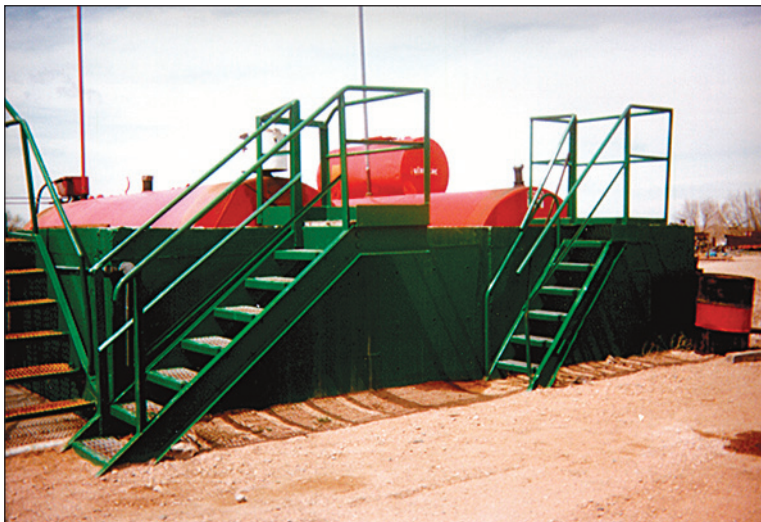
**Figure 17b.** Properly constructed containment facilities can protect the aquifer from potential fuel spills. (Photograph courtesy Lafarge.)

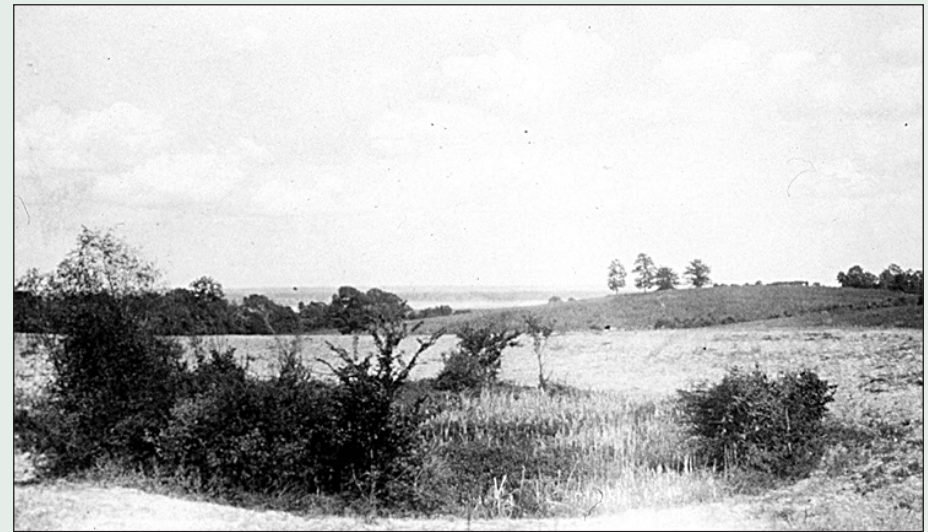
**Figure 18.** Natural sinkhole near Ste. Genevieve, Missouri (*USGS photographic library-Shaw #891*).

Natural sinkholes (fig. 18) can form through the dissolution of rock (solution sinkhole) or through the failure of a bed-rock roof overlying a cavern (collapse sinkhole). The formation of both of these types of sinkholes occur over periods of geologic time, not within a human lifetime. The solution of rock has little to do with the final cause of sinkhole collapse, however, it can set the stage for some human-induced event in the future (Thorpe and Brook, 1984; White and White, 1995). Of an estimated 4,000 sinkholes formed in Alabama between 1900 and 1976, only 50 were natural collapses (Newton, 1976).

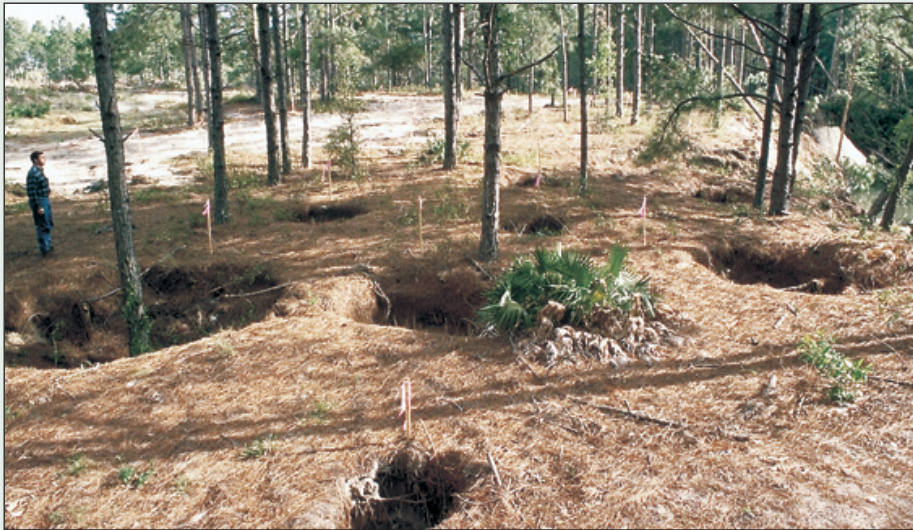
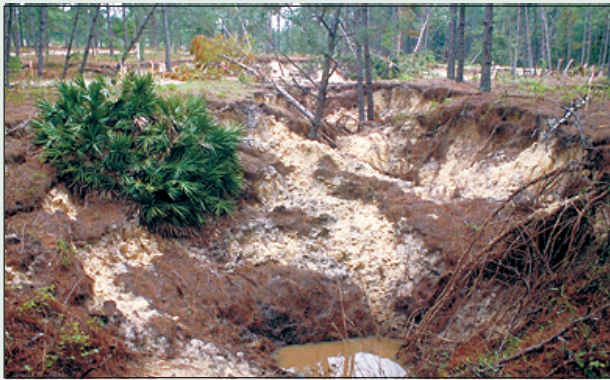
**Figure 19.** Human-induced sinkholes formed during the development of an irrigation well affected a 20-acre area and ranged in size from less than 1 foot to more than 150 feet in diameter. (Photograph courtesy Ann Tihansky, USGS.)

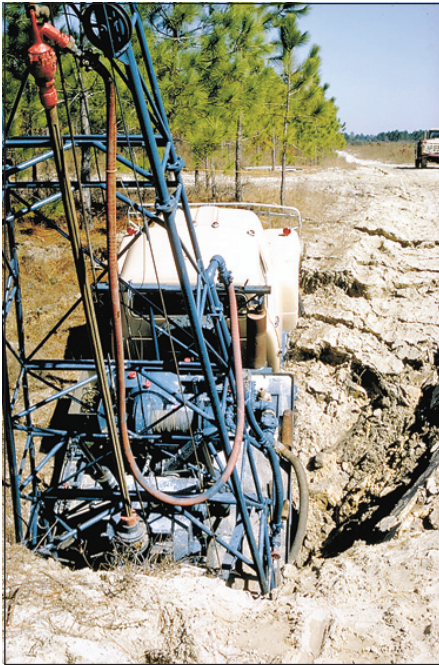
**Figure 22.** "A giant sink hole opened up on Thursday, September 19 [1975] at a drilling site near Tampa, Florida and swallowed up a well-drilling rig, a water truck, and a trailer loaded with pipe all valued at \$100,000. The well being drilled was down 200 ft when the ground began to give way to what turned out to be a limestone cavern. Within 10 minutes all the equipment was buried way out of sight in a crater measuring 300 ft deep, and 300 ft wide. Fortunately, the drilling crew had time to scramble to safety and no one was hurt." -from National Water Well Association newsletter. (Photograph courtesy Tom Scott.)

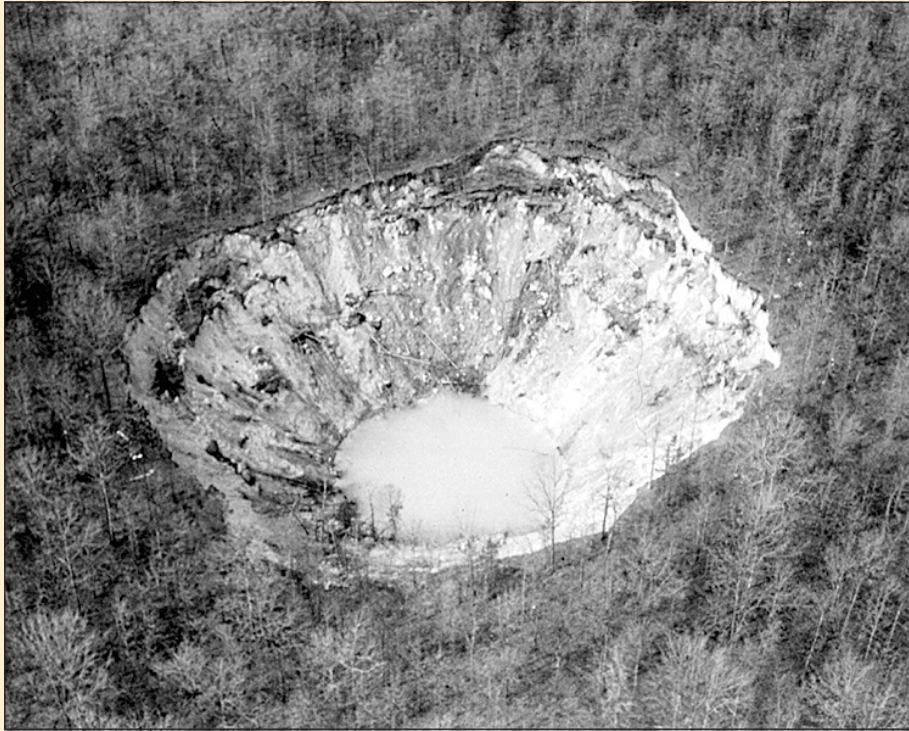
**Figure 23.** The “December giant,” a large sinkhole, developed rapidly in Shelby County, Alabama, in December 1972. The sinkhole measures 145 m long, 115 m wide, and 50 m deep. (USGS Photographic Library-USGS #140.)

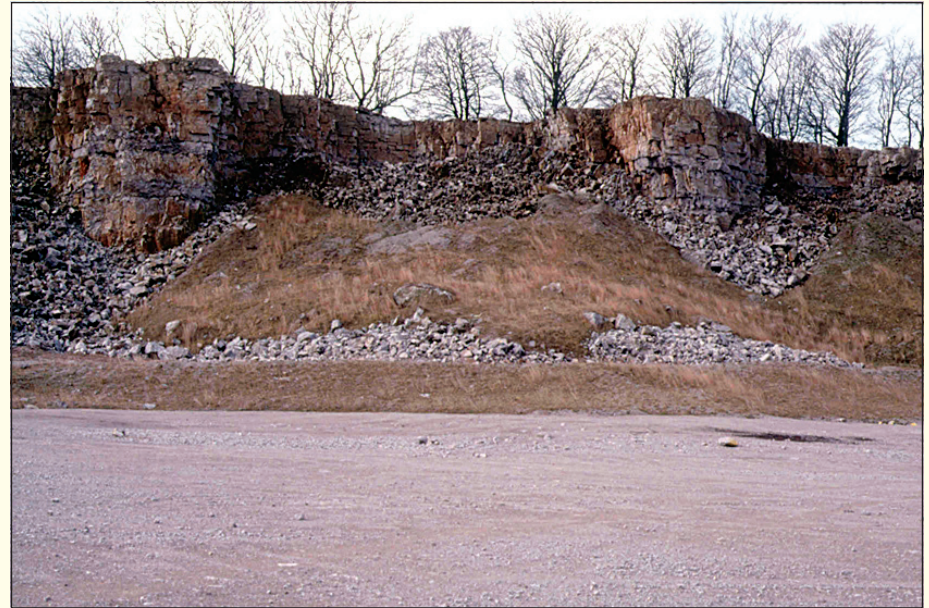
**Figure 24.** Face of limestone quarry after restoration blasting and habitat reclamation. (Photograph courtesy John Gunn.)
