Responding to Submerged Oils in Freshwater Environments

David Usher

Freshwater Spills Symposium - 2006

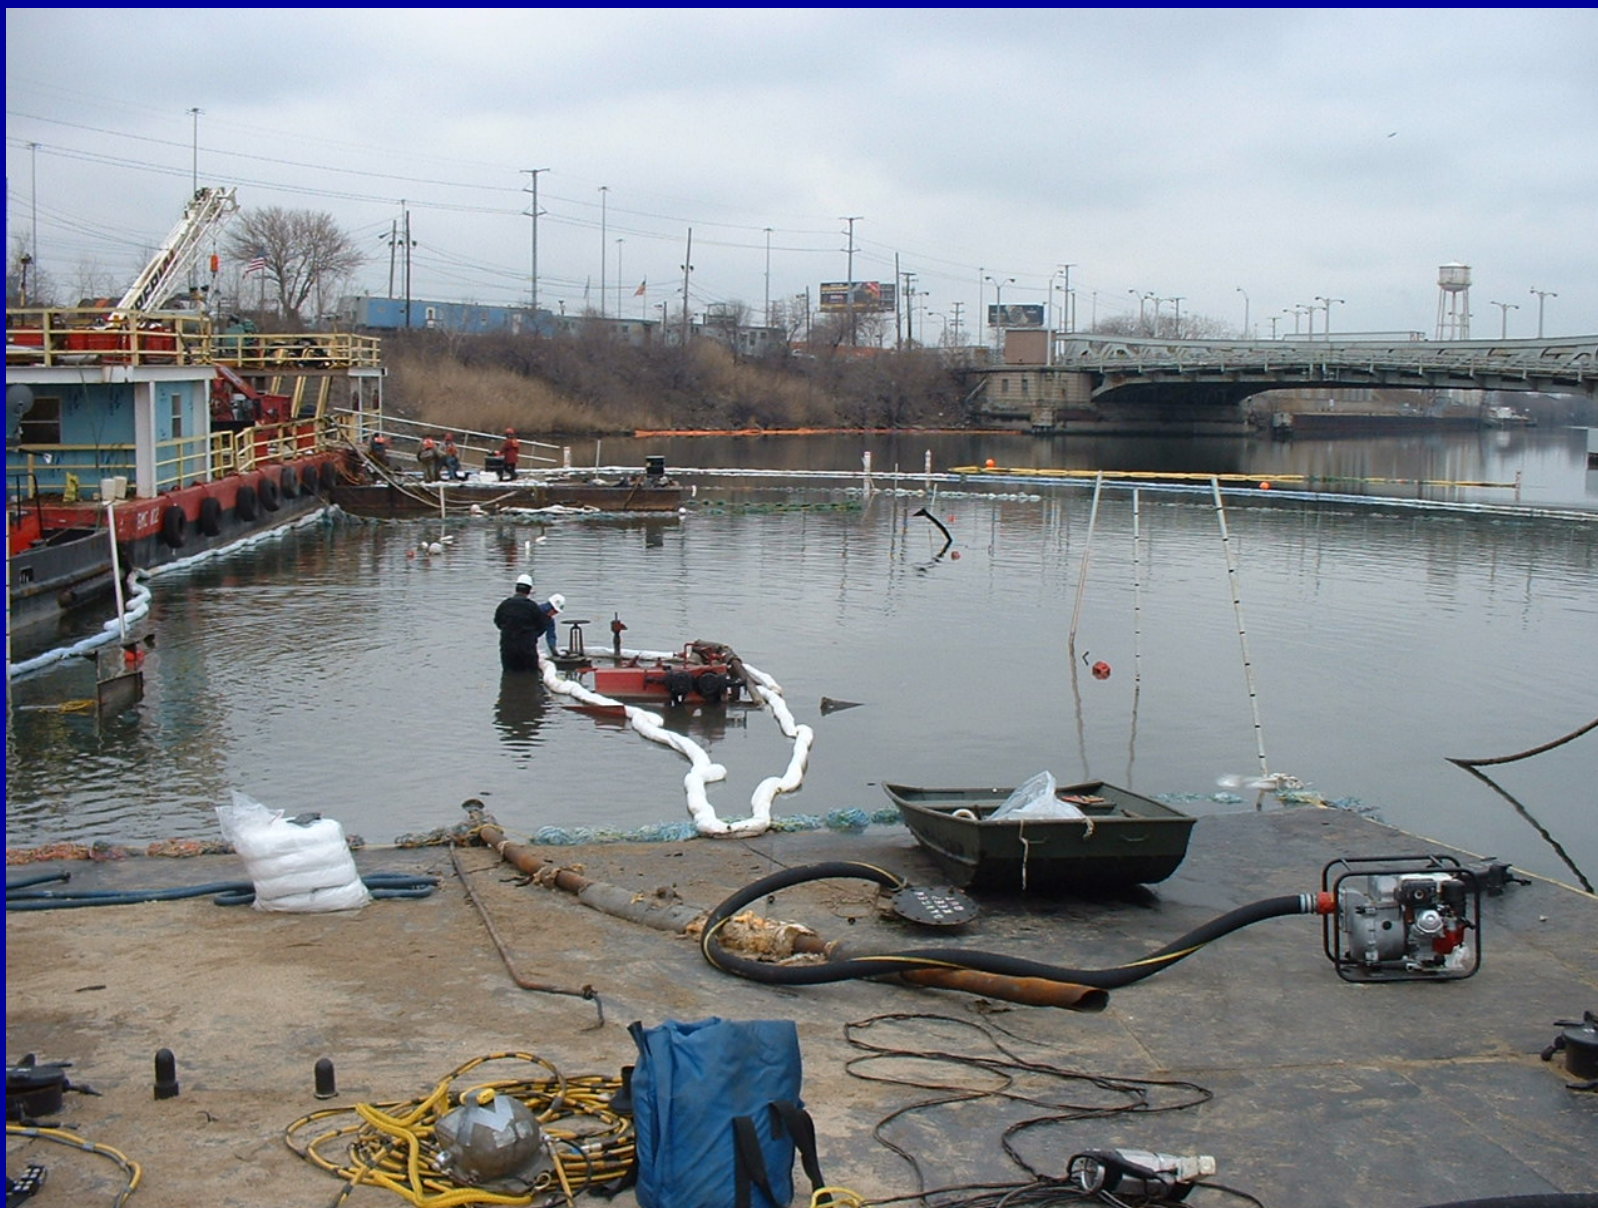
Photo taken from the exposed bow of the barge, with the stern ~295' to the rear and under ~20 feet of water. At this point, all oil is thought to remain on board.

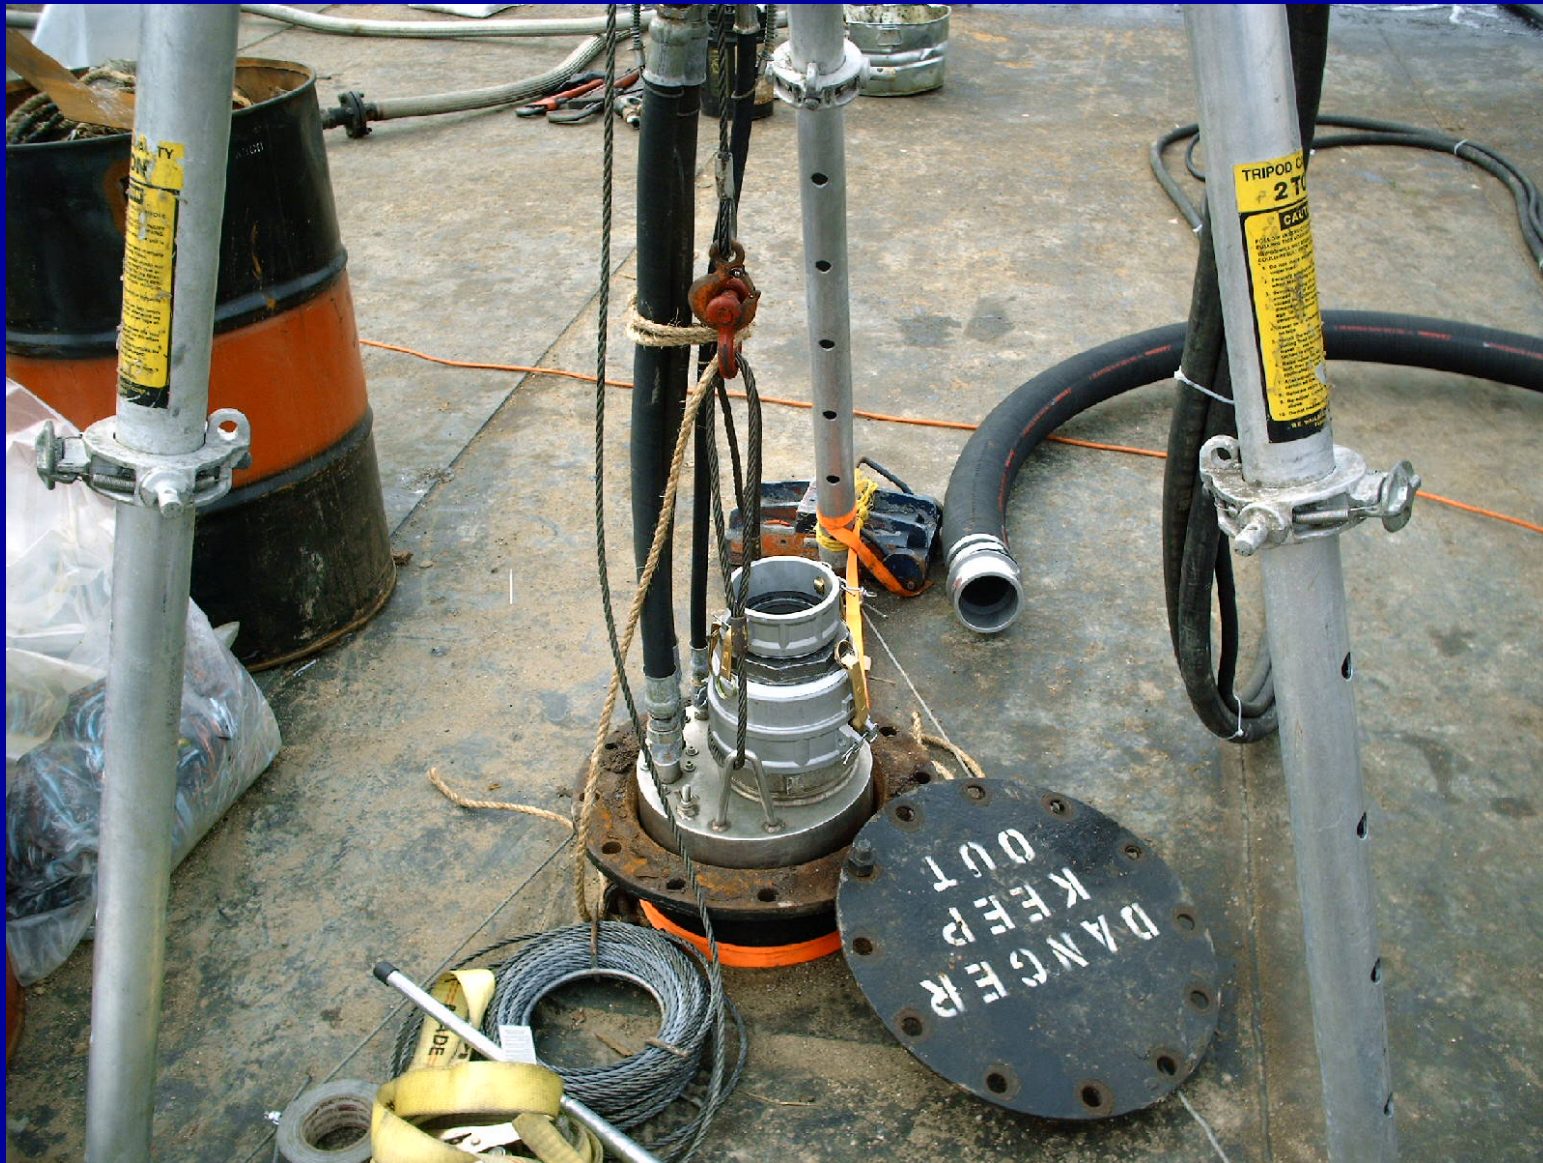
When heat could be maintained on the product and the oil was well contained (such as at the #1 cargo tank which remained intact after the explosion), a hydraulic submersible pump (MPC model KMA 333) easily transferred the contents.

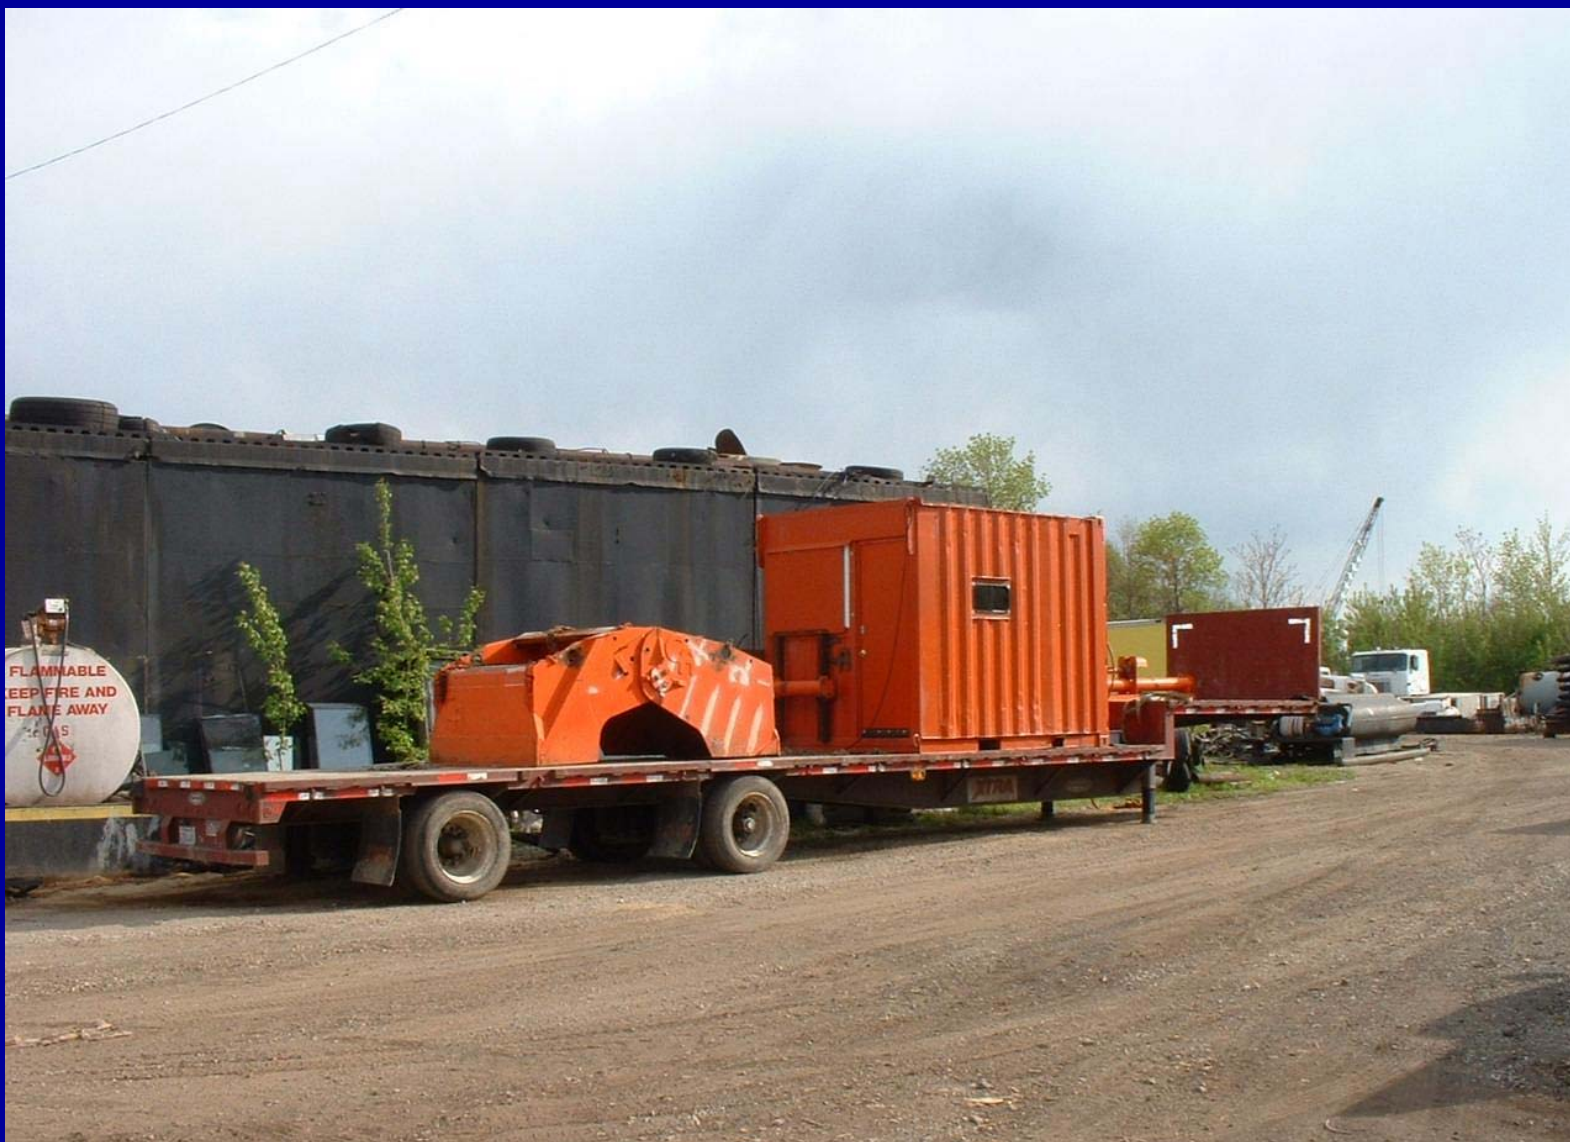
After considering a number of different approaches, this environmentally-friendly clamshell dredge unit was mobilized to the site. The dredge minimizes the amount of contaminated water runoff associated with such operations.

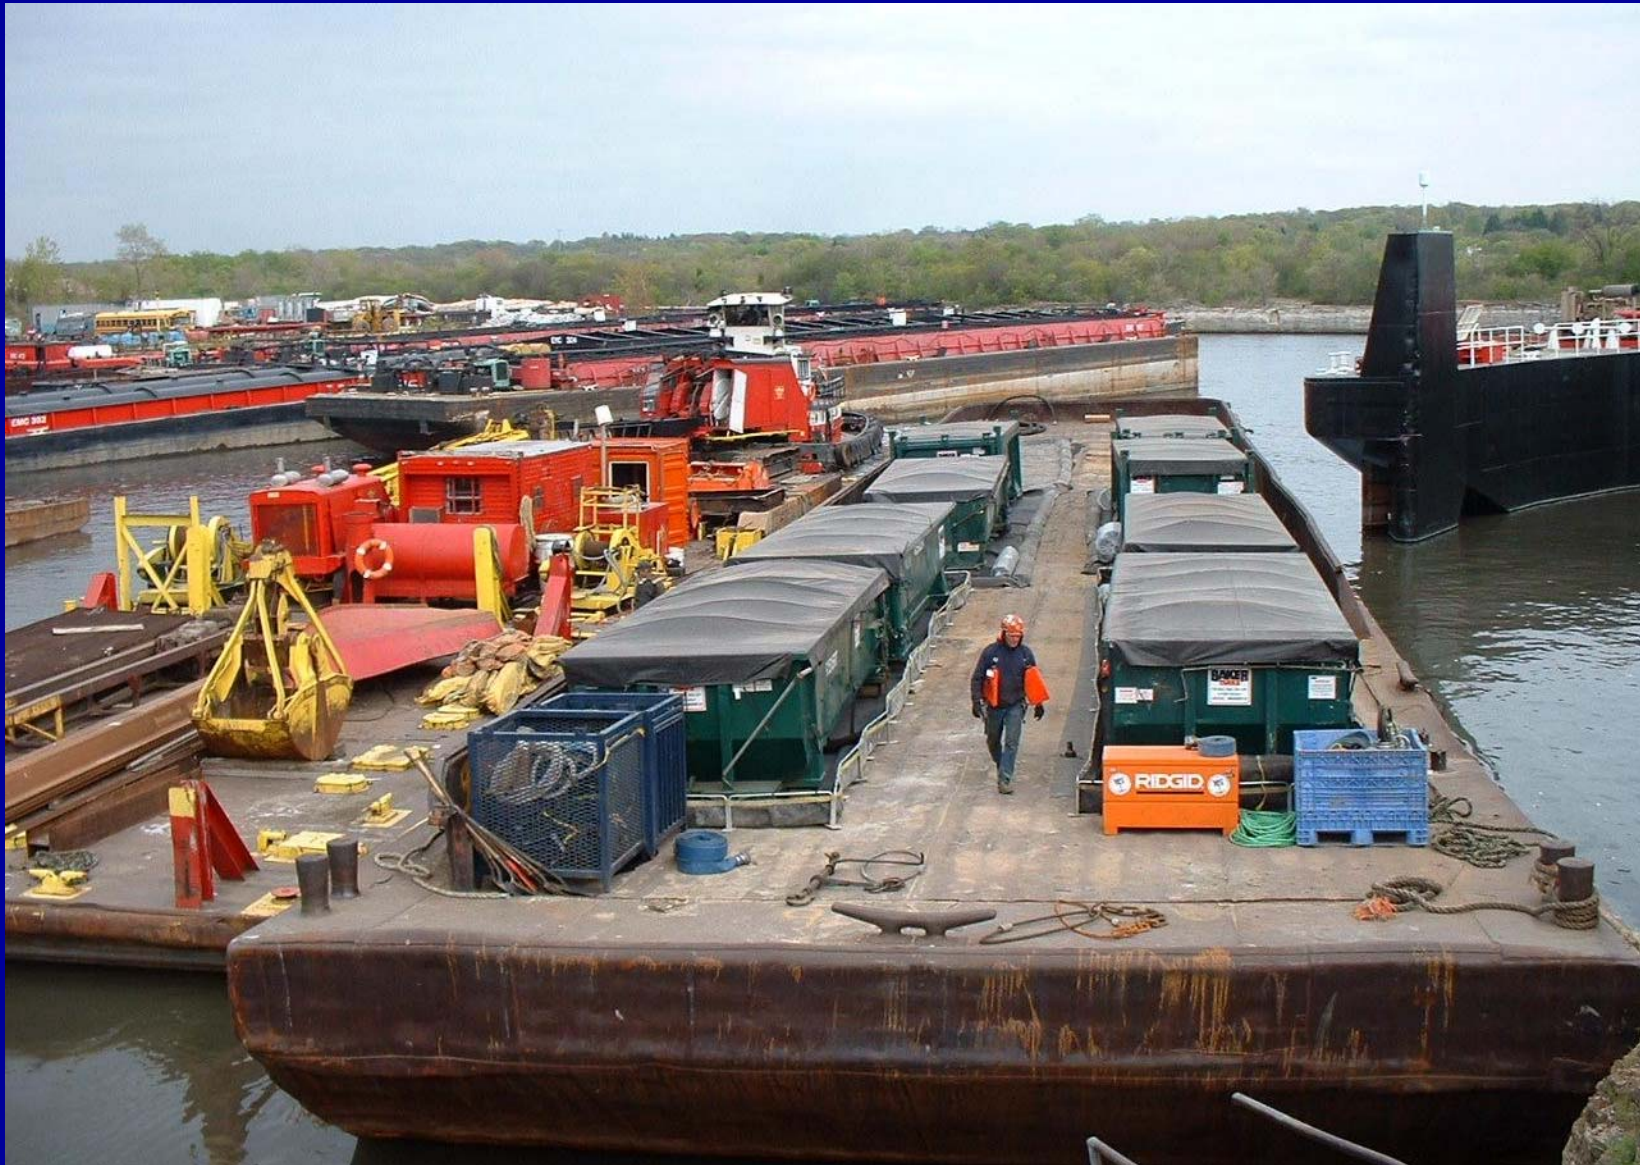
Two platform barges were sourced and obtained. One and was outfitted with a series of recovery boxes (20 cubic yard – DOT-approved). The boxes were sealed with waterproof foam at their doors.

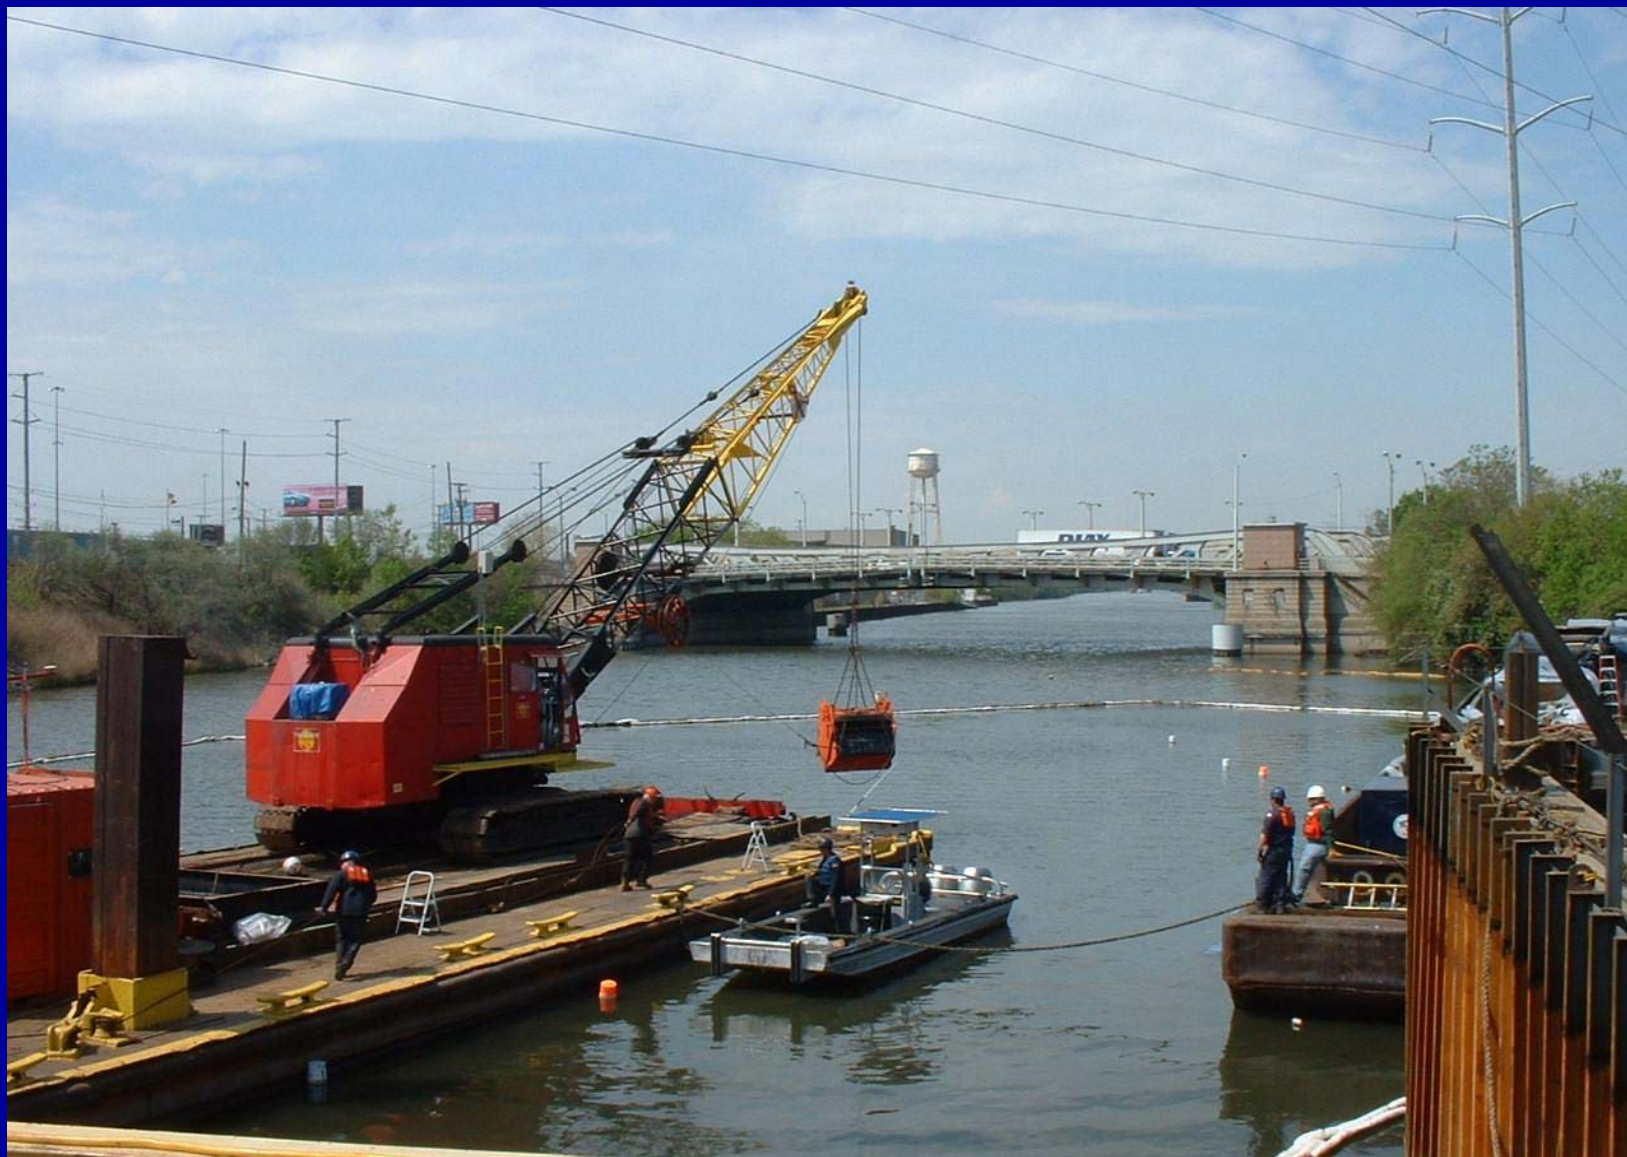
The second barge housed the crane unit that was used to deploy the environmental clamshell bucket. The second barge also housed the GPS system, analytical processing center and computers.

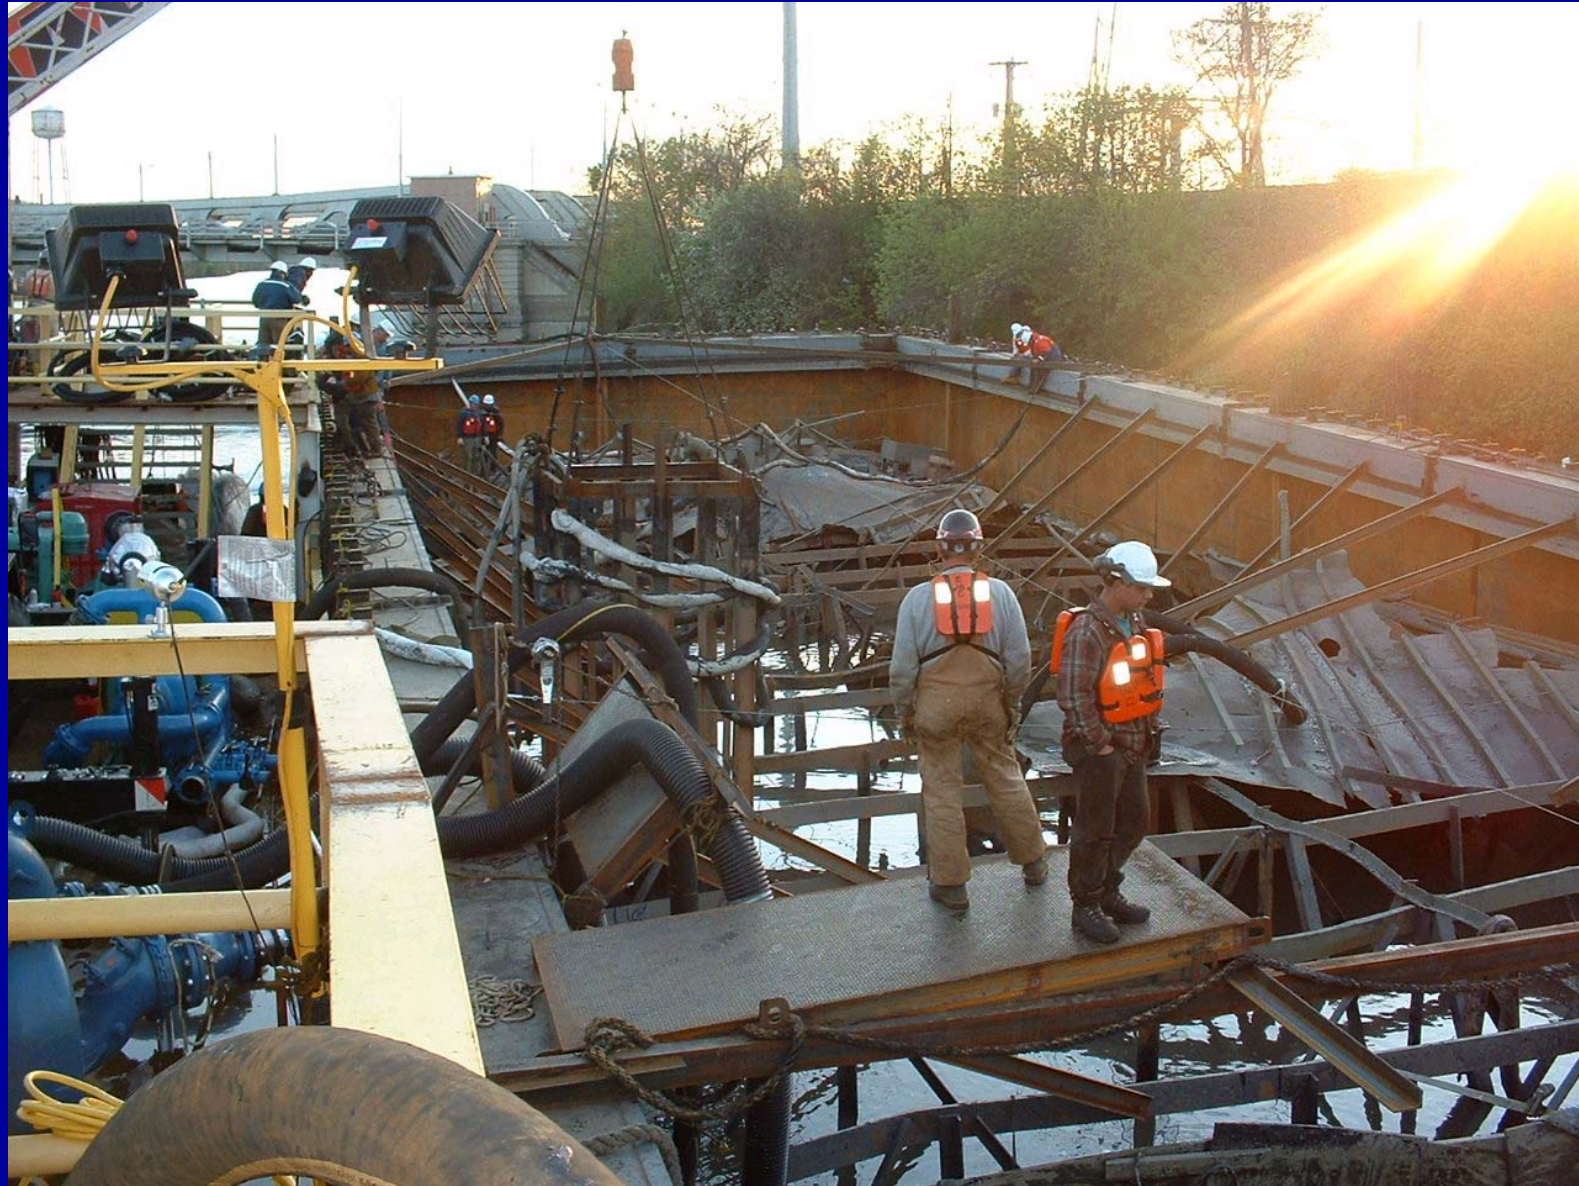
A cofferdam was eventually outfitted around the stern of the barge and she was dewatered. This resulted in the refloating of the barge and her transport to a facility where the remaining oil was removed from the tanks.

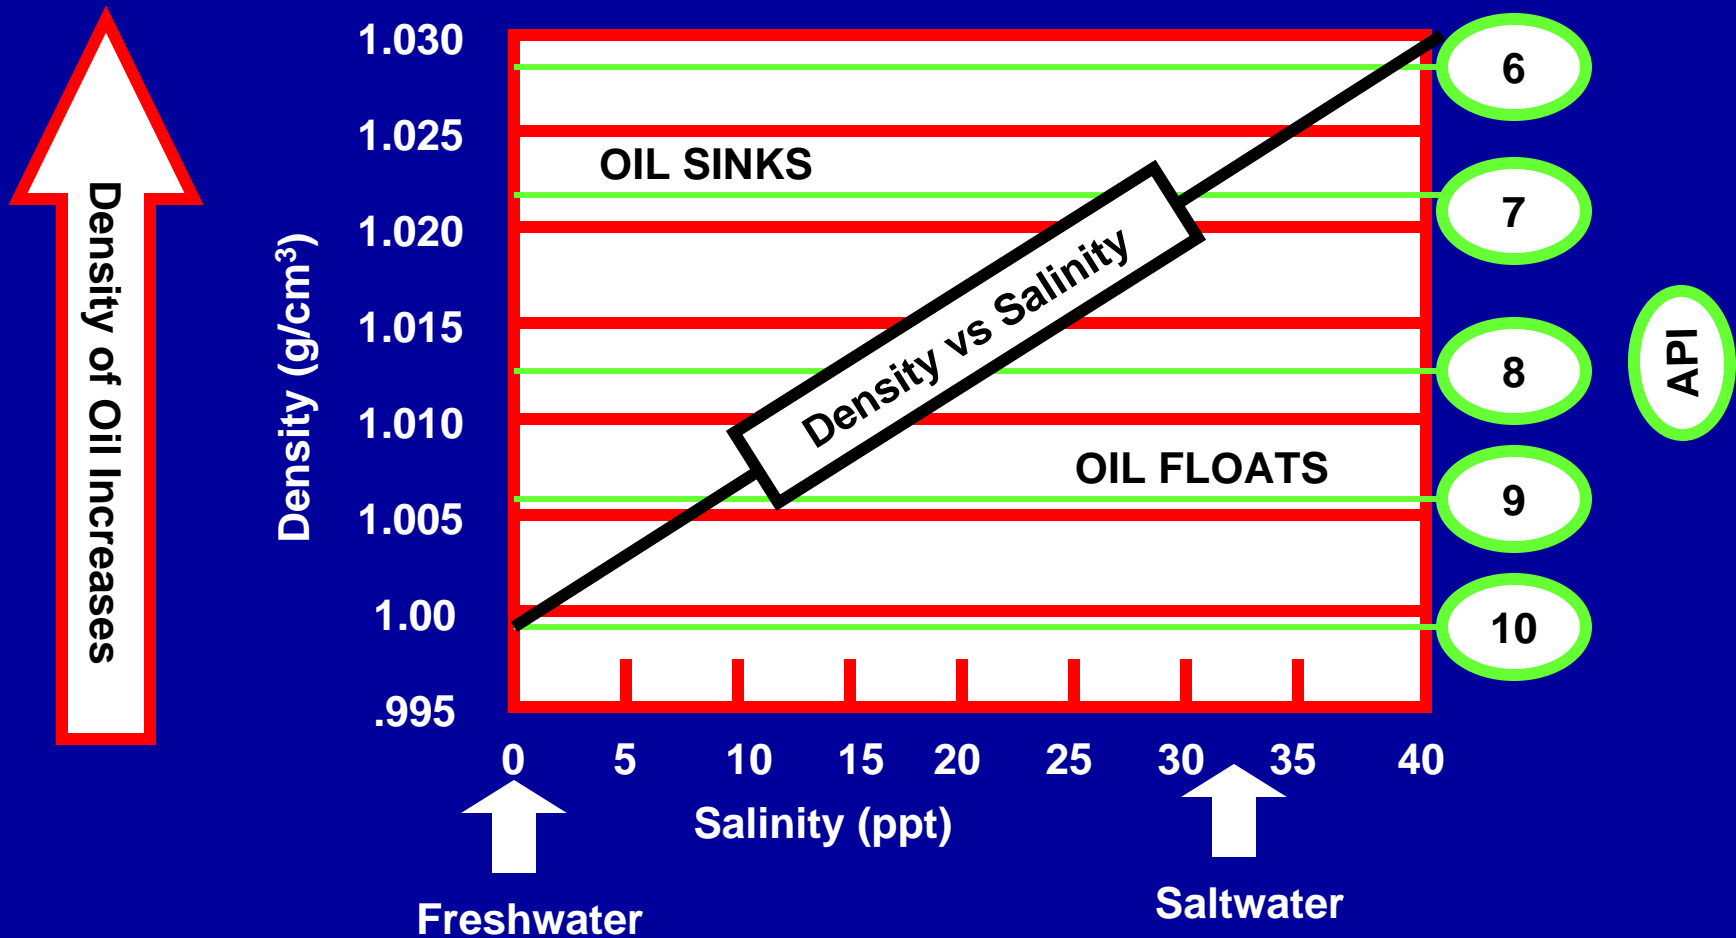
Relationship between Water Density & Salinity

Note: This table applies to water at a temperature of 59 degrees F, changes in water temperature will alter this information (water density decreases as its temperature increases)

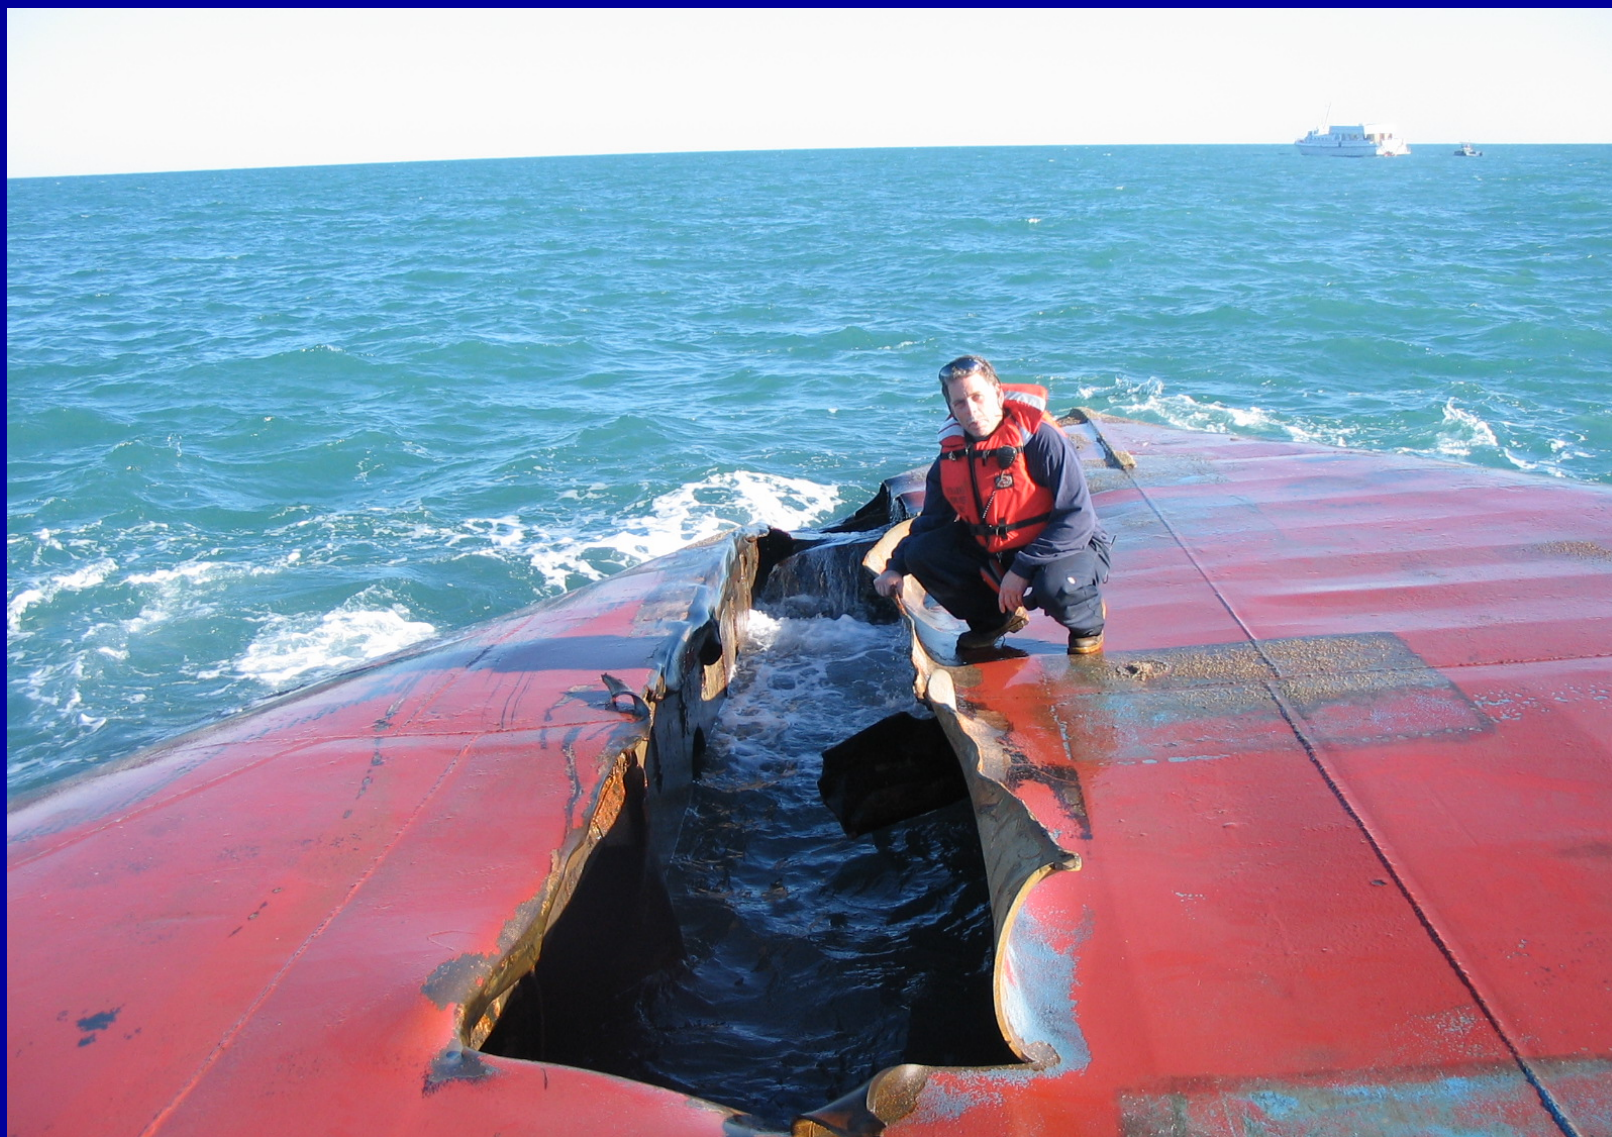
A large gash in the hull of the now completely inverted DBL 152.

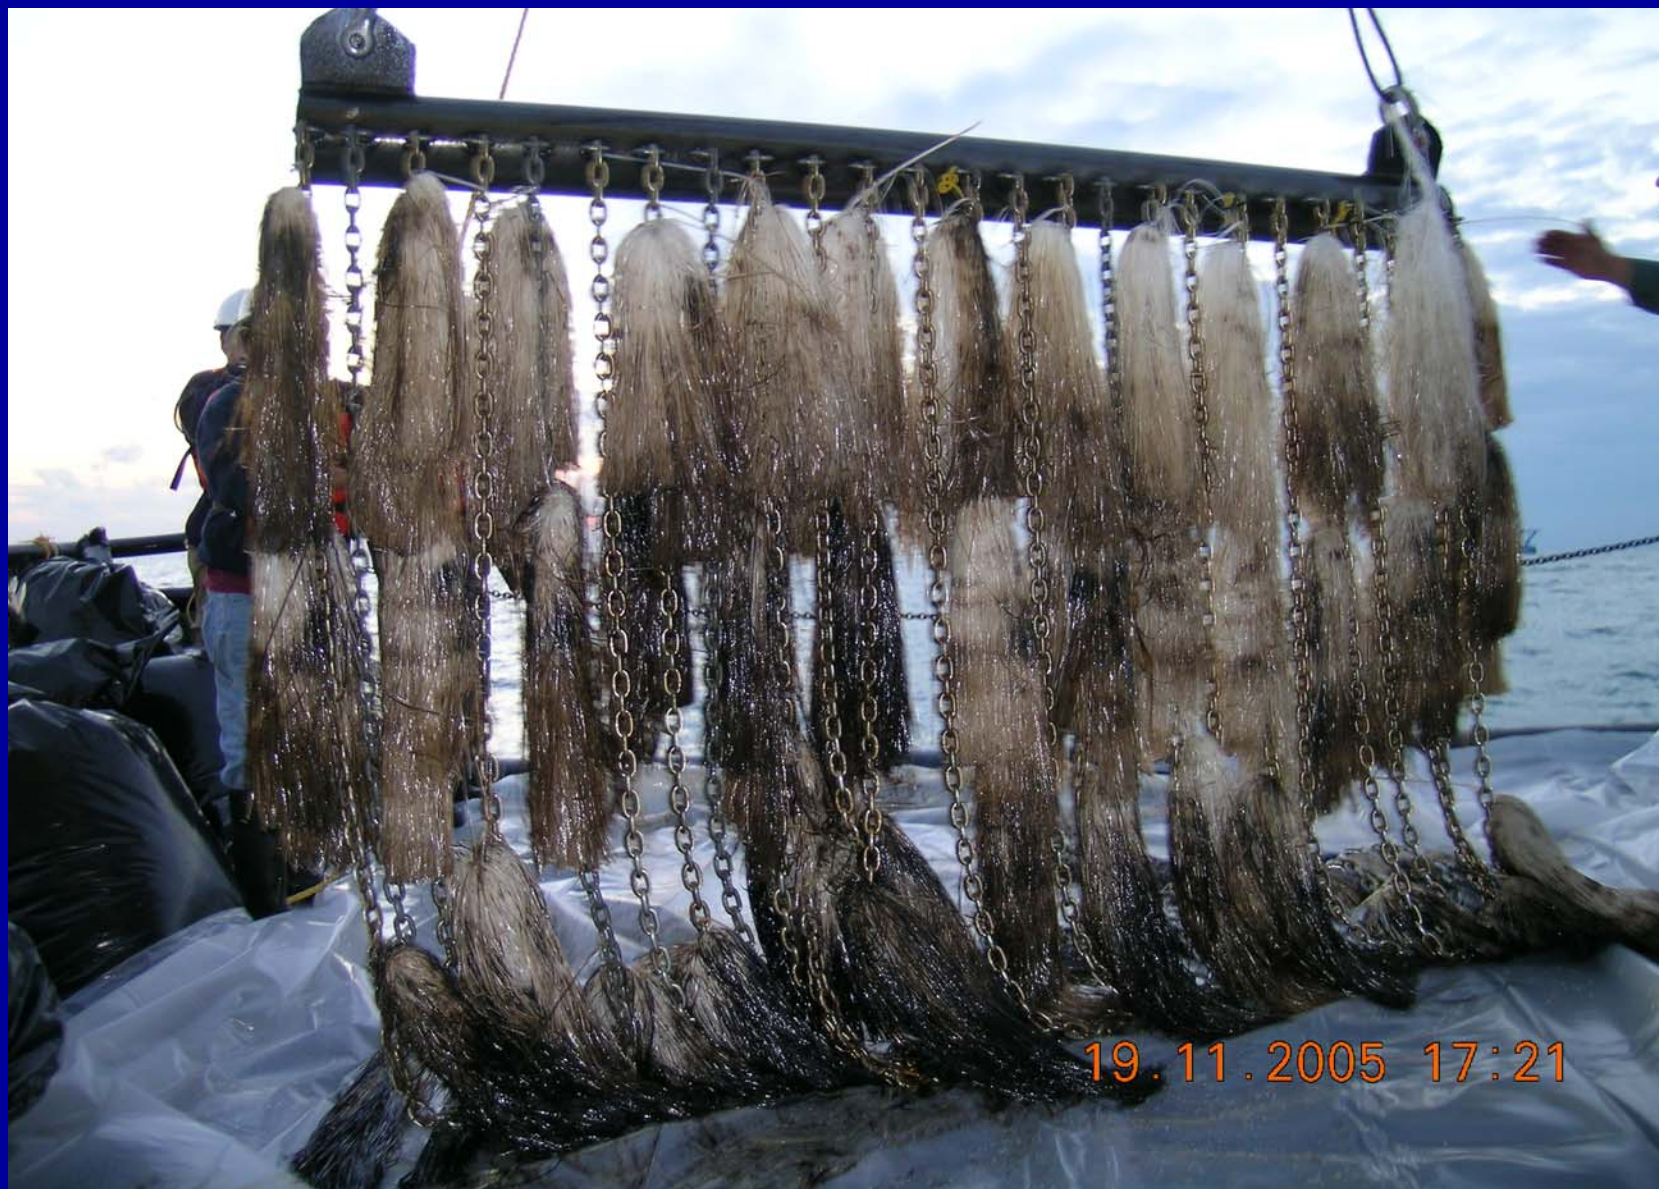
This absorbent trawling device was used to detect the presence of oil on the bottom of the Gulf. An area of approximately 100 square miles was covered by surveys.

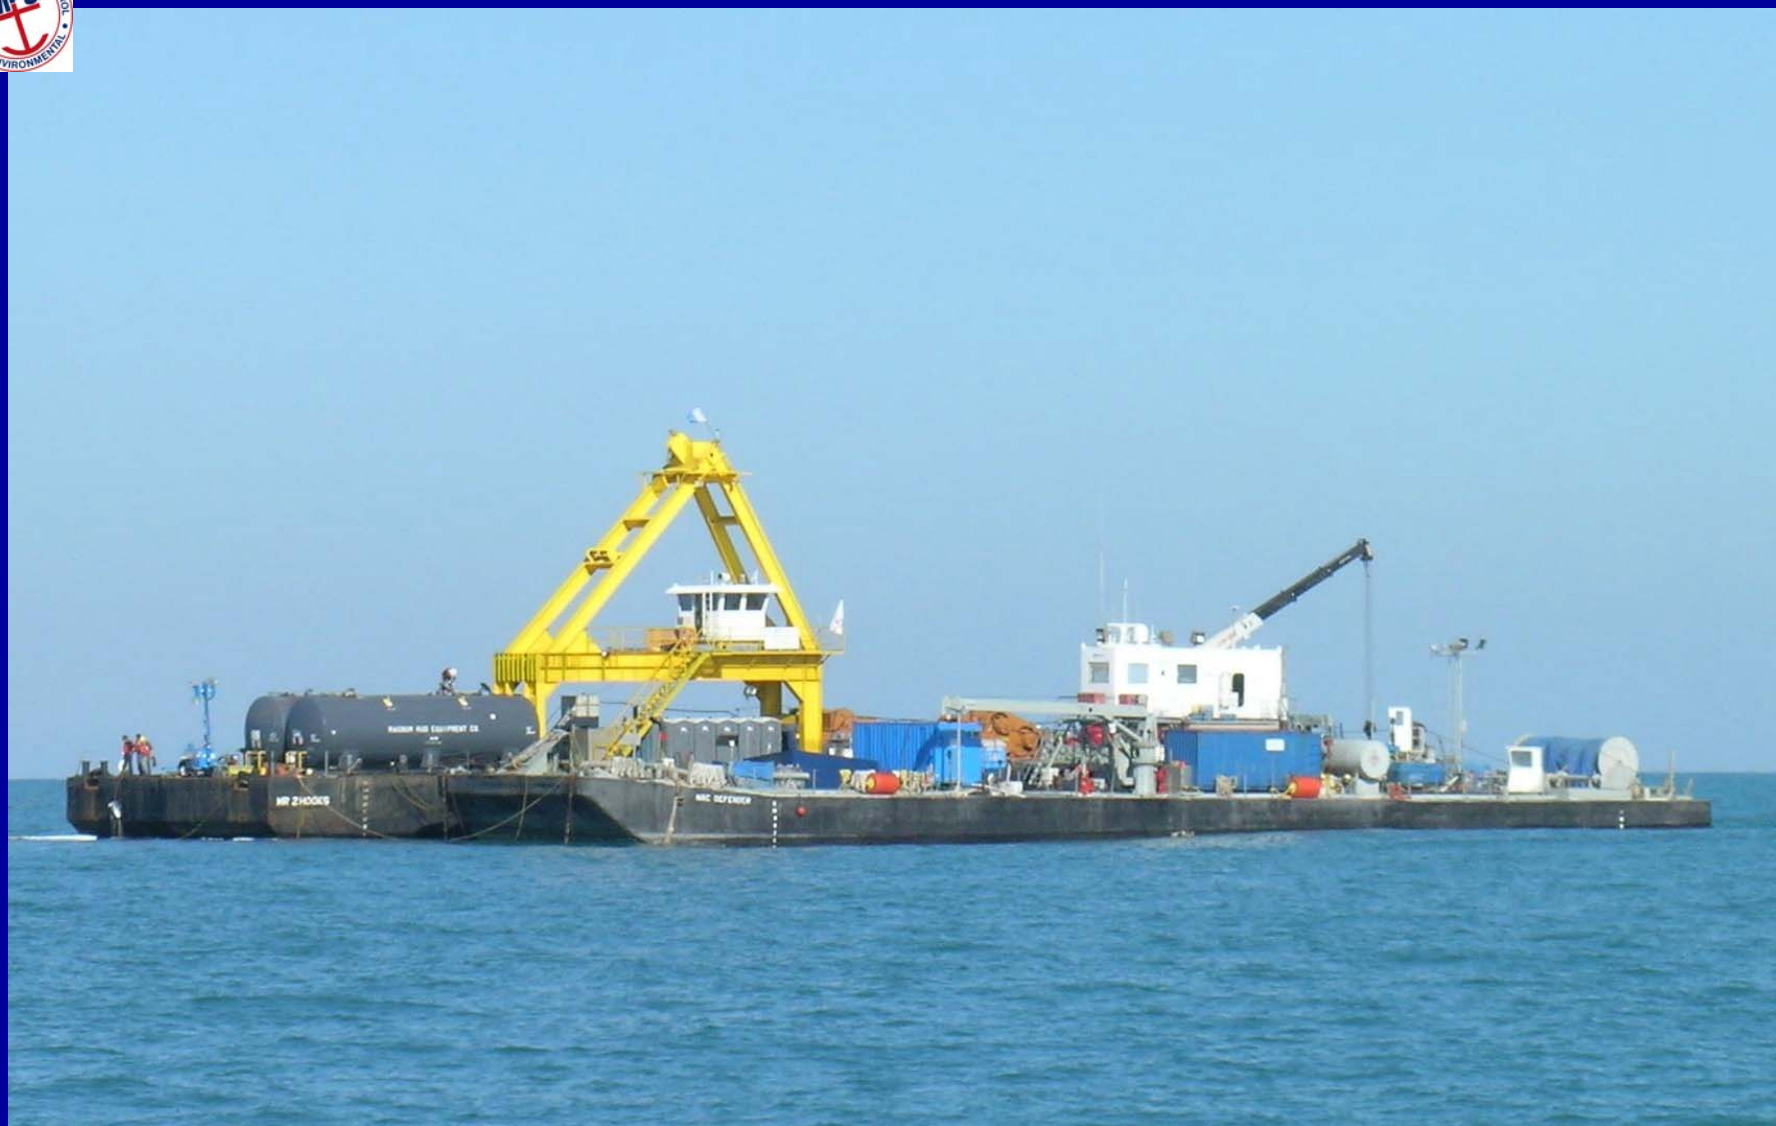
A 250' x 50' barge was secured, and the recovery and decanting equipment was positioned on board. Note that a receiving barge is positioned alongside (in front of) the recovery barge in this photo.

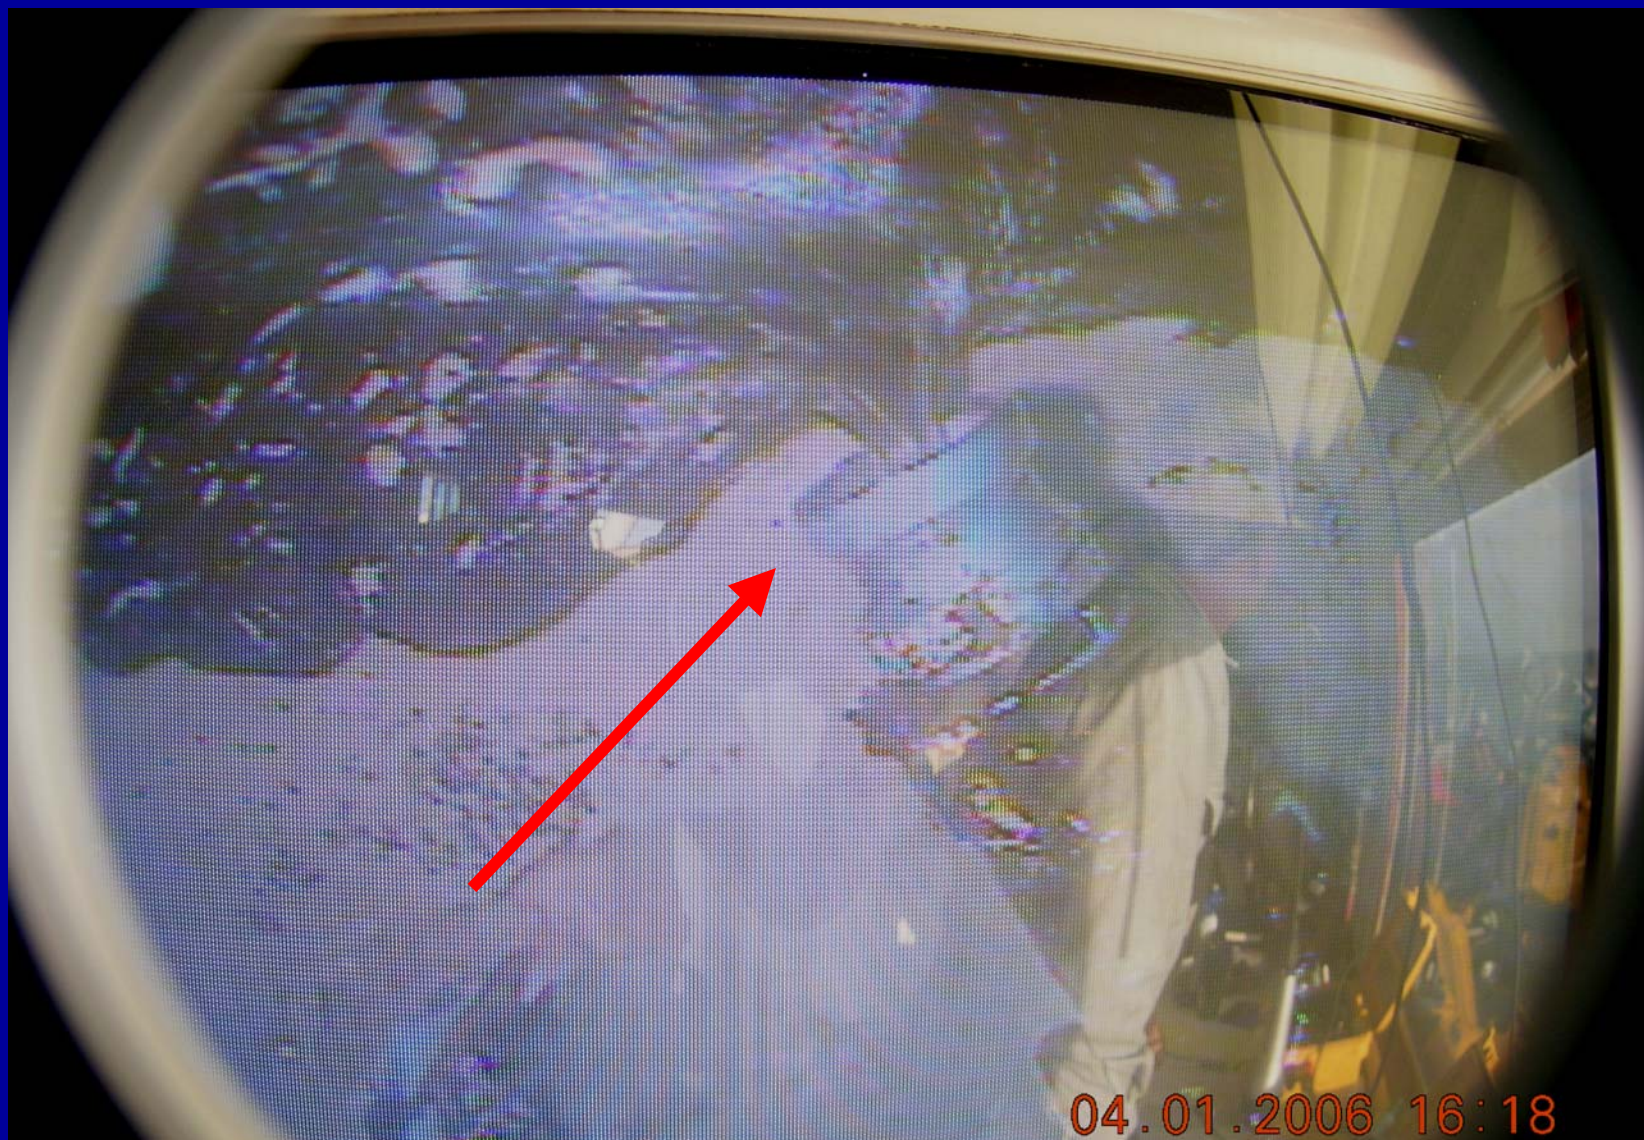
In this remarkable diver photo we see the oil being gently lifted from the seabed, with the vortex drawing almost exclusively oil/water mixture without drawing in excessive amounts of sediments.

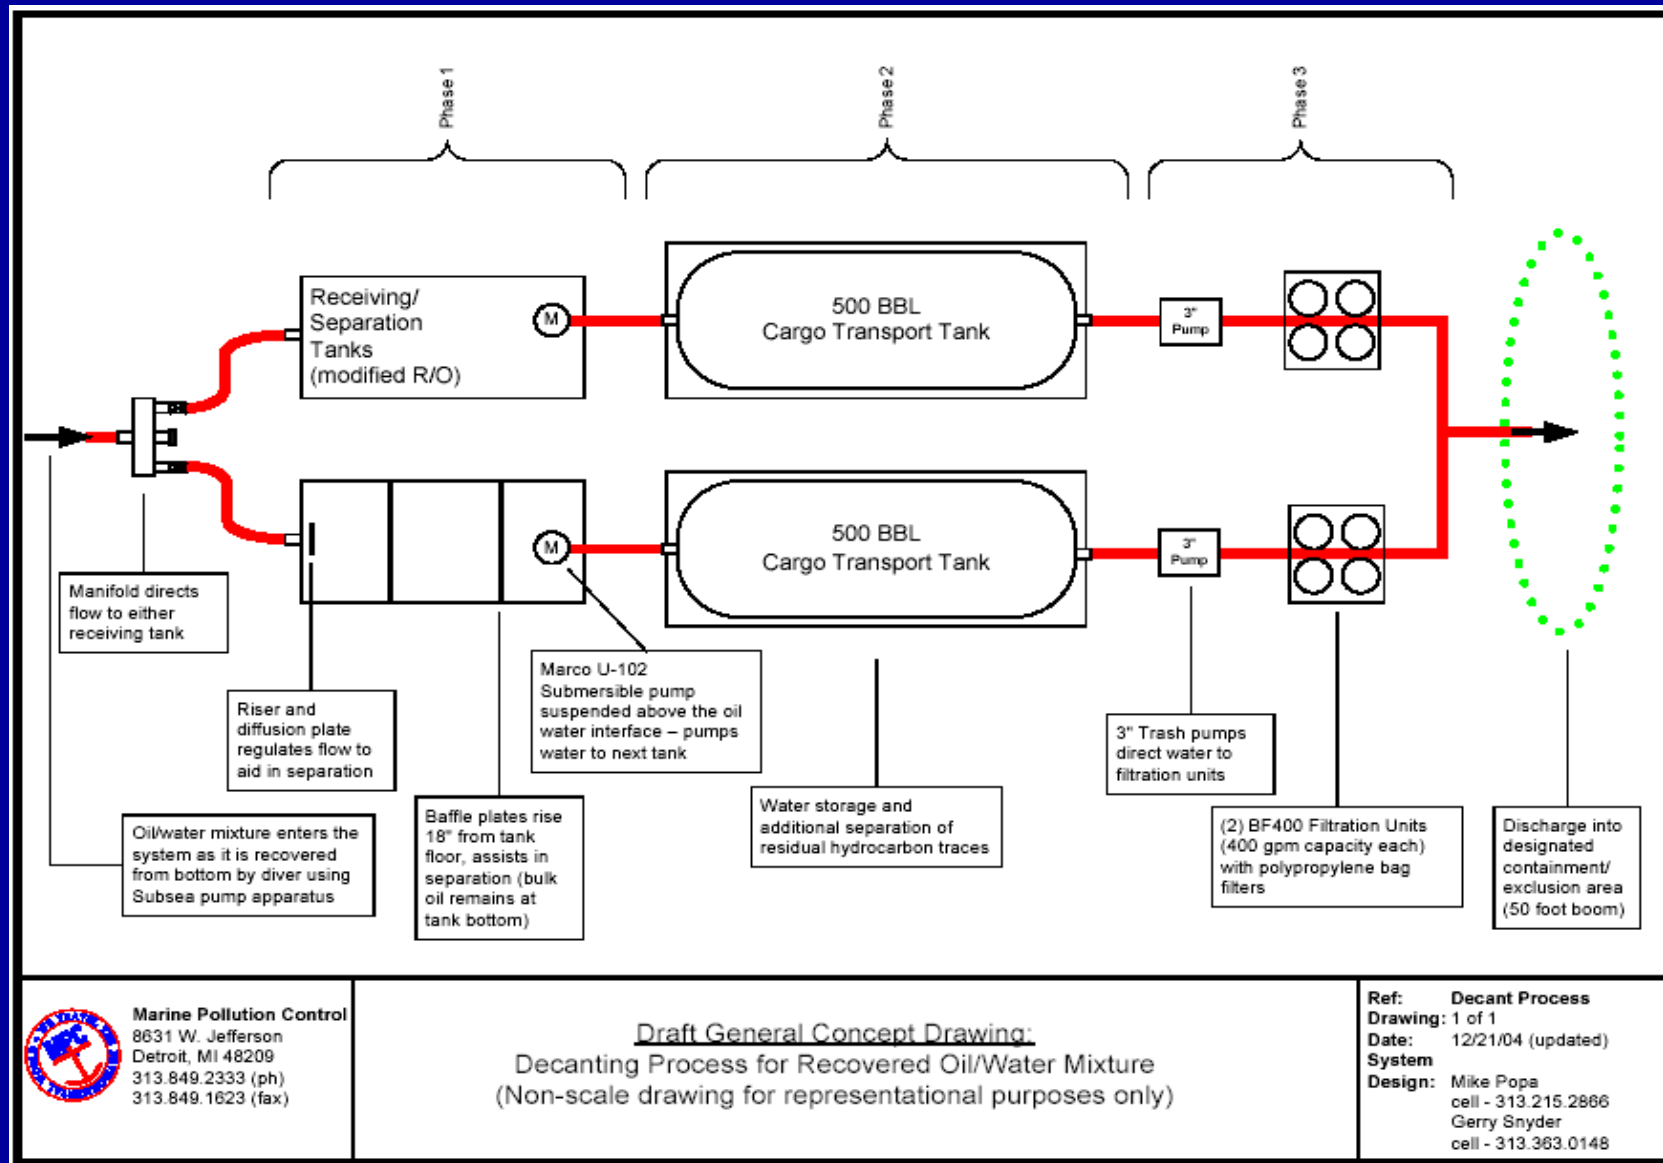
A critical component of the recovery process was the storage and decanting of the oil/water mixture that would be recovered. The system included holding tanks, absorbent based recovery components and a filtration package.

- **Water decanting operations proved difficult in that wave conditions kept the oil in constant agitation, slowing the separation phase**
