Responding to Submerged Oils in Freshwater Environments

David Usher

Freshwater Spills Symposium - 2006

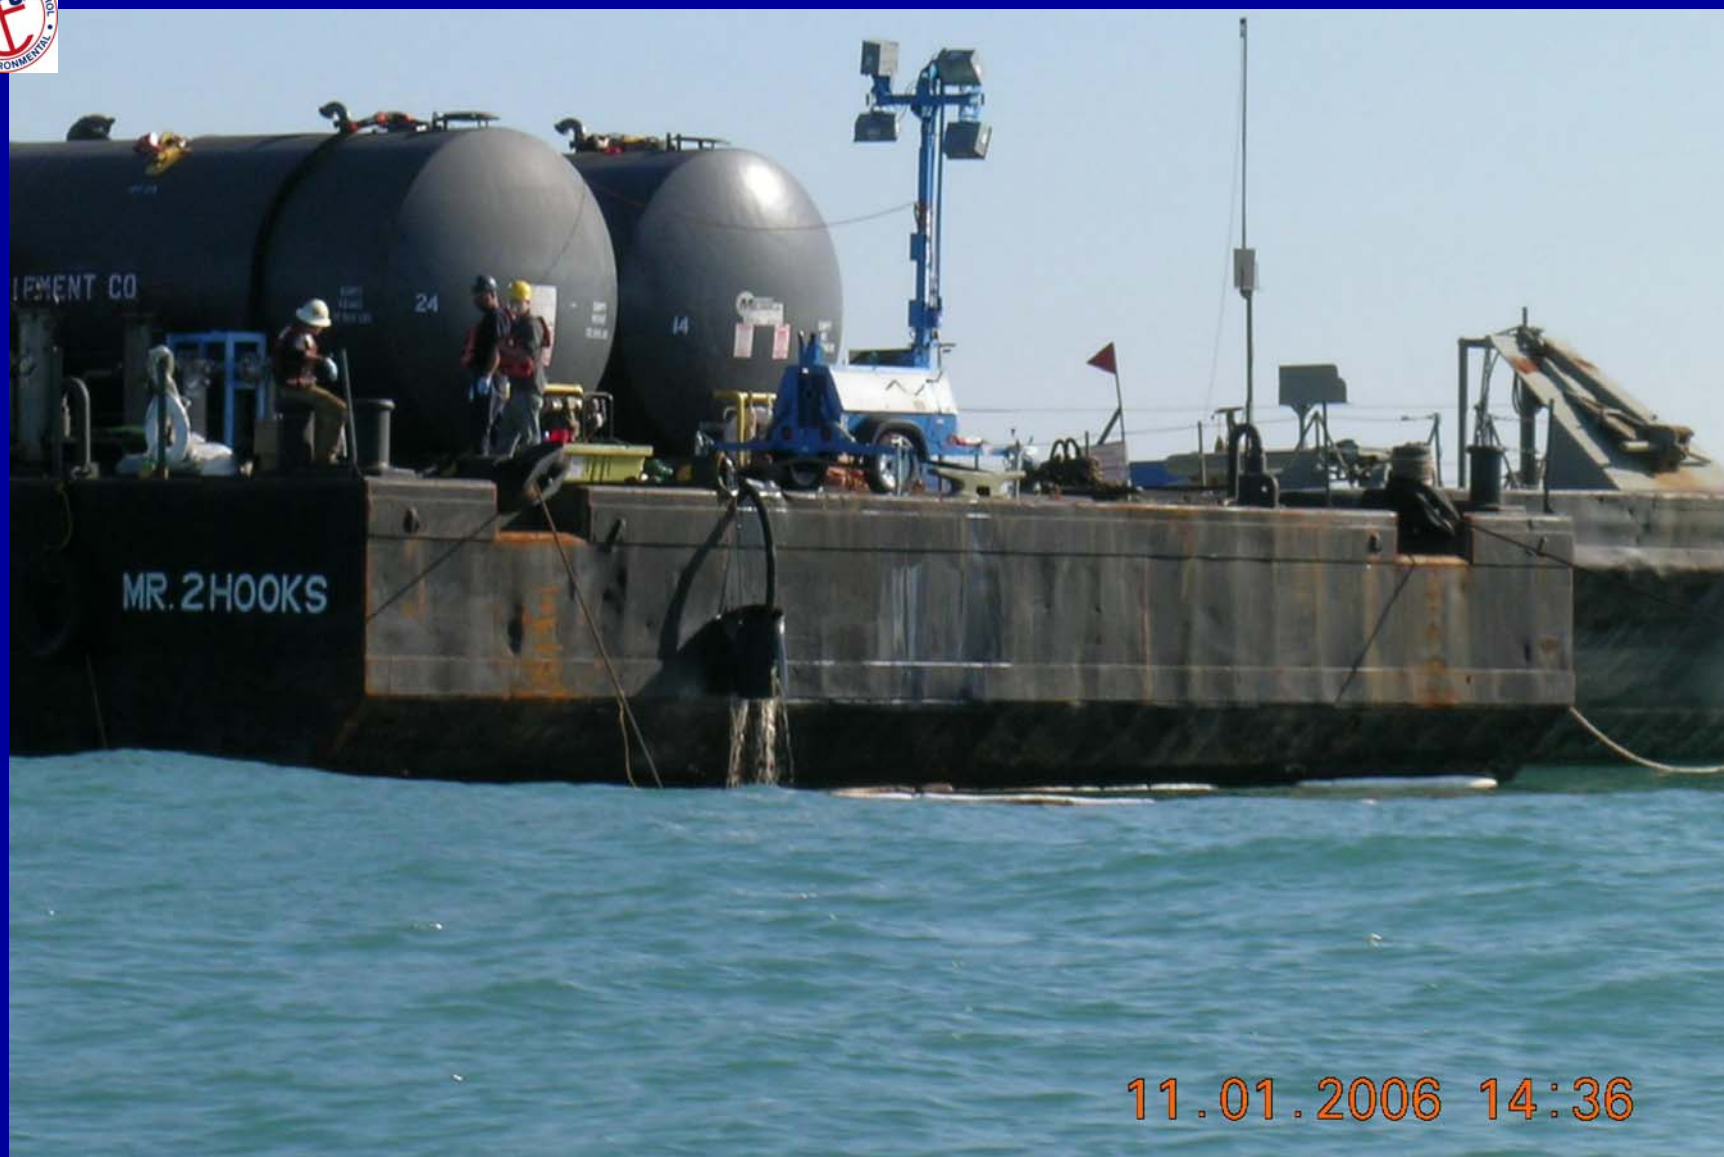
The final stage of the decanting operation included discharge of the filtered water through a chamber that contained absorbent recovery devices, into a contained area at the end of the barge.

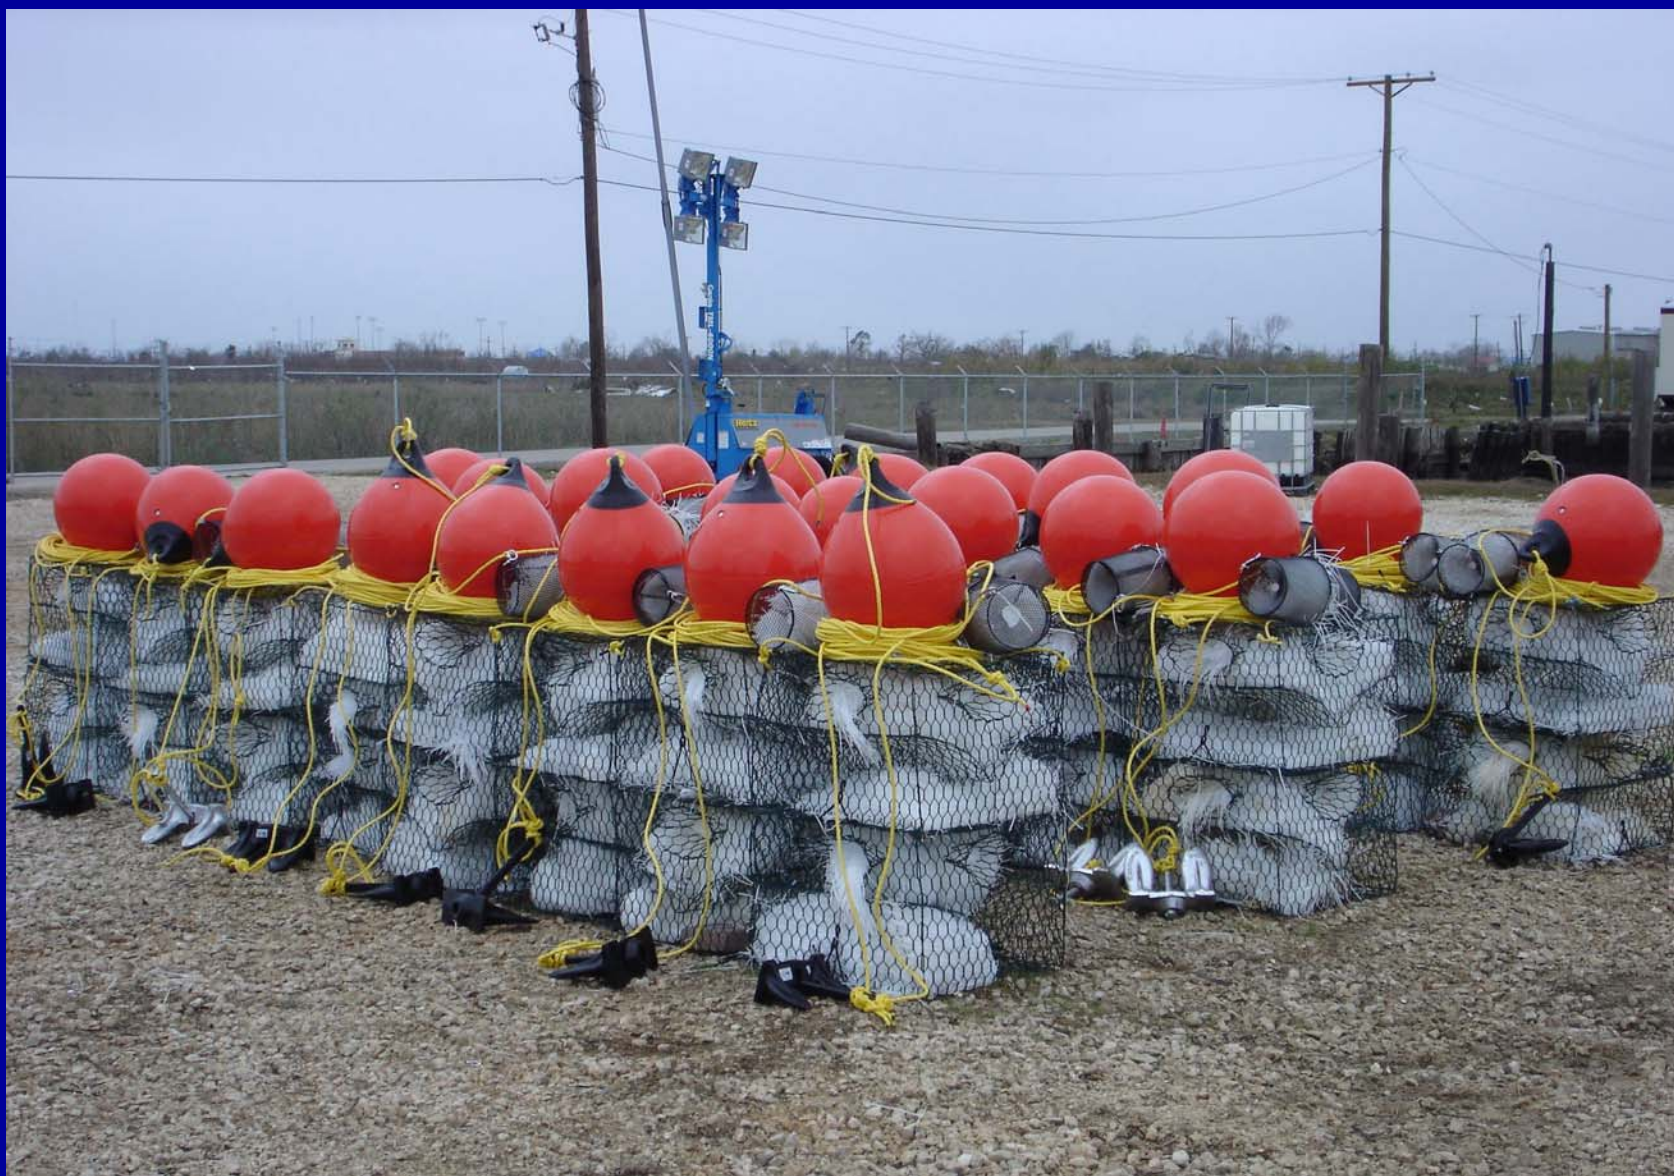
These specially-designed “crab pot” submerged oil detection devices would be left in position after practical oil recovery operations had ceased, and would be monitored over time to ensure that masses of oil were remobilizing in the area.

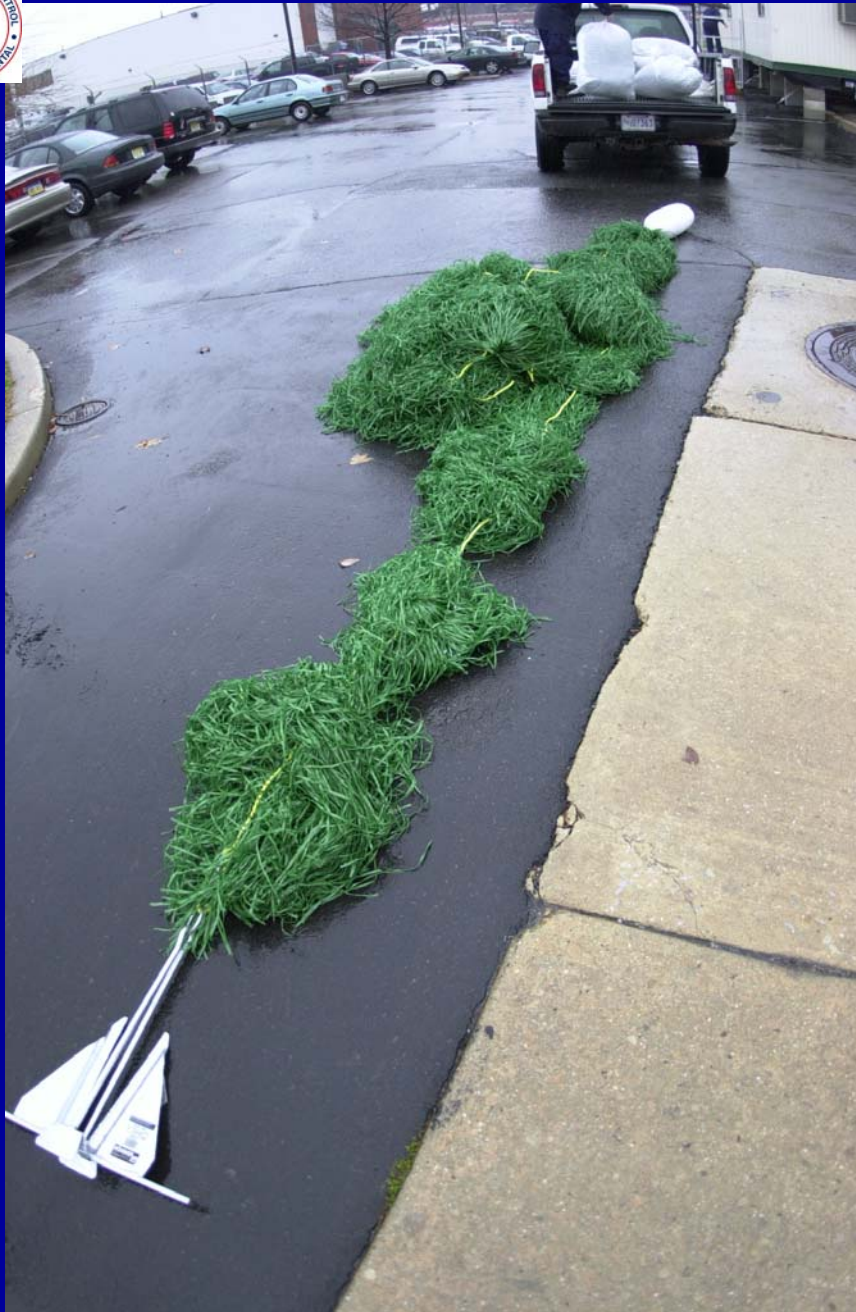
To search for submerged oil in the murky waters, this snare trap was devised.

In operation, the unit was dragged by a support vessel in an area suspected to have subsurface contamination.

If, when retrieved, oil was present, the decision to mount a dive survey and/or recovery operation was made.

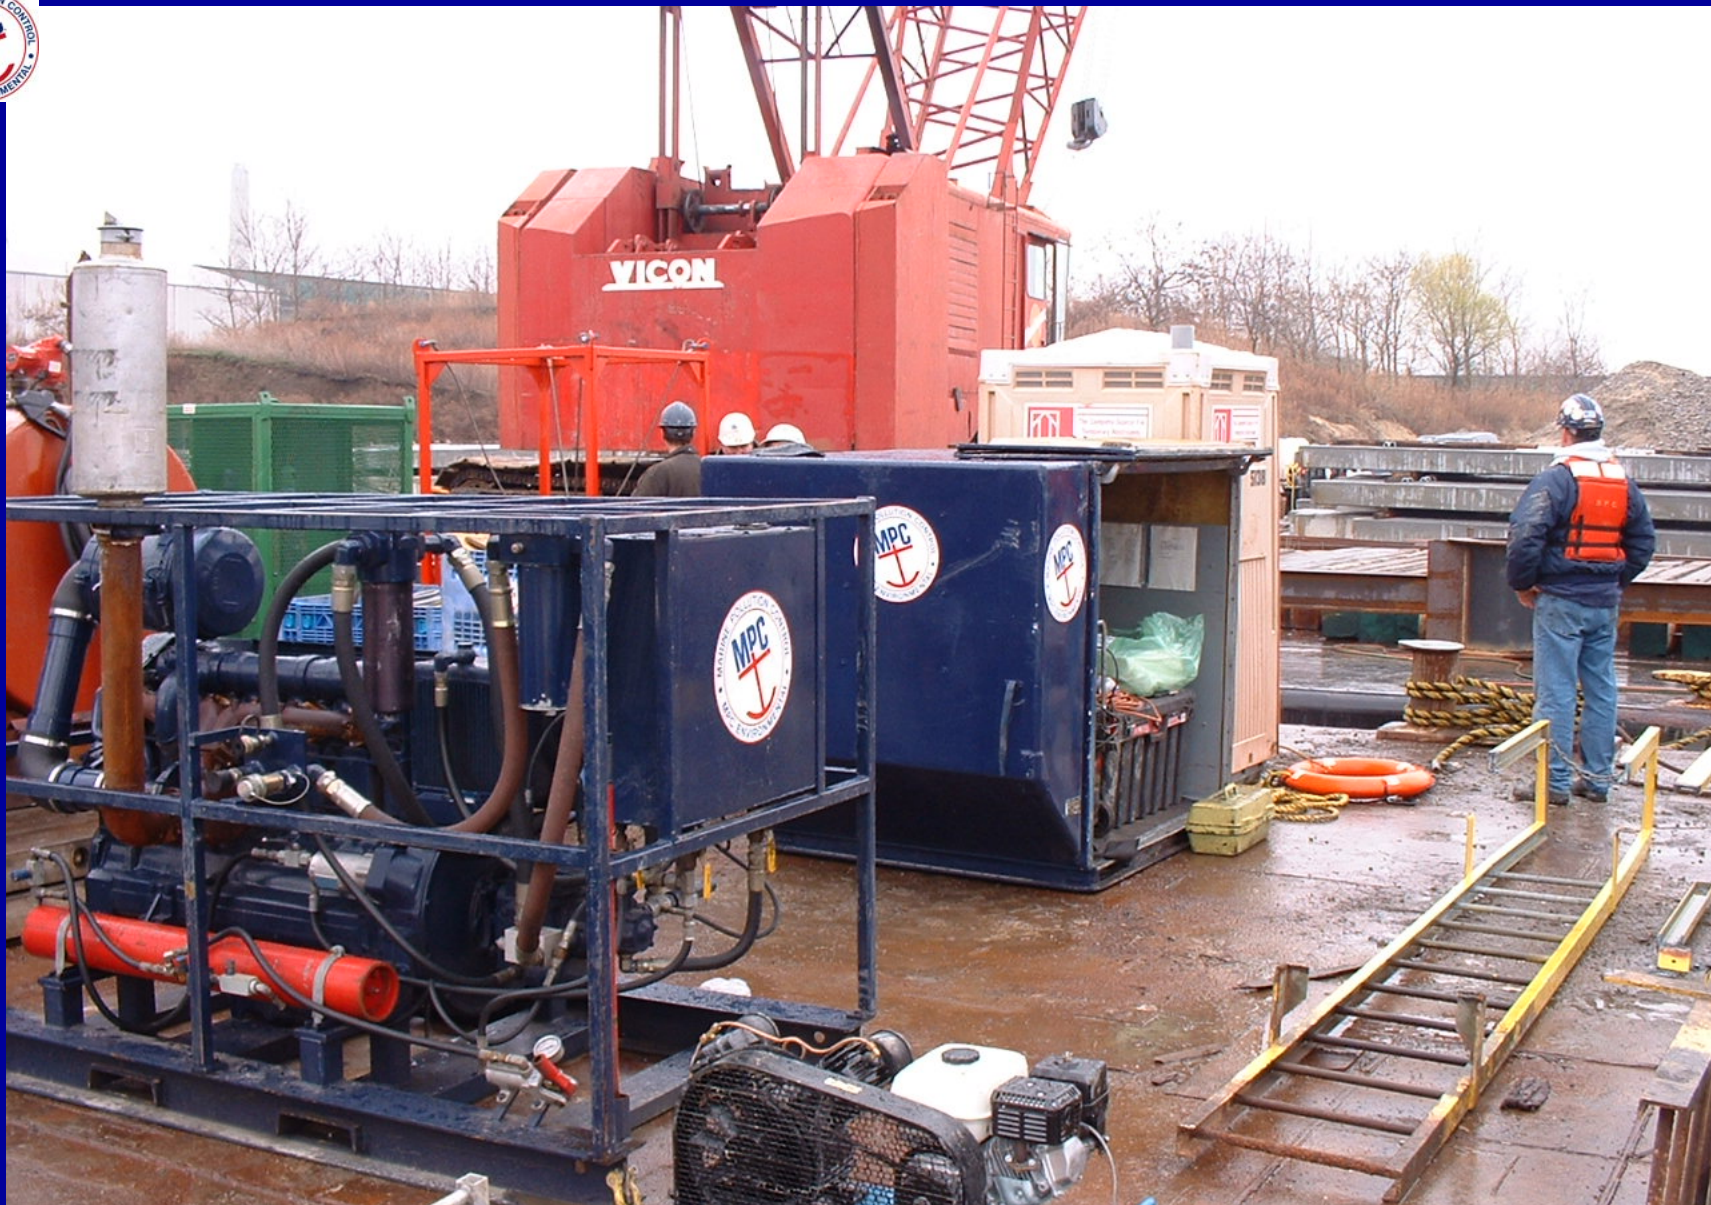
Diesel hydraulic powerpacks provide the necessary power for the submersible pumps to run. They are controlled at the surface by diver verbal commands.

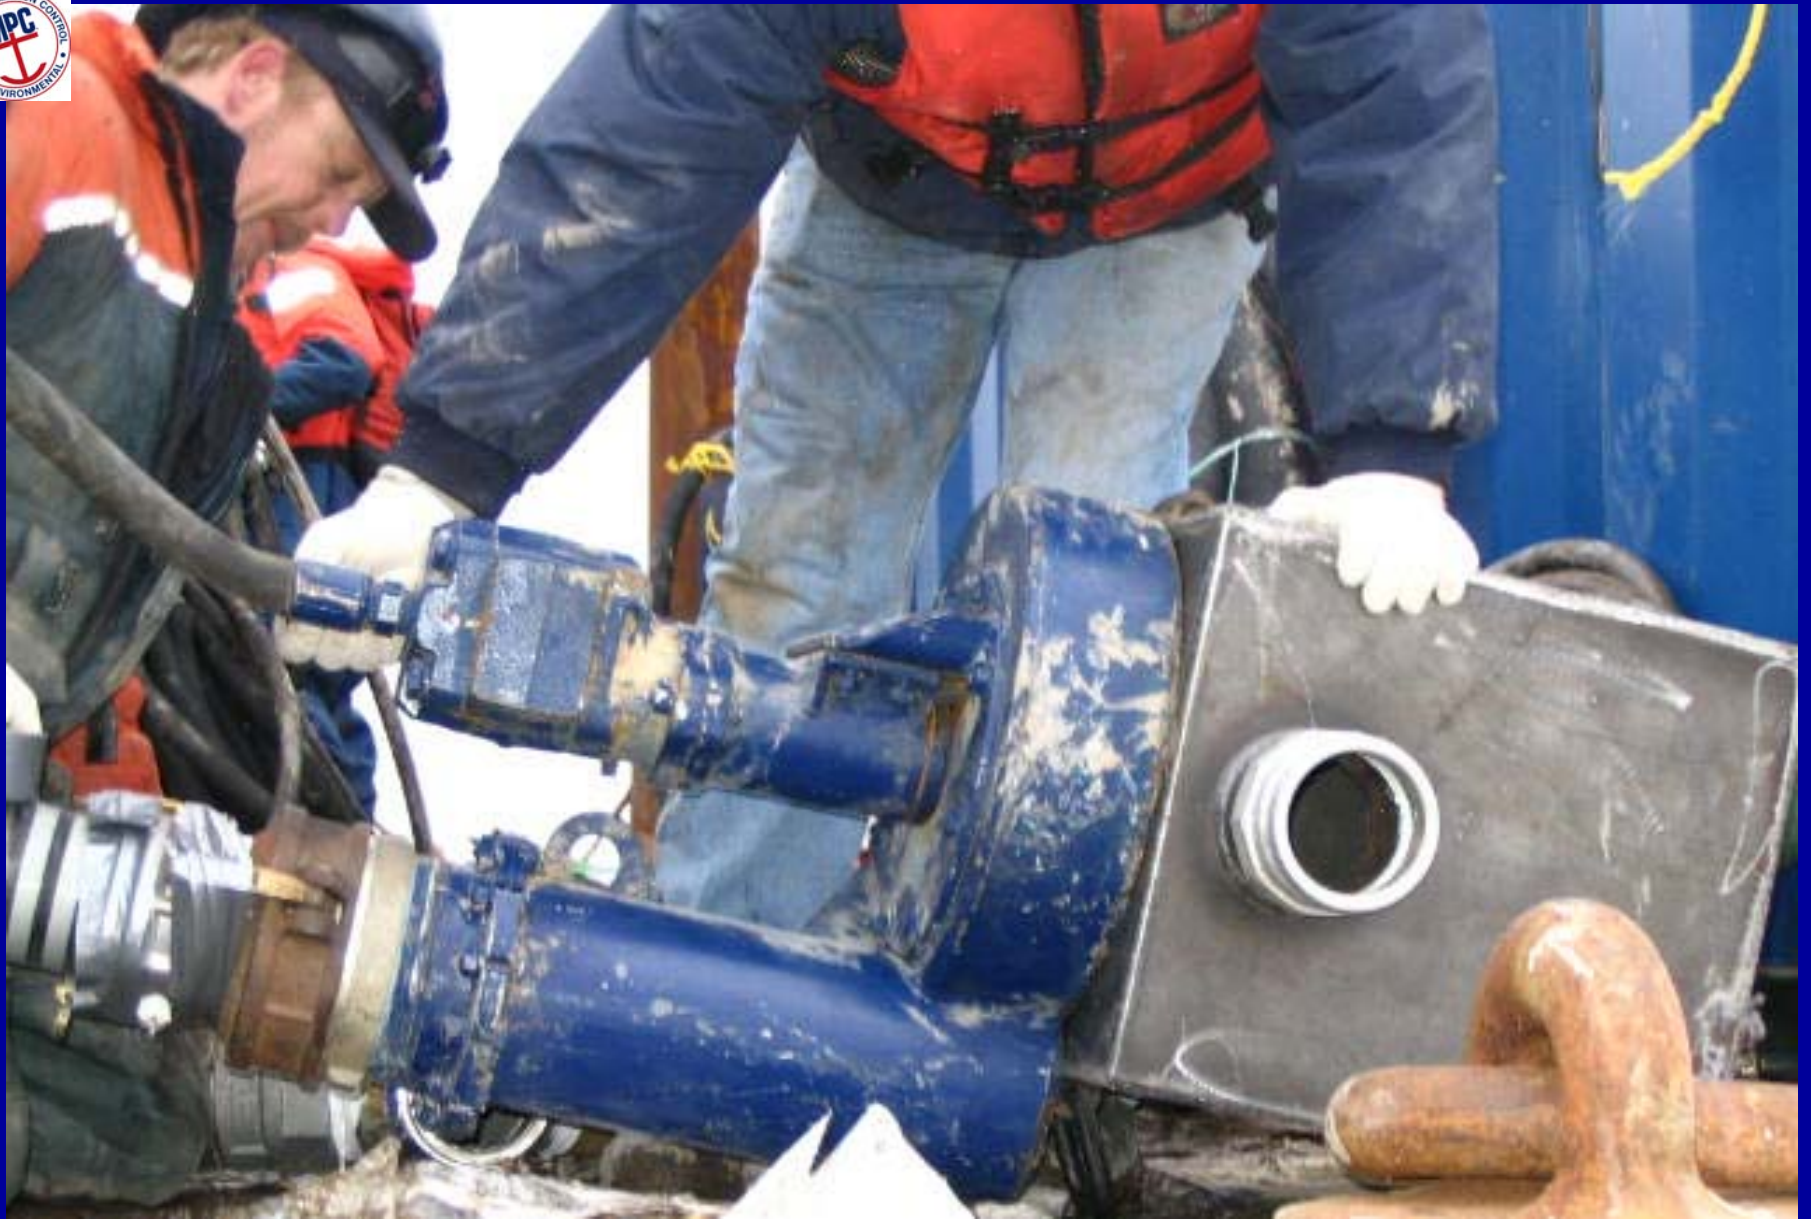
A hydraulic submersible pump mounted on a steel debris box. The debris box decreases the likelihood that rock or other object will jam the pump.

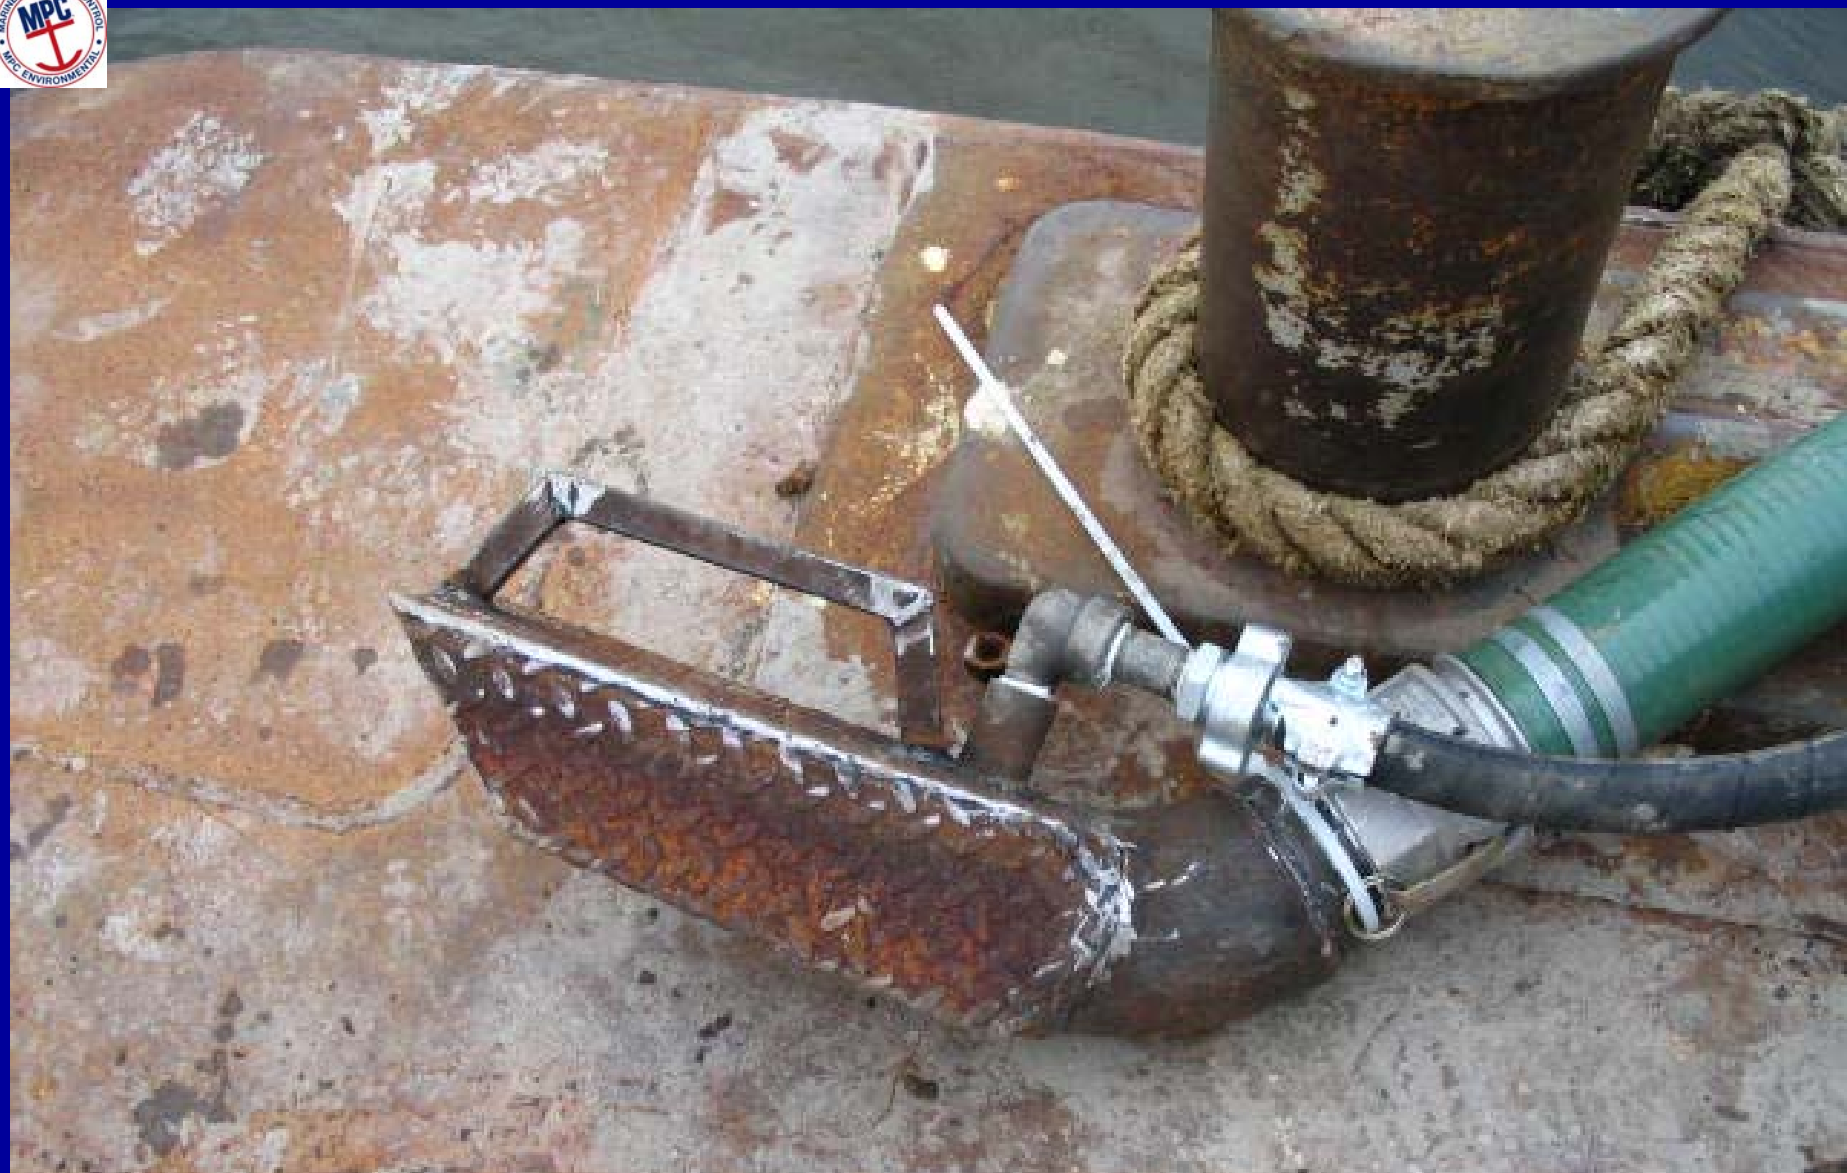
Divers would use these steam-enabled duckbill nozzles to “vacuum” up the oil from the river bottom.
