Coeur d'Alene, Idaho
31 March – 4 April, 2003

Florida's Bioassessment Program Applications

Florida Department of Environmental Protection

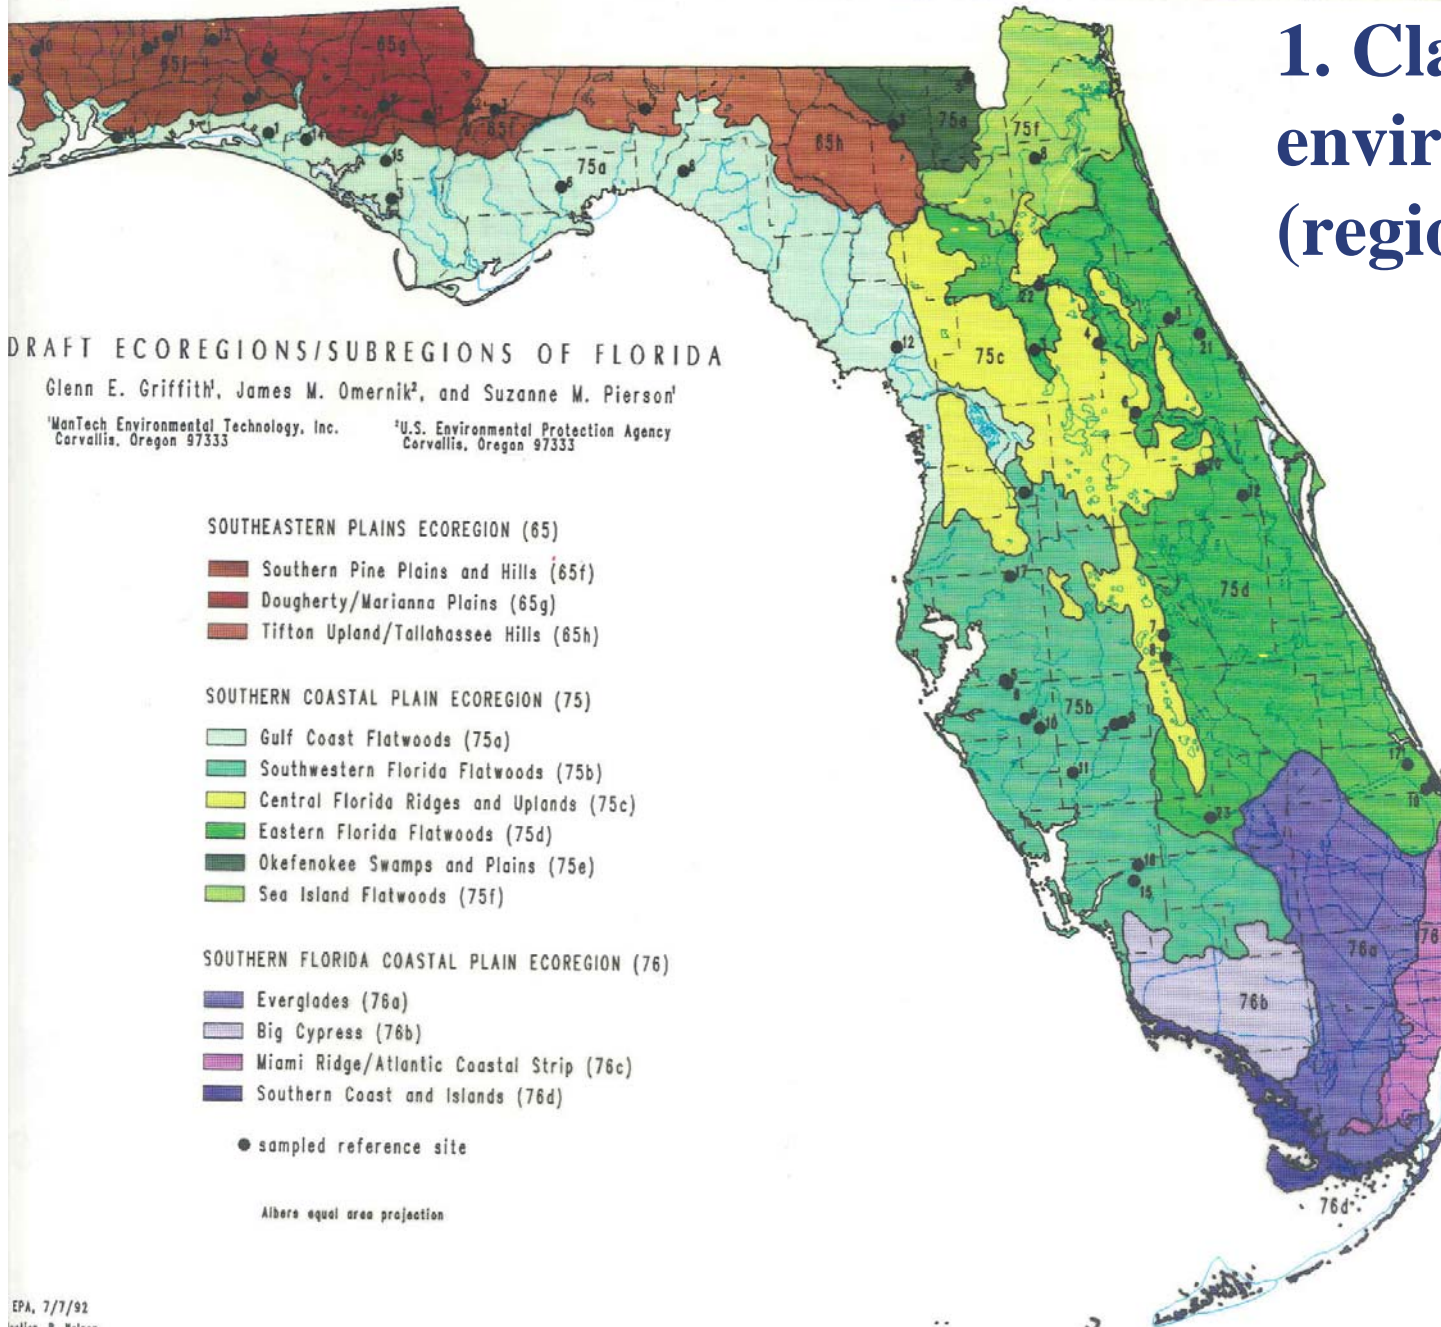
DRAFT ECOREGIONS/SUBREGIONS OF FLORIDA

SOUTHEASTERN PLAINS ECOREGION (65)

- Southern Pine Plains and Hills (65f)
- Dougherty/Marianna Plains (65g)
- Tifton Upland/Tallahassee Hills (65h)

SOUTHERN COASTAL PLAIN ECOREGION (75)

- Gulf Coast Flatwoods (75a)
- Southwestern Florida Flatwoods (75b)
- Central Florida Ridges and Uplands (75c)
- Eastern Florida Flatwoods (75d)
- Okefenokee Swamps and Plains (75e)
- Sea Island Flatwoods (75f)

SOUTHERN FLORIDA COASTAL PLAIN ECOREGION (76)

- Everglades (76a)
- Big Cypress (76b)
- Miami Ridge/Atlantic Coastal Strip (76c)
- Southern Coast and Islands (76d)

● sampled reference site

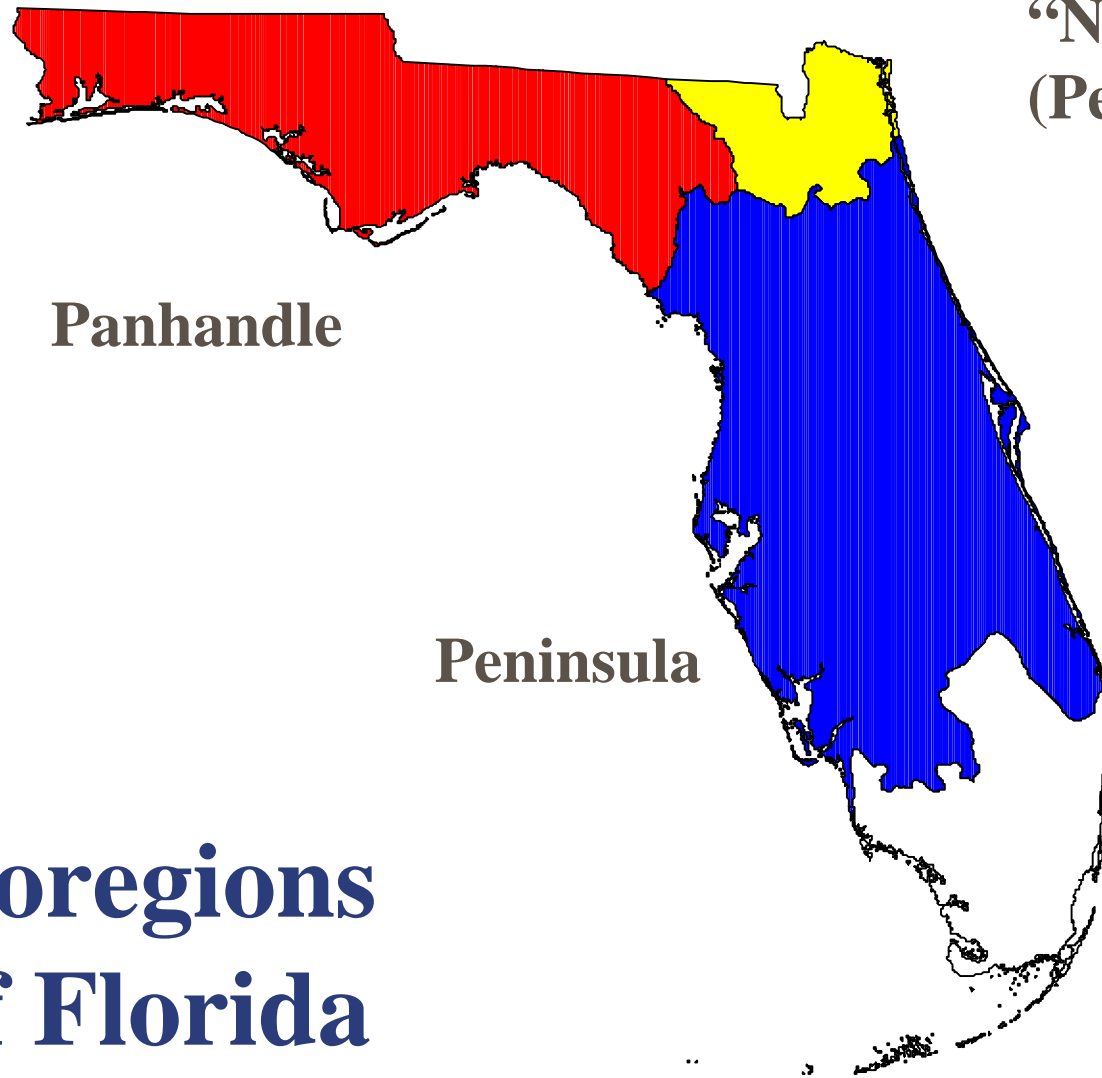
Bioregions of Florida

Panhandle

Peninsula

“Northeast”
(Peninsula)

Ecoregion
76 not
included

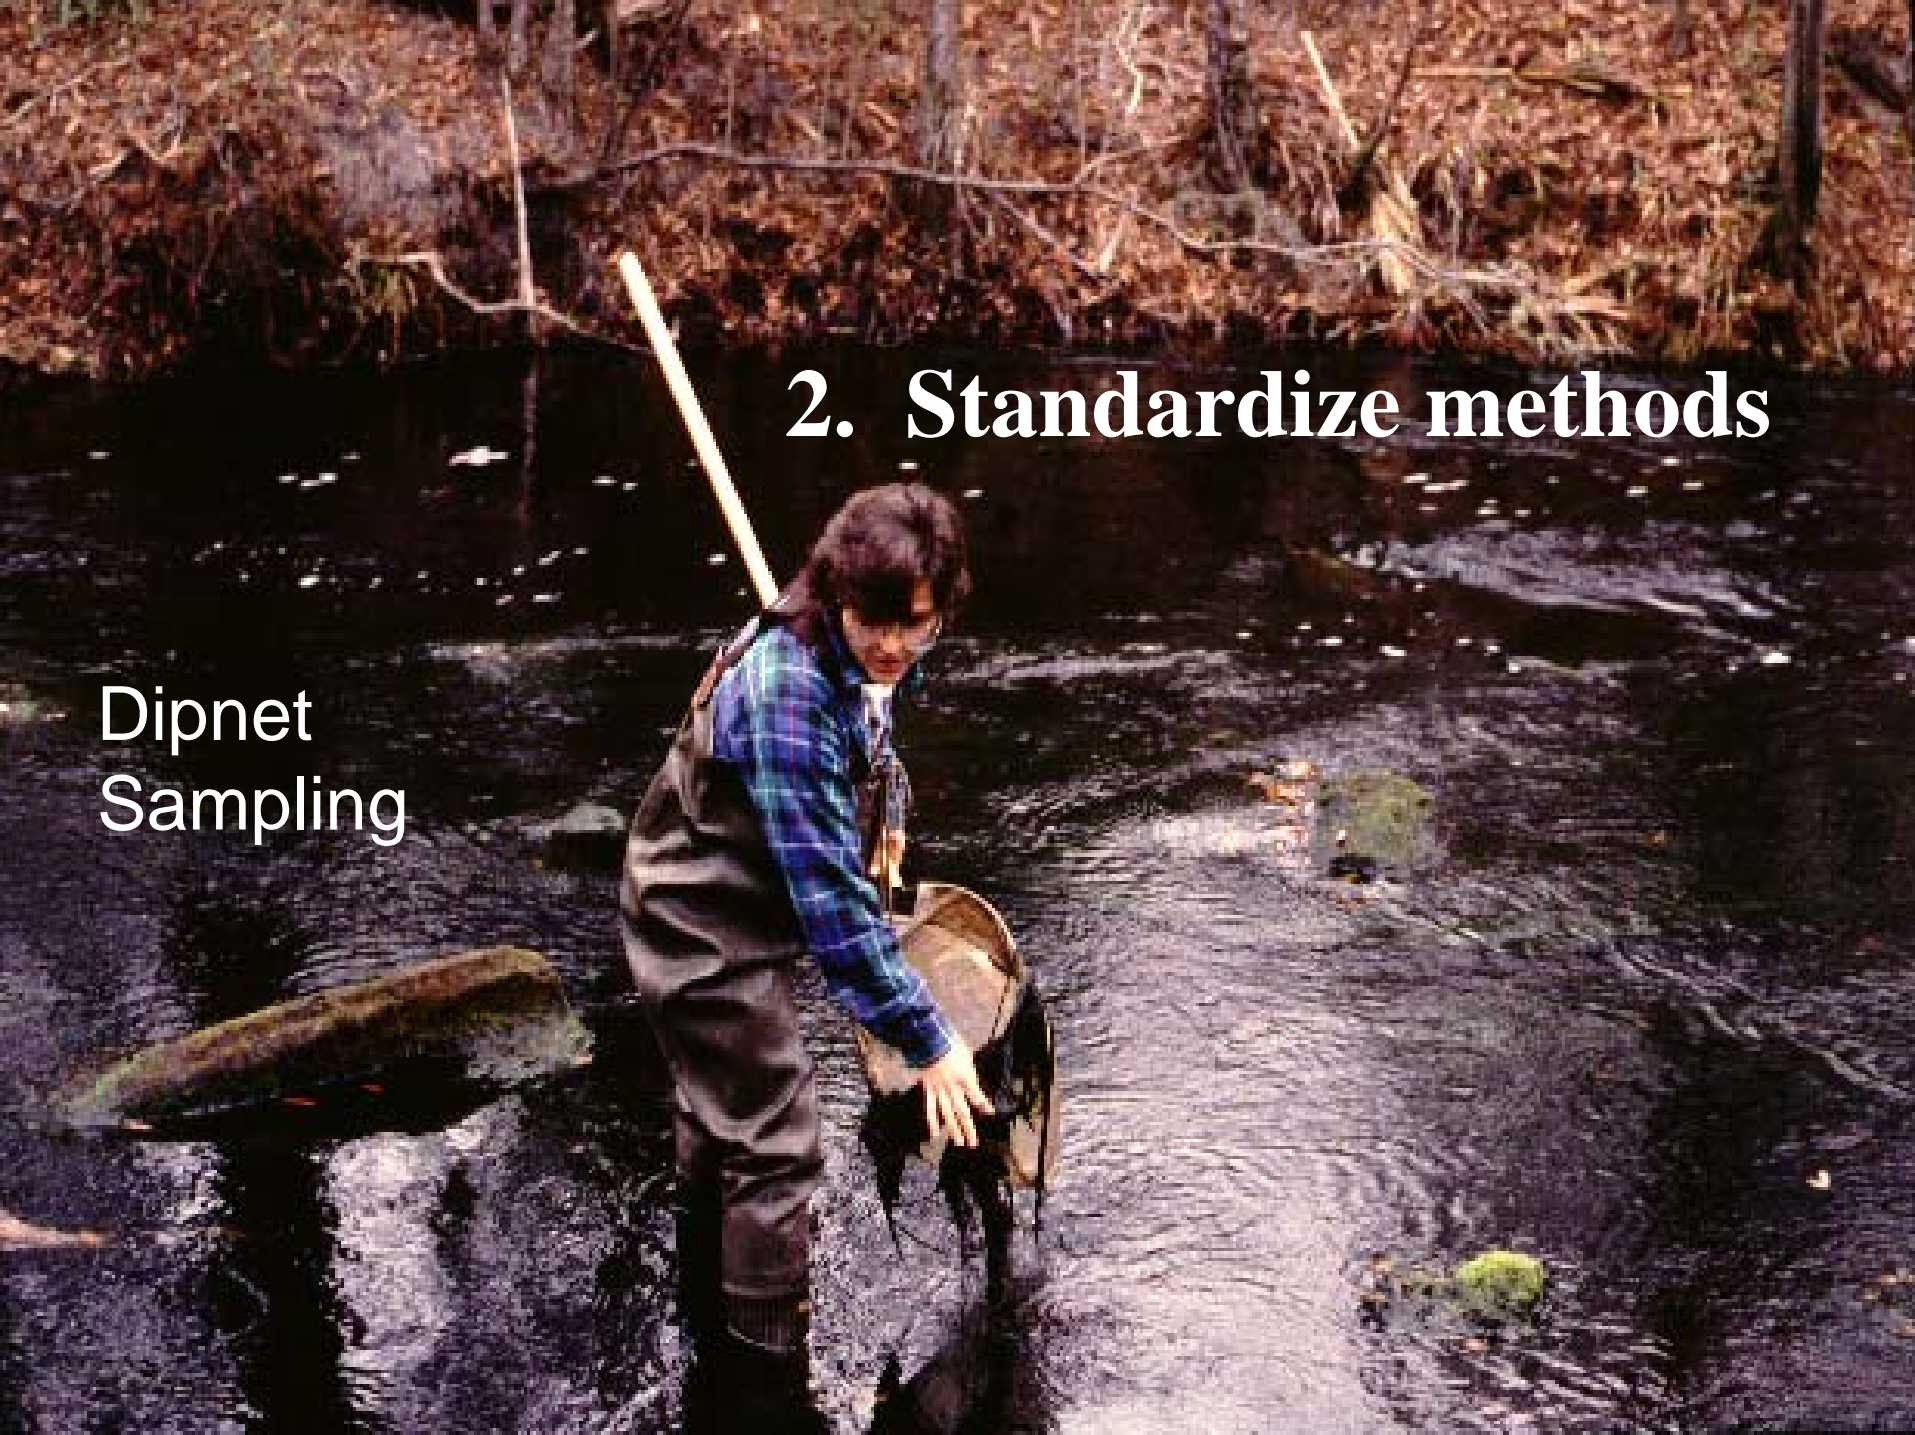
Dipnet
Sampling

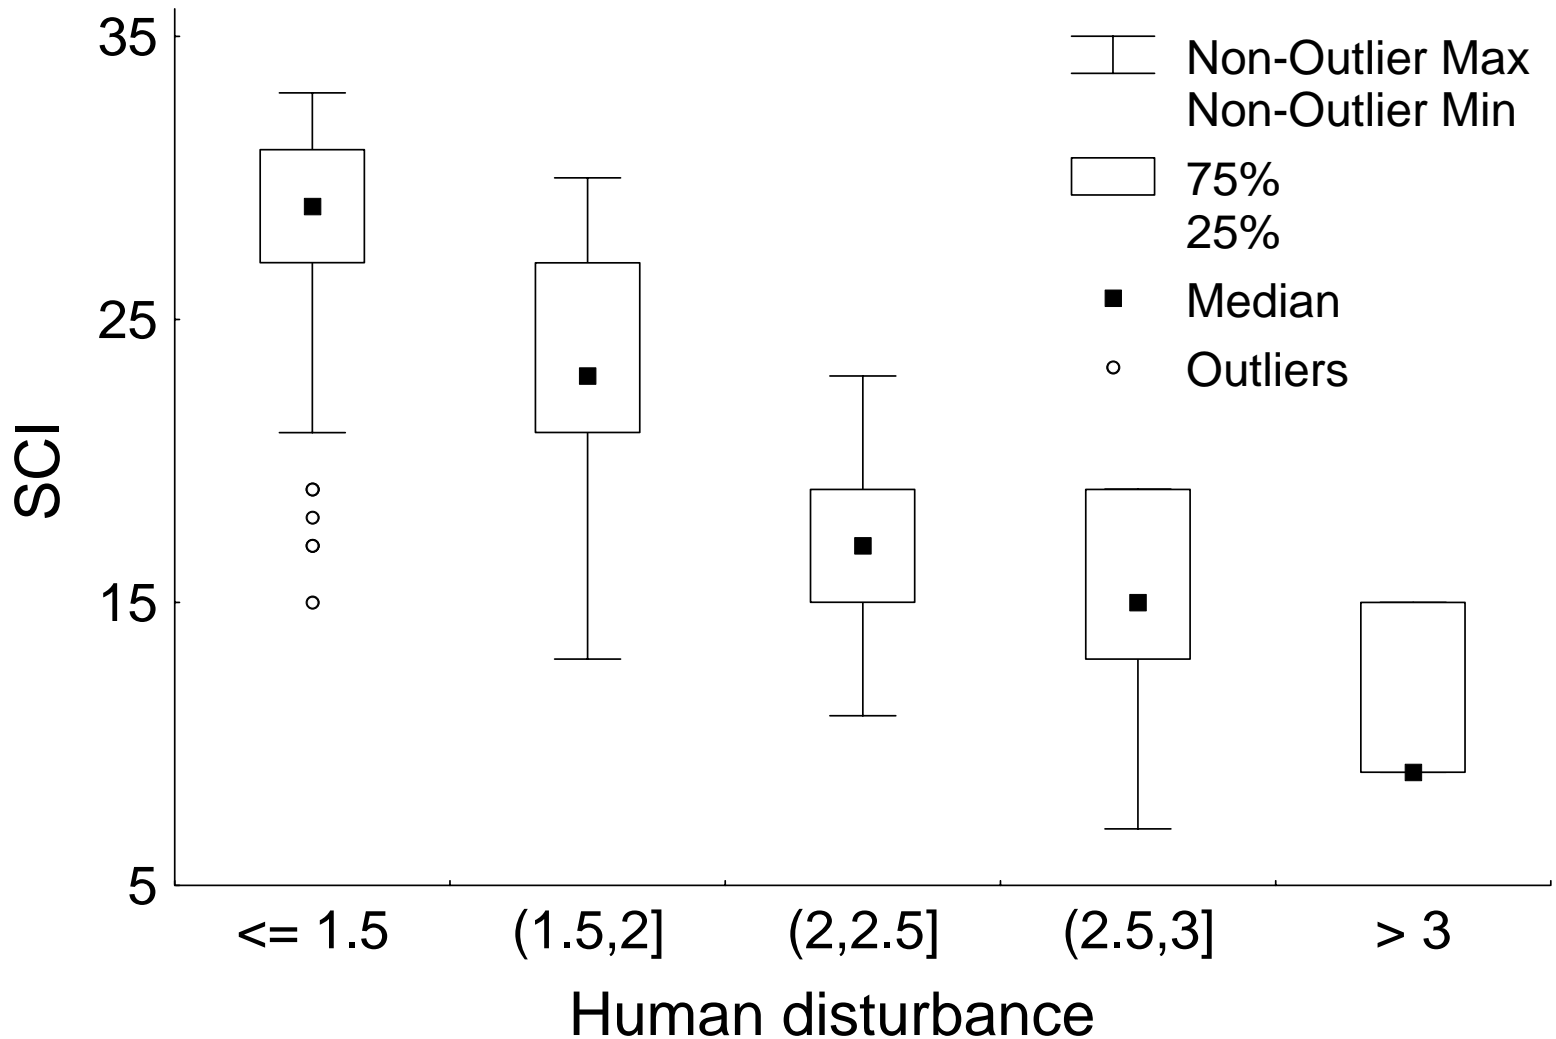
Components of the Stream Condition Index (SCI)

Response to disturbance

| ■ Taxa Richness | Decrease |
| ■ EPT Index | Decrease |
| ■ % Contribution Dominant Taxon | Increase |
| ■ Florida Index | Decrease |
| ■ # Chironomidae | Decrease |
| ■ % Filter-feeders | Decrease |
| ■ % Diptera | Increase |

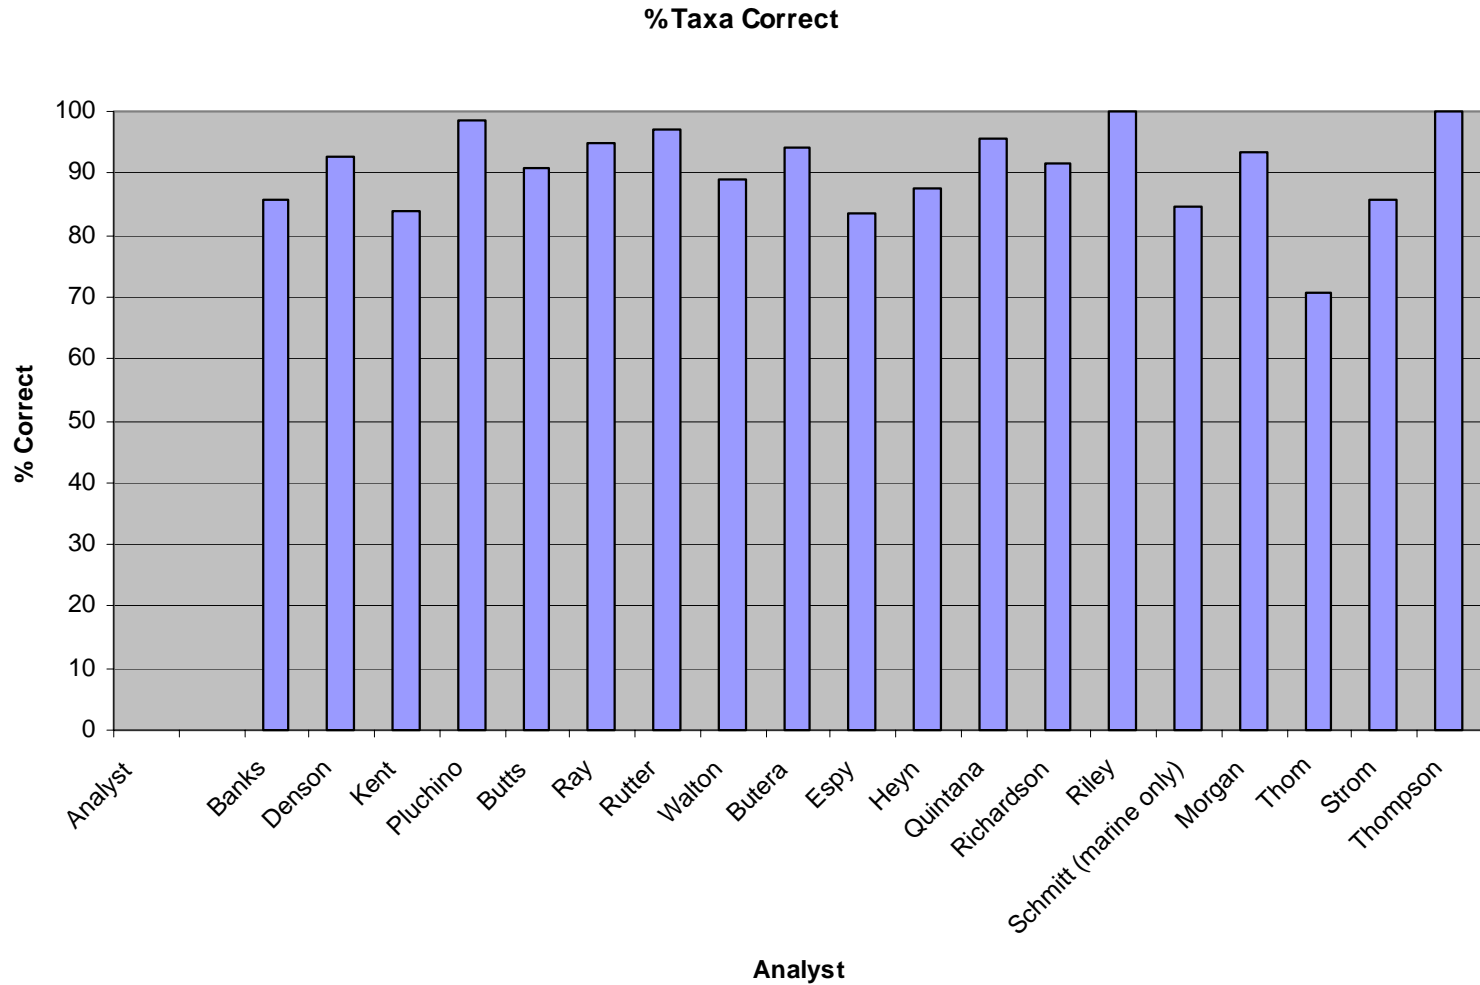
Taxonomic RR Results

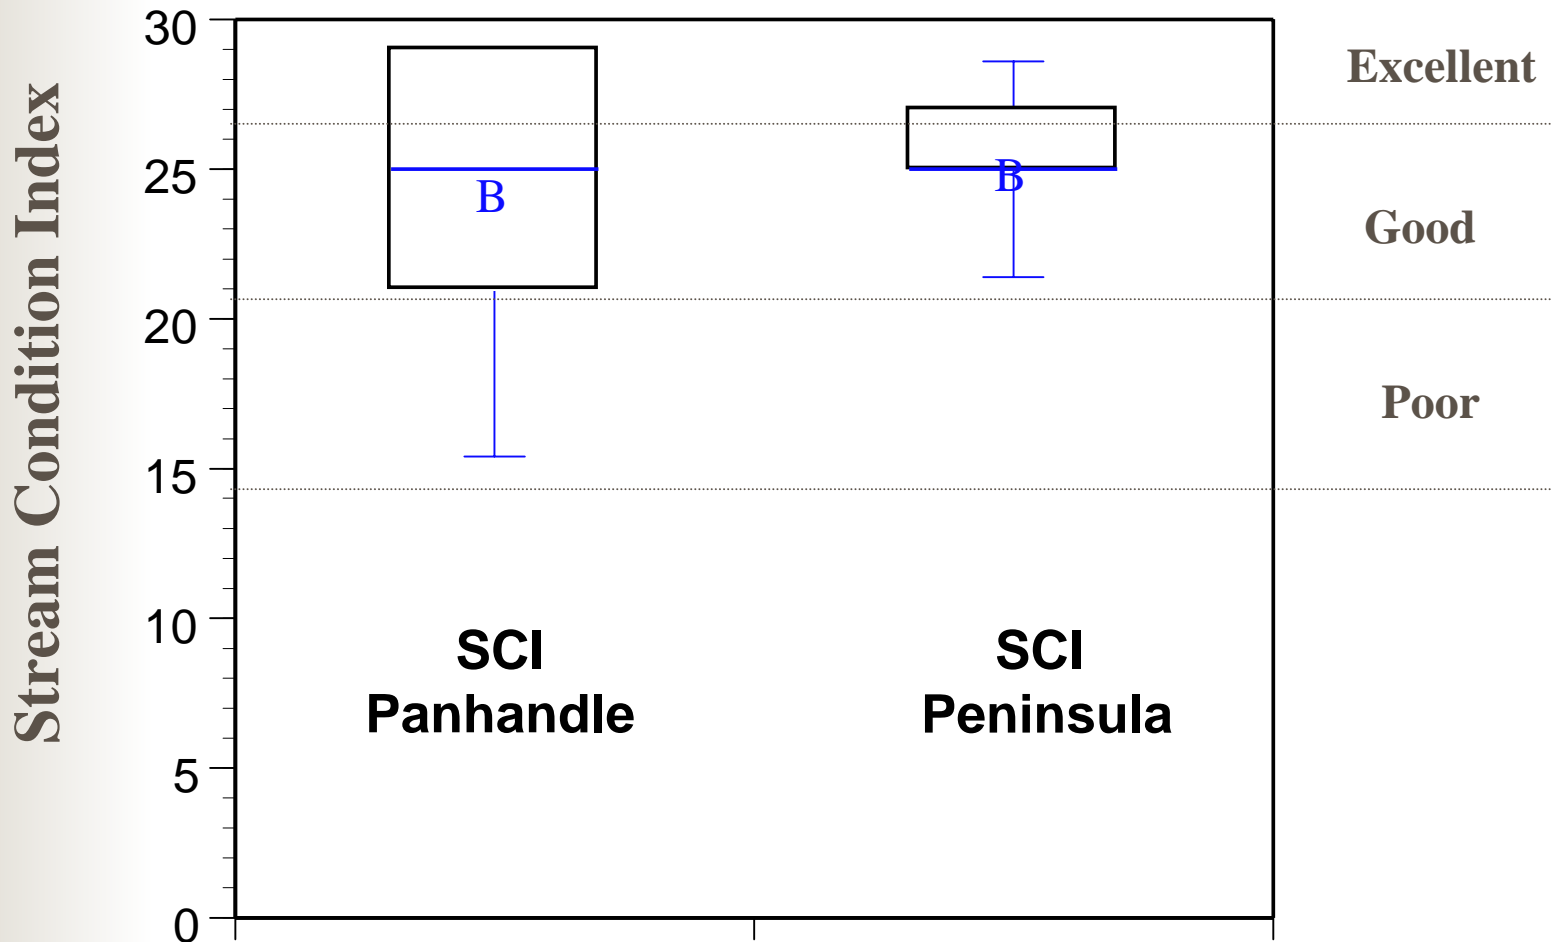
Health of Spring-Dominated Streams Compared with Reference Sites

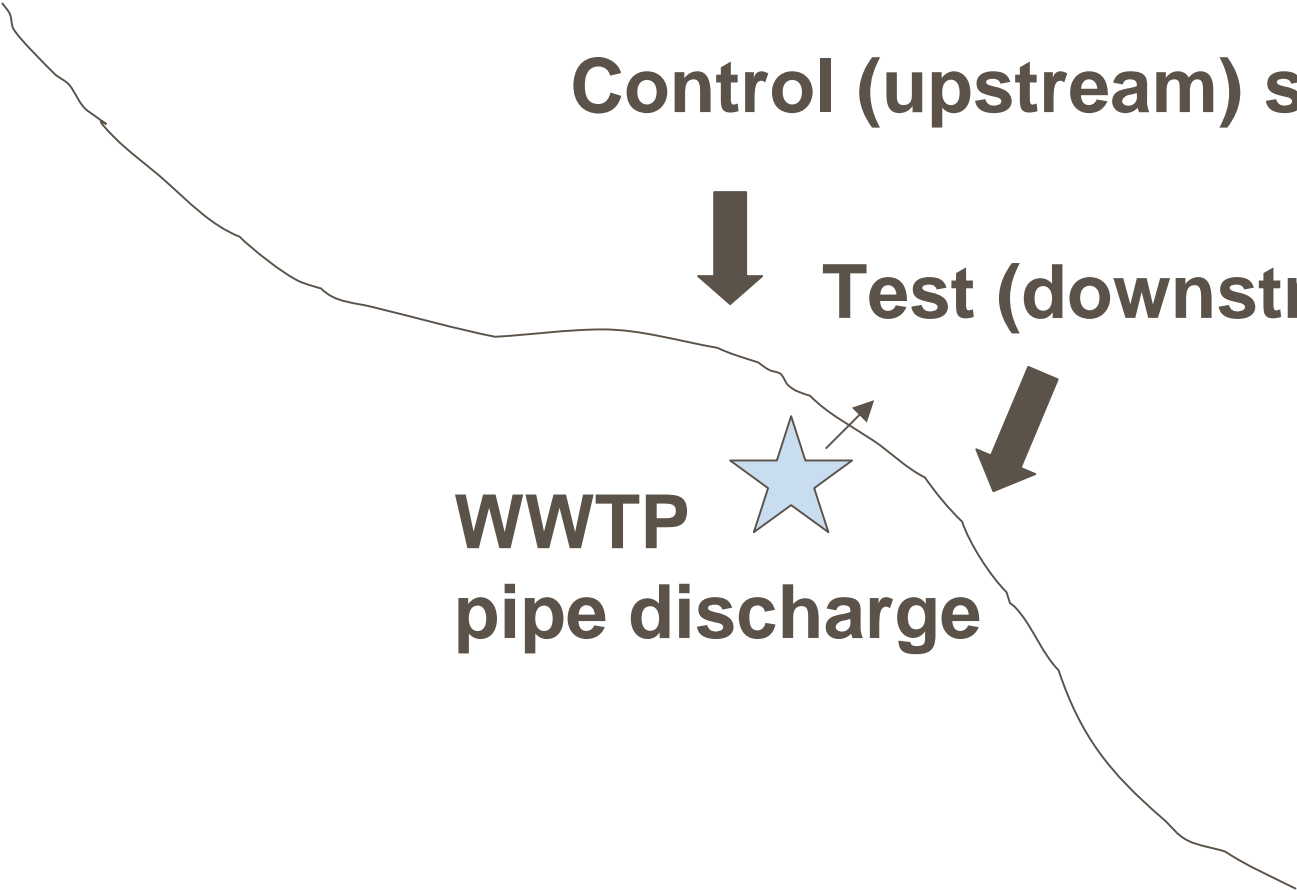
Control (upstream) site "A"

Test (downstream) site "B"

**WWTP
pipe discharge**

Results: Macroinvertebrate community data suggest degradation at the Test Site related to the facility's effluent. The Shannon-Weaver Diversity Index was 63% lower at the Test Site (0.9) compared to the Control Site (2.4), a violation of the Class III Biological Integrity Criterion (62-302.530 (11) FAC). Quantitative macroinvertebrate data showed 95.6% of the total community consisted of dipterans and the number of individuals rose from 87 at the Control Site to 1,811 at the Test Site. These results may indicate an increase in productivity in response to nutrient enrichment from the facility. In qualitative dipnet data, the dominant taxon comprised 81.6% of the community compared with 25.5%, and taxa richness was 68% lower at the Test Site compared to the Control Site. The Control Site received a SCI score of 21, which placed it in the "Good" category, while the Test Site received the lowest possible score of 7, placing it in the "Very Poor" category. Periphyton cell density was twice as high at the Test Site compared to the Control Site, reflecting a ten-fold increase in percentage of green algae at the Test Site. This change in algal community structure may also be related to the facility's effluent. The SCI and algal community composition data indicate an imbalance of flora or fauna, a violation of FAC 62-302.530 (48)(b).

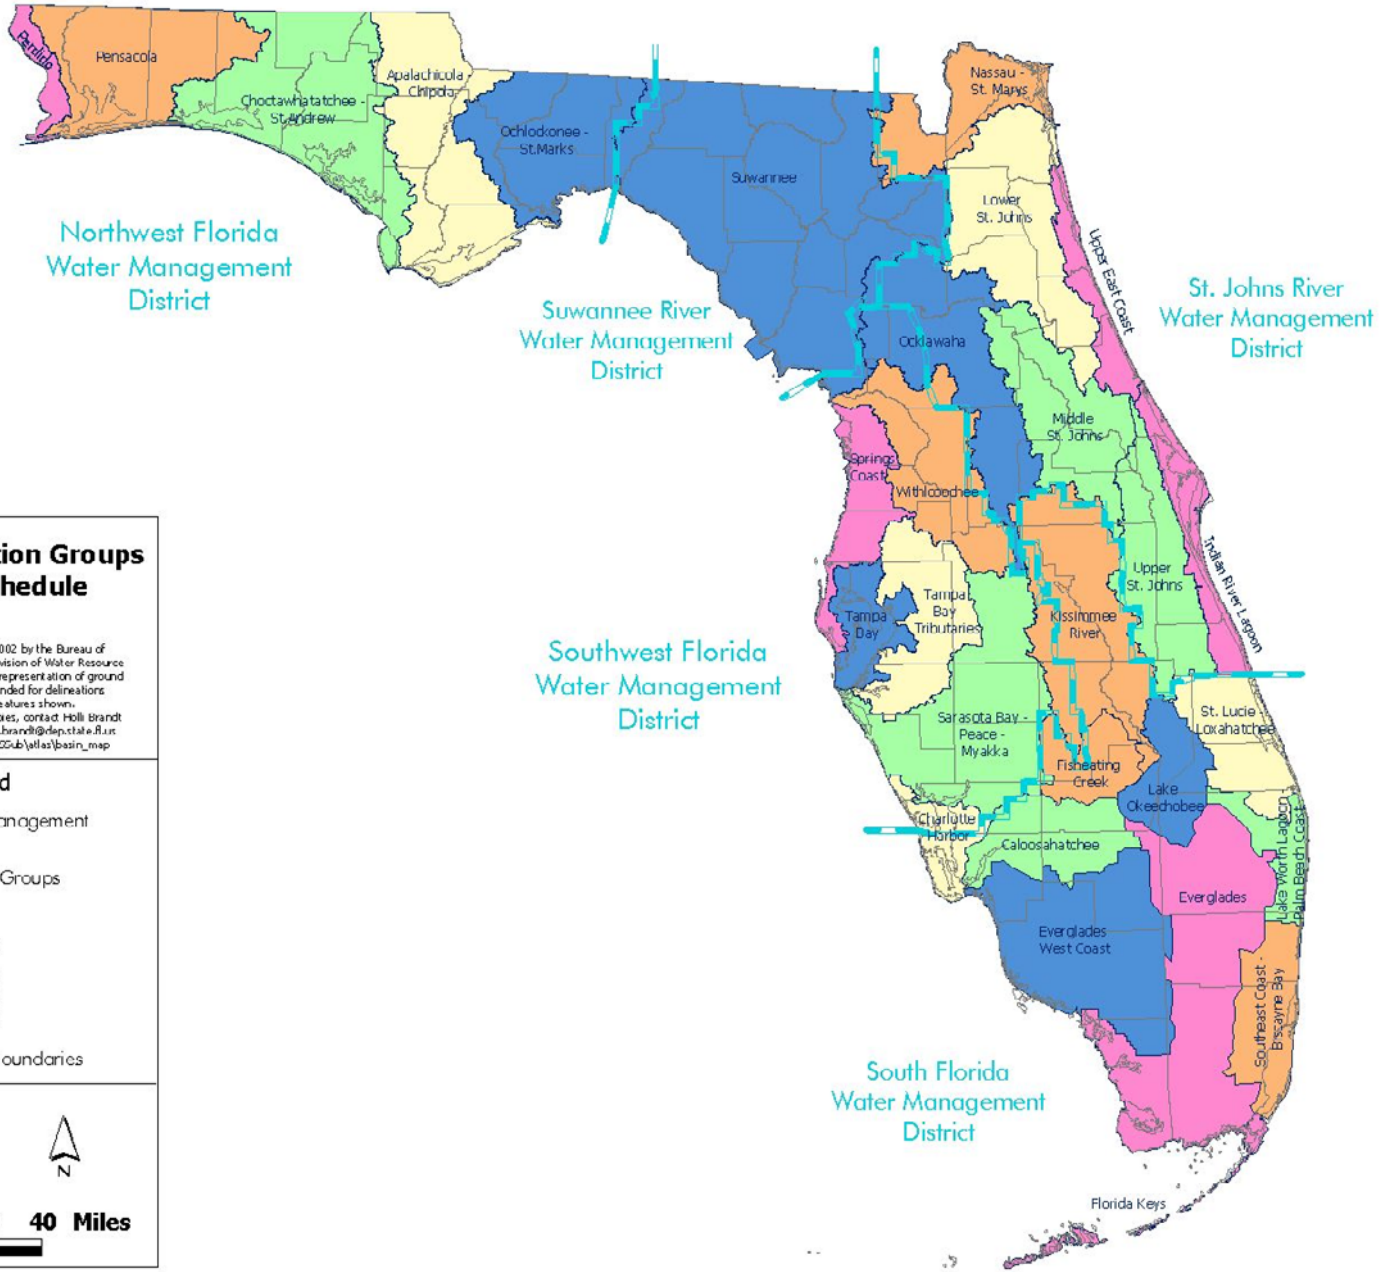
Basin Rotation Groups and Schedule

- Group 1
- Group 2
- Group 3
- Group 4
- Group 5

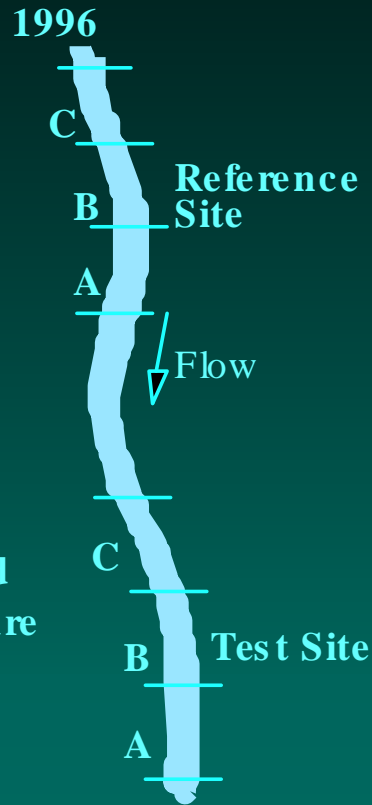
**Before
Silviculture
Activities**

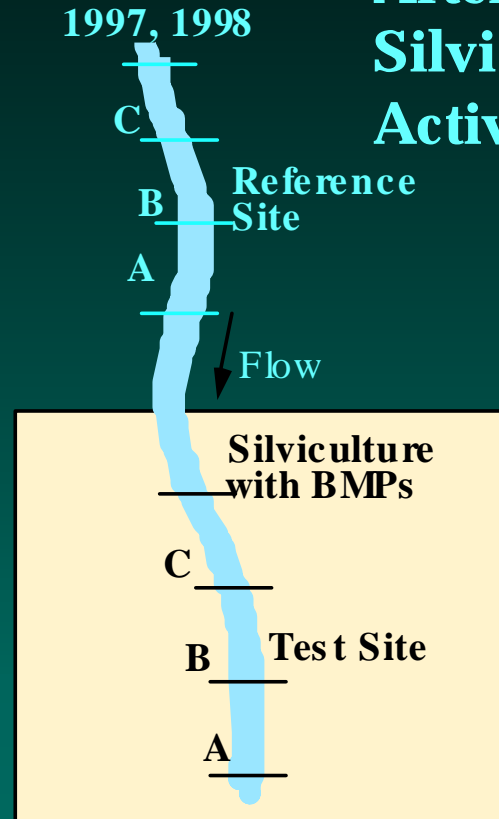
**After
Silviculture
Activities**

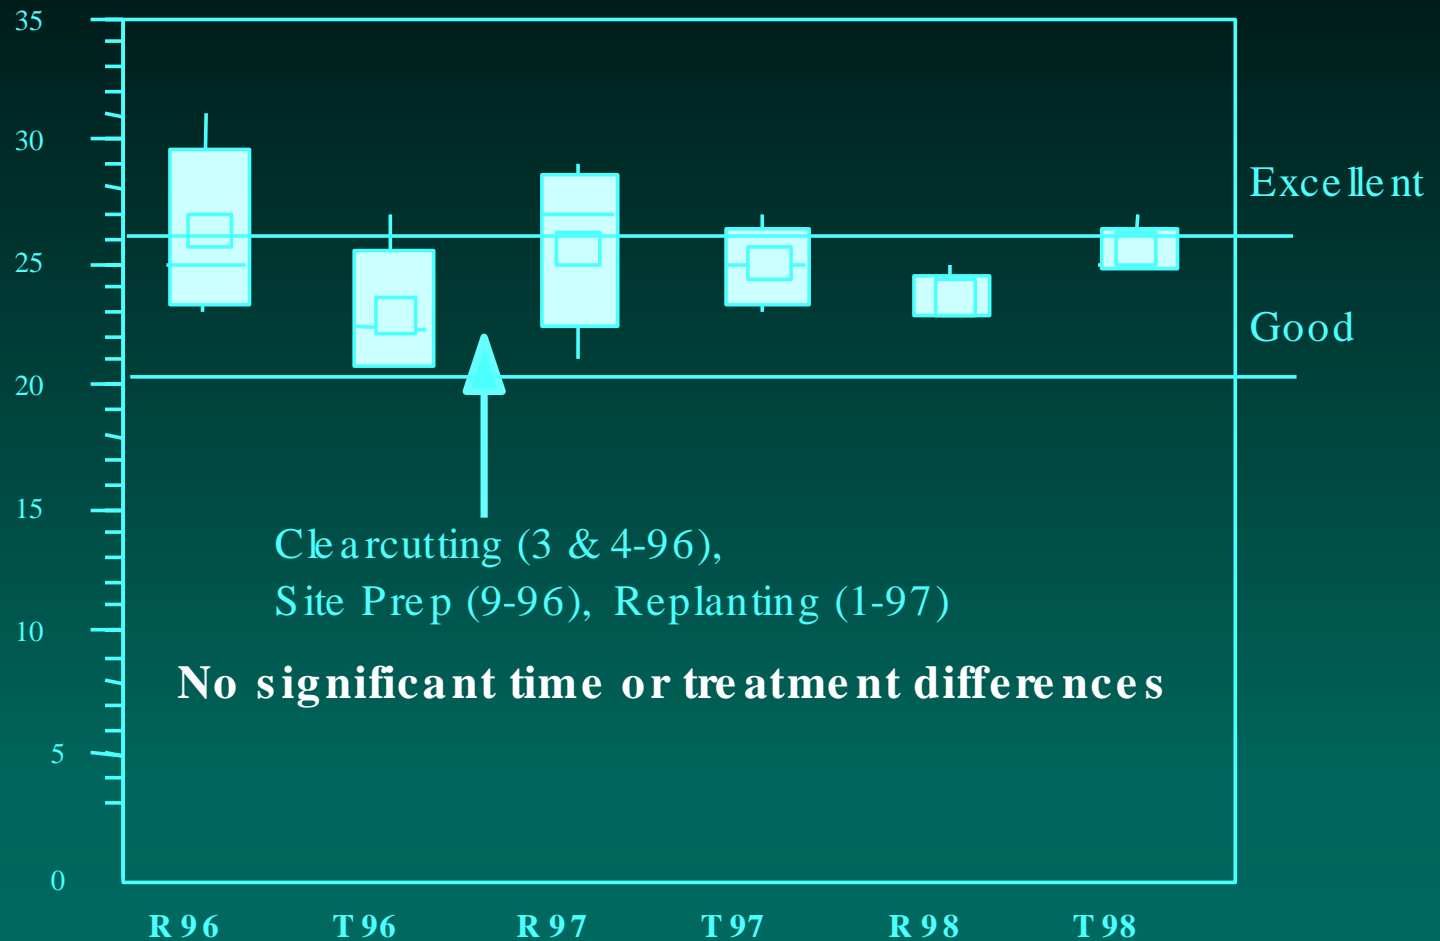
San Julia SCI Results

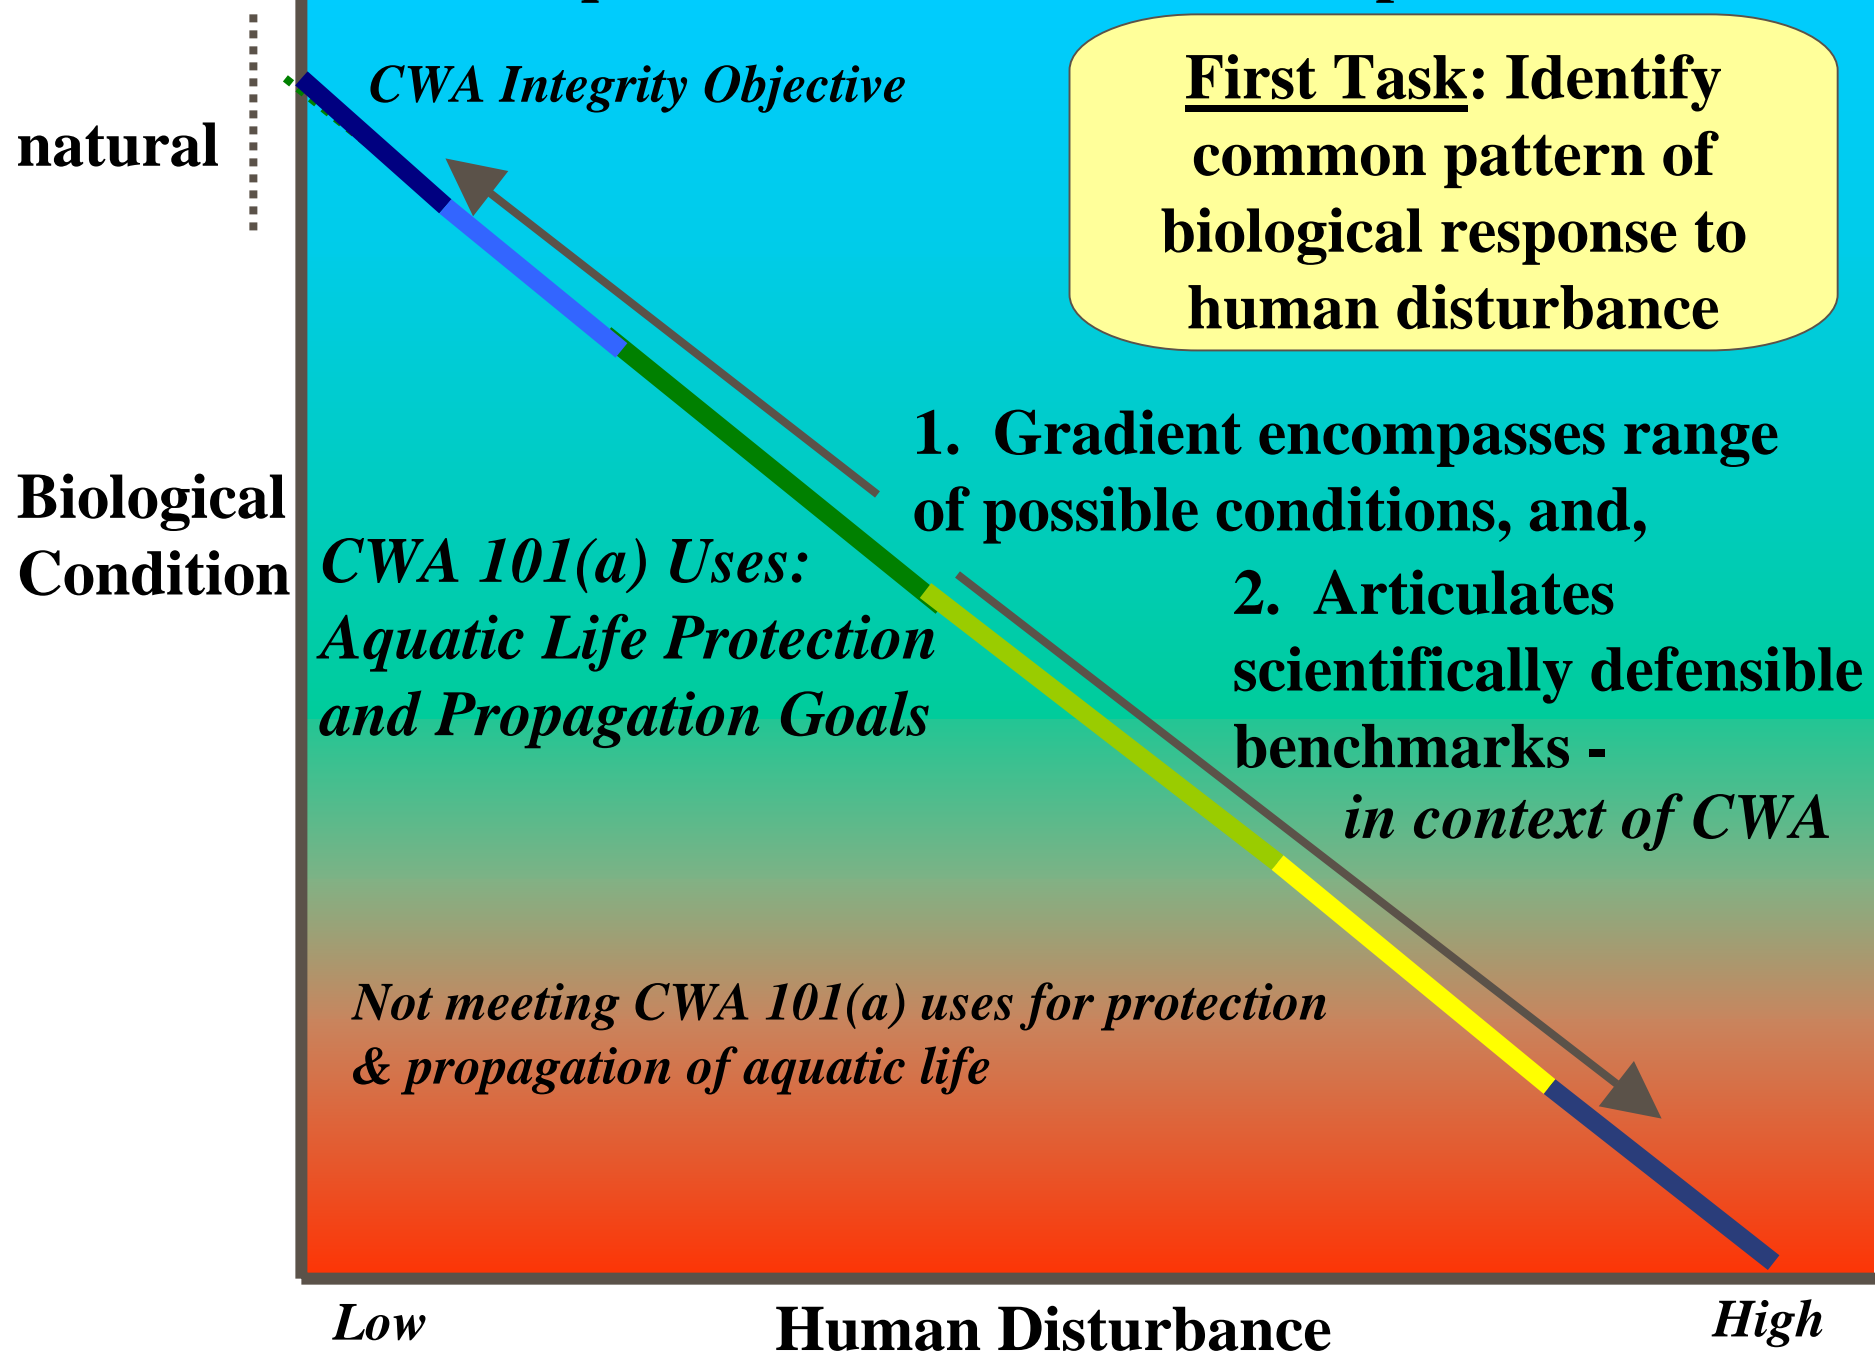
Tiered Aquatic Life Uses: Draft Conceptual Framework

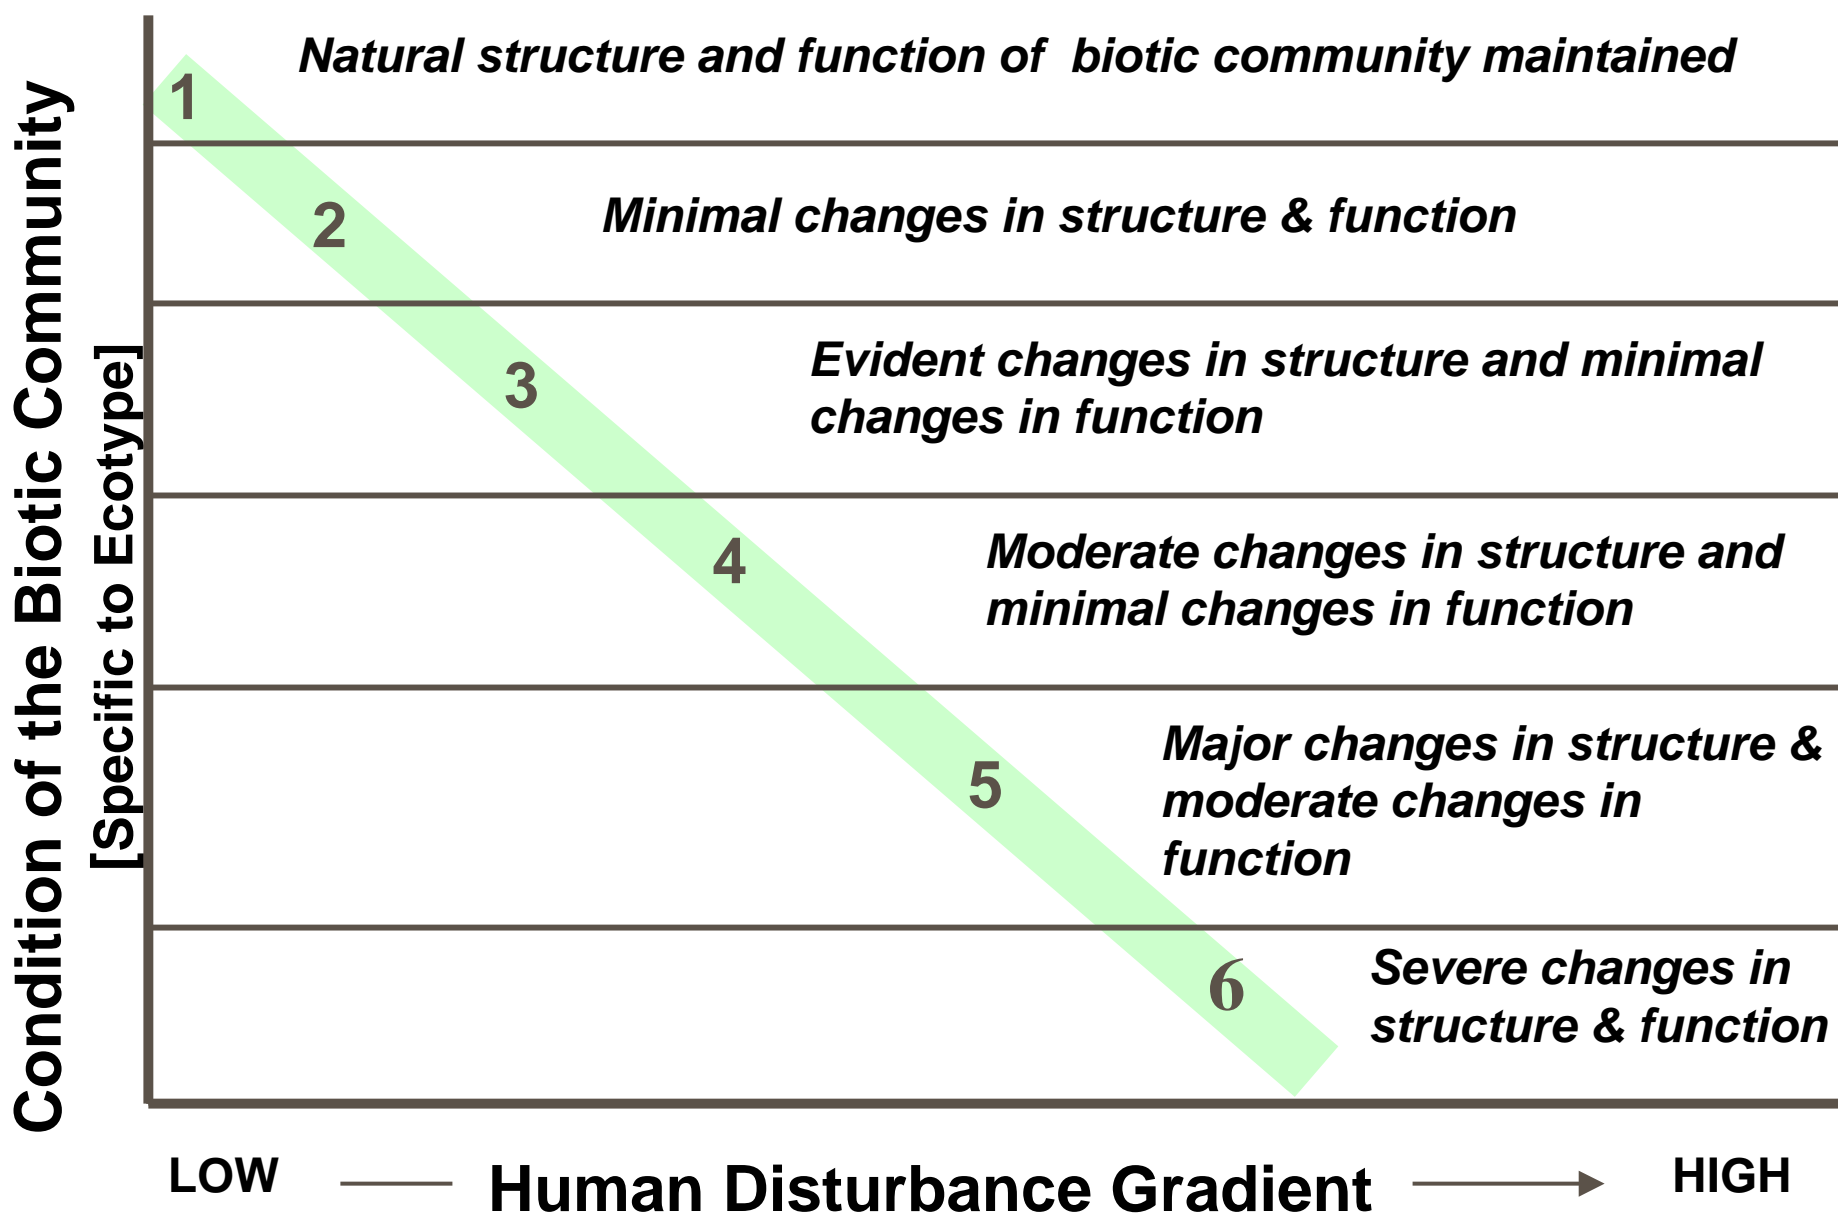
Tiered Aquatic Life Use Conceptual Model: Draft Biological Tiers
