## ALASKA Pioneering Precast in Alaska

### THE 7-MONTH REPLACEMENT OF 18 BRIDGES ON THE STORIED DALTON HIGHWAY

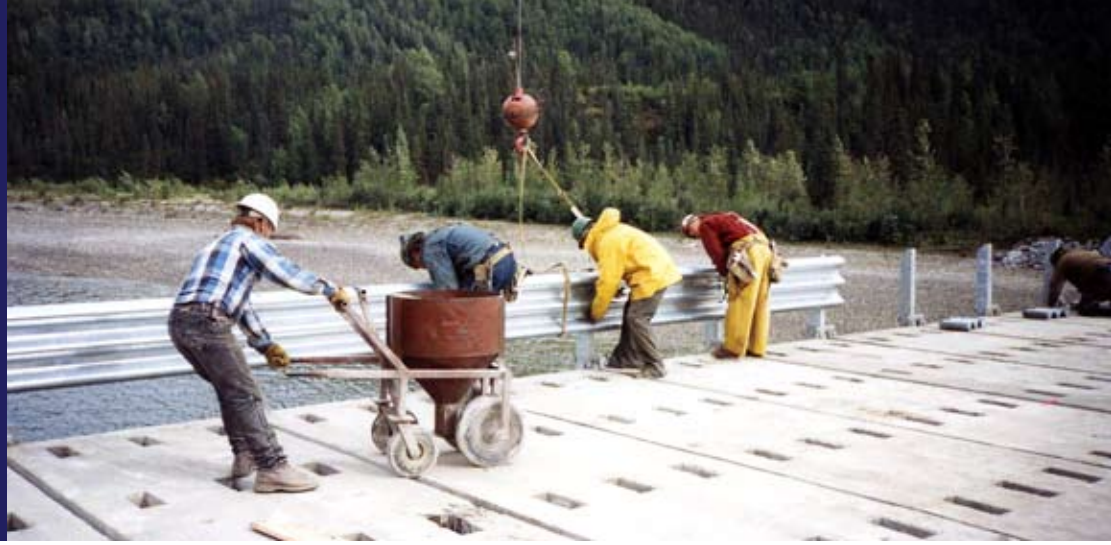
*Crews work on a bridge deck replacement along the Dalton Highway. Precast concrete panels will save money on repair and maintenance costs and ease impacts on drivers.*
