# DESIGN AND PERFORMANCE ISSUES RELATING TO LOCAL SCHOOLS (K-12) 10

## 10.1 INTRODUCTION

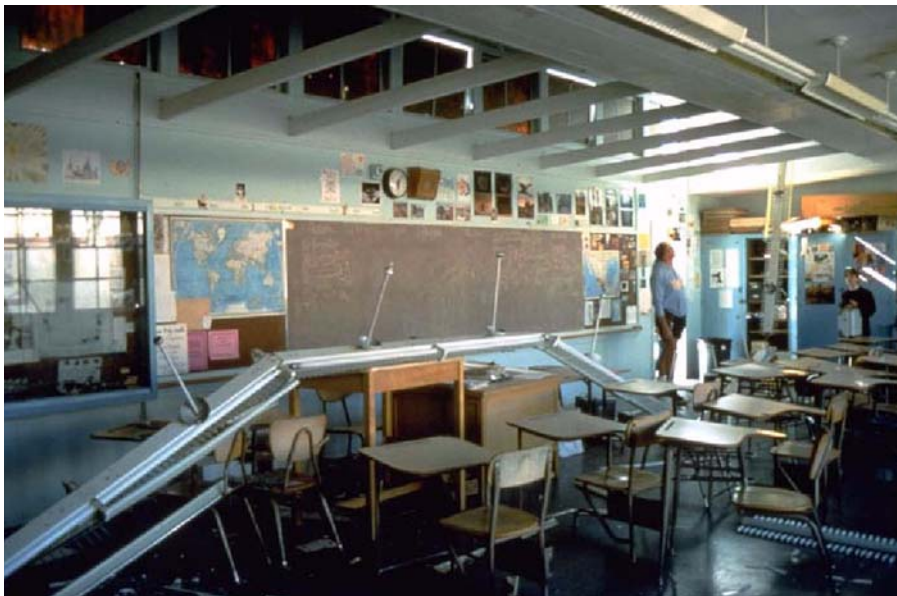
Figure 10-1 Nonstructural damage at Northridge Junior High where lights fell onto desks during the 1994 Northridge earthquake. (photo courtesy of the Earthquake Engineering Research Institute)

In the Northridge, California, earthquake of 1994, State inspectors posted red UNSAFE placards on 24 school buildings, and yellow RESTRICTED USE placards on 82, although this was later considered overly conservative. No structural elements collapsed. There was, however, considerable nonstructural damage as shown in Figure 10-1. This was costly to repair, caused closure of a number of schools and, if the schools had been in session, would have caused casualties. The Field Act focused on structural design and construction, and only recently were nonstructural components included in the scope of the Act.

Falling nonstructural components and systems present a significant potential for injuries to building occupants as shown in Figure 10-1. In addition to the injury potential and economic loss resulting from repair and clean-up costs, excessive service interruption can result from lighting fixture and water, mechanical, and electrical equipment damage.
