4.1 INTRODUCTION

This chapter outlines the earthquake risk to schools and the processes and methods that can be used to reduce it. An explanation of the nature and probability of earthquakes is provided, together with procedures for determining the earthquake threat to specific locations. An assessment of the scope and effectiveness of seismic building codes is followed by an explanation of how to evaluate the vulnerability of a school building. Current methods of designing for seismic resistance in new buildings and upgrading existing buildings lead to a discussion on determining acceptable risk and the use of performance-based design to achieve community objectives in providing for seismic safety.

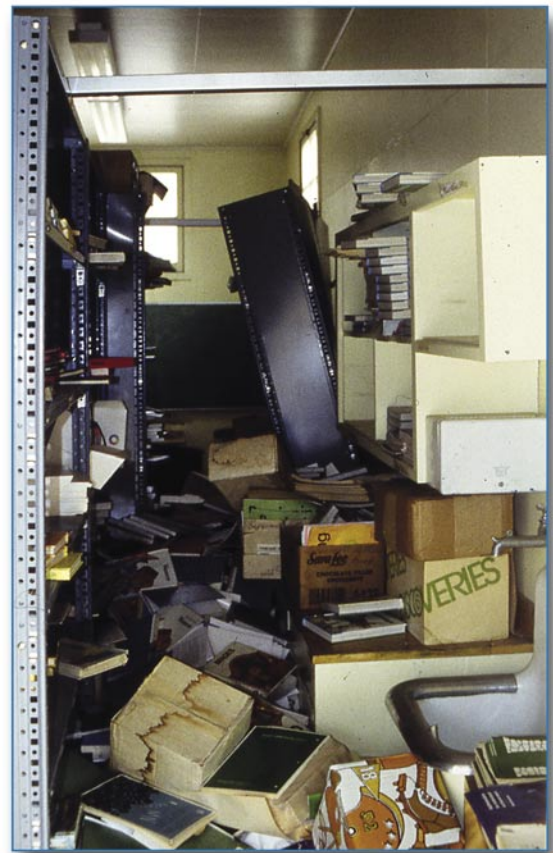
Figure 4-10
Fallen filing cabinets and shelves, Northridge,
CA, 1994

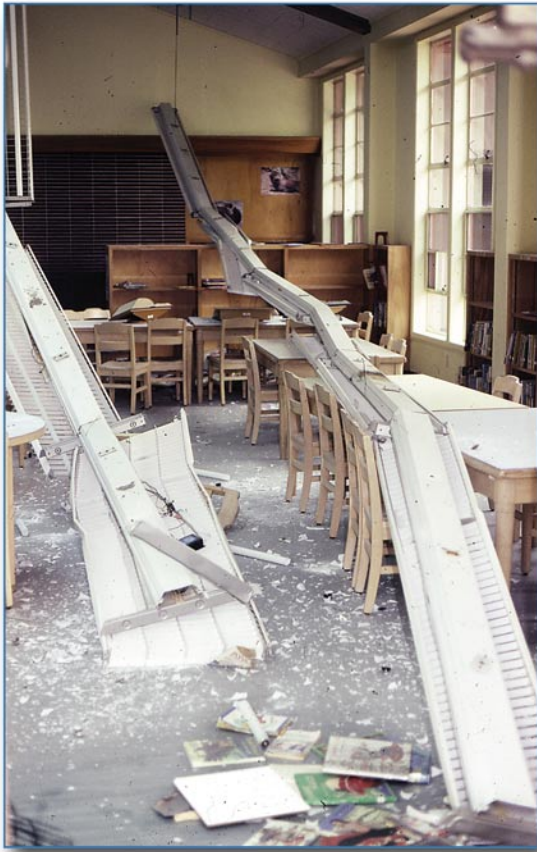
Figure 4-12
Fallen light fixtures, library, Coalinga, CA, 1983
SOURCE: GARY MCGAVIN, REDLANDS, CA

Pendant light fixtures have sometimes fallen if they are insecurely attached and not designed to swing freely (see Figure 4-12). Sudden breakage of large glass areas is a specific hazard because of the dense occupancy in many school rooms; design of glazing to resist wind-borne debris and physical attack may also assist in protecting it from earthquake motion. This kind of damage has been significant in California schools that have suffered recent earthquakes.

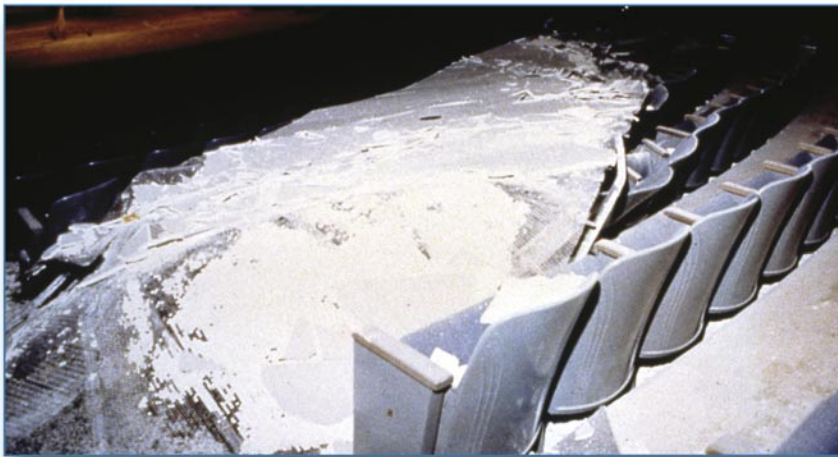
Figure 4-13
Fallen heavy lath and
plaster ceiling across
auditorium seating,
Northridge, CA, 1994
SOURCE: GARY MCGAVIN,
REDLANDS, CA

Heavy hung lath and plaster ceilings in older auditoriums (and assembly buildings) can be dangerous and need careful inspection of their attachment and materials. If deficient in safety, replacement is the only acceptable solution (see Figure 4-13).

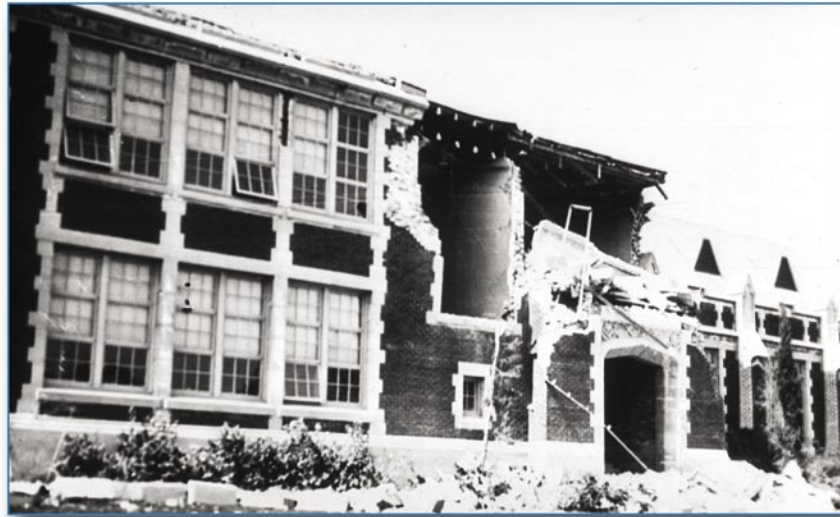
Figure 4-14
Damage to the John Muir
School, Long Beach, CA,
1933

Considering the number of significant earthquakes in California since the early years of the 20th century, there has been remarkably little severe structural damage to schools, except in the Long Beach earthquake of 1933, and there have been very few casualties. In California, no school child has been killed or seriously injured since 1933. This good fortune has been primarily because all major California earthquakes since 1925 have occurred outside school hours (see Figure 4-14).

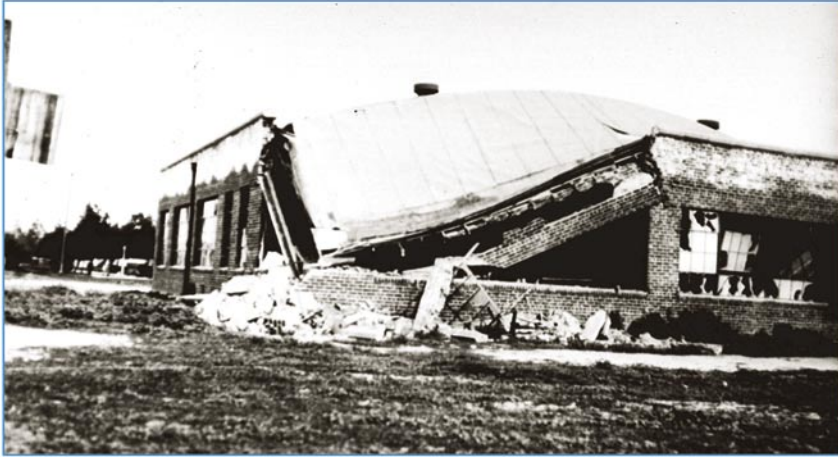
Figure 4-15
Damage to shop building,
Compton Junior High
School, Long Beach, CA,
1933

In the Long Beach earthquake that occurred at 5:55 p.m. on March 10, 1933, damage to unreinforced masonry school buildings was so severe that there would have been many casualties had they been occupied. As a result, the state passed the Field Act within a month of the earthquake (see Figures 4-15 and 4-16).

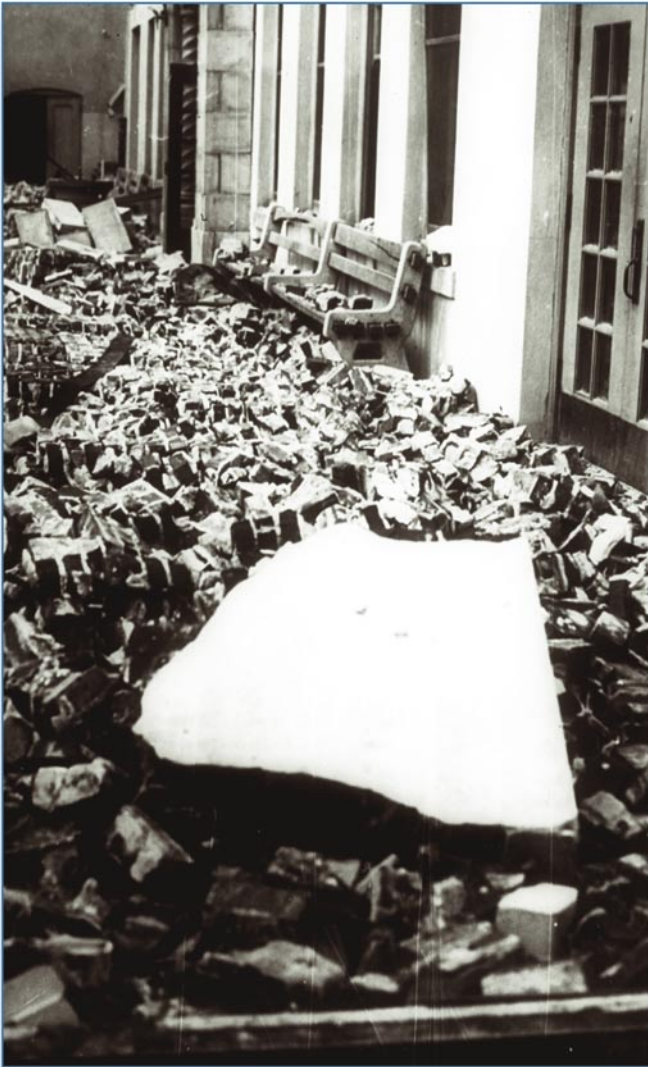
Figure 4-16
A dangerous passage way between two
buildings, Polytechnic High School, Long
Beach, CA, 1933

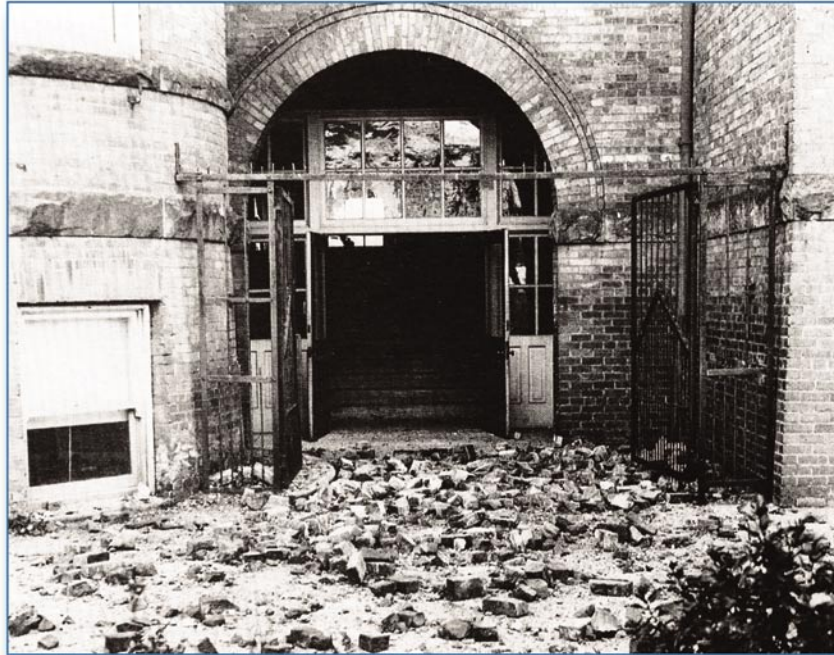
Figure 4-23
Collapse of roof over stage, Seattle, WA,
1949

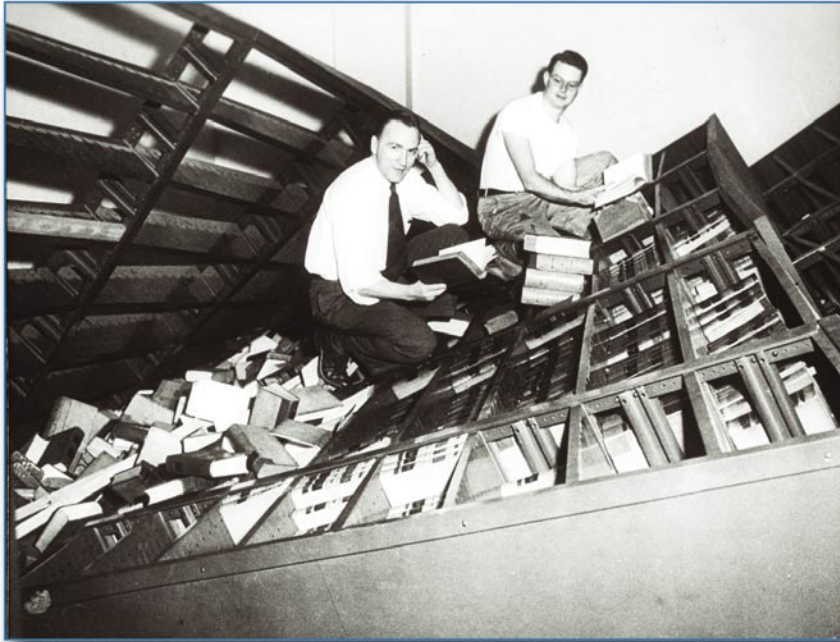
Figure 4-24
Damage to library shelving,
Seattle, WA, 1949

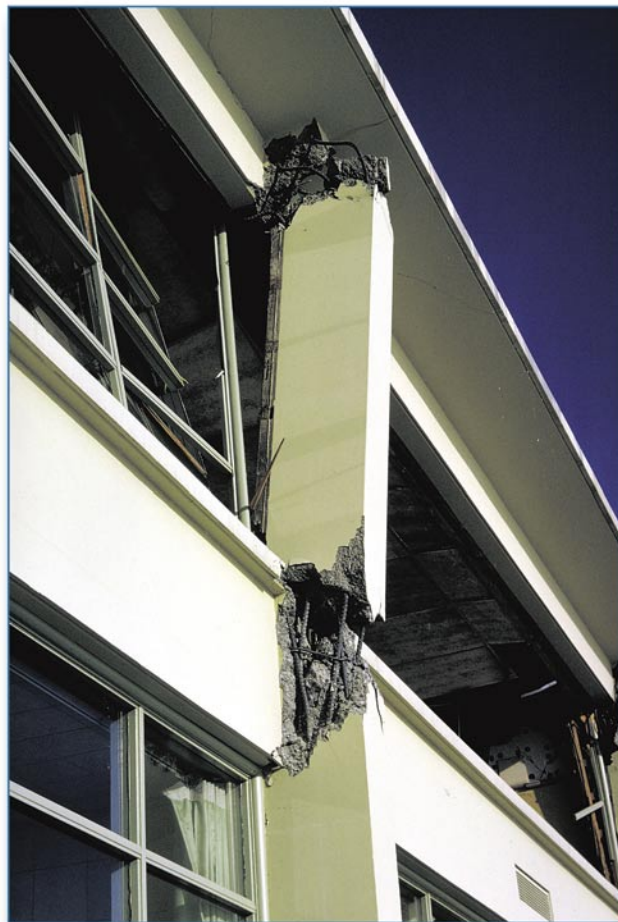
Figure 4-26
Brittle failure at nonductile concrete column,
West Anchorage High School, 1964

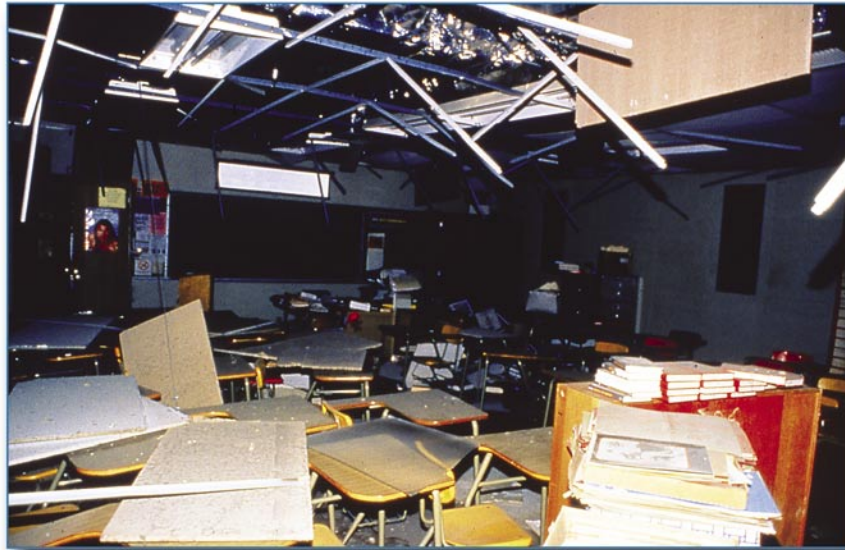
Figure 4-27
Ceiling damage,
Northridge, CA, 1994

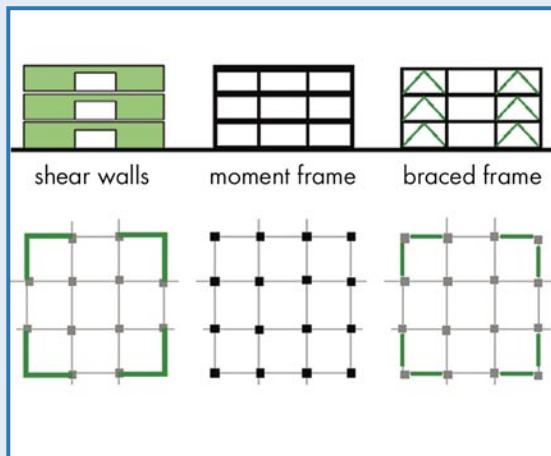
Lateral Force Resisting Systems – Basic Types

The systems have major architectural implications. Shear walls, which should run uninterrupted from foundation to roof, may impose major planning constraints on a building. Moment frames create unobstructed floors, but, because of their special connection requirements, are expensive. They are subject to more deformation that may result in costly damage to nonstructural components and systems. Braced frames are a common compromise.

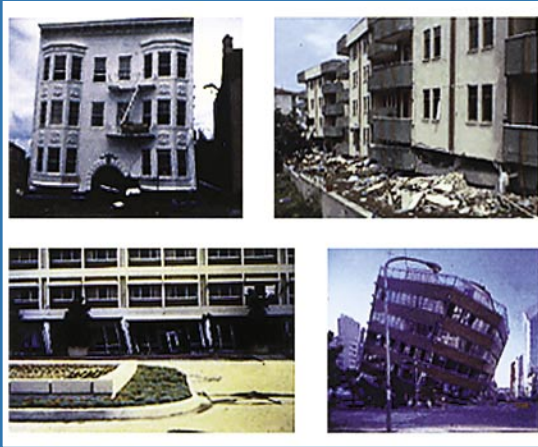
Soft Stories

Typical examples of soft story-induced damage.

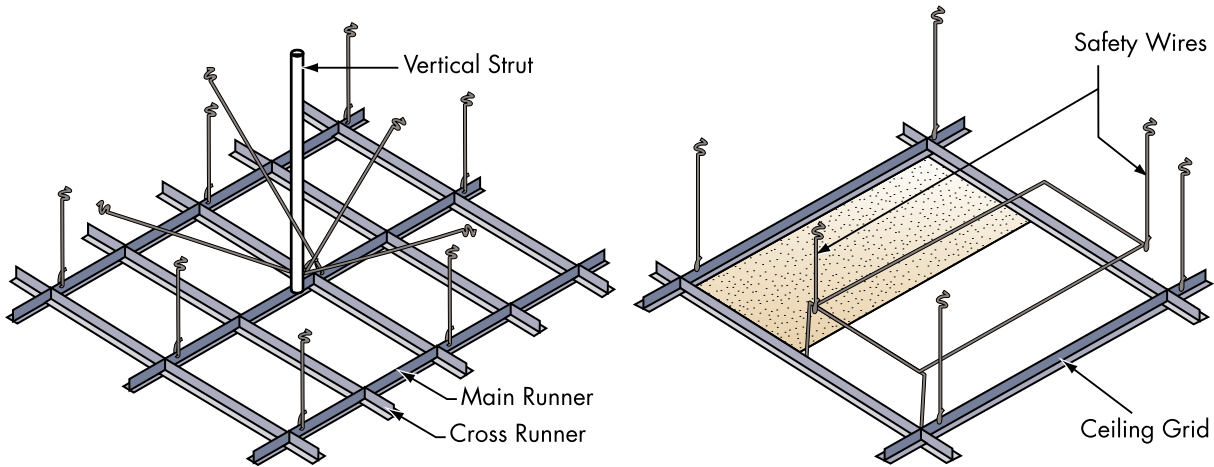
Figure 4-32 Suspended ceiling and light fixture bracing and support

Figure 4-33
Bracing tall shelving to the structure

Reduction of damage to nonstructural components depends on using methods of supporting and bracing the components to prevent failure (see examples in Figures 4-32, 4-33, 4-34, and 4-35). Seismic codes provide the design force for which the above components must be designed, together with a number of specific design requirements that must be followed.

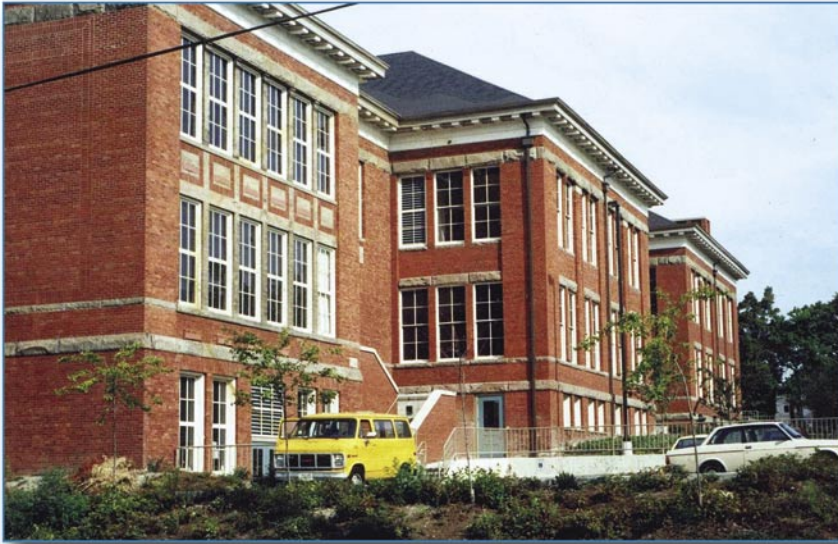
Figure 4-37
Retrofit of B.F. Day
Elementary School, Seattle,
WA

Seismic retrofit at any large scale is expensive, both in design and construction, because of the more complex analyses that must be conducted and the construction constraints that must be overcome. In addition, closure of a school for an extended period (beyond that of the normal summer break) is usually unacceptable. Major seismic retrofit is rare, although some successful projects have been done, primarily with the goal of saving a building that is not only a place of learning, but a historic community resource as well. The retrofitting of the B.F. Day School in Seattle was one such project (see Figures 4-37 and 4-38).
