**Site PR-2-1B, Prefumo Creek Golf Course Dams**

Restoration Actions  
within the San Luis Obispo Creek Watershed

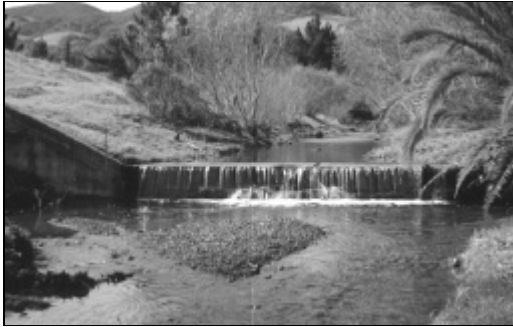
**Figure 13. Photograph of Prefumo Creek, Fish Barrier PR-2-1B**

**Problem:** Two small check dams create a change in grade of approximately 3-feet each. These structures impede the upstream passage of adult salmonids under low flow conditions and juveniles under all flow conditions.

**Project Description:** These barriers will be made passable at low flows by cutting notches, 12 to 18 inches deep and 4 to 6 feet wide in the centers to concentrate low flows. The remainder of the structures can be left in place to prevent upstream downcutting and other possible hydrologic impacts. A single rock weir below each weir will further improve passage for smaller fish.

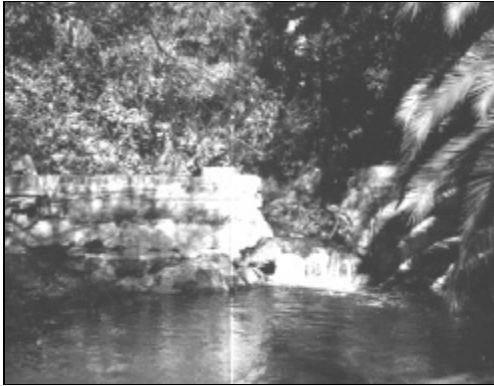
**Figure 15. Photograph of Stenner Creek, Fish Barrier ST-2-1B.**

**Problem:** This is a concrete flash board dam that has been abandoned and is no longer used for stream diversions. The structure channels the stream flow through a 4-foot wide notch that creates a drop of approximately 3-feet under low flow conditions, preventing free upstream passage for adult and juvenile fish.

**Project Description:** The spillway section of the dam between the two abutment wing walls will be removed down to its foundation or to bedrock.

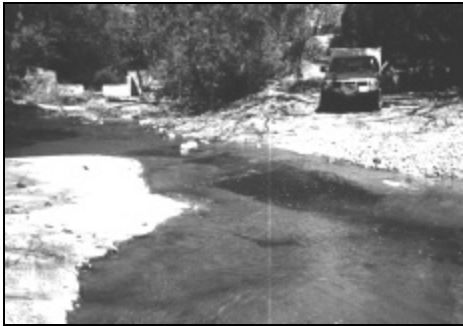
**Figure 16. Photograph of Stenner Creek, Fish Barrier ST-2-2B**

**Problem:** This is a concrete low-flow vehicle crossing that has a drop of approximately 2-feet at the downstream end. This is a barrier to juvenile fish passage at low flows when the smooth concrete barrier causes water to sheet and become too shallow for fish passage. It may also

be a velocity barrier at high flows to migrating adult fish.

**Project Description:** Passage will be improved by constructing a series of rock weirs in the downstream channel to an elevation that will back water up over the concrete crossing.

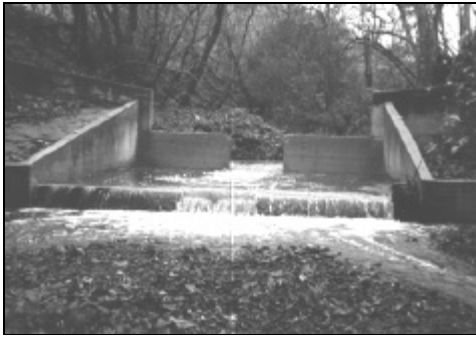
**Figure 17. Photograph of Stenner Creek, Fish Barrier ST-2-3B.**

**Problem:** This is a concrete flash board dam that is no longer used for stream diversion. The barrier has a partial opening broken out, but continues to prevent free upstream passage for adult and juvenile salmonids during low flows due to an abrupt elevation change.

**Project Description:** The dam will be modified by removing the center concrete weir and leaving the abutments and spillway plunge pool in place.

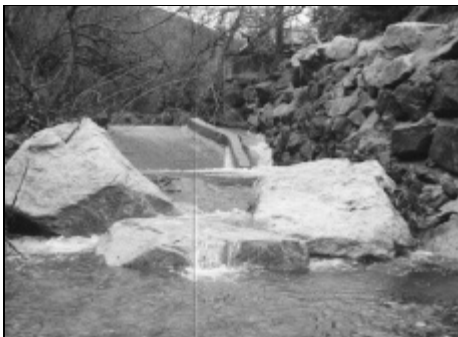
**Figure 18. Photograph of Stenner Creek, Fish Barrier ST-3-1B**

**Problem:** This is a small concrete diversion dam that provides water to Cal Poly. Three boulder weirs were previously added to the channel below the dam to provide fish passage, but one more weir is needed to complete the job.

**Project Description:** An additional boulder weir will be added at the base of the incline.
