SIGNALIZED INTERSECTION SAFETY STRATEGIES

Provide Skid Resistance in Intersection and on Approaches

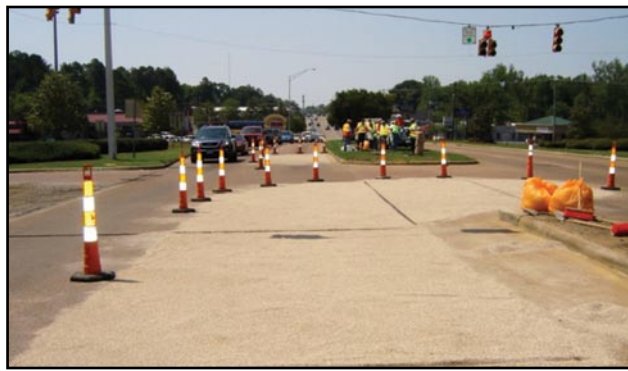
The surface friction of this intersection is being improved.

Slippery pavement should be addressed to reduce the potential for skidding. The coefficient of friction is most influenced by vehicle speed, vehicle tire condition, and pavement surface condition. Consideration should be given to improving the pavement condition to provide good skid resistance, especially during wet weather. This can be accomplished by:

- providing adequate drainage,
- grooving existing pavement, and
- overlaying existing pavement.
