UNSIGNALIZED INTERSECTION SAFETY STRATEGIES

Provide Supplementary Stop Signs Mounted Over the Roadway

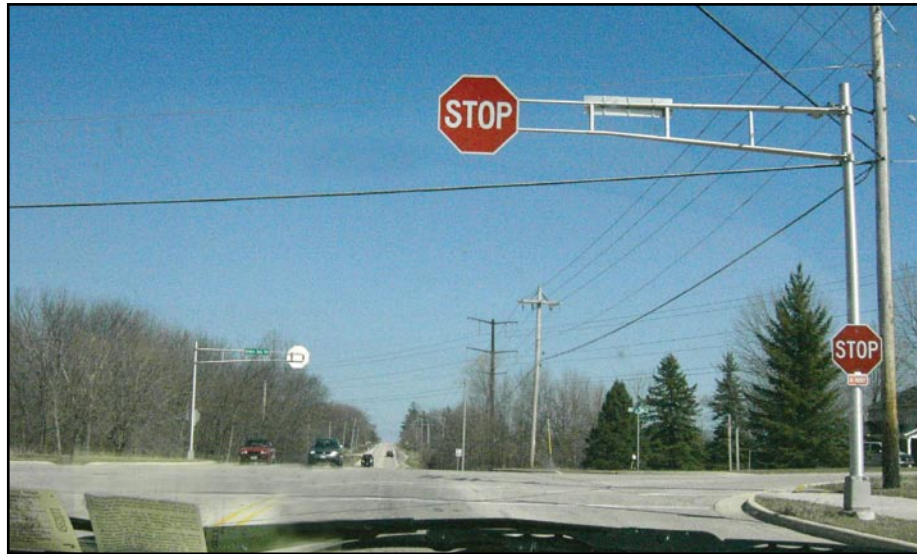
Photo by: Texas Transportation Institute

Many stop signs at stop-controlled intersections are not readily visible to approaching drivers due to geometric conditions, presence of vegetation, or other objects (such as tall vehicles) that can limit the view of the regular stop signs. Thus, intersection crashes may occur because approaching drivers may be unaware of the presence of the stop sign at the intersection. The visibility of stop signs and, thus, the ability of approaching drivers to perceive them, can be enhanced by providing supplementary stop signs suspended over the roadway.

Locate the supplementary overhead sign (or signs) in the direct line of sight of approaching drivers.
