U.S. Department
of Transportation
**Federal Railroad
Administration**

**EFFECTS OF COUPLER HEIGHT MISMATCH
ON THE STRUCTURAL INTEGRITY OF
RAILROAD TANK CAR STUB SILLS**

1. Report No. DOT/FRA/ORD-01/14	2. Government Accession No.	3. Recipient's Catalog No.	
4. Title and Subtitle Effects of Coupler Height Mismatch on the Structural Integrity of Railroad Tank Car Stub Sills		5. Report Date December 14, 2001

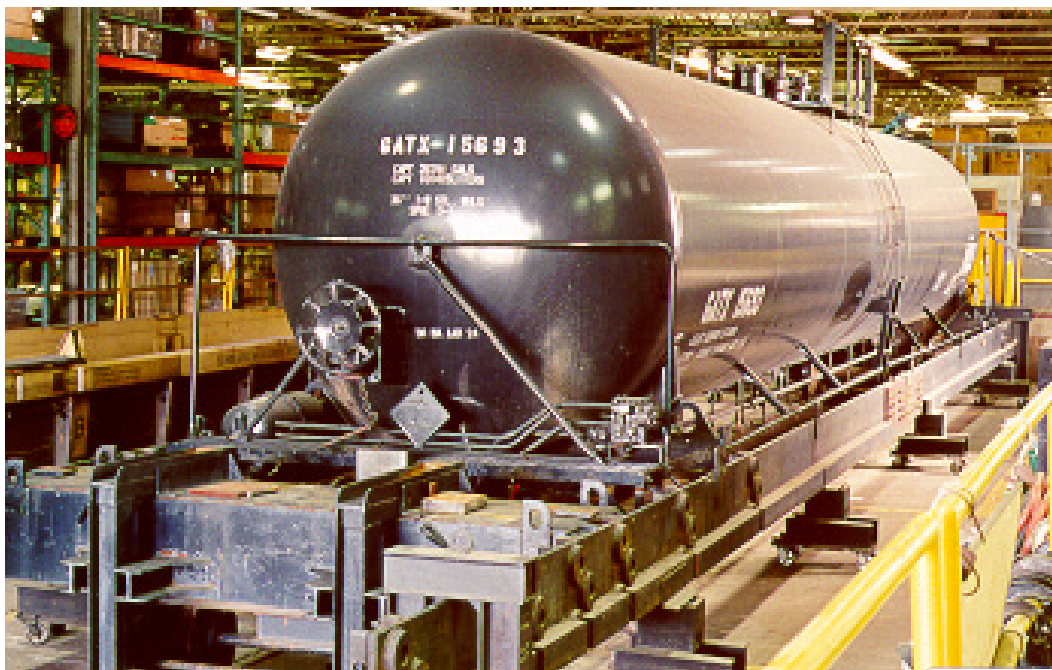
Figure 4. Tank car in the squeeze frame

For this test both draft gears that came with the car were replaced with nullified draft gears. The nullified draft gears were constructed by welding a type 'F' follower plate to the top of a standard draft gear cylinder. A plunger fabricated from a type 'F' coupler shank was used to apply the test load to the solid draft gear. This combination of type 'F' coupler shank and follower plate simulated the AAR required ball end restraint. The truck springs were blocked to align the test car with the test fixture loading ram. The compressive load was provided by a system of five hydraulic cylinders controlled by five control valves, to ensure an even and progressive loading. Load was measured using a precision load cell located between the cylinder ram and the test car plunger. Figure 4 shows the tank car in the squeeze fixture.

These tests were performed at three different loading heights. For the standard height tests, the longitudinal squeeze load was applied directly at the center line of draft. For the next series, the loads were applied 2" below the centerline of draft, at the rear lugs. This was accomplished by adding shims to the lower portion of the draft gear housing base. For the third series the loads were applied 2" above the centerline of draft, at the rear lugs, accomplished by adding shims to the upper portion of the draft gear housing base.

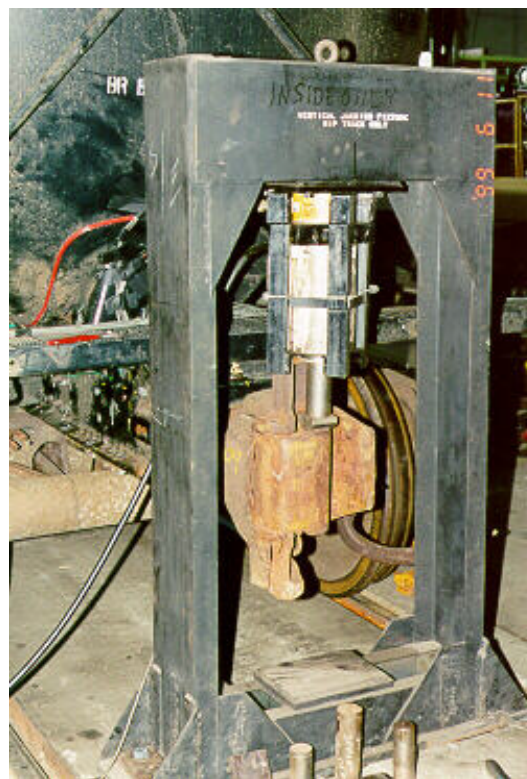
Figure 5. Coupler vertical load test

Coupler vertical load tests were performed on the loaded test car, with vertical loads being applied to the coupler head near the pulling face. Loads in the downward direction were applied using a hydraulic jack and a load frame and measured using a load cell located between the jack and the frame. Figure 5 shows the test setup. Loads were applied in 10 kip increments up to 50 kips and then released to zero load in 10 kip increments. This test sequence was performed twice, followed by another test series with loads applied in the upward direction. All loads were applied at the "A" end (instrumented end) of the test car. Output from the load cell, two displacement transducers, and all forty two (42) strain gage channels, was recorded at each load increment. One displacement transducer was located on the bottom of the striker. The second was located 36" inboard of the striker.

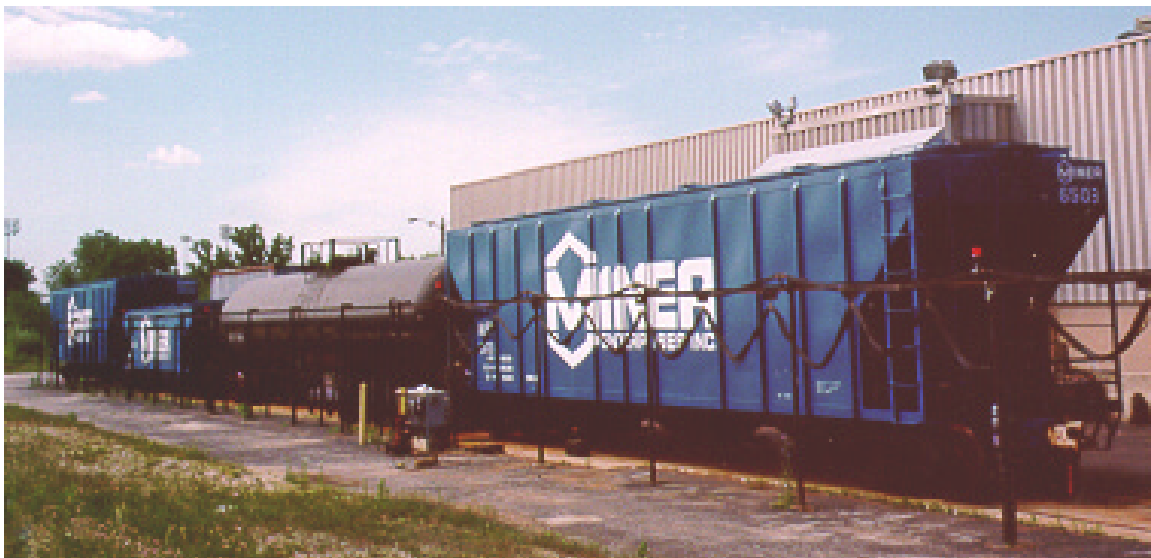
Figure 6. Cars on impact test track

The hammer car was a hopper car loaded to weigh 263,000 lb. There were 2 backup cars behind the tank car weighing a total of 397,000 lb, with hand-brakes applied on the last car (figures 6,7). The tank car, hammer car and backup cars were all equipped with 'E' couplers. The hammer car was accelerated to different impact speeds using an inclined test track (impact ramp). Desired impact speeds were obtained by releasing the hammer car from different heights on the impact ramp. The 'A' end of the tank car was the struck end. The hammer car used a set of M-901 E draft gears for all the tests. The tank car and the backup cars were bunched together after each impact. Height mismatches between cars were achieved by replacing one of the inner truck springs of either the hammer car or the tank car (struck car) with a solid block.

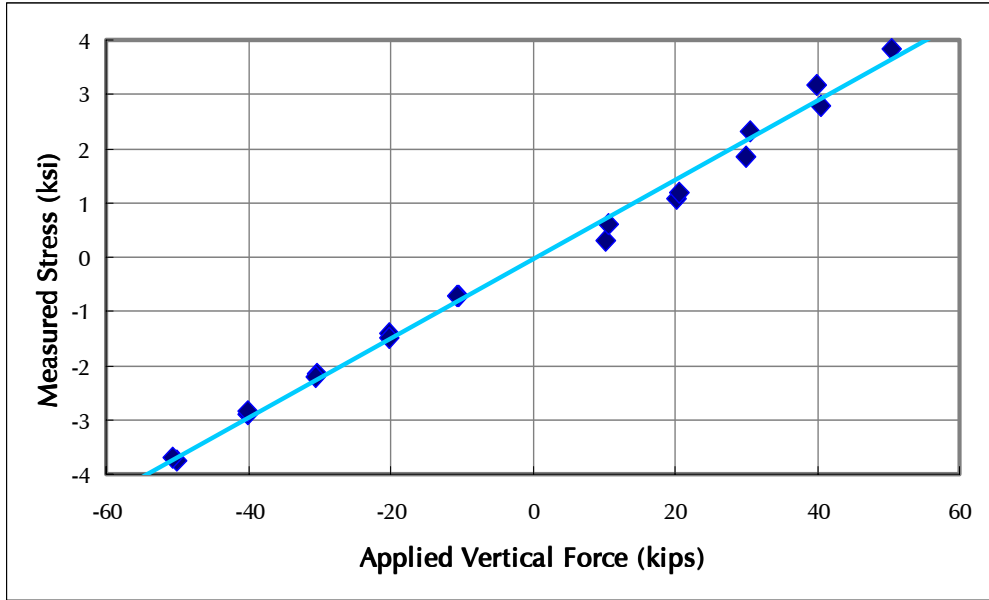
Figure 9. Vertical force calibration - Gage 14

Gages 14 & 15 were calibrated using test data from the static vertical force tests. Figures 9 & 10 show the linearity of gage behavior. The linear fit for both gages had a correlation coefficient greater than 0.99, indicating an excellent fit. The next step was to evaluate cross-talk levels of these gages (14 & 15) under longitudinal forces. The output of the gages under the longitudinal forces applied during the squeeze test was also studied. This curve was almost flat (very small slope) indicating the lack of response of the gages to applied longitudinal force. However, this small slope was taken into account when evaluating vertical force levels during the impact tests. The high level of correlation with applied vertical forces and negligible response to applied longitudinal forces indicates that these gages can be reliably used to measure vertical forces under impact conditions.

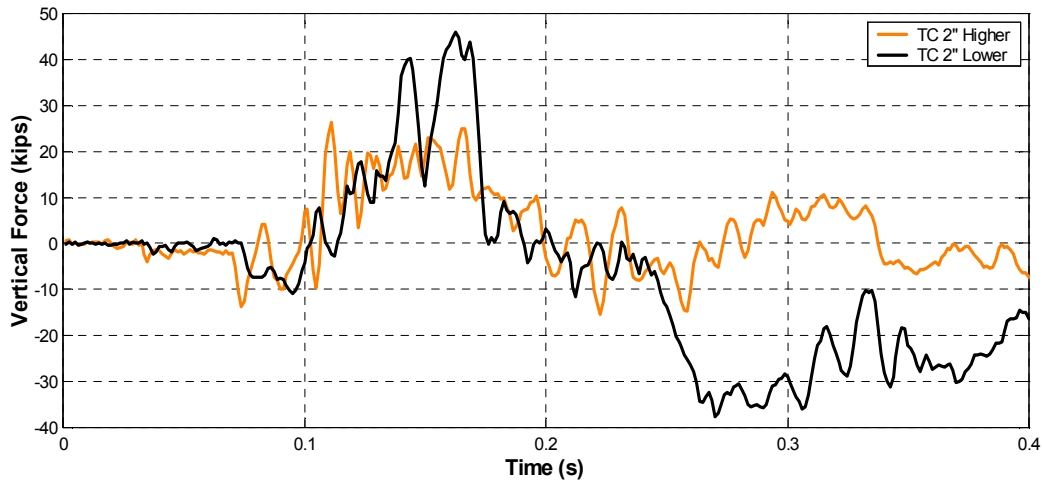
Figure 15. Vertical force comparison - 7.5 mph

Figure 15 shows vertical force traces from 7.5 mph impacts for two different cases of coupler height mismatch. In this instance, the case where the tank car (TC) is 2" higher produces peak vertical forces of 26 kips and 15 kips in the upward & downward directions, respectively. The case where the TC is lower produces peak vertical forces of 46 kips and 38 kips in the upward & downward directions, respectively. Obviously, the case where the tank car is 2" lower gives higher vertical force peaks than when the tank car is 2" higher.

The above trend was seen for most cases with few exceptions. The condition where the tank car is lower almost consistently produces higher peak forces, especially in the downward direction. As previously mentioned (see section 3.1.2), downward vertical forces tend to be more critical than upward vertical forces. Essentially, stresses on the

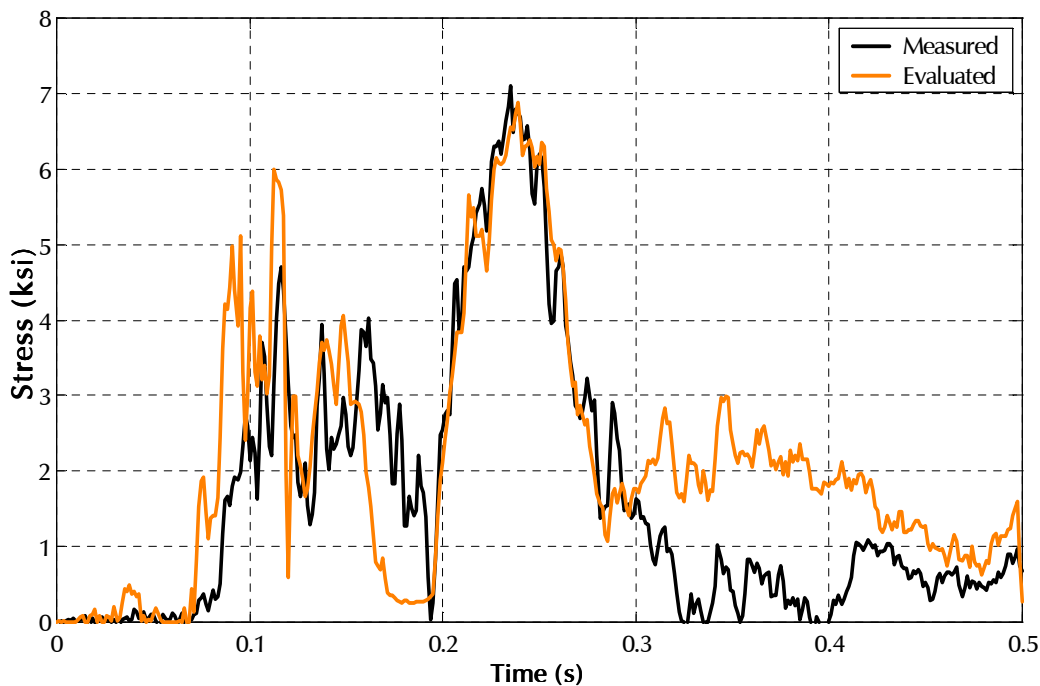
Figure 28. Comparison of stress time histories - Cars level - 4 mph impact

We then developed a mathematical model to evaluate principal stresses at points A & B based on these calibration factors and the measured longitudinal force (instrumented coupler) and vertical force (sill gages) histories. This is a simple model that evaluates stresses purely as a function of the force input. It does not take into full consideration draft gear characteristics, time lag between application and response, or other dynamic factors. However, the model still predicts stress histories that are comparable to the measured values in many cases. Figure 28 shows time histories from measured and evaluated principal stresses at the tank head (location A) for a speed of 4 mph. Figure 29 shows a similar history for a speed of 8 mph. As seen, the model predicts stress histories that are comparable to the measured histories in these cases. Good correlation between measured and evaluated stresses was seen in many cases. This was especially true at higher speeds. However, in some cases, especially at lower speeds the evaluated and measured values did not match up very well. This is because, the low speed performance of draft gears is highly dependent on the stick-slip behavior of the draft gear wedges which is not repeated reliably in impact tests.
