MNMM Fatal 2008-08

- Machinery Accident
- May 3, 2008 (Kentucky)
- Sand & Gravel Operation
- Co-owner
- 51 years old
- 45 weeks experience

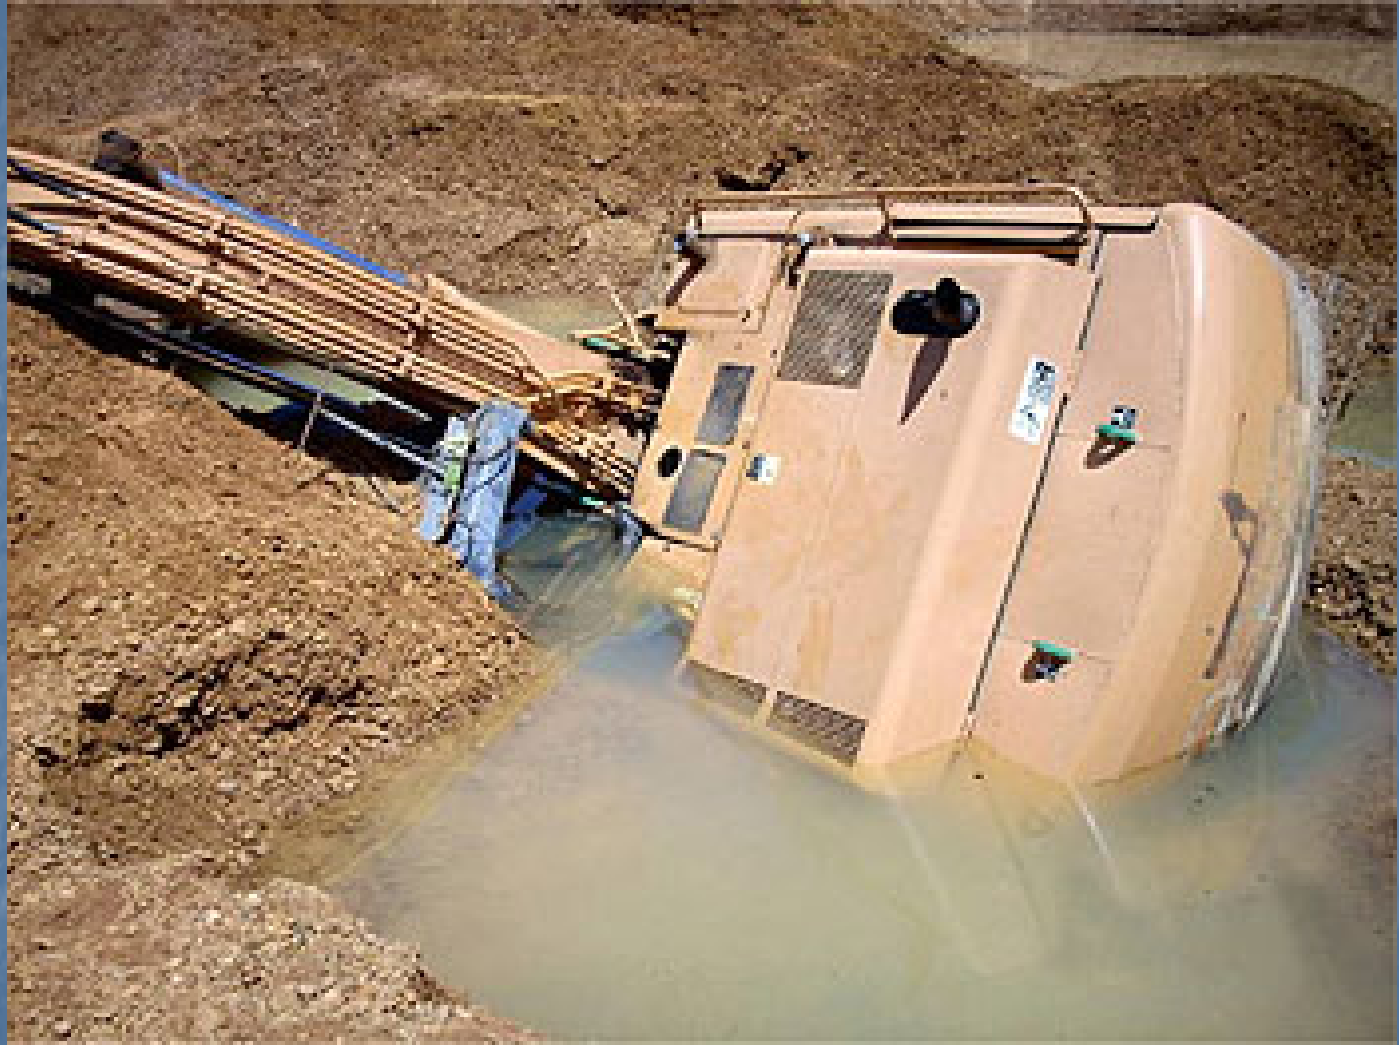
The victim was fatally injured when the excavator he was operating fell into an 8-foot deep sump hole. He was attempting to clean a clogged ditch to drain water from the pit after a recent rain. Sump holes had previously been dug in the pit floor to drain water. The pit floor was covered by several feet of water and the sump holes were not visible.

Management policies and procedures were inadequate and failed to ensure that persons could safely perform tasks when working on the pit floor. Potential hazards were not identified and addressed before performing the task of dewatering the pit.

- Examine working places, identify hazards, and assess and control risks. Be alert to changing conditions. Maintain a safe distance from the edge of excavations and slopes. If the safety of travelways cannot be positively determined, do not travel on them.
- Where hazards in travelways are not clearly distinguishable or immediately obvious, install barriers, markers, or other warning devices to aid equipment operators and limit travel of mobile equipment.
- Ensure all miners are trained to recognize workplace hazards, specifically the limited visibility inherent to the operation of large equipment.
- Wear seat belts when operating self-propelled mobile equipment.
