MNMM Fatal 2008-01

- Fall of Person Accident
- January 21, 2008 (California)
- Cement Operation
- Contractor Truck Driver
- 58 years old
- 3 years experience

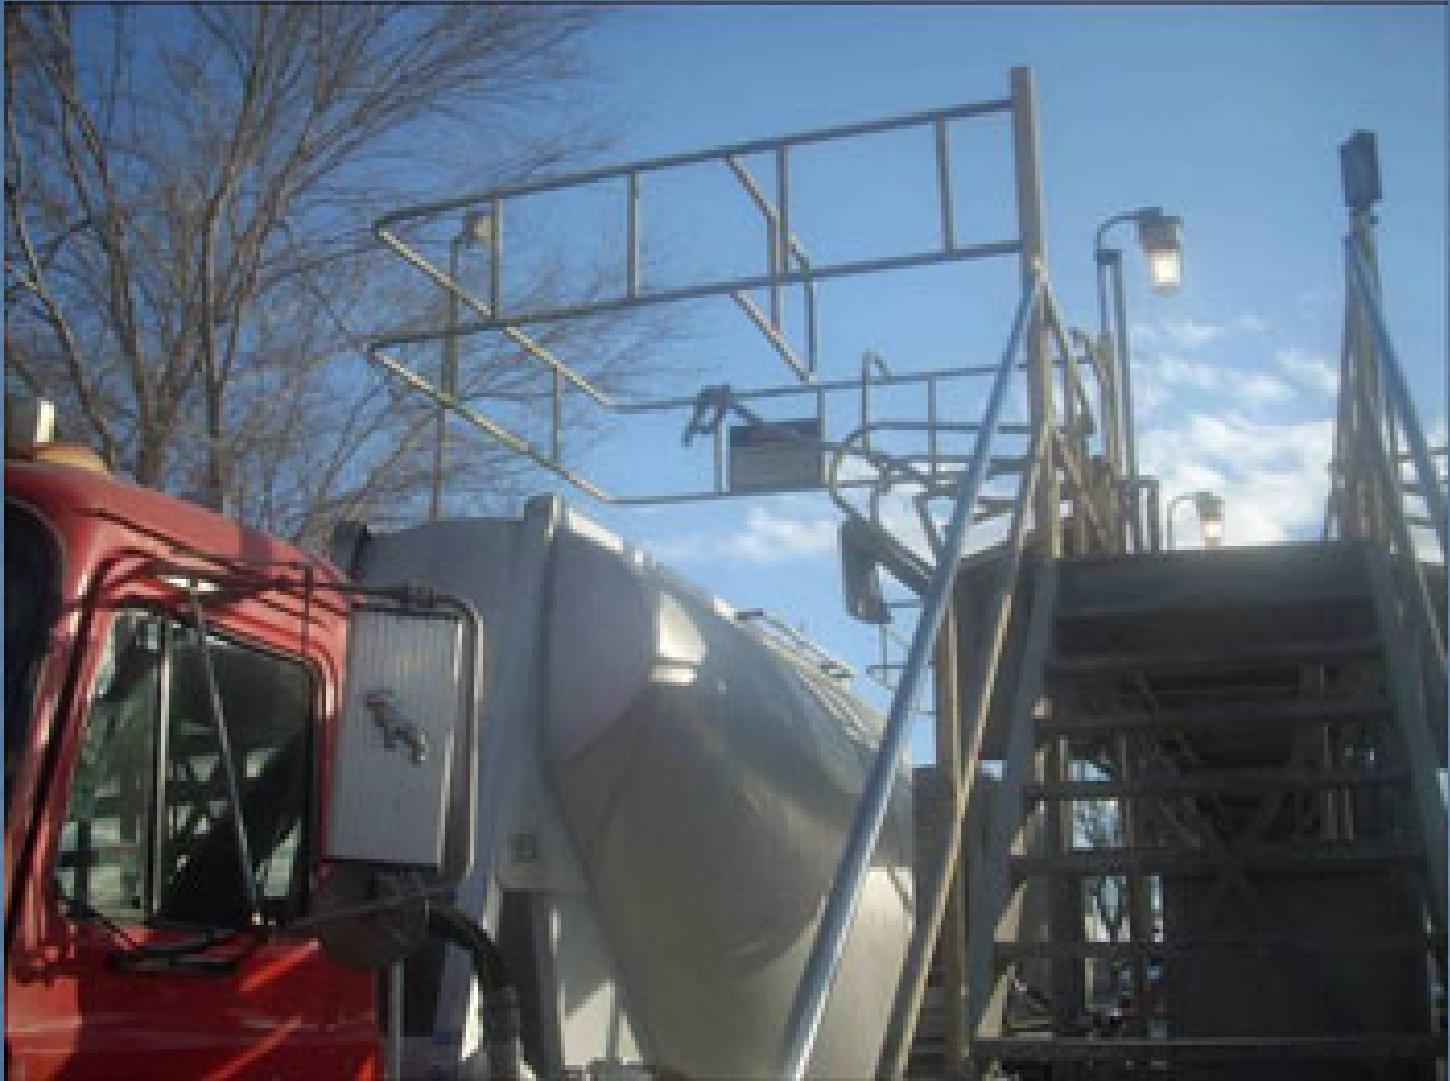
The victim was fatally injured when he fell from the top of a bulk cement trailer to the ground below. He was on top of the trailer closing and securing the hatches after the trailer was loaded with cement.

- Management did not provide equipment or establish policies and procedures to ensure contract truck drivers could safely open and close the hatches on their bulk trailers.

- Discuss work procedures; identify all potential hazards; and ensure the job is done safely. (SLAM) Stop, Look, Analyze, and Manage.
- Train all miners to recognize hazards from falling and ensure that safe work procedures are discussed and established.
- Ensure that persons wear fall protection where there is a danger of falling.
- Establish traffic patterns that ensure safe alignment of vehicles with access equipment.
