Prepared in cooperation with the  
Florida Department of Environmental Protection and the  
Northwest Florida Water Management District

## **Drier Forest Composition Associated with Hydrologic Change in the Apalachicola River Floodplain, Florida**

Scientific Investigations Report 2008-5062

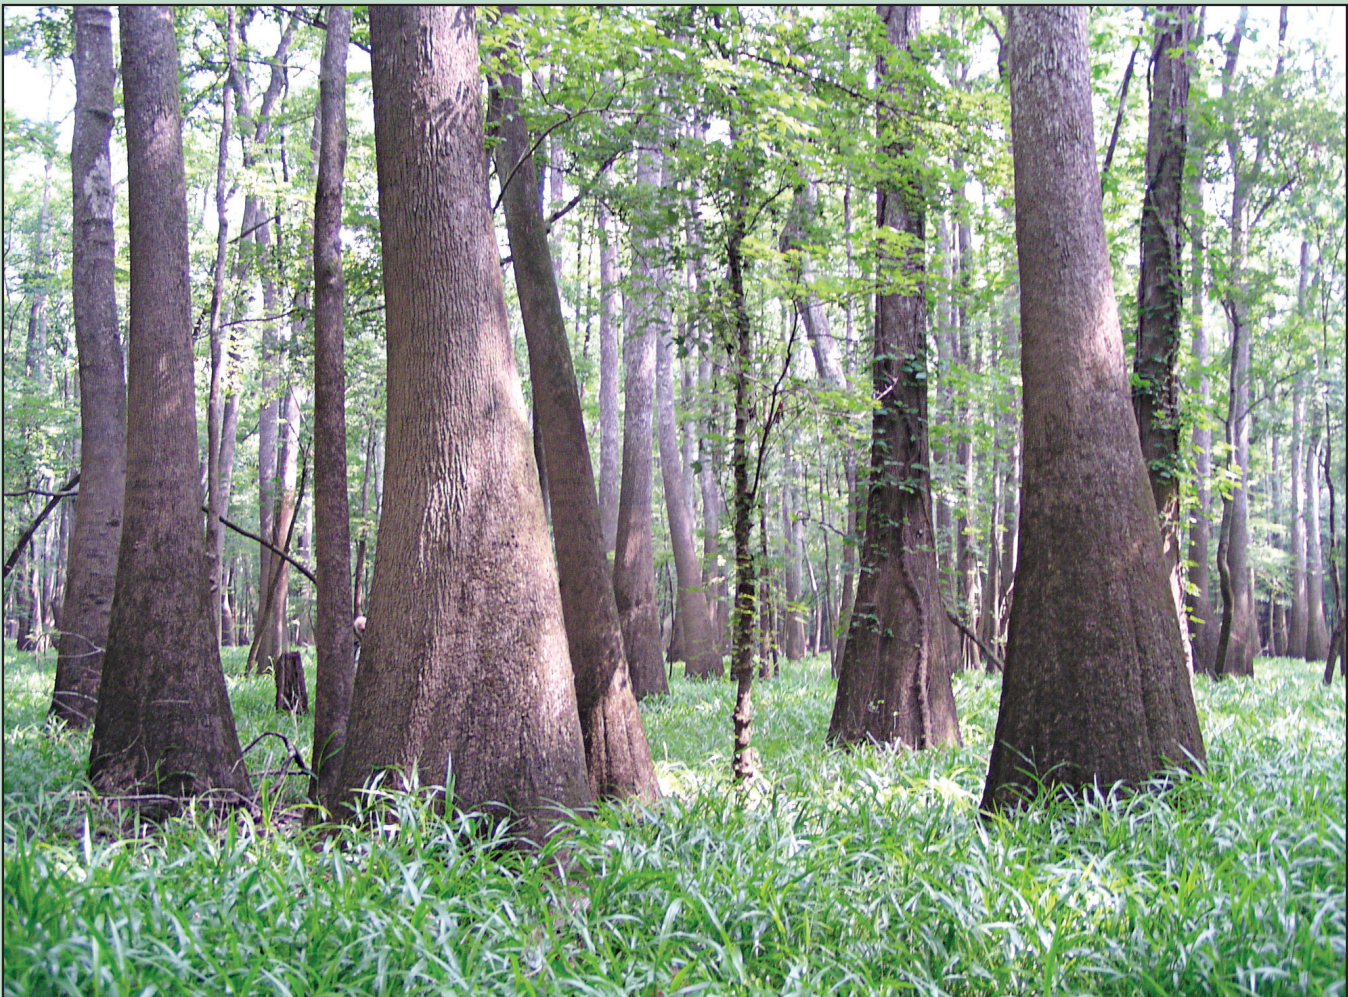
*Cover photo—*

Perennial grasses growing on the swamp floor of the *Torreya* transect on the Apalachicola River floodplain in June 2006. In September 1979, the same area was described by Helen Light as having “absolutely no ground cover.” Grasses and sedges may be much more abundant in swamps today, because flood durations are shorter and trees are less dense than in 1979. *Photograph taken by Lee Reed*
