# Structural Testing of 9 m Carbon Fiber Wind Turbine Research Blades

*To be presented at the AIAA 2007 Wind Energy Symposium  
Reno, Nevada  
January 8–11, 2007*

**Conference Paper**  
**NREL/CP-500-40985**  
**January 2007**

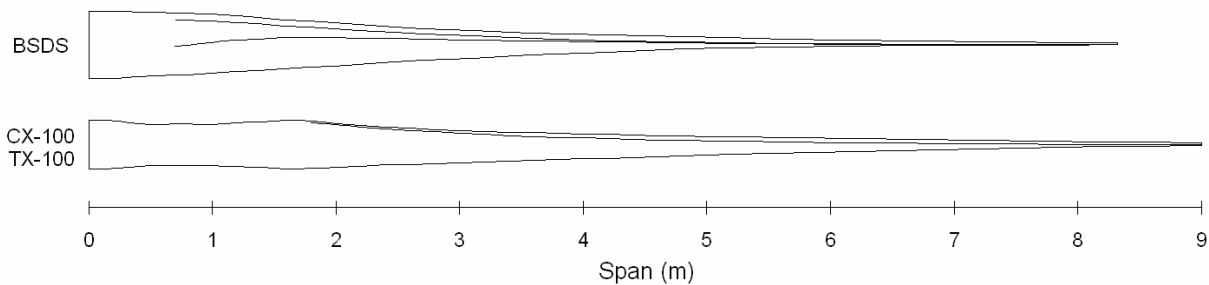
**Figure 2: 9 m blade geometries as viewed from the trailing edge.**

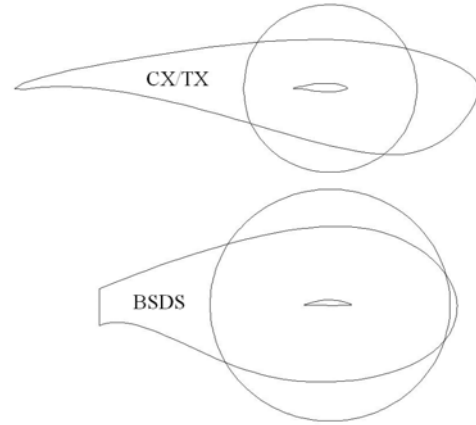
Figure 3: 9 m airfoil geometries at root, max-chord, and tip.

Figure 3 shows the airfoil geometries and relative sizes at the root, max-chord, and tip of the CX-100, TX-100, and BSDS blades. Note that in the figure the airfoils are shown without pre-twist. The BSDS blade can be seen to have a larger root diameter while also having a shorter max-chord length. The tip airfoil of the BSDS blade is representative of the outboard airfoils in the blade which are thin and aerodynamically high performing.

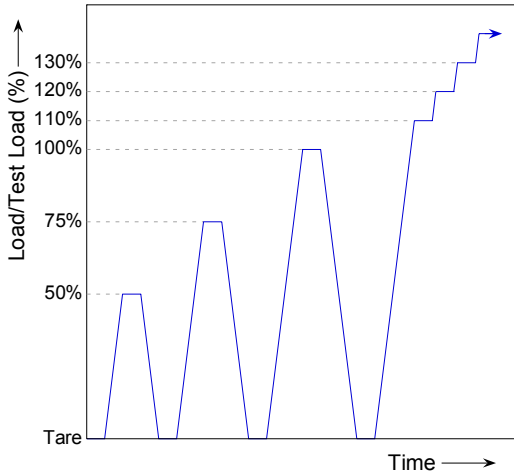
**Figure 6: Loading sequence for 9 m blade tests.**

The blades were loaded and unloaded in increasing 25% increments up to the 100% test load as shown schematically in Figure 6. At each load step, the load was held for approximately 60 s. The 100% test load was calculated by multiplying the design load distribution for each blade by 1.10 to account for test-to-test variability. The resulting distribution was then approximated with a piece-wise linear fit achieved by point loads applied at the three saddle locations. The desired and applied test moment distributions for the CX-100, TX-100 and BSDS blade tests are shown in Figure 7, Figure 8, and Figure 9

respectively. After reaching the 100% test load, loads were increased in 10% increments and held for 60 s until failure occurred (see Figure 6).

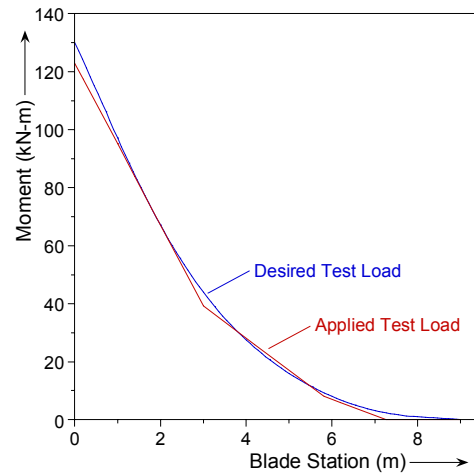
**Figure 7: CX-100 test loading distribution.**

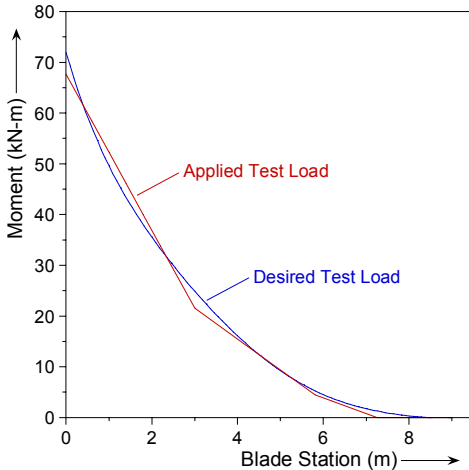
**Figure 8: TX-100 test loading distribution.**

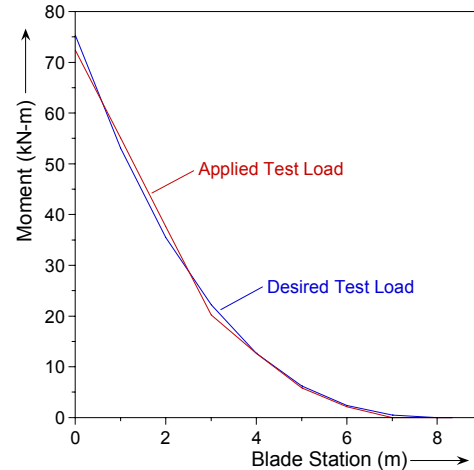
**Figure 9: BSDS test loading distribution.**

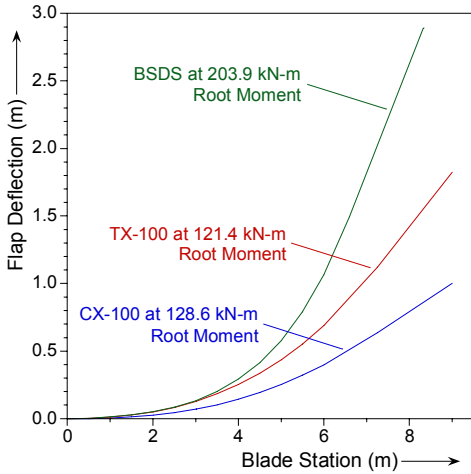
**Figure 10: Maximum deflections for 9 m blades.**

All three blade designs successfully withstood the prescribed test loads. Figure 10 shows the maximum deflections that were measured in the three blade tests along with the corresponding root moments. The deflections are the result of a polynomial fit of the string pot results. The maximum tip deflections for the CX-100, TX-100, and BSDS blades were 1.05 m, 1.80 m, and 2.79 m respectively. Figure 11 compares the deflections at a root moment of 100 kN-m. The results show that the CX-100 blade was significantly stiffer than the TX-100 and BSDS blades.

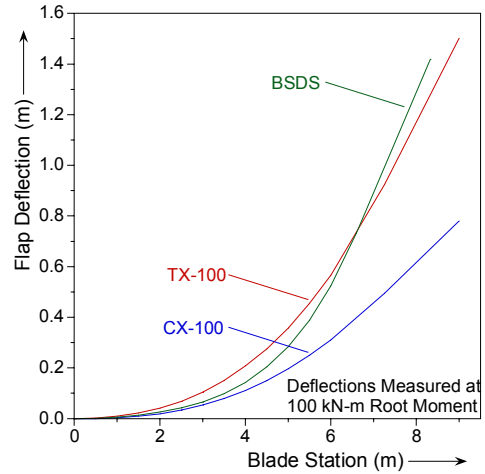
**Figure 11: 9m blade deflections at 100 kN-m root moment.**

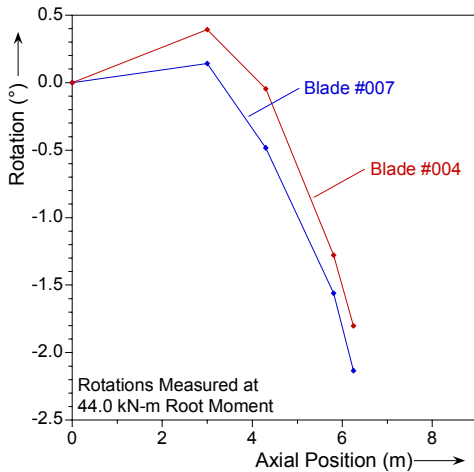
**Figure 12: TX-100 #004 and #007 twist angles at 44 kN-m root moment.**

The rotation angles about the spanwise axis at different stations of the TX-100 blade were measured during the test. The measurements were taken both from leading edge and trailing edge mounted string pots, and inclinometers mounted along the blade centerline. A positive angle corresponds to an increasing angle of attack for the airfoil at a given station. Figure 12 shows the twist angles that were measured at a 44.0 kN-m root moment in the test of blade #004 (blade with added material) and blade #007 (blade without added material) of the TX-100 blade set. Blade #004 did not twist as much as blade #007 at the same load. This provides evidence of the effect that the extra leading material had on blade #004. Figure 13 shows the rotations measured along blade #004 at the 100% test load and at the failure load. The TX-100 blade showed a maximum twist of about  $-5^\circ$  at the 6.25 m station for a root moment of 116.9 kN-m.

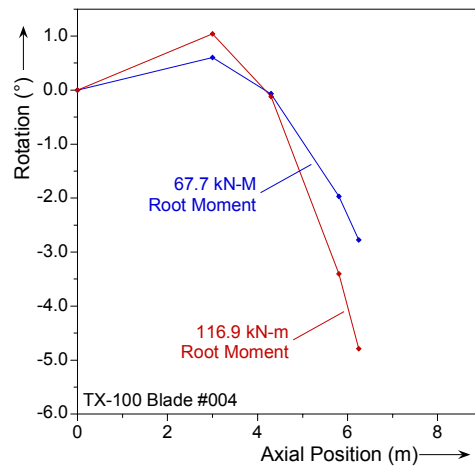
**Figure 13: TX-100 #004 twist angle at test load and near failure.**

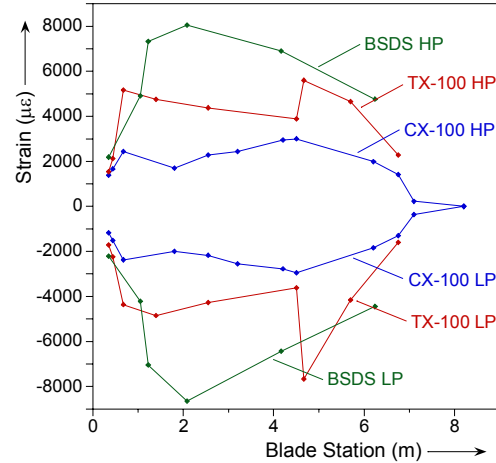
Figure 14: 9 m spar cap strains near failure.

Figure 14 shows the strains that were measured along the high-pressure and low-pressure spar caps for the three blades that were tested. Note that for the TX-100 blade, the spar cap terminates at the mid-span of the blade and thus strains outboard of that point are along the blade centerline. The carbon spar cap of the CX-100 blade experienced strains of around  $3000 \mu\epsilon$  before failure. The TX-100 blade exhibited maximum strains of approximately  $5500 \mu\epsilon$  near the termination point of the spar cap and strains elsewhere in the blade were generally lower. The high strain at the spar cap termination was likely the result of a stress concentration emanating from the tapered end of the spar cap (see Figure 1). The carbon spar cap of the BSDS blade experienced maximum strains of over  $8000 \mu\epsilon$  on both the high-pressure and low-pressure surfaces.

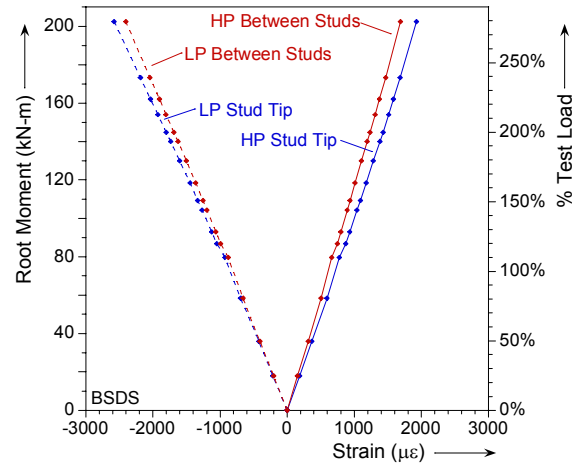
Figure 18: BSDS threaded rod strains.

Also of interest for the BSDS blade was the behavior of the root mounting studs. A novel root mounting stud design was implemented into the BSDS blade. The installation of the root mounting fasteners was integrated into the laminate infusion. Gages were placed near the tip of the most highly loaded root studs on the upper (low pressure) and lower (high pressure) surfaces. Gages were also placed at the same spanwise stations but between the root studs in the circumferential direction on the blade surface. Figure 18 shows the strain at these locations with respect to applied load. The resulting strains are relatively similar in magnitude and linear throughout the loading, indicating that the implementation of the root studs did not cause a significant stress concentration, with a relatively smooth load path between laminate and root stud. The root area was not observed to exhibit any signs of damage throughout testing.

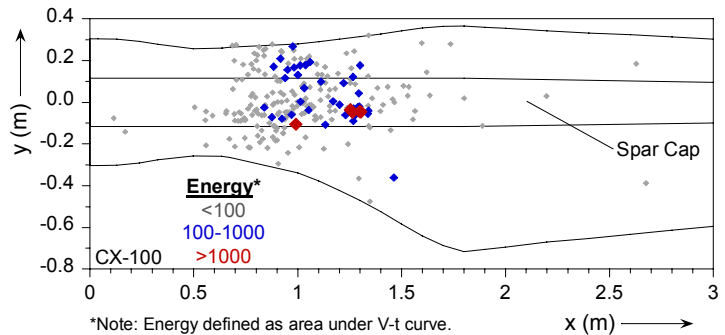
Figure 20: Acoustic event locations and energies for CX-100 blade test.

where  $a$ ,  $b$ , and  $n$  are fitting constants and  $\alpha$  is the angle between the direction vector from the sensor to the event and the blade pitch axis. The resulting located events for the CX-100, TX-100, and BSDS blade tests are shown in Figure 20, Figure 21, and Figure 22 respectively. Each event is color coded with a respective energy range. It should be noted that this energy is not the true energy, as it represents the integral of the voltage vs. time curve. The true energy is defined by the integral of the voltage squared vs. time curve. These voltage vs. time results are useful for comparative

purposes however. The events are overlaid on outlines of each blade. Since the locations of the acoustic events are two-dimensional, the outlines are of the flattened low-pressure skins of the blades. In addition to the outlines of the blades, important regions such as spar caps and material boundaries are shown.

During the CX-100 test, several high-energy events were located between 1.20 m and 1.30 m along the spar cap. The CX-100 blade was observed during failure to experience a catastrophic buckling of the low-pressure skin near the 1.2-m station. A post mortem inspection of the blade in this region showed a large crack in the bond joint between the low pressure skin and the shear web. A photograph of the crack is shown in Figure 23.

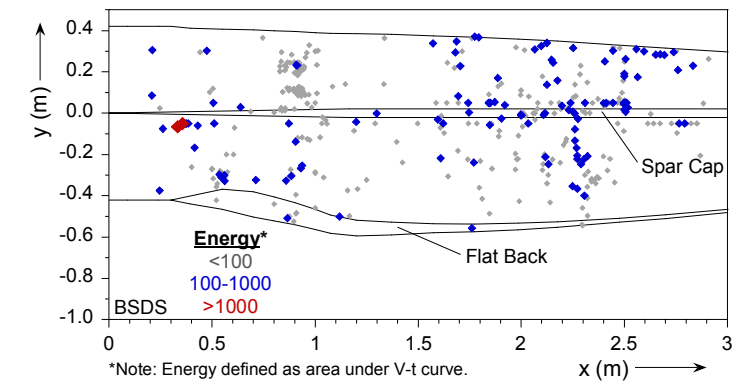
**Figure 22: Acoustic event locations and energies for BSDS blade test.**

During the BSDS test, the only high-energy events were located around 0.350 m, which is the station where the shear web terminates on the root end. A closer examination of this area after the test showed that a large crack had developed between the low-pressure skin and the shear web in the bonding joint. A photograph of the crack is shown in Figure 25.

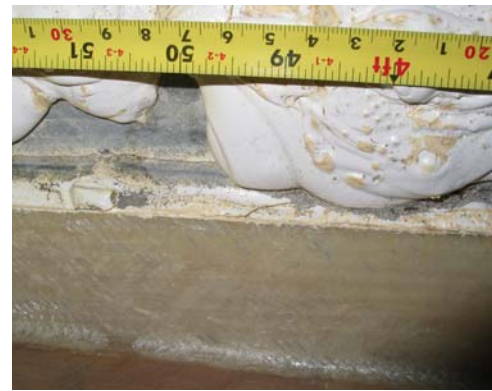
**Figure 23: Crack in shear web to LP skin bond joint at 1.20-1.30 m on the CX-100 blade.**

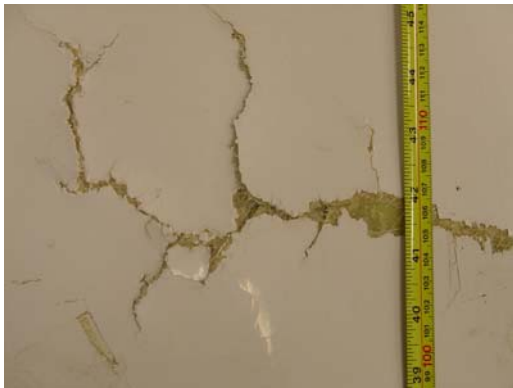
**Figure 24: Crack near blade centerline on TX-100 blade.**

The TX-100 blade test produced high-energy events just beyond the 1.00 m station. The blade eventually failed at the 1.0-m station, with a failure described as a buckling of the compressive skin, initiated towards the leading edge. A photograph of the fracture is shown in Figure 24.

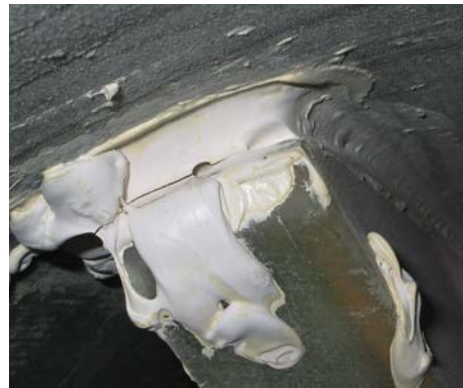
**Figure 25: Crack at shear web termination on the LP surface of the BSDS blade.**

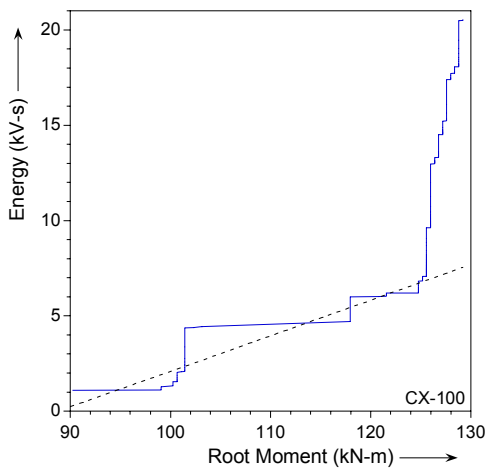
**Figure 26: CX-100 acoustic energy accumulation.**

In addition to indicating the location of damage occurring within a blade, acoustic emission monitoring is also a valuable tool for assessing when failure is occurring locally or globally. Figure 26, Figure 27, Figure 28, show the sum of the acoustic emission energy detected by all of the sensors in the root region of the CX-100, TX-100, and BSDS blades respectively. In each plot a trend line is drawn through the initial linear portions of the response. At some load, the response begins to become non-linear, indicating an acceleration of the acoustic emissions and the greater potential of failure. For the CX-100 and TX-100 blades, the acoustic emissions accelerate rapidly beyond root moments of 125 kN-m and 115 kN-m respectively. The response from the BSDS blade remained mostly linear until a root moment of 140 kN-m was reached. The accumulation of acoustic energy in the BSDS blade did grow non-linearly after 140 kN-m, although not as rapidly as for the other two blades.

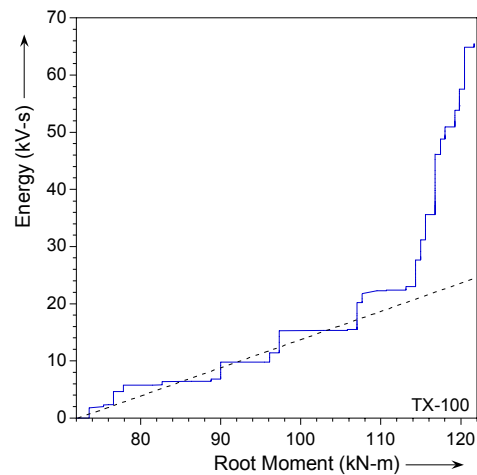
**Figure 27: TX-100 acoustic energy accumulation.**
