U.S. Department  
of Transportation  
**Federal Railroad  
Administration**

# Thermal Protection Study of Cryogenic Tank Cars

1. Report No. DOT/FRA/ORD-85/12		2. Government Accession No.		3. Recipient's Catalog No.	
4. Title and Subtitle THERMAL PROTECTION STUDY OF CRYOGENIC TANK CARS				5. Report Date May 1985

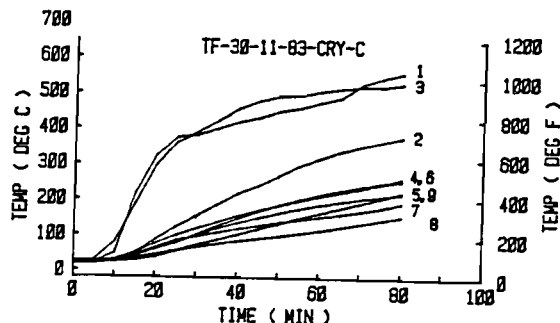
Figure 9: Pool Fire Test on Perlite with Nonevacuated Panel

An unmodified panel of perlite, was tested in the pool fire environment for 100 minutes (TF-30-11-83-CRY-C). The temperatures are shown in Figure 9. After a short interval of about 5 minutes, the upper thermocouples (Numbers 1, 2, and 3) had begun losing thermal protection due to perlite falling into the bulge. The remaining thermocouple measurements gradually increased, thus indicating the maintenance of a protective layer of perlite. None of the temperatures from these protected thermocouples exceed 316 °C (600 °F) at the end of 100 minutes.

TF-30-11-83-CRY-C was the only test conducted for the full 100 minutes as would have been required if an actual insulation evaluation program were in progress. But, based on the data and various factors concerning the test setup, it appeared that only qualitative conclusions concerning insulation characteristics could be realized and thus testing for more than 50 minutes would not be worthwhile for the following reasons. First of all, the densities of
