# Fire Tests on Insulation for Aluminum Tank Cars

An evaluation of glass fiber, ceramic  
fiber, and mineral fiber materials in  
torch-fire and pool-fire environments

1. Report No. DOT/FRA/ORD-87/04	2. Government Accession No.	3. Recipient's Catalog No.	
4. Title and Subtitle <b>Fire Tests on Insulation for Aluminum Tank Cars</b>  An evaluation of fiber glass, ceramic fiber, and mineral fiber materials in torch-fire and pool-fire environments		5. Report Date August, 1987

14. Sponsoring Agency Code	
15. Supplementary Notes			
16. Abstract  <p>Tests were conducted at the Transportation Test Center to determine the vulnerability to fire of aluminum tank cars designed to transport hazardous materials under pressure when the aluminum was protected by three types of insulation. Glass, mineral, and ceramic fiber blankets, each covering a specimen of aluminum plate commonly used in tank car construction, were subjected to standard torch-fire and pool-fire tests while instrumentation recorded the rise in temperature of the aluminum plate. The tests were conducted per the procedures described in CFR Title 49, Part 179.105-4, "Thermal Protection," with the exception that the aluminum plat

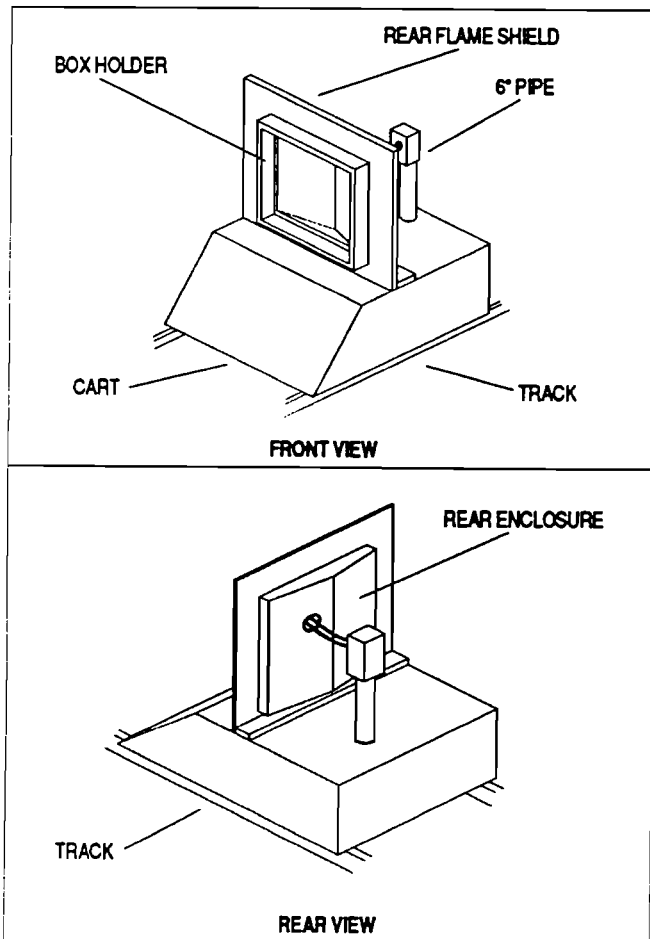
Fig. 1: Front and rear views of the test cart and specimen holder as used in the torch tests.

The test cart is a tracked vehicle used to carry the insulation system and its holder to the desired distance from the torch nozzle (Figure 1). By moving the test cart to within a nominal 12 ft. of the torch nozzle, the stage is set for a torch-fire simulation test. Likewise, by moving the cart to approximately 21 ft. from the torch nozzle, the arrangement is in position for a simulated pool fire test.

The test specimen holder is mounted vertically on top of the test cart, as shown in Figure 1. The holder is designed to accept a 4 ft. square bare plate or a

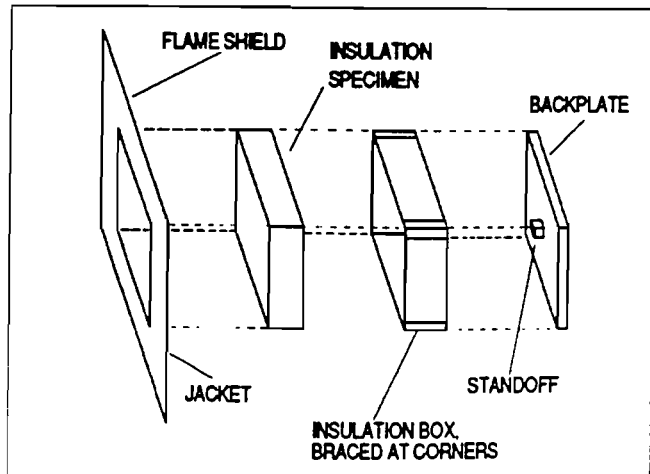
Fig. 2: Exploded view of the specimen holder, showing the backplate, standoff, insulation box and insulation sample, jacket, and flame shield.

multiple-component insulation system (Figure 2). The holder consists of a holder box or spacer, a rear flame shield, and a rear enclosure with double access doors.

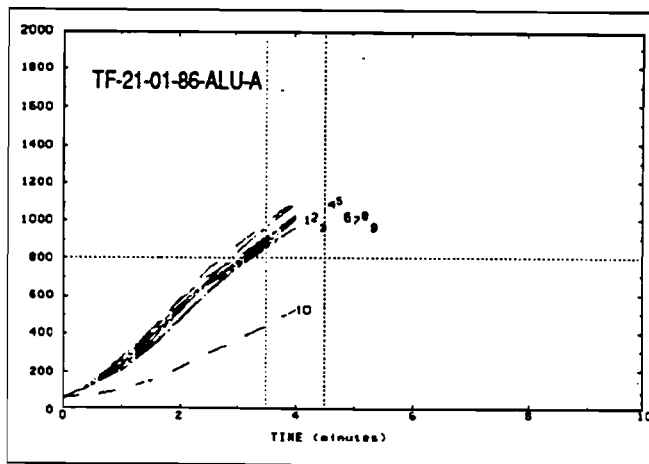
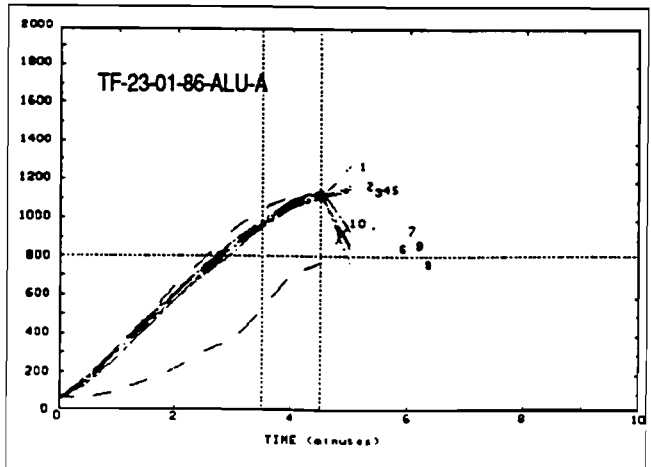
Figs. 3 (top) and 4: Results of the torch fire simulations on uninsulated aluminum plate. Vertical axes in these and all similar plots is deg. F.

Figures 3 through 7 illustrate the rapid temperature rise and resultant failure of the bare aluminum plate in each test. A new aluminum plate specimen was installed for each of the five tests.

Results of the torch fire simulation tests are presented in Figures 3 and 4. The nozzle-to-specimen distance was 11 ft. 3 in. The high-temperature flame caused the plates to exceed the 800 deg. F limit within 3 min. of the start of the tests, 27 min. short of the CFR requirement.

The torch was shut off just before reaching the minimum melting temperature of the aluminum, so that the plate's physical condition could be checked. The post test examination revealed that the center area of the plate was slightly pushed in or concave, by

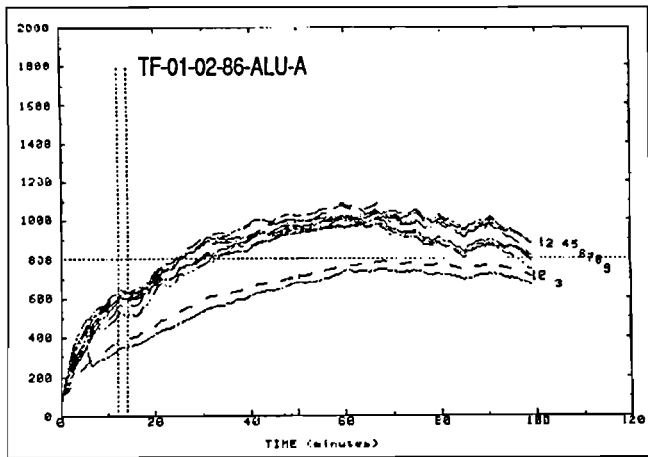
Figs. 5, 6 and 7: Results of the pool fire simulations on uninsulated aluminum plate. See text for description of the data.

Results from the pool fire simulation tests are presented in Figures 5, 6, and 7. The nozzle-to-specimen distance was 20 ft. 9 in. The lower temperature "pool" flame allowed the aluminum plates to survive through two of the three 100-min. pool fire tests.

In the first pool fire test (Figure 5), the plate exceeded the 800 deg. F limit 24-1/2 min. into the test.

All backplate thermocouples rose uniformly in temperature except one. The lag in temperature rise of thermocouple No. 3 throughout the test indicates that it was not functioning properly.

Wind velocity fluctuated between 2 and 10 m.p.h. throughout the test and caused some problems in maintaining constant flame contact with the plate. The wind influence is displayed in thermocouple No. 5 (center of plate), which reached a high of 1,075 deg. F about one hour into the test, but then cooled off to 870 deg. F by the end of the test. Based on the results of the next test (Figure 6), constant flame contact would have melted this plate.

At post test inspection, it was noted that the

aluminum plate specimen exhibited only slight warpage, with no other damage being visible.

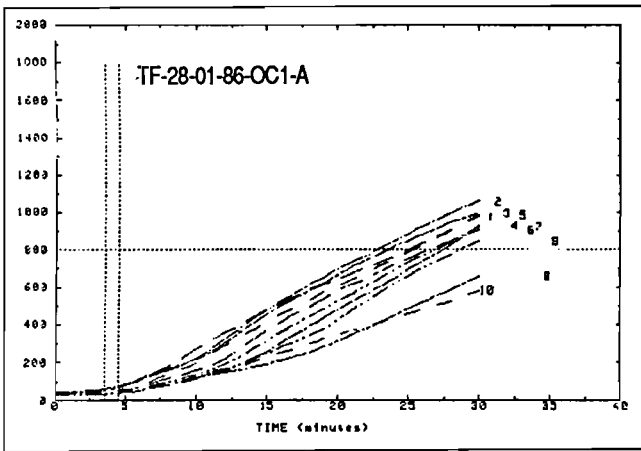
Fig. 8: First torch fire simulation of aluminum plate insulated with glass fiber.

The high-temperature flame caused the backplates to exceed the 800 deg. F limit before the required 30-min. duration; one test (Figure 8) exceeded the limit at 23 min., the other at 19 min.

In the first test (Figure 8), the temperature at eight

of the nine backplate thermocouples rose fairly uniformly. The temperature at thermocouple No. 8 began to rise much more slowly from 12 min. into the test until the end, however.

The post test examination revealed that the glass fiber blanket had fallen down and around the aluminum dowel that supported the oak standoff cube at the center of the backplate. The remains of the insulation blanket were found mostly at the center bottom of the holder frame, protecting the area instrumented by thermocouple No. 8. The oak cube was burned and charred, with its remains having fallen to the bottom of the insulation box. The appearance of the aluminum plate was quite good, with no warpage noted.

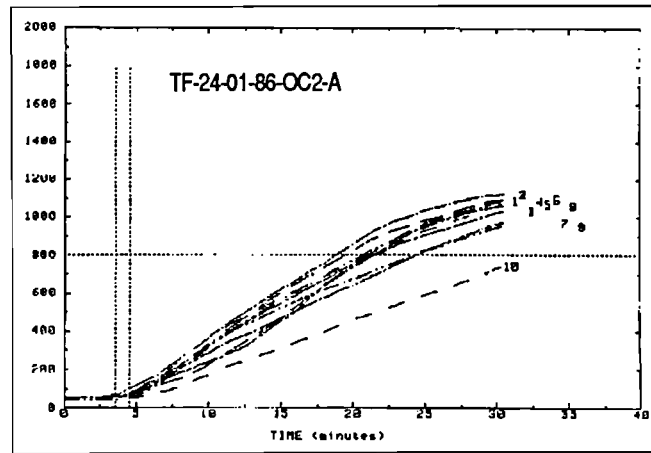
Fig. 9: Second torch fire test of aluminum plate insulated with glass fiber.

The second test, Figure 9, produced much the same result as did the first, although thermocouple No. 8 did not lag behind the others. The post test examination again revealed that the insulation blanket had slumped down and that the oak standoff cube had burned and fallen to the bottom. Appearance of the aluminum plate was good, but slight warpage was visible.

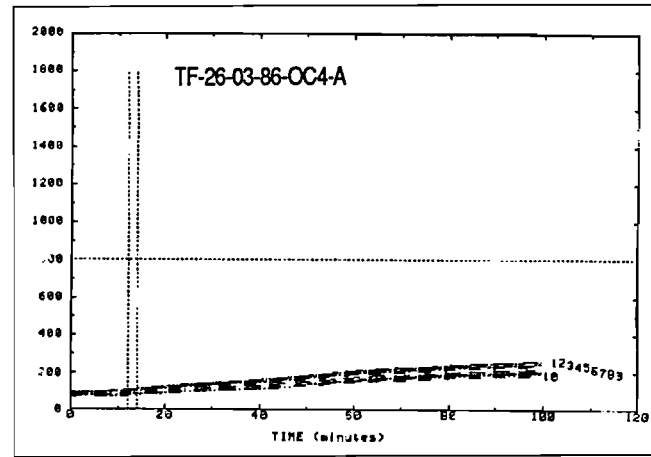
Fig. 10: First pool fire simulation with the glass fiber insulation. Wind conditions kept temperatures low.

In the first pool fire test (Figure 10), the temperature at the backplate reached a high of only 262.5 deg. F (at thermocouple No. 2) at the end of the test. Wind conditions were somewhat disruptive throughout the test, changing from 1 m.p.h. to higher than 10 m.p.h. Problems with the wind were also evidenced by the somewhat cool front jacket temperatures, which reached no higher than 1,000 deg. F during the test (Appendix A).

Post test examination of the glass fiber revealed that it was fully in place over the plate and in good physical condition. Only the surface against the hot jacket had discolored to a white appearance. The oak standoff cube was also in relatively good condition, with one darkened surface. The aluminum backplate never reached 300 deg. F and was in like-new condition.

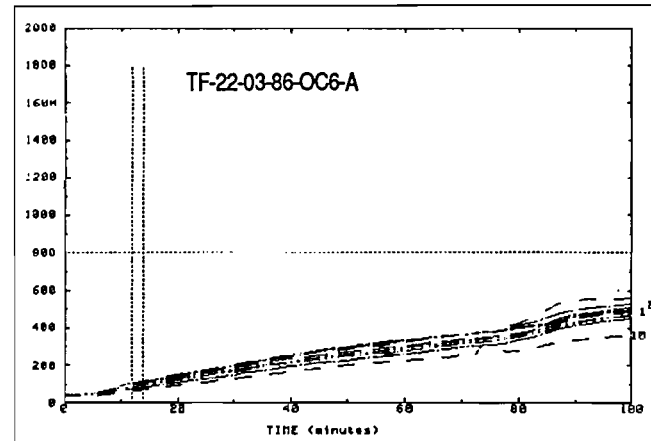
Fig. 11: Second pool fire test of glass fiber insulation, conducted in near-perfect wind conditions.

The second pool fire test (Figure 11) was a more severe test of the aluminum specimens insulated with glass fiber than was the first. Wind conditions were perfect due to a prevailing north wind that averaged only 4 mph. The backplate temperature graph

indicates that the temperatures at all thermocouples rose uniformly, with the center thermocouple (No. 5) being the hottest, reaching a maximum of 559.6 deg. F. This temperature was still well below the 800 deg. limit of the CFR standard. Jacket temperatures (Appendix A) reached a high of 1,331 deg. F, well above those in the previous test.

Post test inspection revealed that the glass fiber

was fully in place over the aluminum plate and, aside from discoloration on the jacket side, was in good physical condition. The oak cube was darkened on one surface. The aluminum plate appeared to be in like-new condition.

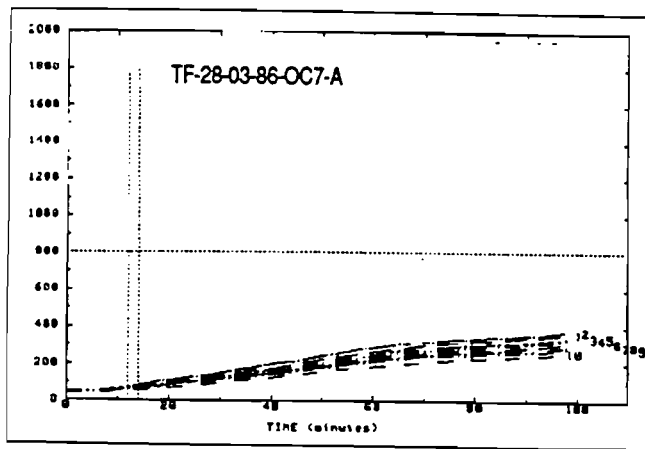
Fig. 12: Final pool fire test with glass fiber insulation, which was conducted in adverse wind conditions.

The third and final pool fire simulation test (Figure 12) was conducted in less-than-perfect wind conditions. Wind speeds changed constantly and abruptly between 4 and 8 m.p.h., interfering with constant flame contact on the jacket. However, the backplate temperatures rose to a higher final value than they did in the first test, with 376.9 deg. F being recorded by thermocouple No. 2. Jacket temperatures (Appendix A) reached a high of 1,137 deg. F, about 200 deg. below the second test and 200 deg. above the first.

Post test inspection of the insulation system revealed that the glass fiber was fully in place over the plate and in good condition. The aluminum backplate never reached 400 deg. F and was in like-new condition.

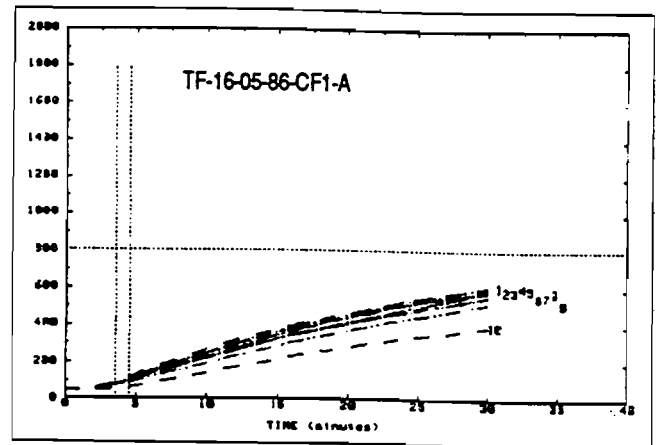
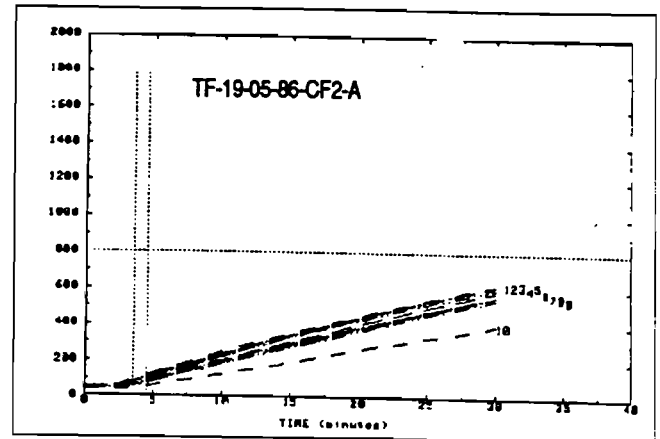
Figs. 13 and 14: Torch fire simulation tests on aluminum plate insulated with ceramic fiber.

The results of the torch fire simulation tests are presented in Figures 13 and 14. The nozzle-to-specimen surface distance was calibrated at 11 ft. 3 in. The ceramic fiber insulation performed very well in a torch fire environment, protecting the aluminum plate and surpassing the CFR standard in both tests.

end of the first test was 612.5 deg. F (at thermocouple No. 1). The highest recorded in the second test was 624.1 deg. F (thermocouple No. 3), well below the 800 deg. F limit and very good for such thin material.

The post test examination revealed that the blanket was fully in place over the aluminum plate and in like-new condition. The aluminum plate was also undamaged.

The second test (Figure 14) again shows the temperatures at all nine backplate thermocouples rising uniformly and in a virtually straight line on the chart. Jacket temperatures were also very uniform and reached a high of 1,726 deg. F near the end of the test. The result was a good, representative torch fire test.

The post test examination again found the blanket fully in place and that the aluminum backplate had

been well protected and was in like-new condition.

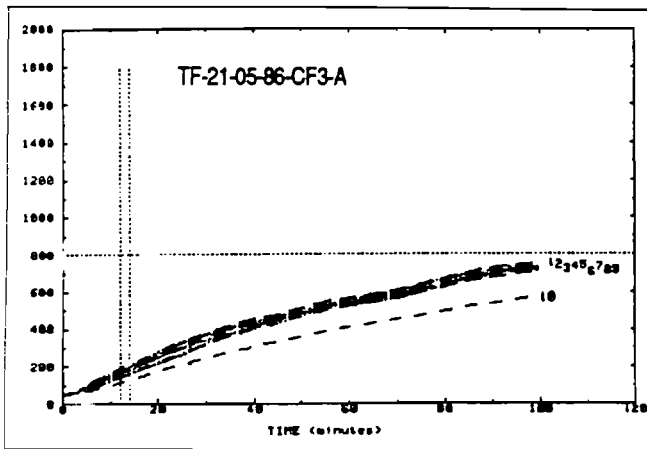
Fig. 15: Results of the first pool fire simulation with the aluminum plate insulated with ceramic fiber.

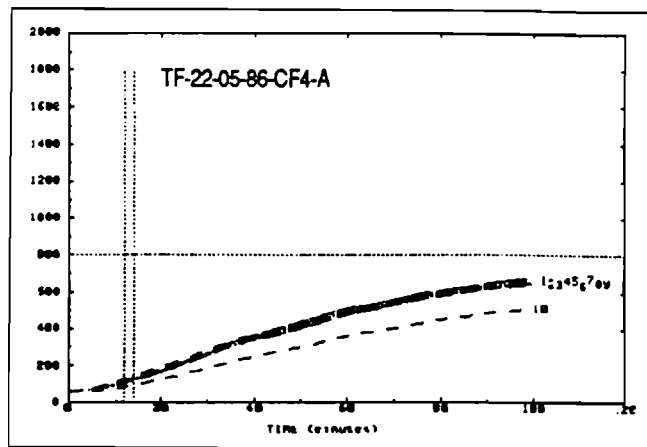
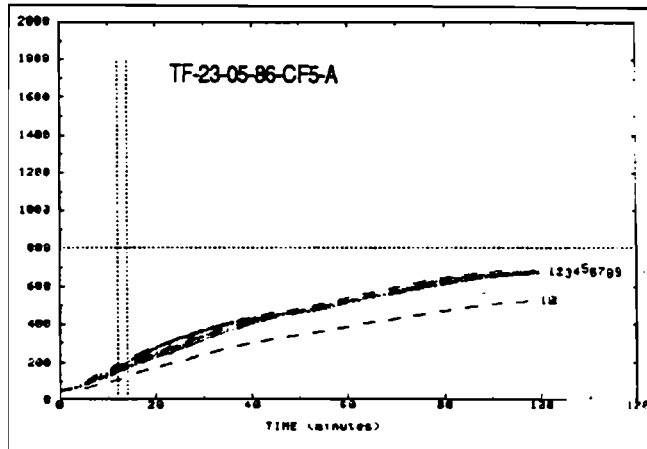
Fig. 16 and 17: Results of the second and third pool fire tests with the aluminum plate insulated by ceramic fiber.

Post test examinations of the specimens in both tests indicated that all components were in like-new condition.

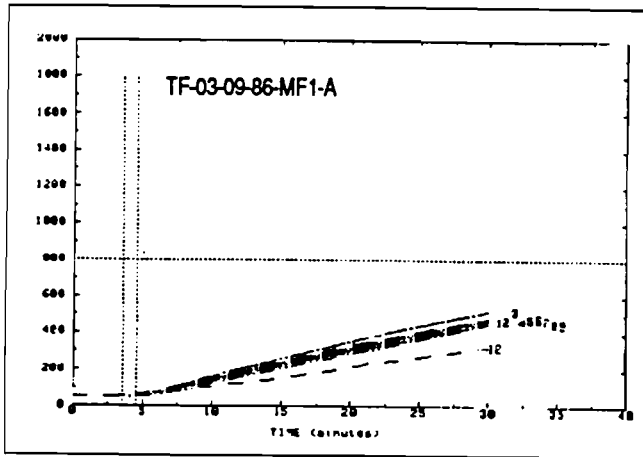
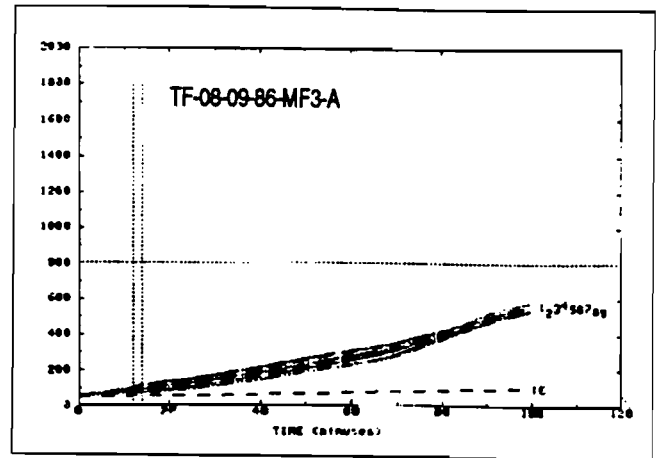
Figs. 18 and 19: First and second torch fire simulations of the aluminum plate insulated with mineral fiber.

The first test (Figure 18) shows the temperatures at all nine backplate thermocouples rising together in nearly straight lines on the graph. Jacket temperatures were high and steady, averaging 1,625 deg. F throughout the test. Good flame contact was made throughout the test.

Post test examination revealed that the insulation

had deteriorated to a certain degree. The foil scrim facing against the jacket had melted into pieces and the mineral fiber material was blackened through about half of its depth. The blanket did remain fully in place throughout the test. However, the blanket tended to break apart into pieces when it was removed from the backplate. This would indicate that a binding agent may have burned away within the blanket material. The aluminum plate was well protected during the test and no visible damage or warping was apparent.

The post test examination again revealed that the blanket was fully in place throughout the test, but that some deterioration had occurred from the heat. The foil scrim facing had been burned away and the insulation was partially blackened through. When removed from the backplate, the insulation broke apart into pieces, possibly indicating that a binding agent had been burned away. The aluminum plate was, again, in like-new condition.

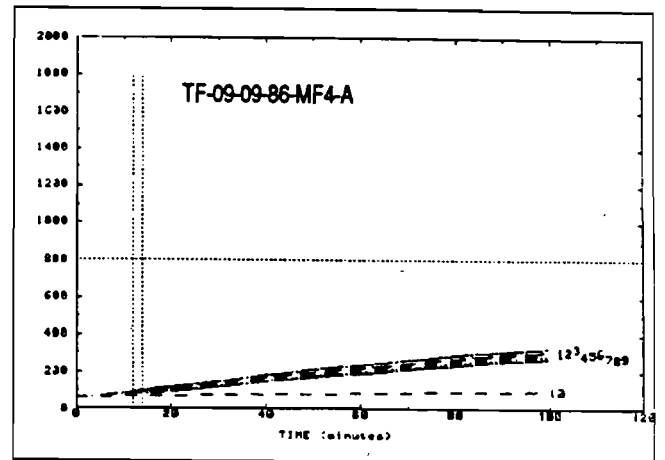
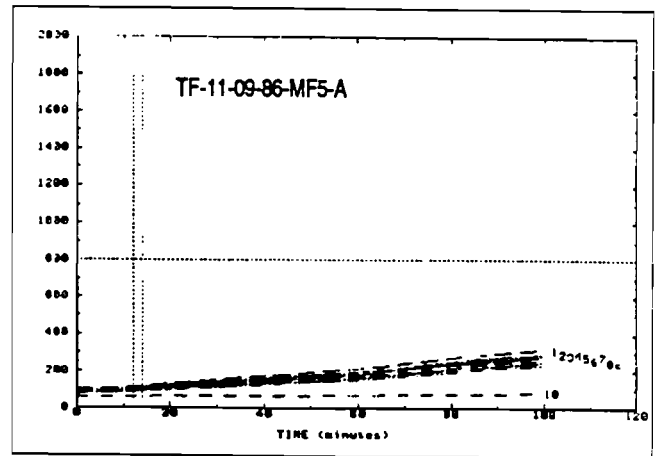
Figs. 20, 21 and 22: First, second and third pool fire simulations of the aluminum plate insulated with mineral fiber.

Results from the pool fire simulation tests are presented in Figures 20, 21, and 22. The calibrated nozzle-to-specimen-surface distance was 20 ft. 6 in. The mineral fiber insulation physically survived and easily surpassed the CFR standard for a pool-fire simulation test series.

An unexplained problem with channel 10 in all

three tests manifested itself in a cool, flat, almost unchanging temperature curve. However, no problems were experienced with the important backplate channels.

Post test examination of the mineral fiber specimen revealed that the blanket was fully in place over the aluminum backplate. The foil scrim facing tended to tear away as the jacket was removed. The blanket did not hold together as well as it had when new. The aluminum backplate was in like-new condition.
